SECTION 25 DRYING
PAD/BURIAL
TRENCH #1,
FACILITY ID
[fCS1912236570]

C-144/Closure
Approval

[289408]
LOGOS OPERATING, LLC
August 24, 2016

Photograph Log
Section 25 Burial Trench #1 and Drying Pad
WPX Energy Production, LLC

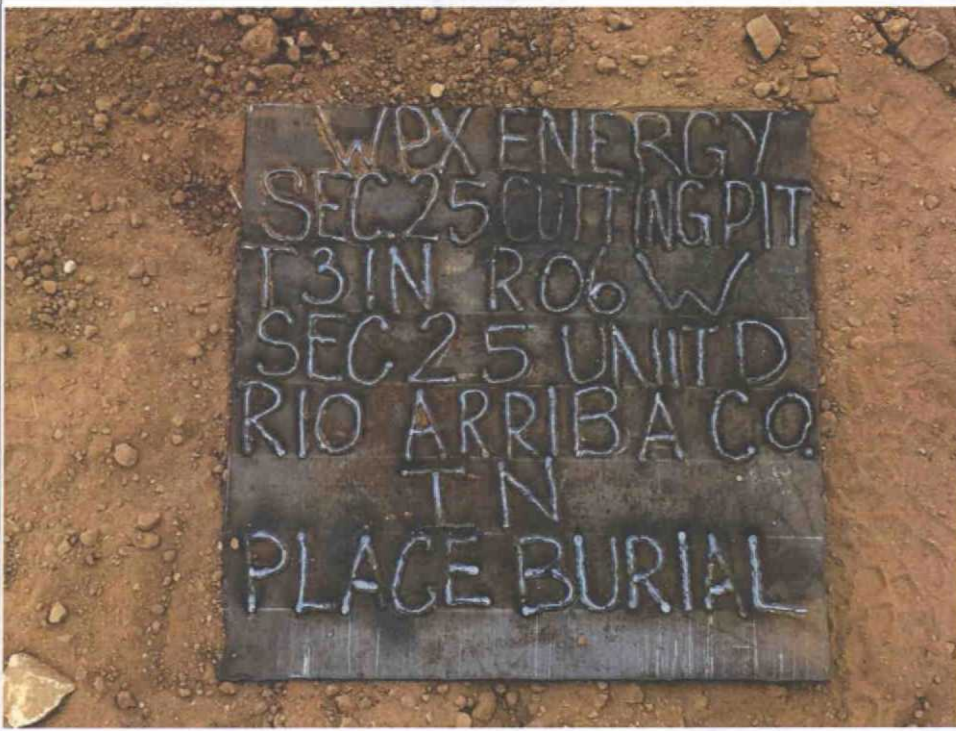
Photograph 1	
Site Name: Section 25 Burial Trench and Drying Pad	
Location: N36.873630, W107.419056 D-25-31N-06W Rio Arriba County, New Mexico	
Photo Taken by: Glenn Shelby	Description: Steel marker set marking location of buried cuttings trench.

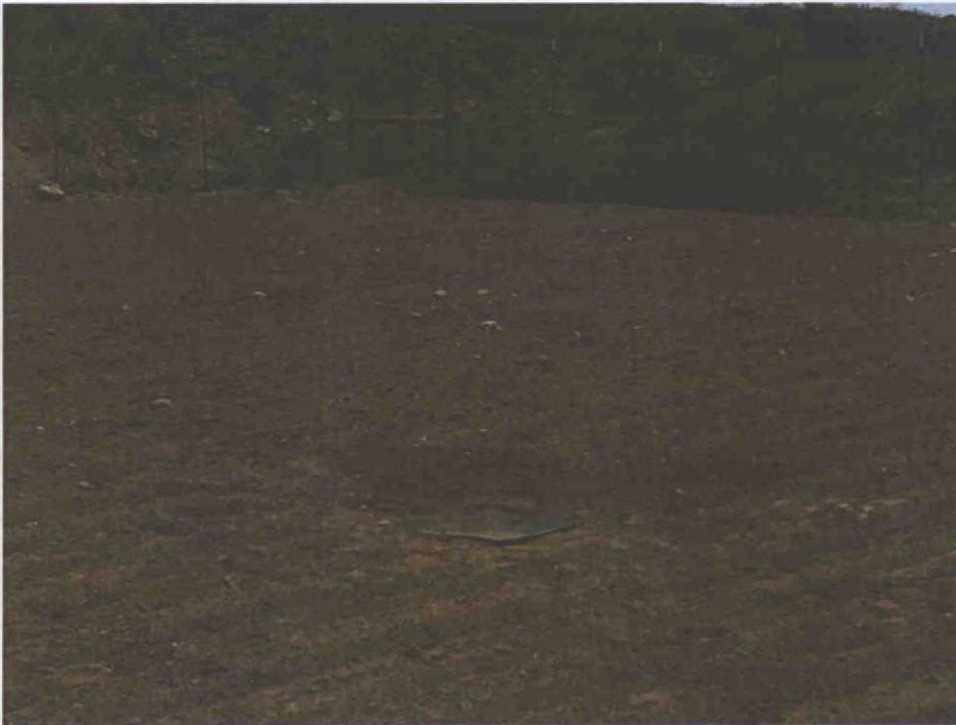
Photograph 2	
Site Name: Section 25 Burial Trench and Drying Pad	
Location: N36.873630, W107.419056 D-25-31N-06W Rio Arriba County, New Mexico	
Photo Taken by: Glenn Shelby	Description: Looking at burial trench with steel marker.

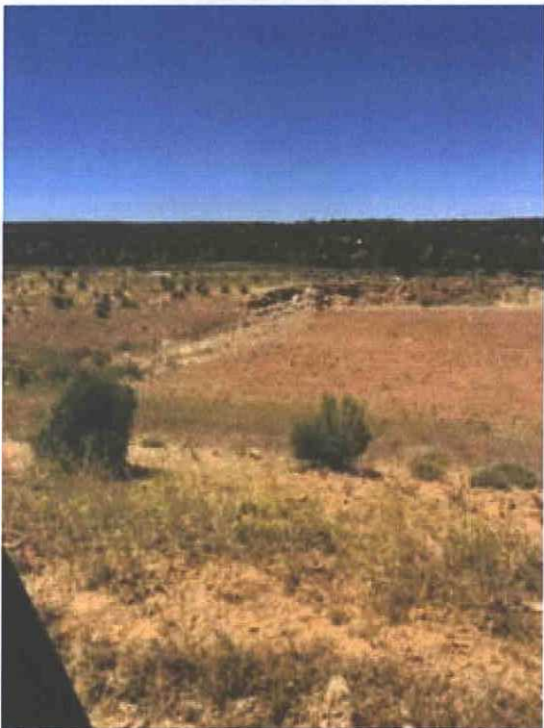
Photograph 3	
Site Name: Section 25 Burial Trench and Drying Pad	
Location: N36.873630, W107.419056 D-25-31N-06W Rio Arriba County, New Mexico	
Photo Taken by: Darrell Bays	Description: WSW, looking at covered burial trench.

Following cover, WPX covered the trench and the drying pad in order to prevent ponding (June 9, 2016). Final reclamation of the area will be completed during final reclamation of the quarry, this area is in use for production/future drilling projects. Upon final reclamation WPX will contour the location to approximately match previous topography meeting the Conditions of Approval in the APD and the direction offered by a BLM/USFS inspector.
