ANNUAL REPORT

2019

Annual Class III
Well Report
Llano Disposal, LLC
BW-37

API - 30-25-26370

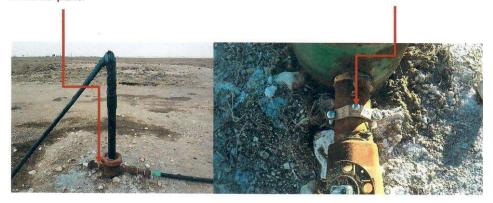
Llano Disposal LLC'S State 4 BSW #1 (BW037)

The existing wellhead was measured on the top screw of a brass clamp; leaving the wellhead on a horizontal plane.

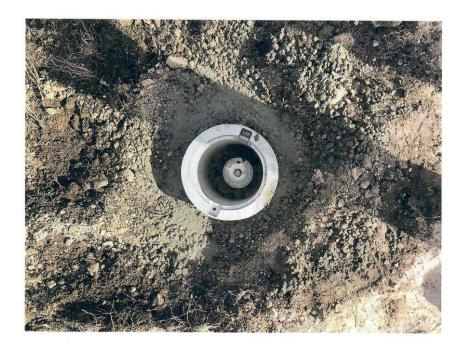
Subsidence Monument 1

A Berntsen three quarter inch Aluminum Top Security Sleeve Monument was set. It consists of a rod driven till refusal into a pre drilled three-foot deep hole with a twelve inch diameter. The sleeved rod is encased in six-inch PVC filled with sand, then topped with a Datum Point and an Aluminum Floating Datum Cap. It is then capped with an Access Cover that must be removed with a flathead screw driver or similar tool. The Monument is pictured below:
