C-147 REGISTRATION PACKAGE

NE Lybrook 2306-06P WSW Pad
Recycling Containment and Recycling Facility

April 2025

ENDURING RESOURCES IV, LLC

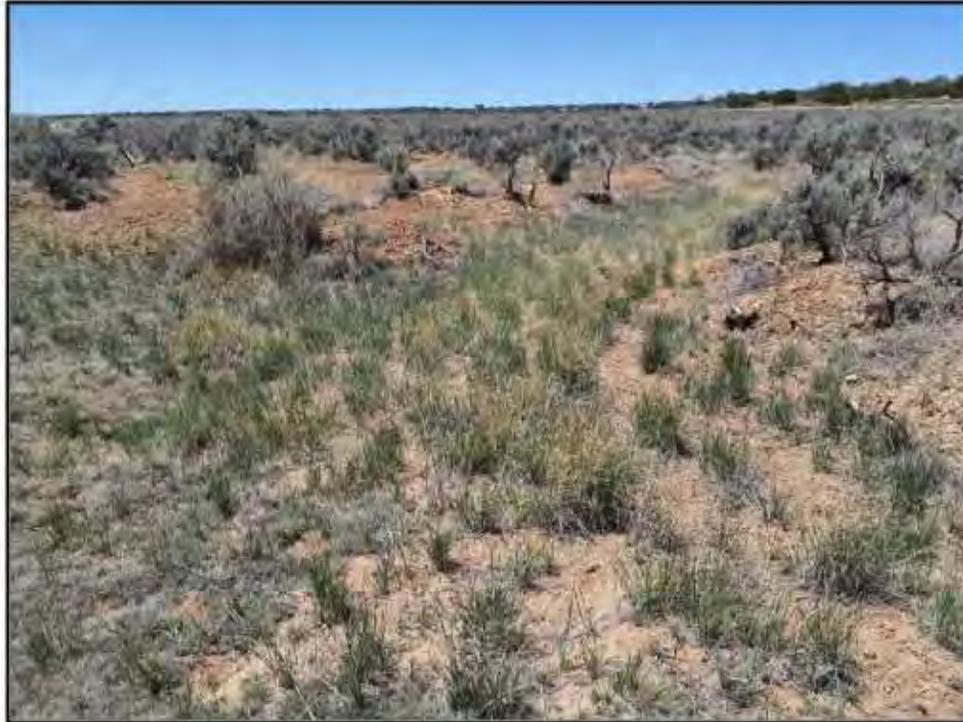
Photograph B-1. Overview of ST01, a non-wetland surface aquatic feature (stream) not containing an OHWM, facing upstream (north).

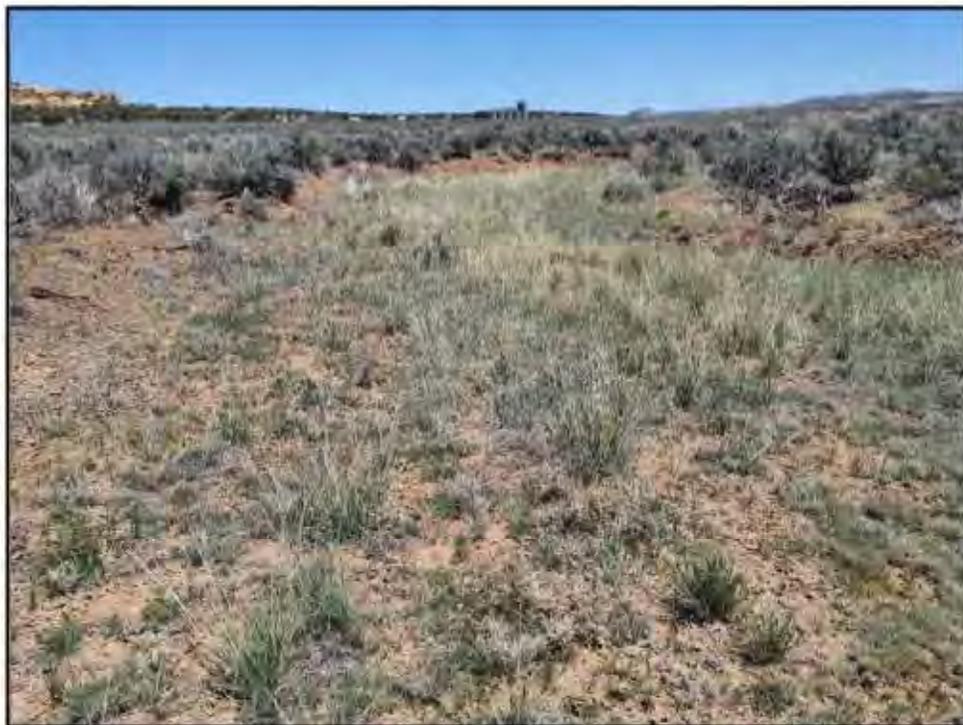
Photograph B-2. Overview of ST01, a non-wetland surface aquatic feature (stream) not containing an OHWM, facing downstream (southeast).

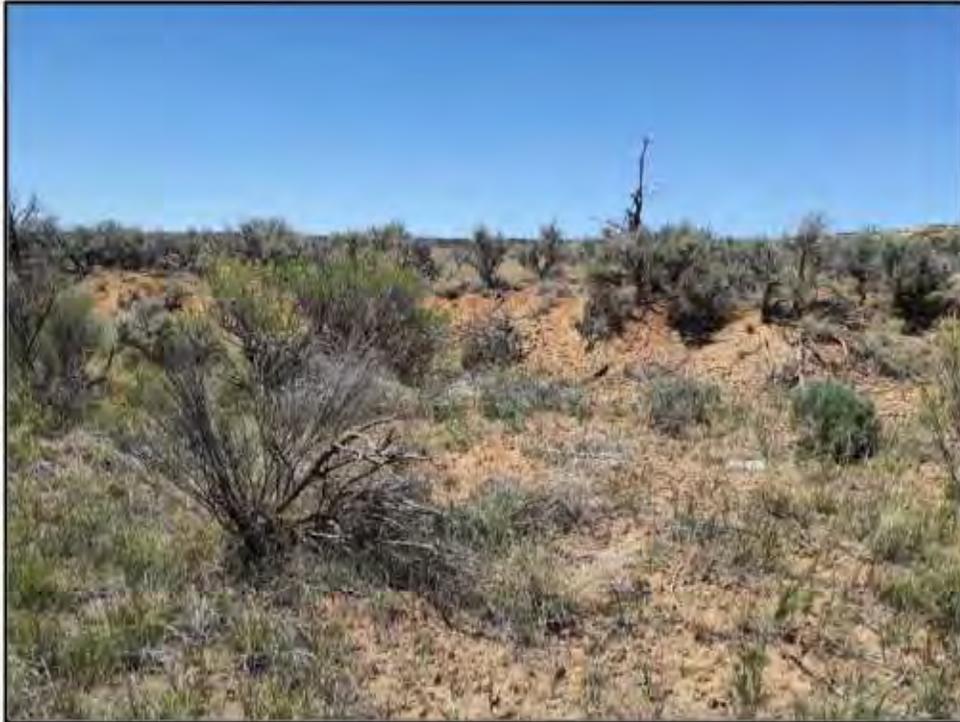
Photograph B-3. Overview of ST02, a non-wetland surface aquatic feature (stream) not containing an OHWM, facing upstream (northeast).

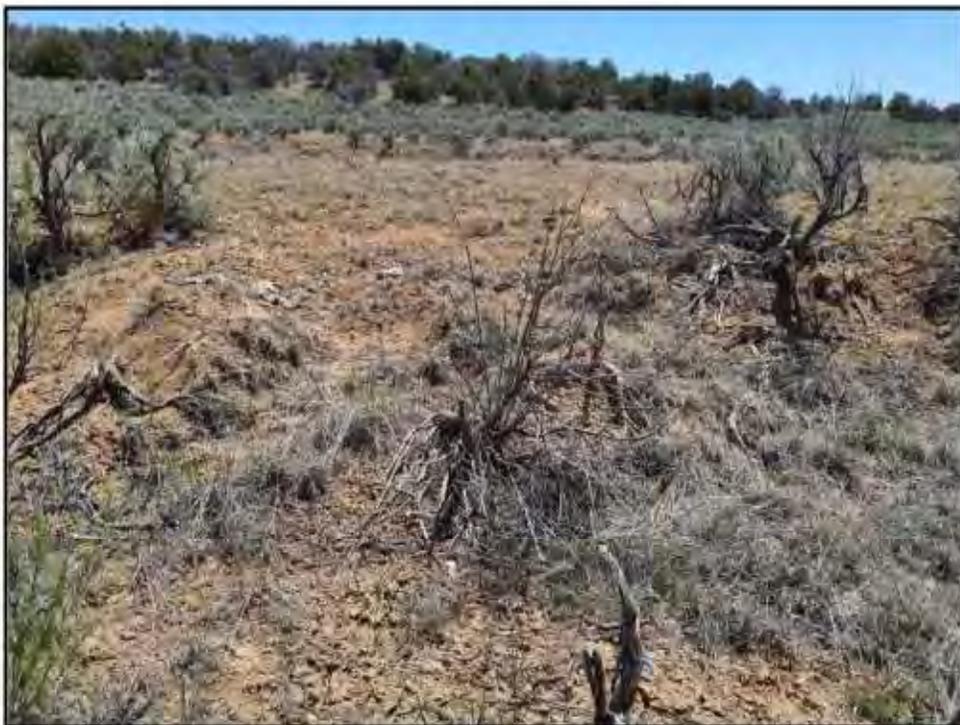
Photograph B-4. Overview of ST02, a non-wetland surface aquatic feature (stream) not containing an OHWM, facing downstream (southwest).

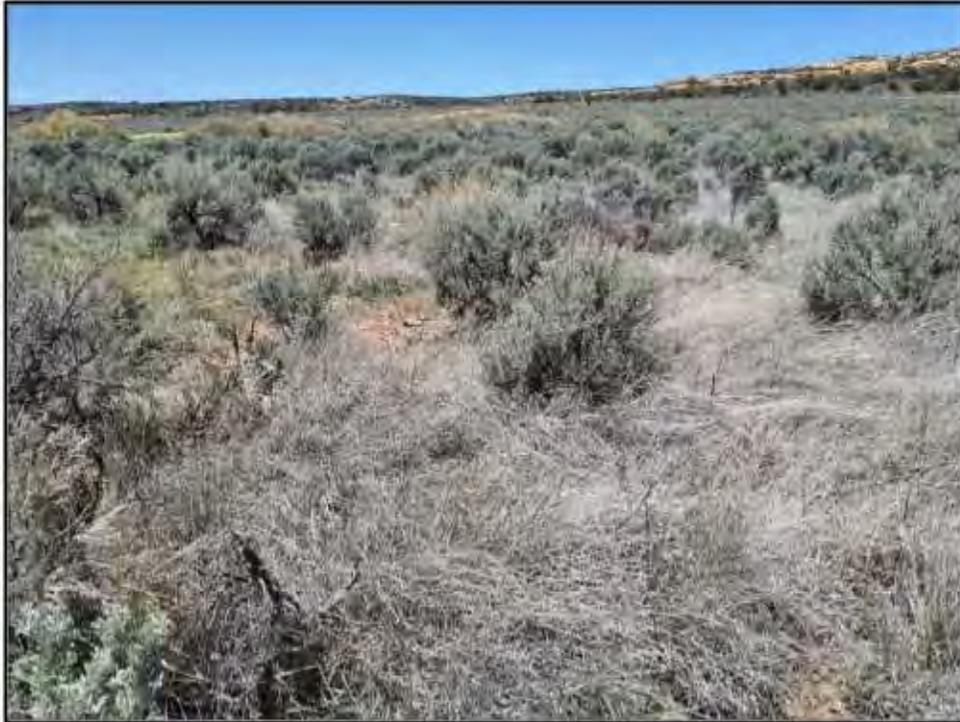
Photograph B-5. Overview of ST03, a non-wetland surface aquatic feature (stream) not containing an OHWM, facing upstream (northwest).

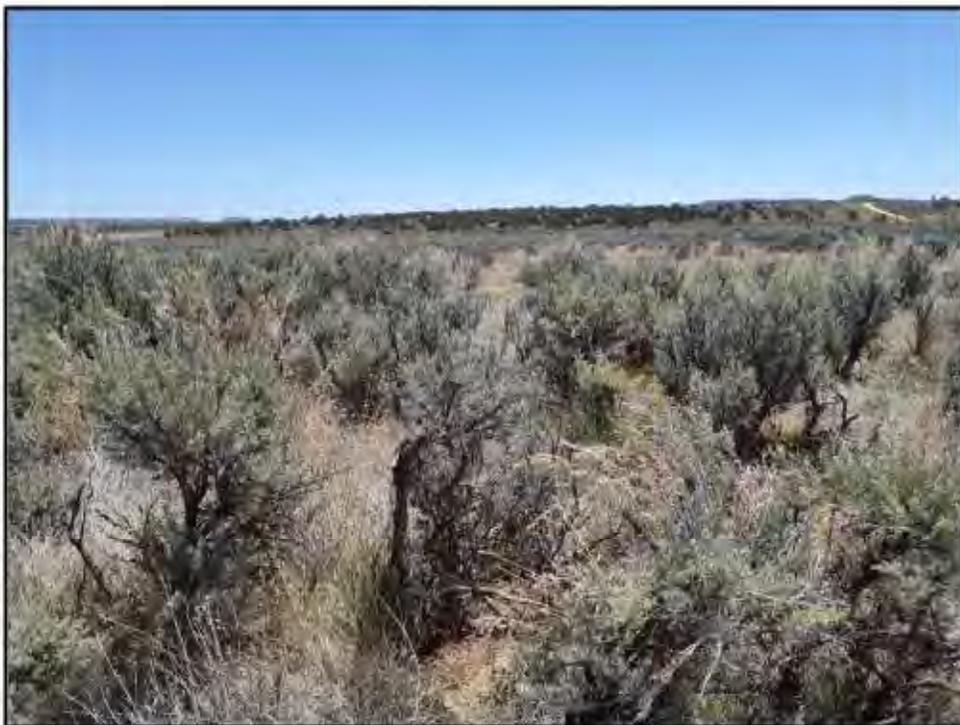
Photograph B-6. Overview of ST03, a non-wetland surface aquatic feature (stream) not containing an OHWM, facing downstream (southeast).

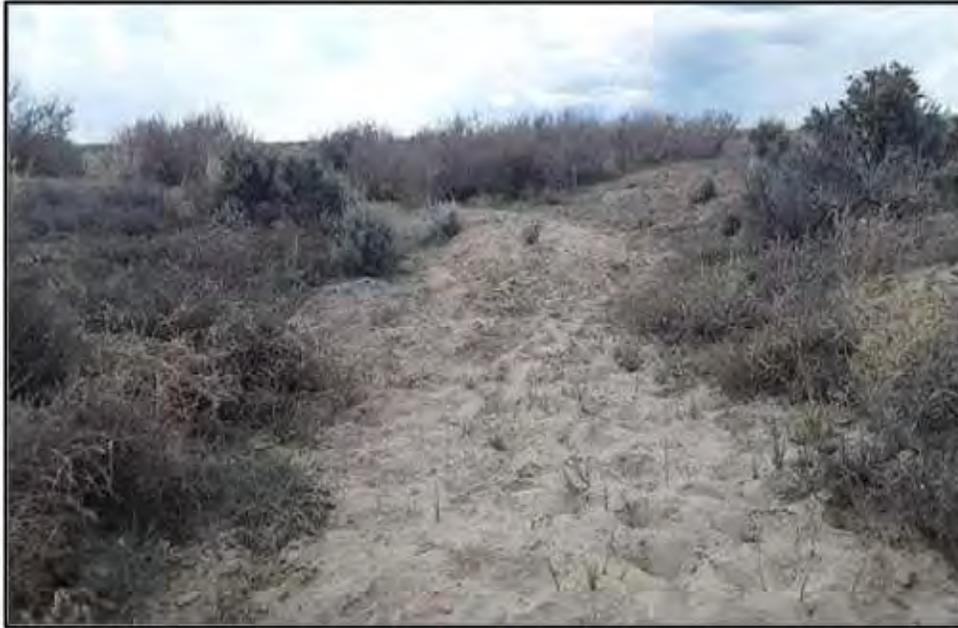
Photograph B-7. Overview of ST04, a non-wetland surface aquatic feature (stream) containing an OHWM, facing upstream (west).

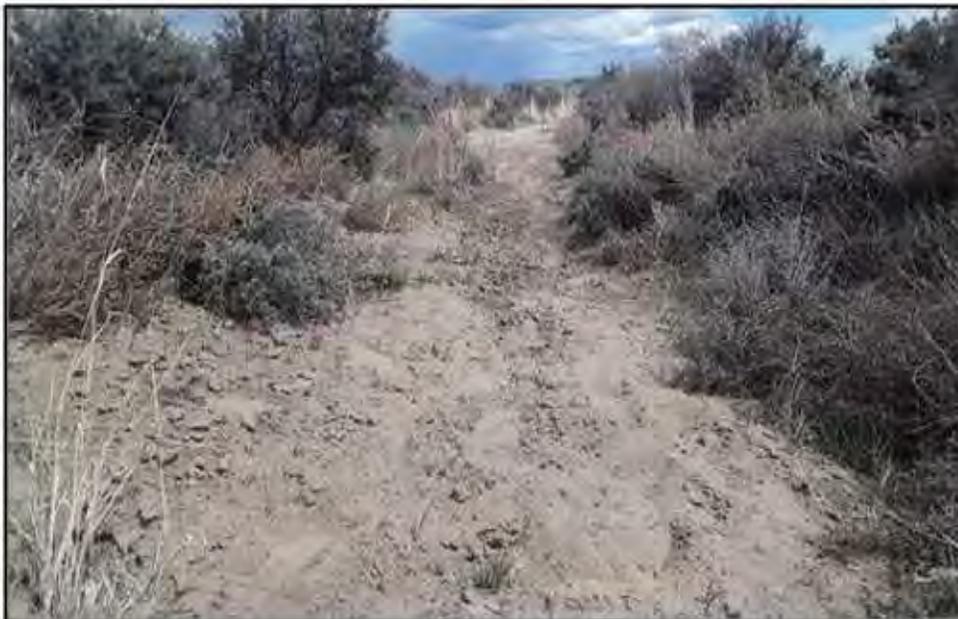
Photograph B-8. Overview of ST04, a non-wetland surface aquatic feature (stream) containing an OHWM, facing downstream (east).

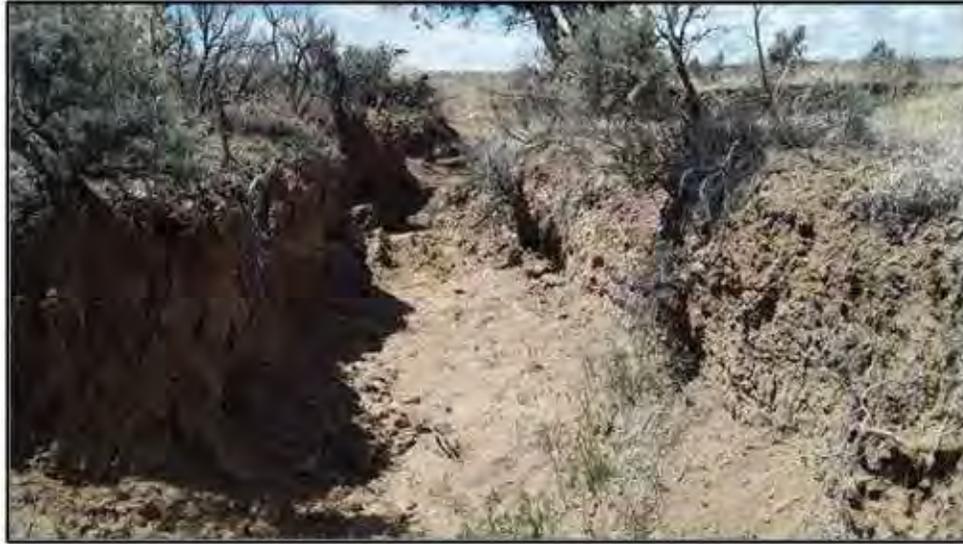
Photograph B-9. Overview of ST05, a non-wetland surface aquatic feature (stream) containing an OHWM, facing upstream (northwest).

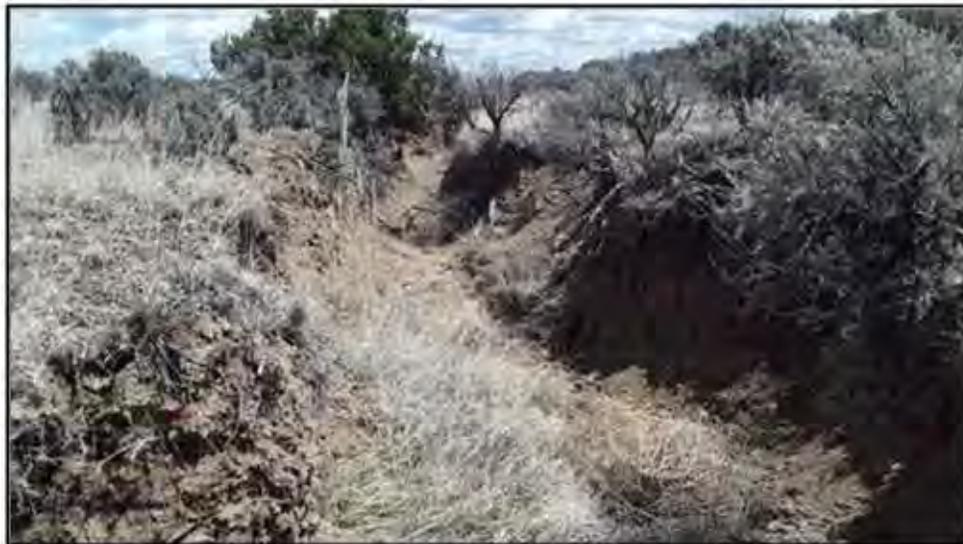
Photograph B-10. Overview of ST05, a non-wetland surface aquatic feature (stream) containing an OHWM, facing downstream (southeast).

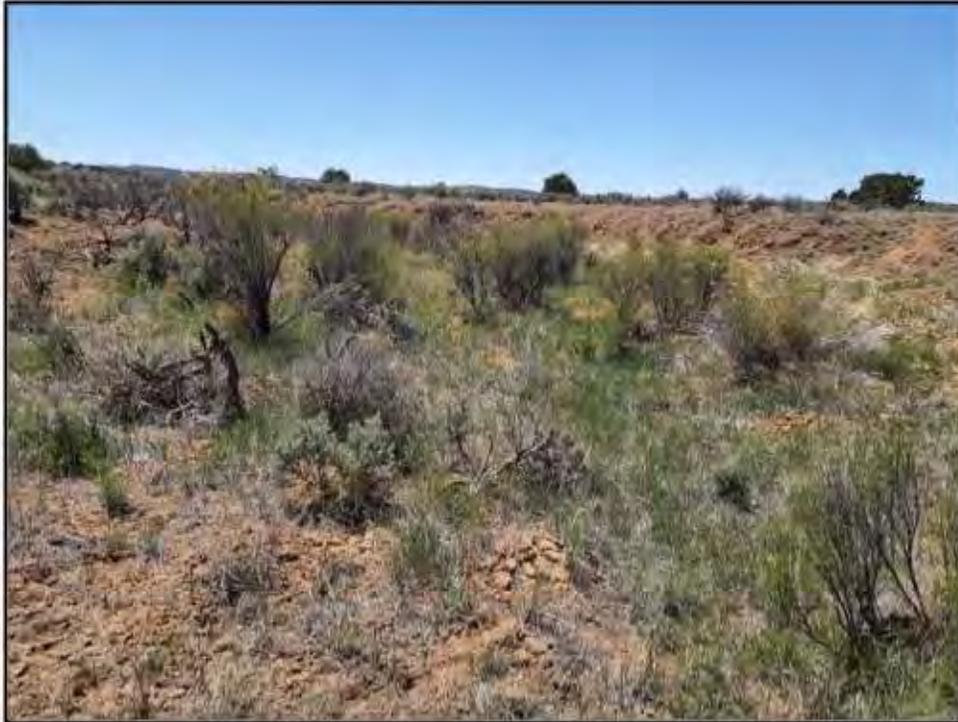
Photograph B-11. Overview of ST06, a non-wetland surface aquatic feature (stream) not containing an OHWM, facing upstream (northwest).

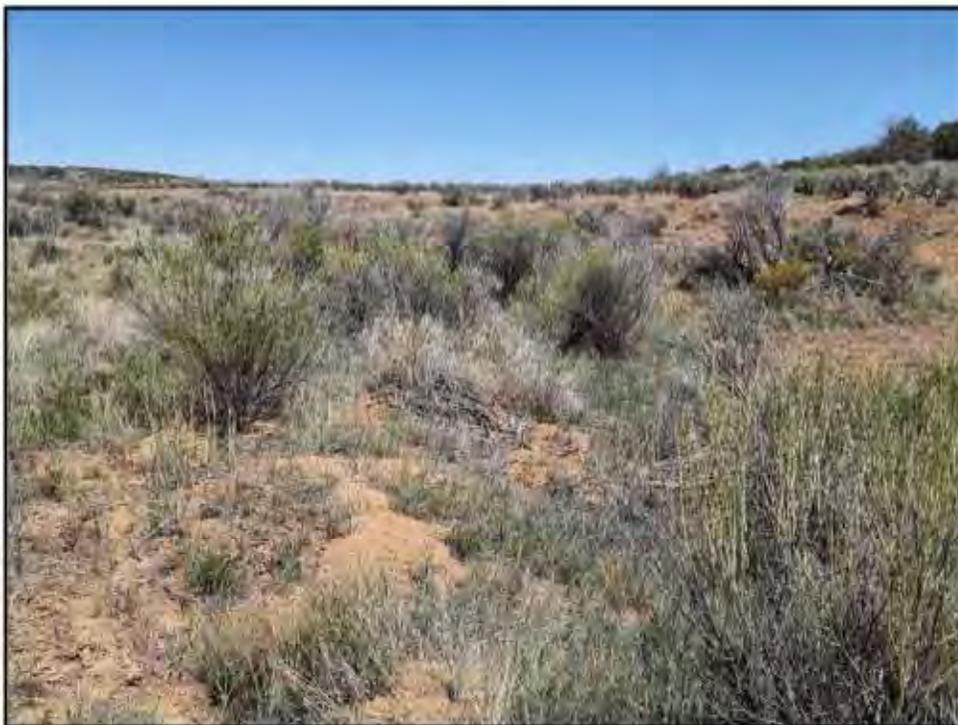
Photograph B-12. Overview of ST06, a non-wetland surface aquatic feature (stream) not containing an OHWM, facing downstream (southeast).

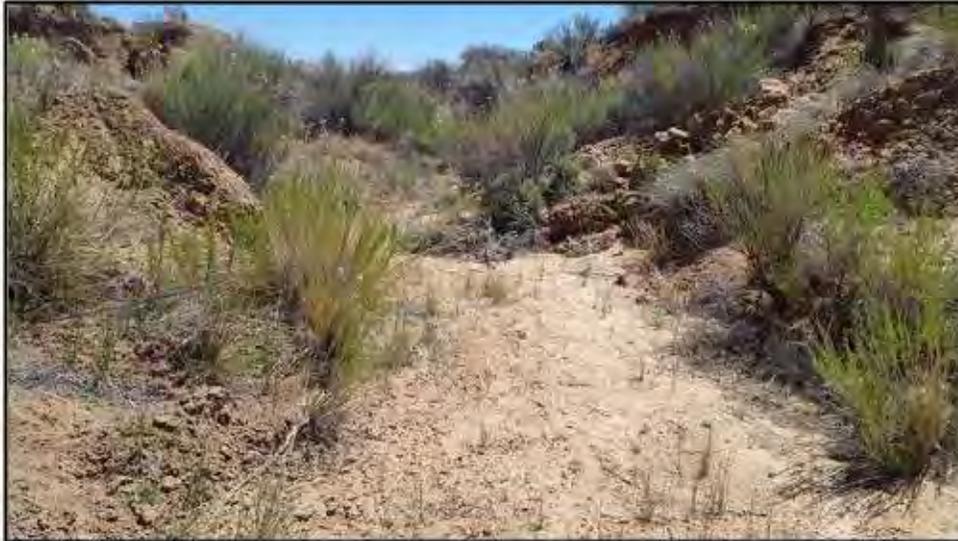
Photograph B-13. Overview of ST07, a non-wetland surface aquatic feature (stream) containing an OHWM, facing upstream (northwest).

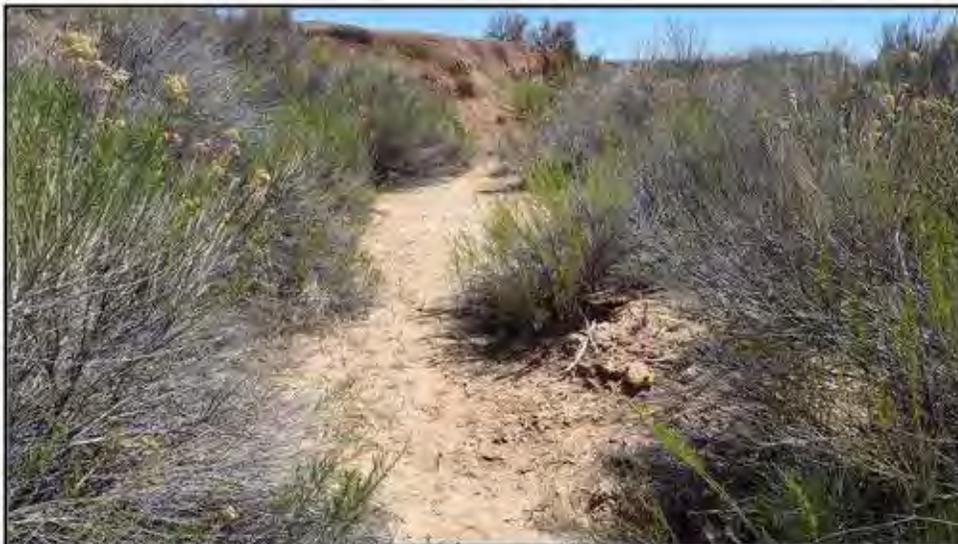
Photograph B-14. Overview of ST07, a non-wetland surface aquatic feature (stream) containing an OHWM, facing downstream (southeast).

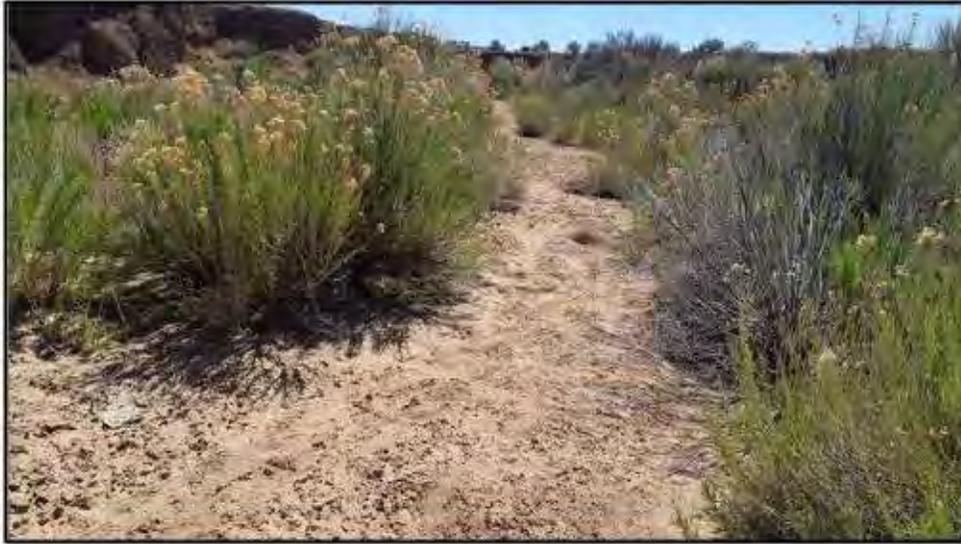
Photograph B-15. Overview of ST08, a non-wetland surface aquatic feature (stream) containing an OHWM, facing upstream (northwest).

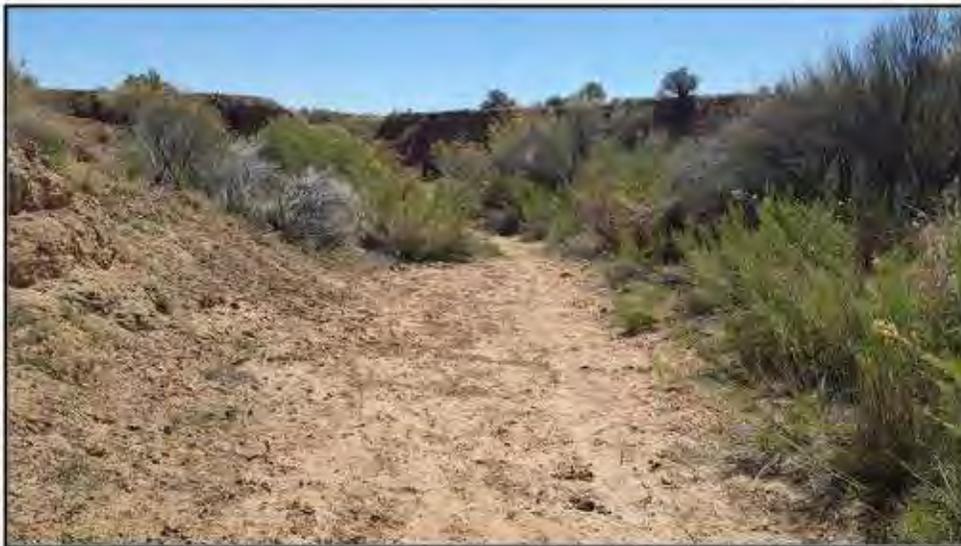
Photograph B-16. Overview of ST08, a non-wetland surface aquatic feature (stream) containing an OHWM, facing downstream (southeast).

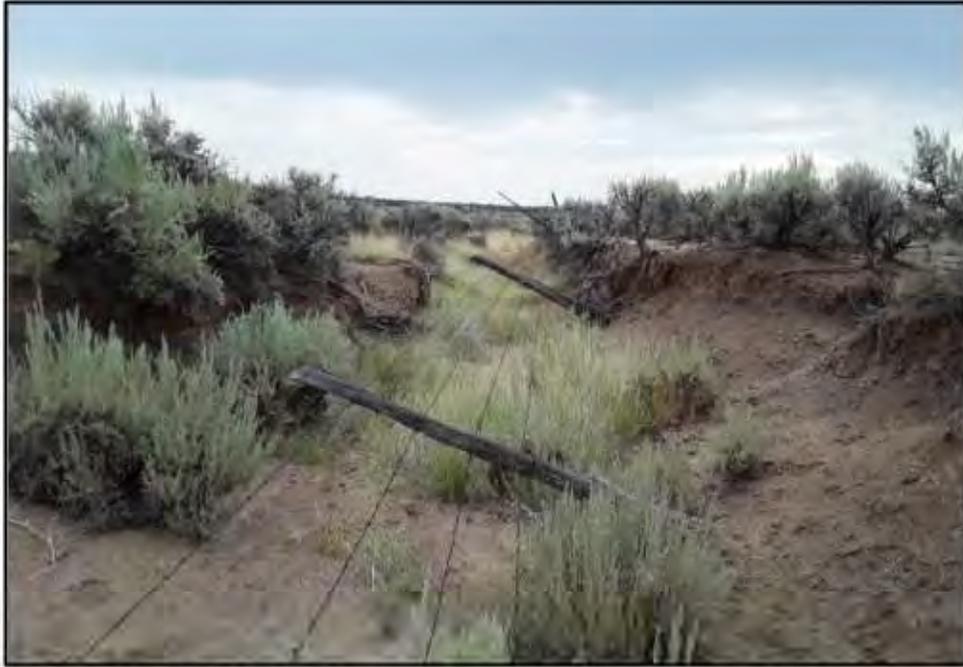
Photograph B-17. Overview of EF04, a non-wetland erosional feature (stream) not containing an OHWM, facing upstream (northeast).
