Release Notification

Site Name: Wool Head B Battery	Site Type: Tank Battery
Date Release Discovered: 06/07/2020 @ 23:00	API#

Characterization, Workplan, & Closure
Incident ID: NRM2016453805
AEP #: 06072020-2300-prodops
Location: Wool Head "B" Pad Battery

Site Map	Plate 01
Wool Head B Pad 06072020 AEP #: 06072020-2300-prodops	09/21/2020

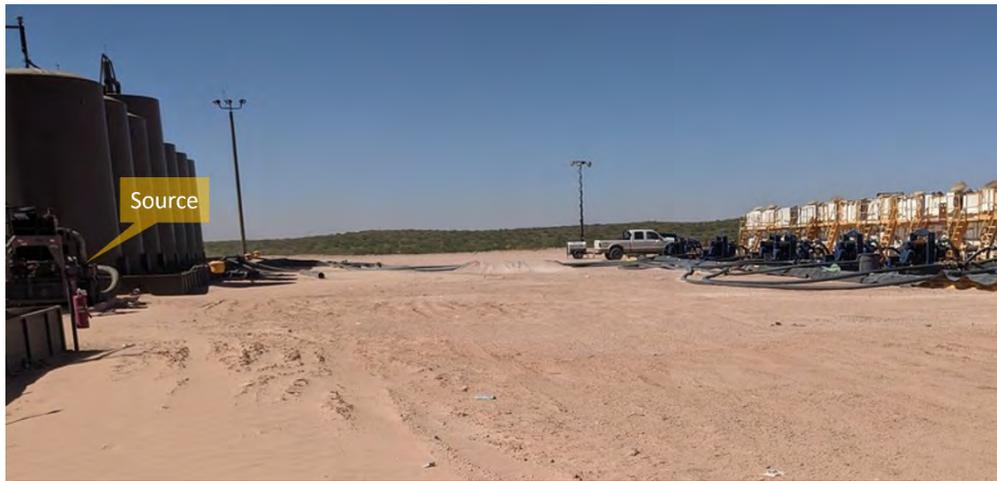
Cause of Release: Actuator valve failed to open causing pump to over pressure Poly Transition on Pump causing a rupture in pipe resulting in a release of approximately 10 bbls. Outside containment on Location. Release contained on production pad. 35' x 75' approximately produced water residue.

The produced water release occurred on June 07, 2020 caused by an actuator valve failing to open causing pump to over pressure the poly-transition fitting on the pump, thus causing a rupture in pipe resulting in a release of approximately 10 bbls. The release was outside of the tank battery containment and remained on an active production pad. The release covered an area of approximately 11,874 sq. ft. The source of the release is at coordinates 32.4578074, -103.5915909 (Latitude/Longitude; NAD 83). The release occurred of State surface.

Figure 1: Photo of release area on June 9, 2020. Photo is viewing south from northeast release extent. GPS: 32.4581456 N, -103.5917231 W. Date: 2020-06-09 09:58:37

As discussed above, soil samples obtained during characterization exhibit chloride and hydrocarbon concentrations, within the upper 2-feet, below the most stringent closure criteria listed in Table 1 of 19.15.29 NMAC. Furthermore, soil sample results from 1 to 2-feet below ground surface (bgs) show a decrease in chloride concentrations with the exception of 'HA East' that exhibited a chloride concentration of 128 mg/kg at 0 to 1-foot and 1 to 2-feet. TPH, benzene, and BTEX were below laboratory detection limits in all samples.

Therefore, we propose "No Further Action" and ask for closure of the regulatory file. The release extent remains on an active production pad for oil and gas operations (Figure 1).

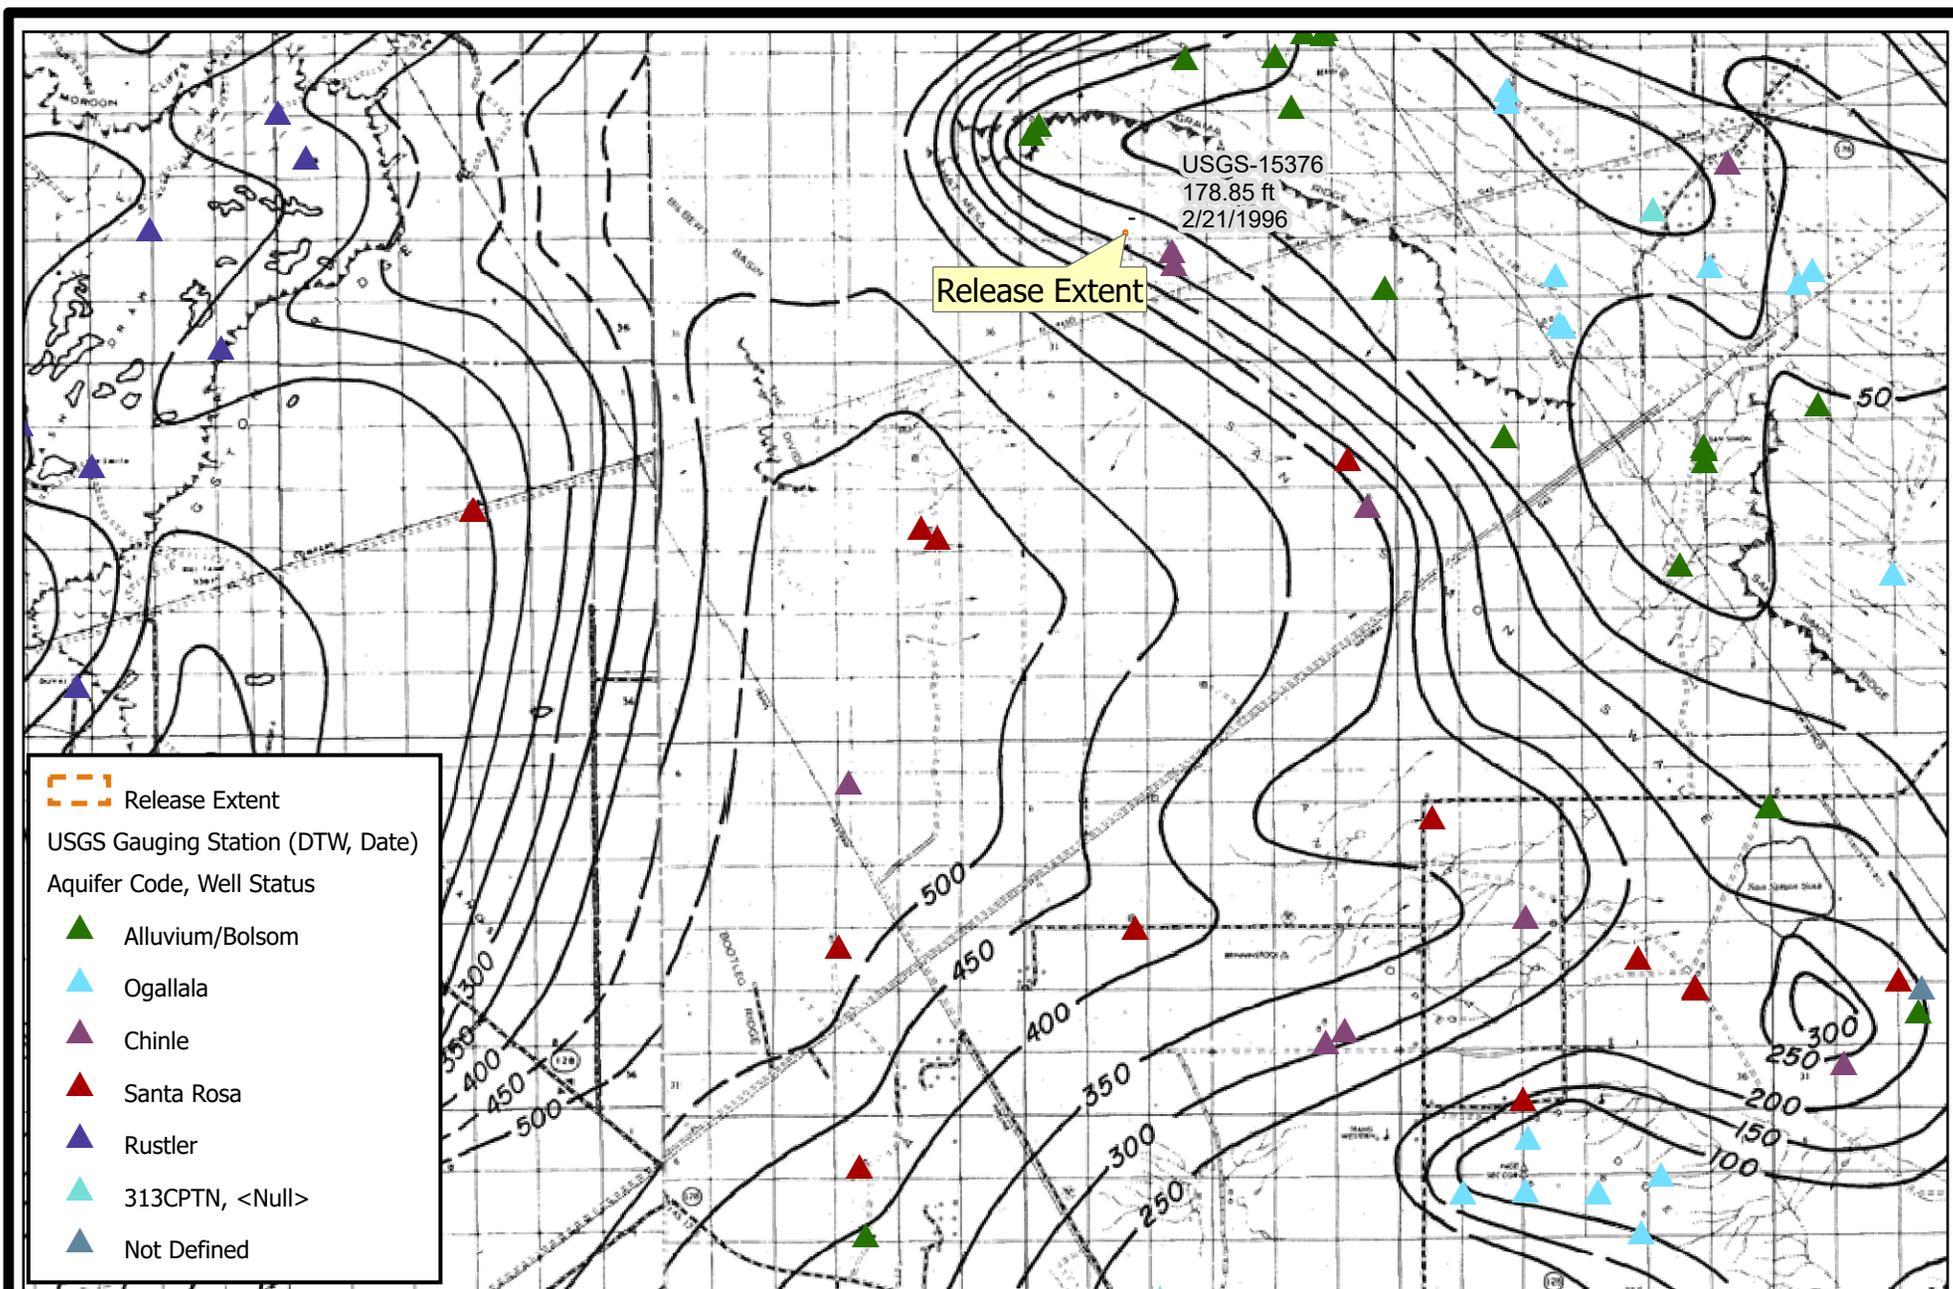
Depth to Water
 Base Map: OFR-95
 Wool Head B Pad 06072020
 AEP #: 06072020-2300-prodops

What is the shallowest depth to groundwater beneath the area affected by the release? <u>Plate 2</u>	___203___ (ft bgs)
Did this release impact groundwater or surface water?	<input type="checkbox"/> Yes <input checked="" type="checkbox"/> No
Are the lateral extents of the release within 300 feet of a continuously flowing watercourse or any other significant watercourse? <u>Plate 4</u>	<input type="checkbox"/> Yes <input checked="" type="checkbox"/> No
Are the lateral extents of the release within 200 feet of any lakebed, sinkhole, or playa lake (measured from the ordinary high-water mark)? <u>Plate 4</u>	<input type="checkbox"/> Yes <input checked="" type="checkbox"/> No
Are the lateral extents of the release within 300 feet of an occupied permanent residence, school, hospital, institution, or church? <u>Plate 5</u>	<input type="checkbox"/> Yes <input checked="" type="checkbox"/> No
Are the lateral extents of the release within 500 horizontal feet of a spring or a private domestic fresh water well used by less than five households for domestic or stock watering purposes? <u>Plate 3</u>	<input type="checkbox"/> Yes <input checked="" type="checkbox"/> No

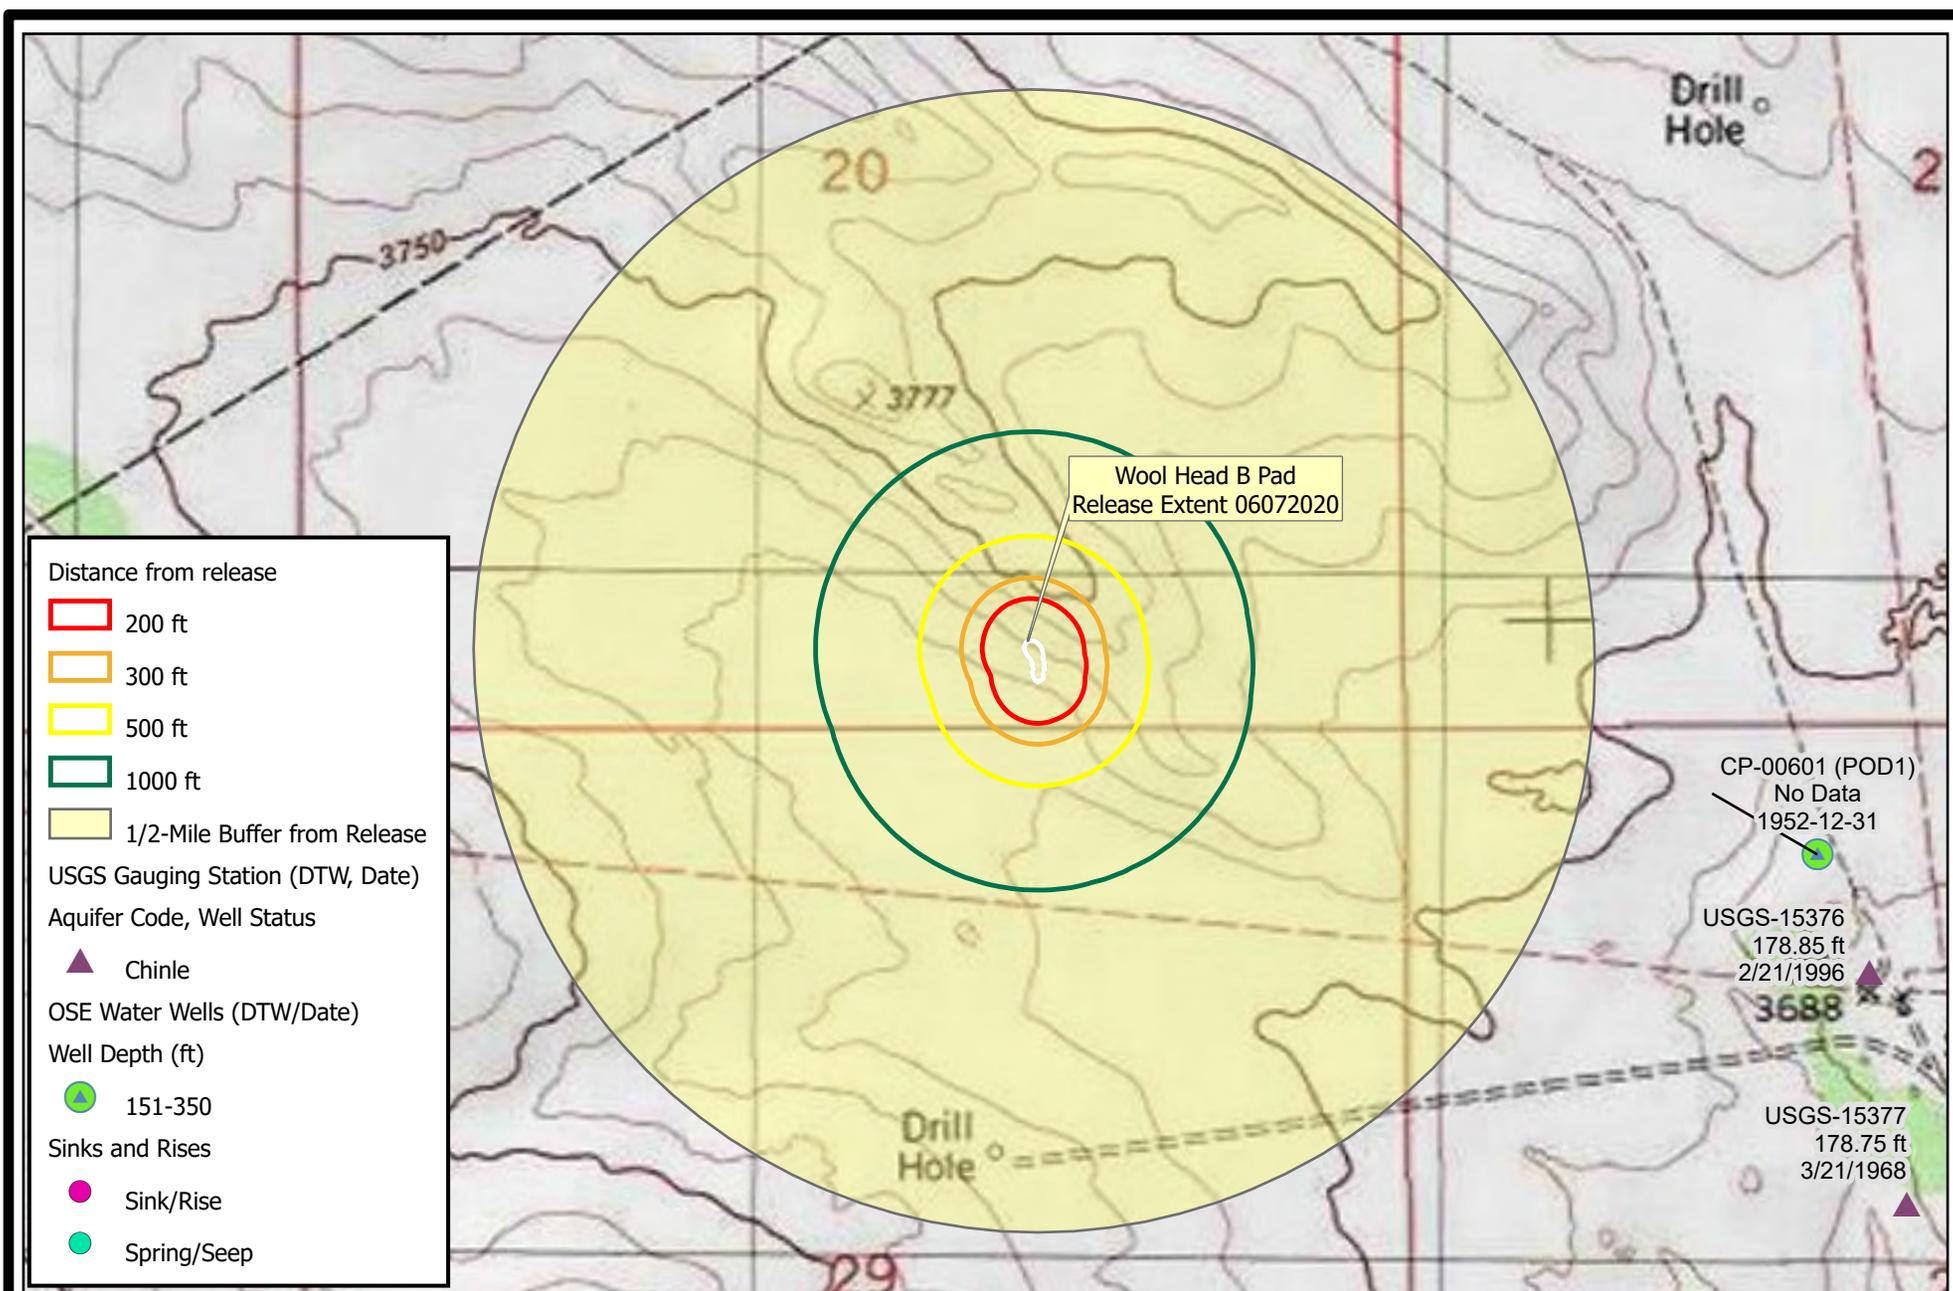
Wellhead Protection	Plate 03
Wool Head B Pad 06072020 AEP #: 06072020-2300-prodops	09/21/2020

Are the lateral extents of the release within 1000 feet of any other fresh water well or spring? <u>Plate 3</u>	<input type="checkbox"/> Yes <input checked="" type="checkbox"/> No
Are the lateral extents of the release within incorporated municipal boundaries or within a defined municipal fresh water well field? <u>Plate 3</u>	<input type="checkbox"/> Yes <input checked="" type="checkbox"/> No
Are the lateral extents of the release within 300 feet of a wetland? <u>Plate 6</u>	<input type="checkbox"/> Yes <input checked="" type="checkbox"/> No
Are the lateral extents of the release overlying a subsurface mine? <u>Plate 7</u>	<input type="checkbox"/> Yes <input checked="" type="checkbox"/> No
Are the lateral extents of the release overlying an unstable area such as karst geology? <u>Plate 8</u>	<input type="checkbox"/> Yes <input checked="" type="checkbox"/> No
Are the lateral extents of the release within a 100-year floodplain? <u>Plate 9</u>	<input type="checkbox"/> Yes <input checked="" type="checkbox"/> No
