State of New Mexico  
Energy Minerals and Natural  
Resources Department  
Oil Conservation Division  
1220 South St. Francis Dr.  
Santa Fe, NM 87505

## **CLOSURE REQUEST AND REMEDIATION SUMMARY REPORT**

**Centennial Resource Development, Inc.**  
**Pirate State CTB 1**  
**Lea County, New Mexico**  
**Unit Letter "A", Section 16, Township 24 South, Range 34 East**  
**Latitude 32.22384° North, Longitude 103.46814° West**  
**NMOCD Reference # NRH2012164856**

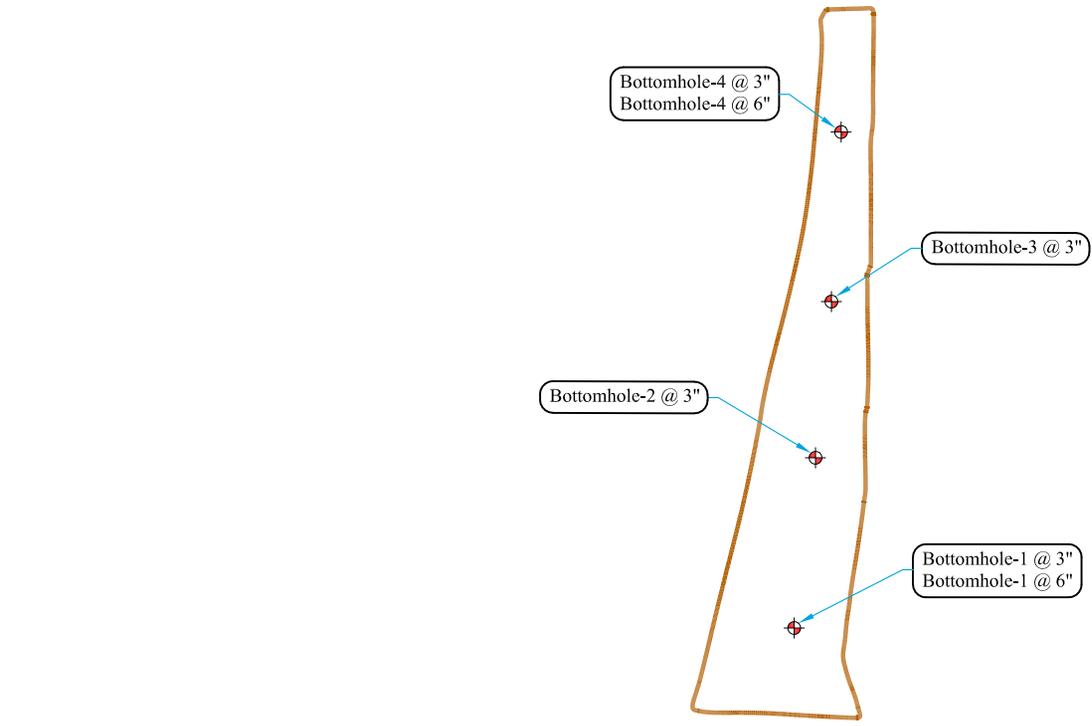
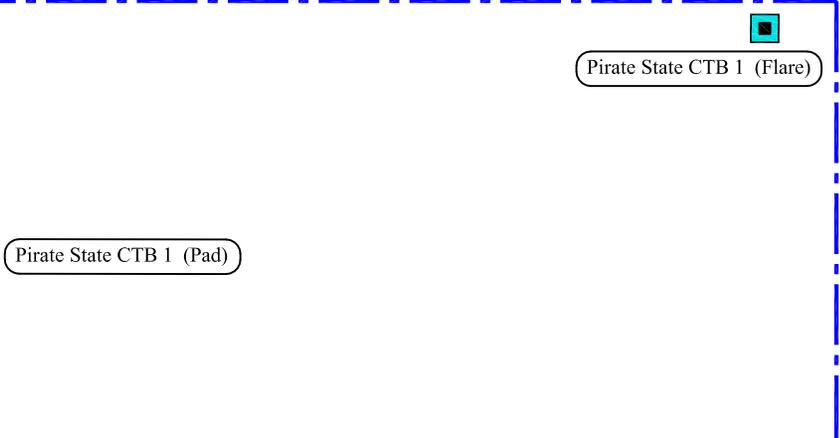
Job No.: <span style="font-size: large; font-weight: bold;">1226-12387</span>	<span style="font-size: large; font-weight: bold;">Figure 2</span>
--	--

Site - Pirate State CTB 1  
 Confirmation Soil Sample Location Map  
 Centennial Resources Development, Inc.  
 Lea County, NM  
 N 32.224384°, W 103.467814°  
 September 2020

= Bottomhole Samples  
 = Flare  
 Excavation Perimeter  
 Site Perimeter

and analyzed for benzene, toluene, ethylbenzene, and xylene (BTEX) using EPA Method SW 846-8021B, Total Petroleum Hydrocarbons (TPH) using EPA Method SW 846-8015M, and chloride using EPA Method E 300.0. A review of laboratory analytical results indicated additional excavation activities were necessary in the area represented by Bottomhole-1 @ 3" due to elevated TPH concentrations and in the area represented by Bottomhole-4 @ 3" due to detectable BTEX concentrations. Please reference Figure 2 for site details and soil sampling locations.

On August 13, 2020, following additional excavation activities, two (2) composite confirmation soil samples (Bottomhole-1 @ 6" and Bottomhole-4 @ 6") were collected from the further excavated areas. The samples were submitted to PBELAB for BTEX and/or TPH analysis. Please reference Figure 2 for site details and soil sampling locations. A review of laboratory analytical results indicated all collected soil samples were below applicable NMOCD limits.

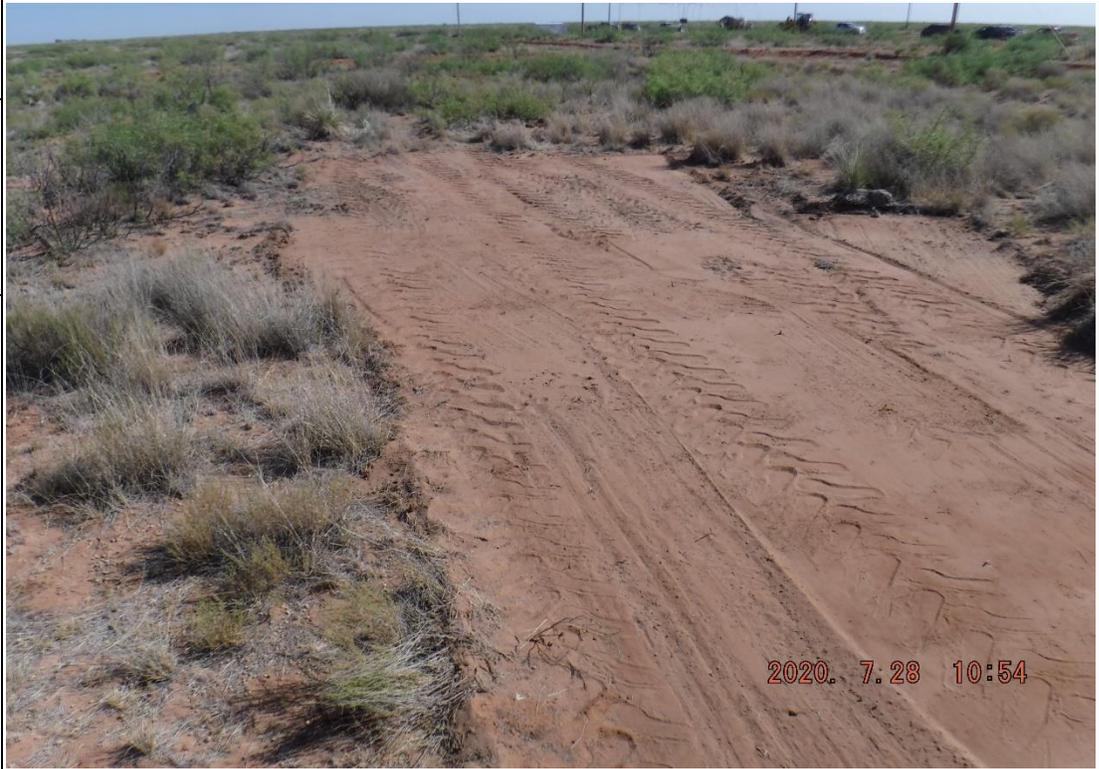
<b>Photo No:</b> 3.

<b>Direction Taken:</b> Northeast	
<b>Description:</b> View of the excavated area.

On July 28, 2020, Etech commenced excavation activities at the Release Site utilizing a backhoe and manual means. Excavated soil was stockpiled on site awaiting disposal. Etech, on behalf of Centennial, collected four (4) composite confirmation soil samples (Bottomhole-1 @ 3", Bottomhole-2 @ 3", Bottomhole-3 @ 3", and Bottomhole-4 @ 3") from the excavated area. Soil samples were submitted to Permian Basin Environmental Lab, LP. (PBELAB) in Midland, Texas

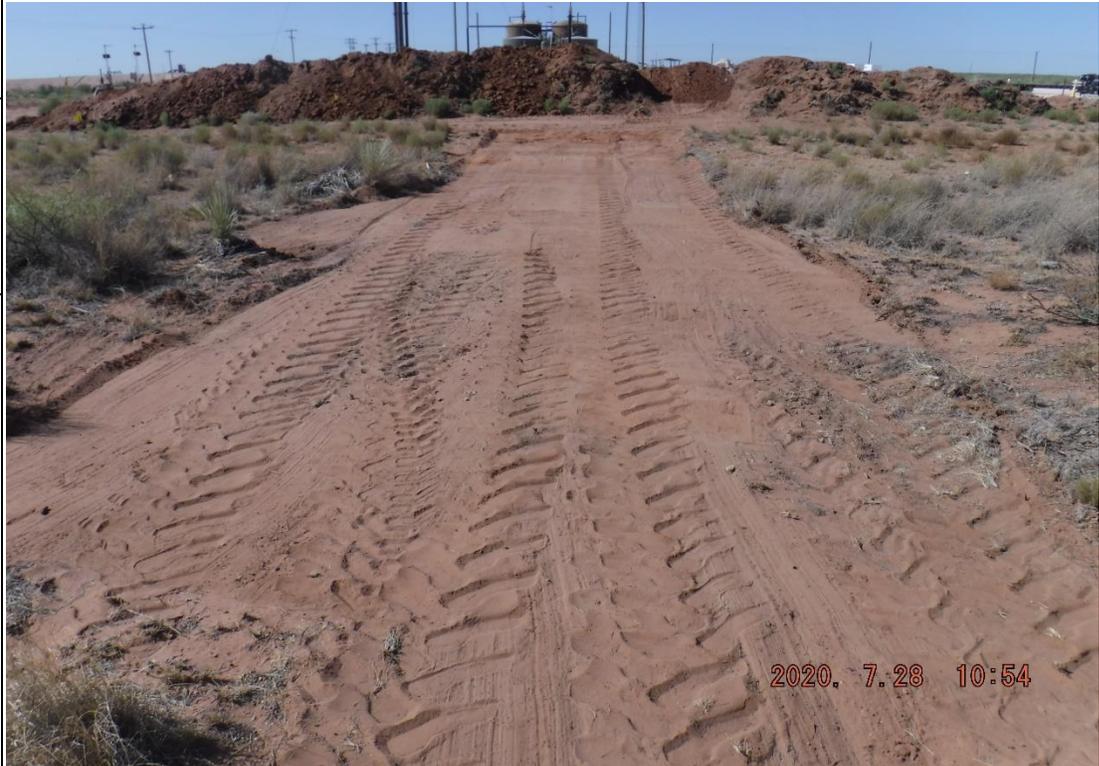
<b>Photo No:</b> 4.

<b>Direction Taken:</b> South	
<b>Description:</b> View of the excavated area.

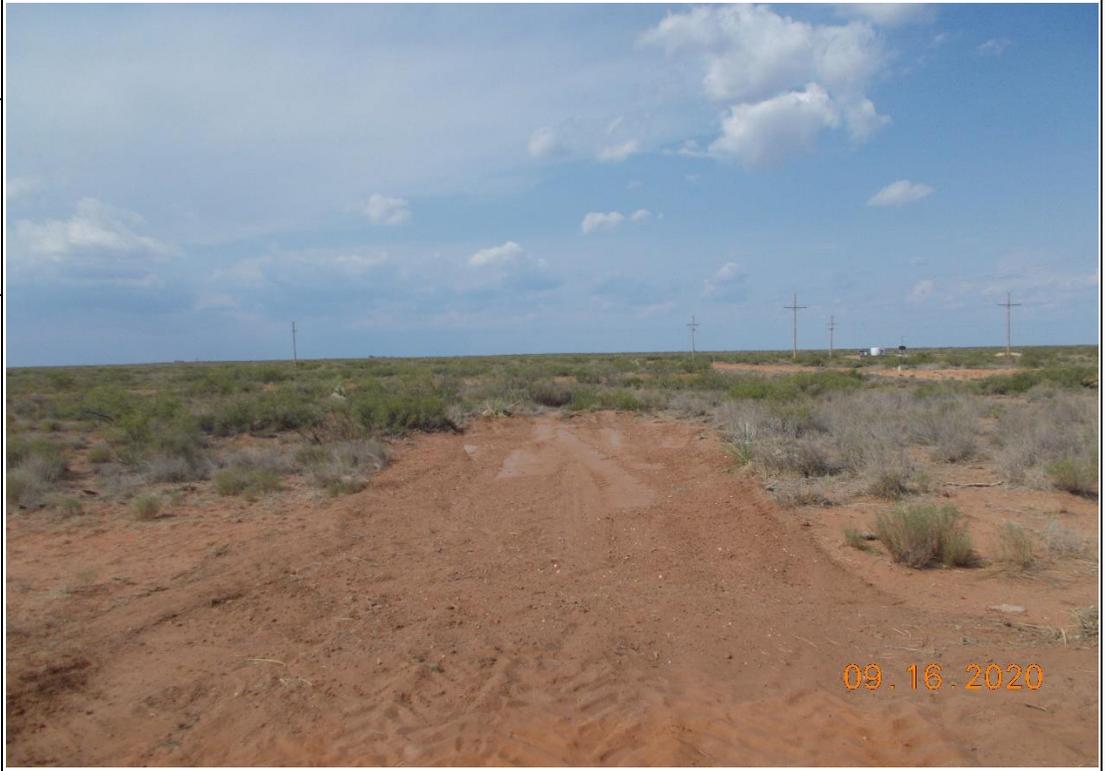
<b>Photo No:</b> 5.

<b>Direction Taken:</b> North	
<b>Description:</b> View of the remediated area.

On September 16, 2020, the excavated area was backfilled with non-impacted like soil from a local source and the site was contoured to fit the surrounding area.

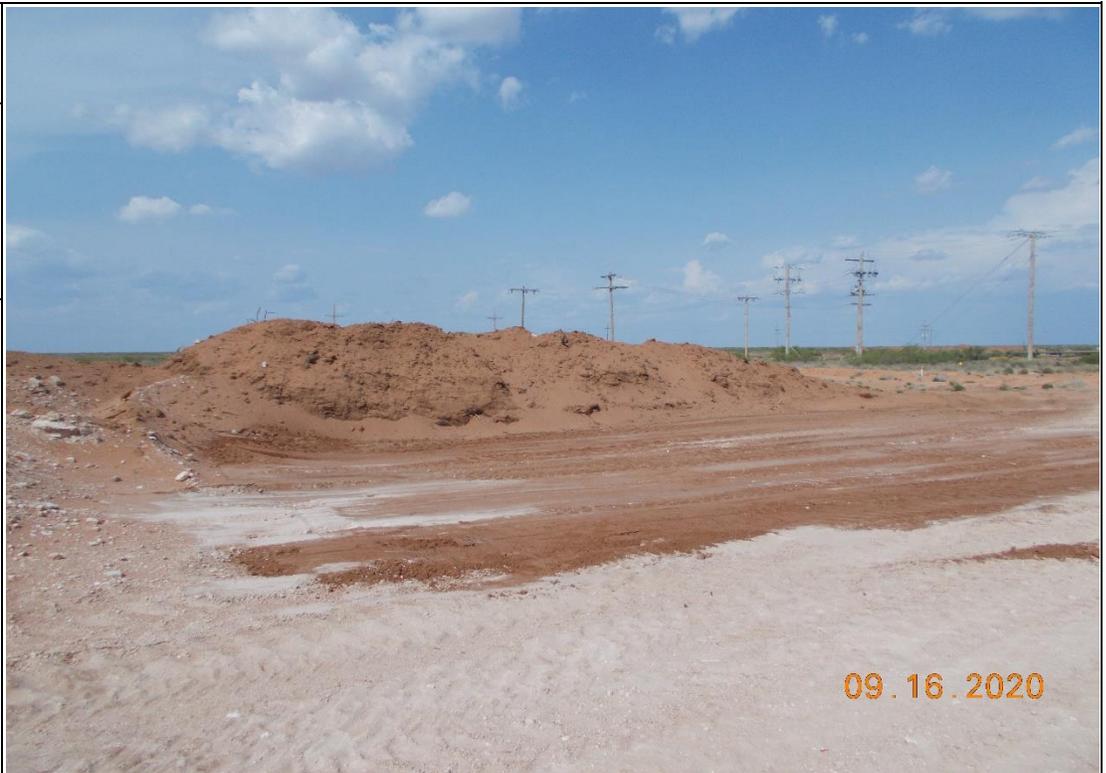
<b>Photo No:</b> 6.

<b>Direction Taken:</b> Northwest	
<b>Description:</b> View of the remediated area.
