October 14, 2020

Vertex Project #: 20E-00141-061

Spill Closure Report: Grandi 22 2H
Unit E, Section 22, Township 22 South, Range 27 East
County: Eddy
Incident Tracking Number: NAB1801736987

2020 Spill Assessment and Closure
October 2020

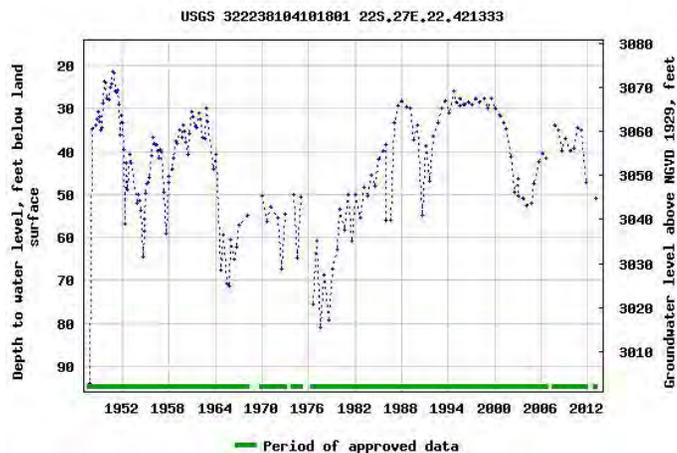
Breaks in the plot represent a gap of at least one year between field measurements.

The nearest recent groundwater well to the site is a 2002 New Mexico Office of the State Engineer-identified well, located approximately 0.4 miles south-southeast of the site, with a depth to groundwater of 57 feet below ground surface (bgs; New Mexico Office of the State Engineer, New Mexico Water Rights Reporting System, 2020). The shallowest recent depth to groundwater value in the vicinity of Grandi 22 is approximately 47 feet bgs as recorded at a 2013 United States Geological Survey well located approximately 0.8 miles due south of the release site (United States Department of the Interior, United States Geological Survey, 2020b). Documentation pertaining to site characterization and depth to groundwater determination is included in Attachment 3.

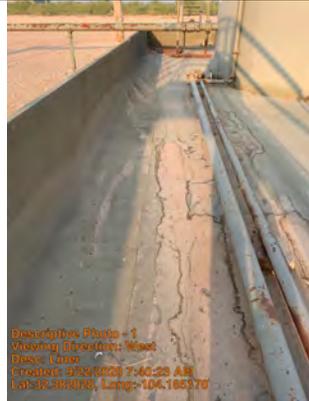
Viewing Direction: West

- 1 During inspection no visible signs of tear, cracks, holes or integrity deficiencies were observed. There was no visual evidence that the release escaped the secondary containment.
- 2 No further remediation activity for this incident is recommended at this time.

Secondary containment wall (south)

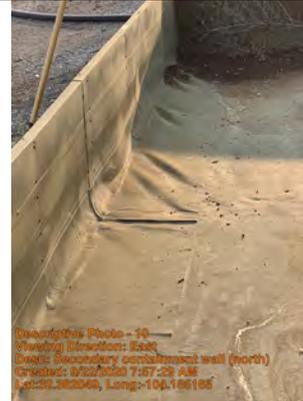
Viewing Direction: East

Secondary containment wall (north)

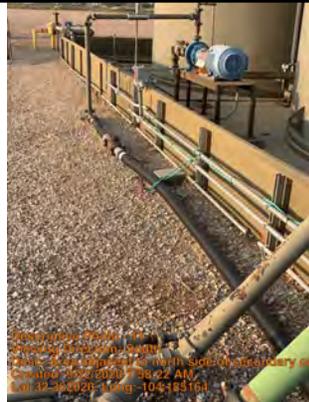
Viewing Direction: South

Area adjacent to east side of secondary containment

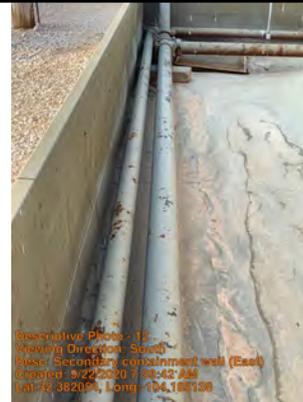
Viewing Direction: South

Secondary containment wall (East)

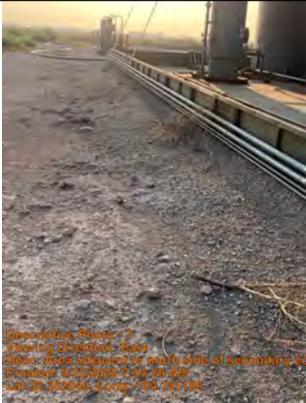
<p><small>Descriptive Photo - 7 Viewing Direction: East Desc: Area adjacent to north side of secondary containment Created: 9/22/2020 7:52:00 AM Lat:32.582021, Long:-104.186220</small></p>
Area adjacent to north side of secondary containment

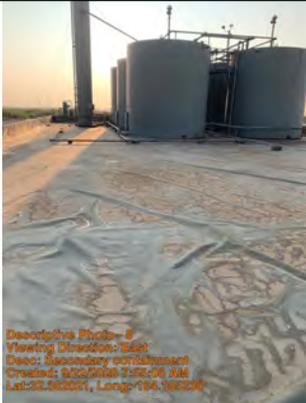
<p><small>Descriptive Photo - 8 Viewing Direction: East Desc: Secondary containment Created: 9/22/2020 7:52:00 AM Lat:32.582021, Long:-104.186220</small></p>
Secondary containment

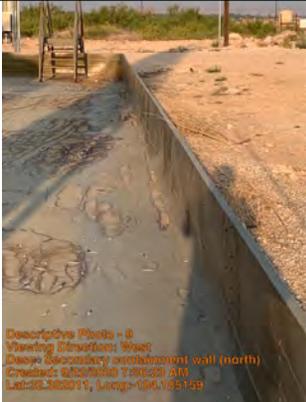
<p><small>Descriptive Photo - 9 Viewing Direction: West Desc: Secondary containment wall (north) Created: 9/22/2020 7:52:00 AM Lat:32.582021, Long:-104.186220</small></p>
Secondary containment wall (north)
