State of New Mexico  
Energy Minerals and Natural  
Resources Department

## Release Notification

NRM2021847858

| <b>Location:</b> | <b>JRU 119 Flowline</b> | |

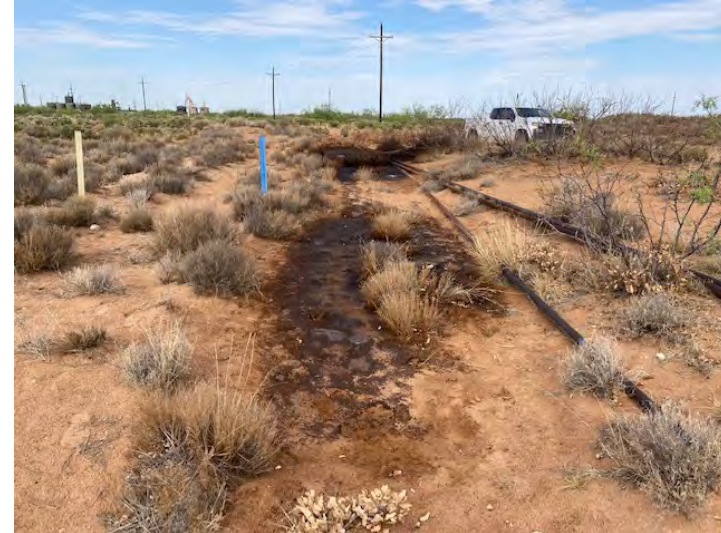
**Photograph 2:** View of release along steel flowline facing southwest.
