Release Notification

Site Name	Rosa Unit 322A	Site Type	Well
Date Release Discovered	9/3/2019	API# (if applicable)	30-039-29941

RE: Production tank had corrosion holes approximately 12-15ft above base, with historical gravel discolored from prior release through corrosion holes at the Rosa Unit 322A well site. Located in Section 28, Township 31 North, Range 4 West, Rio Arriba, New Mexico.

LOGOS Operating, LLC
Site Pictures
Rosa Unit 322A
Figure: 1

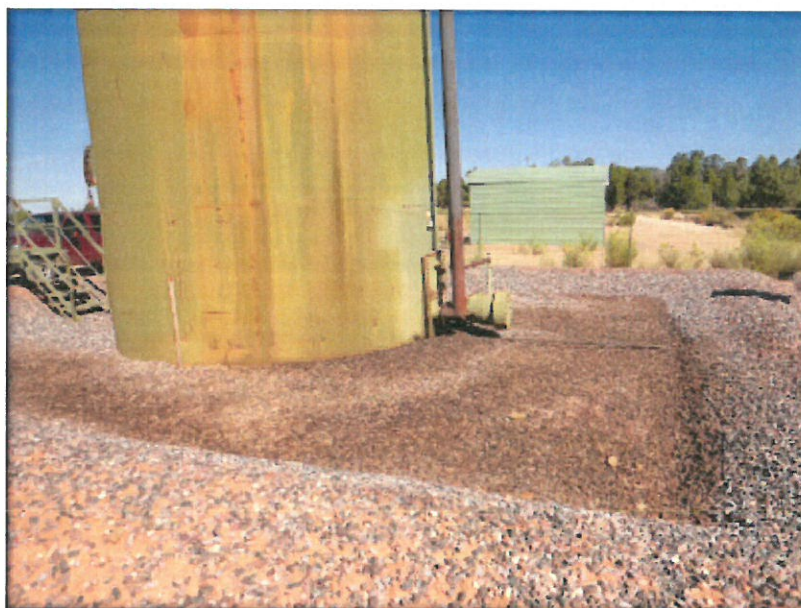
OCD inspector found production tank with corrosion holes approximately 12-15 ft above base, and historical gravel discolored from prior release through corrosion holes. The area will be delineated and remediation will be conducted to the affected area.

Impacted Area

On October 23, 2019, LOGOS Operating, LLC plugged and patched the corrosion holes on the production tank, pulled all remainder of rain water, spread nitrogen and sprayed simple green over the gravel. The entire area was raked in and covered with clean gravel.

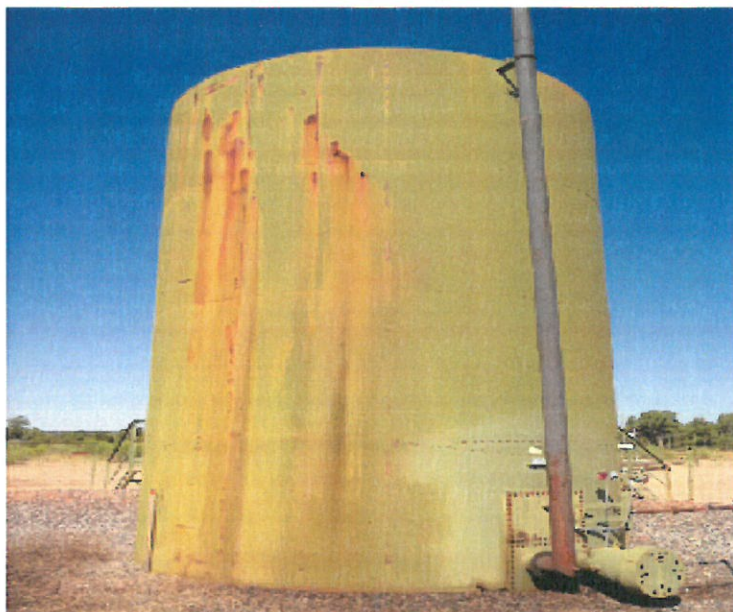
Impacted Area

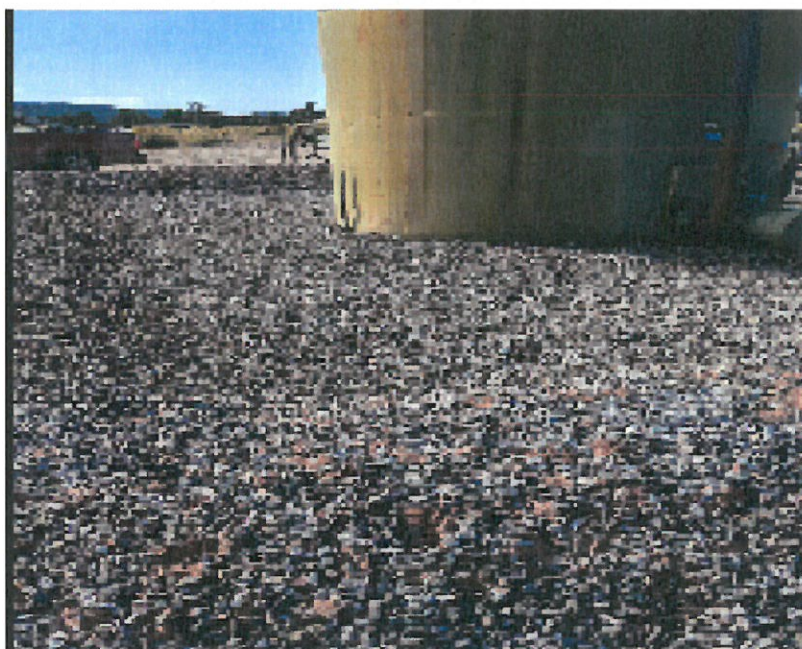
Cleaned up Staining

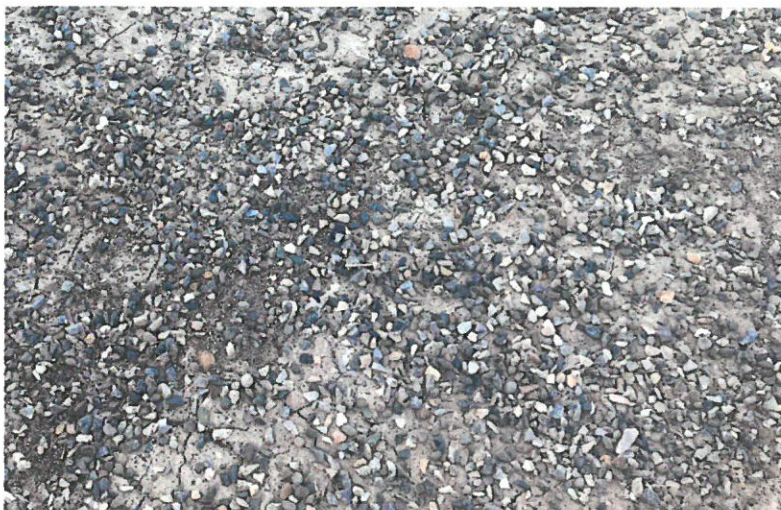
Gypsum added

On March 3, 2020, (2) bags of 40lbs of gypsum was added and spread throughout the entire affected area due to the results over the sample limit from November 1, 2019.

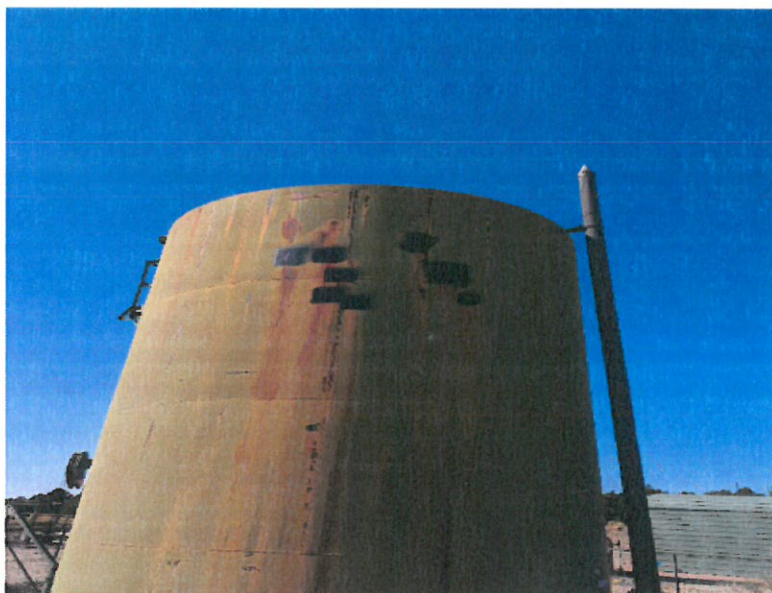
Patched Corrosion Holes on Tank

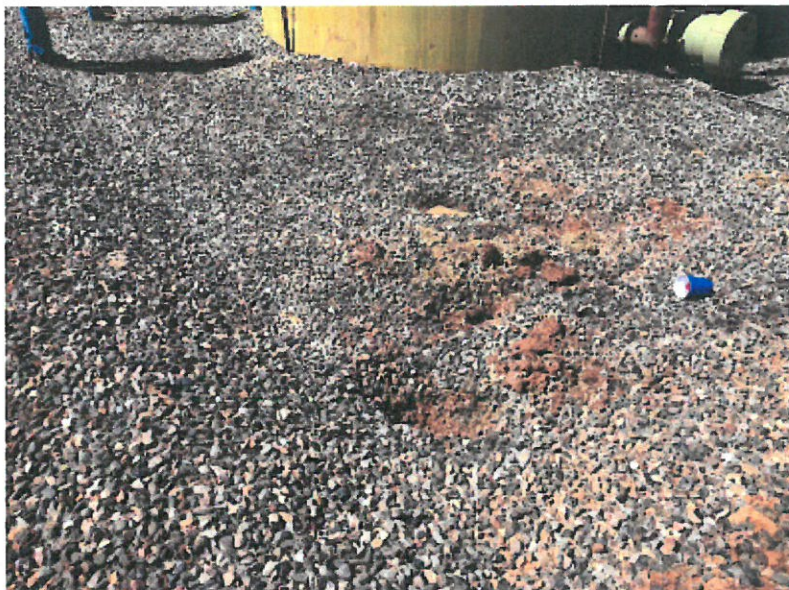
SB-1

Anions by EPA 300.0/9056A		mg/kg	mg/kg			Batch: 2026029
Chloride	213	20.0	1	06/26/20	06/29/20

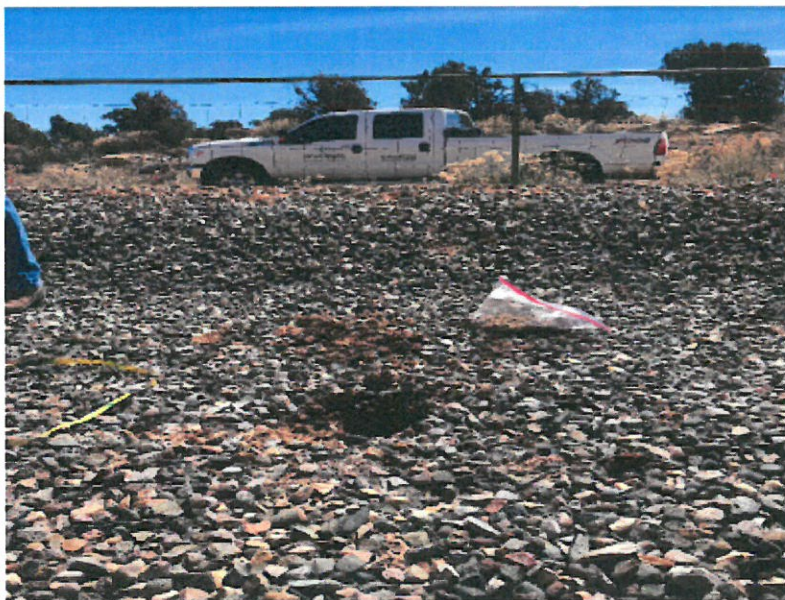
SB-2

Chloride	122	20.0	1	06/26/20	06/29/20

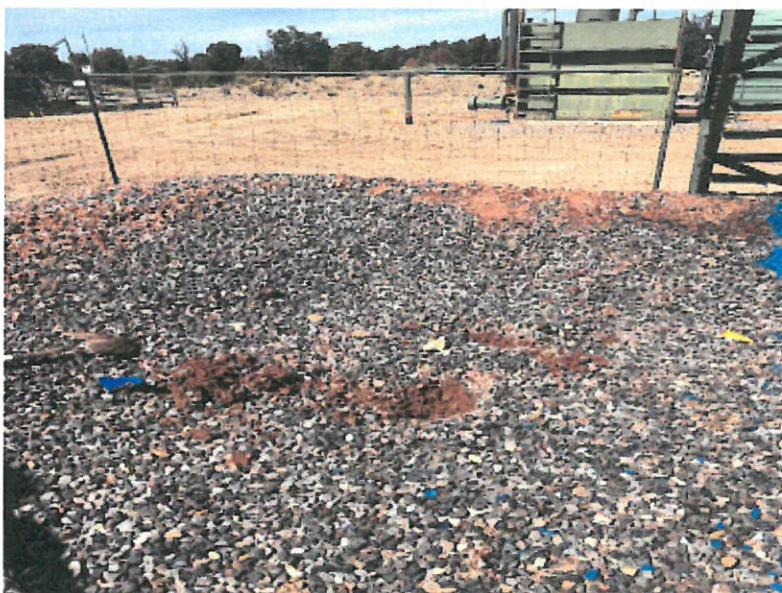
SB-3

Chloride	ND	20.0	1	06/26/20	06/29/20

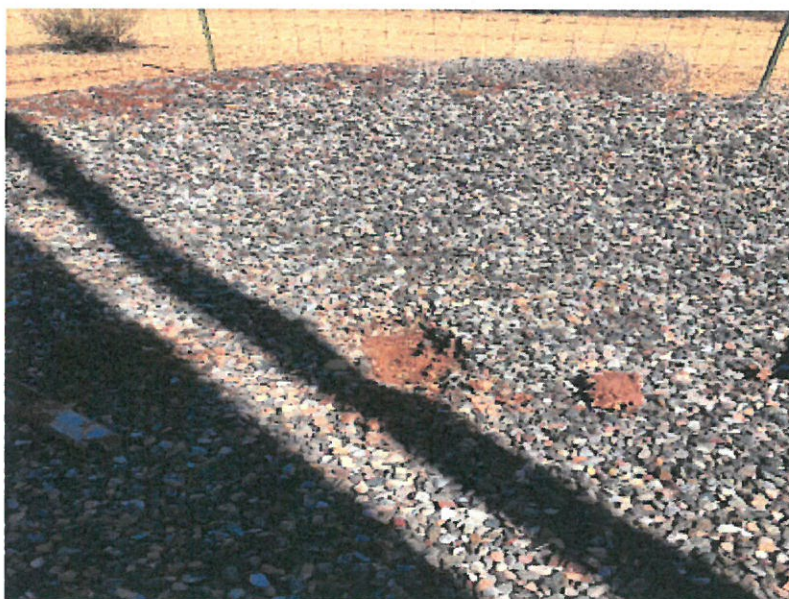
SB-4

Chloride	20.4	20.0	1	06/26/20	06/29/20

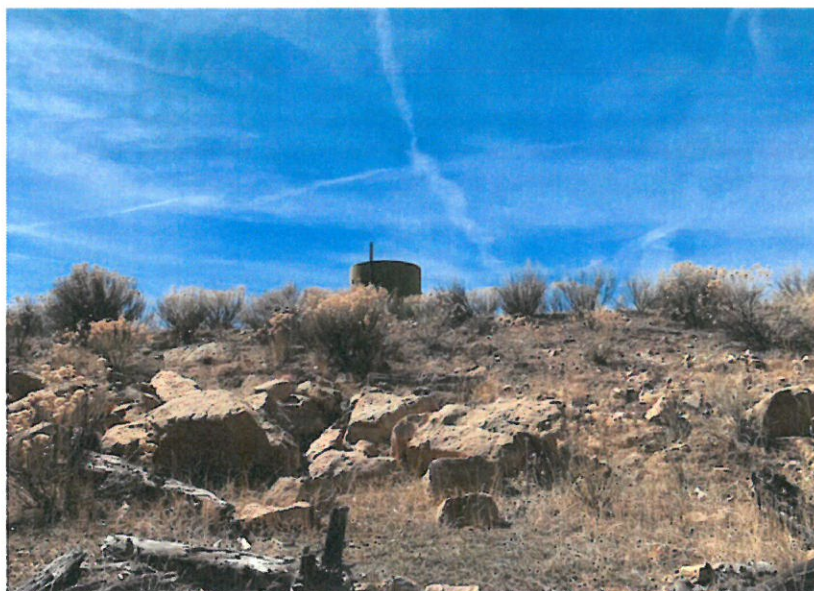
Soil samples were collected at 1 foot intervals in each boring. This location area is in a sand stone rock formation which made it difficult to collect samples passed 1 foot. Sand stone area enclosed in Figure 1 Site pictures.

Sand Stone Formation

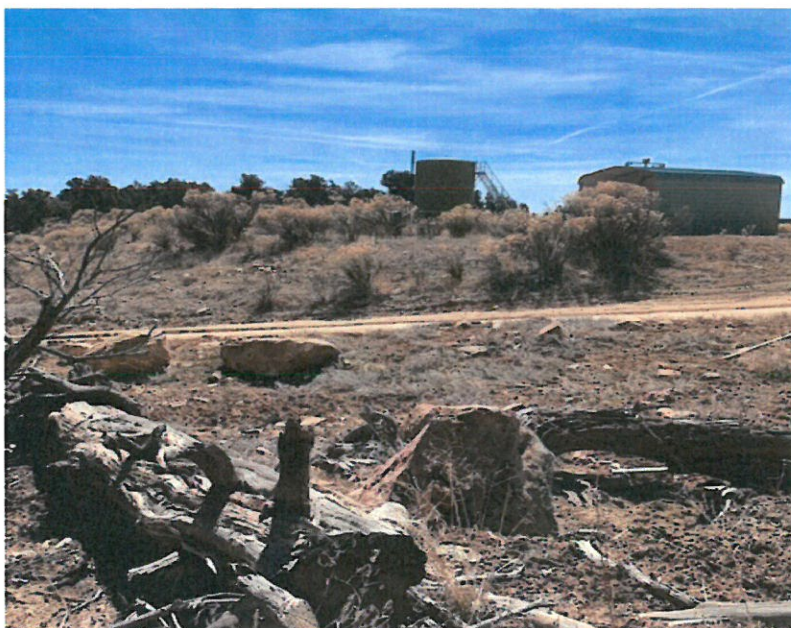
Sand Stone Formation
