## Release Notification

| Site Name: <b>Chaco 2308 4P 149H</b> | Site Type: <b>Wellsite</b> |

### **Chaco 2308 4P 149H Narrative**

Enduring Resources, LLC  
Chaco 2308 4P 149H Photo Page

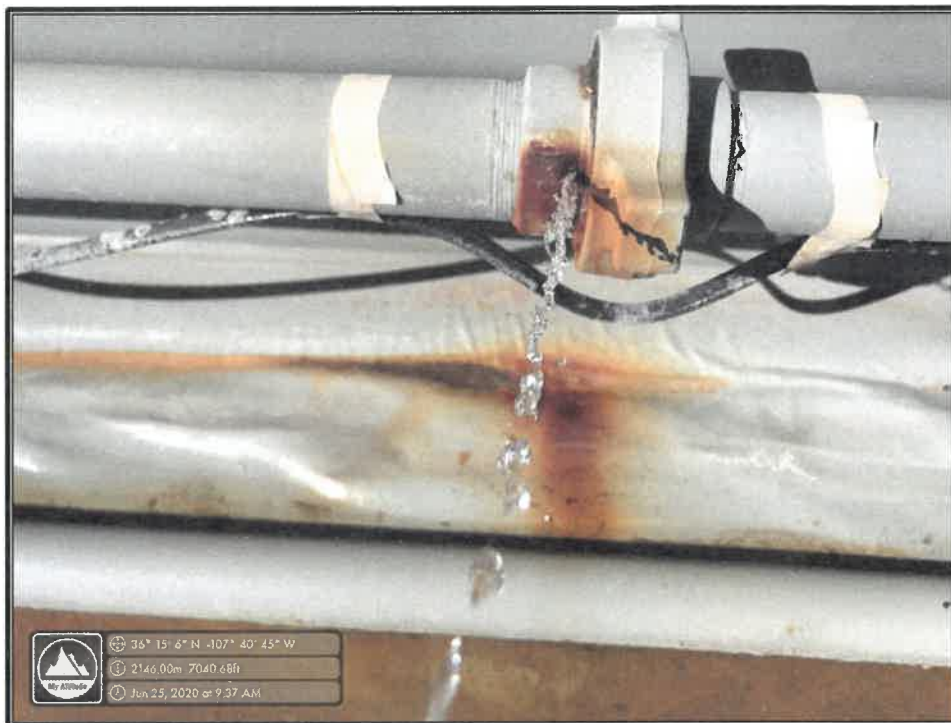
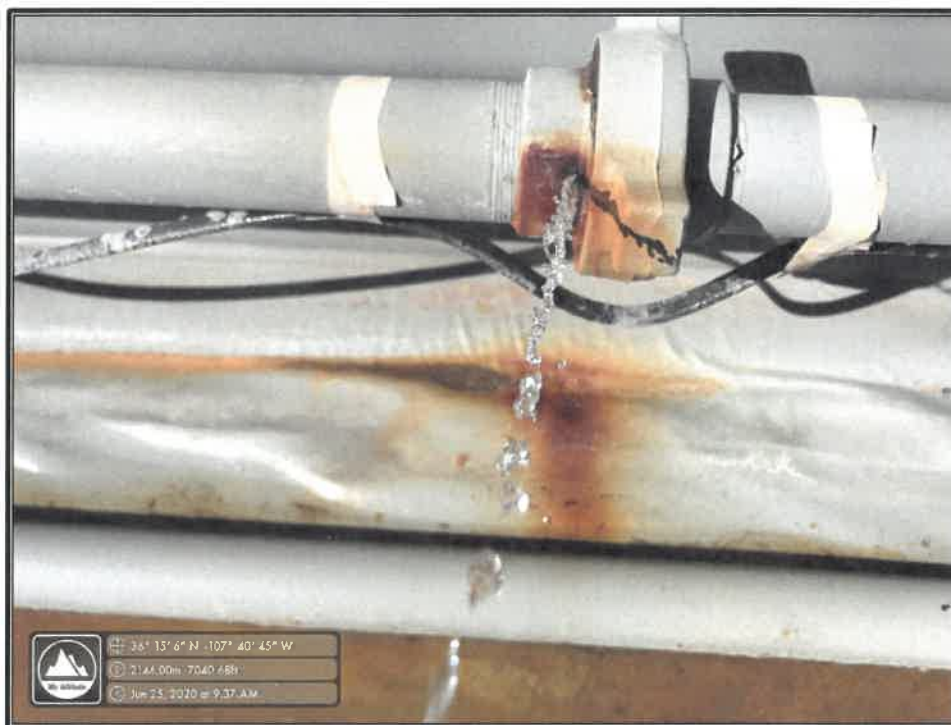
A waterline leak was discovered at the Chaco 2308 4P 149H wellsite. The line leak was due to internal corrosion on the above ground water dump line, leaking 7 bbls of produced water onto the lined secondary containment for this well facility. The leak was stopped and the line repaired.

Photo 1: View of Leaking Line

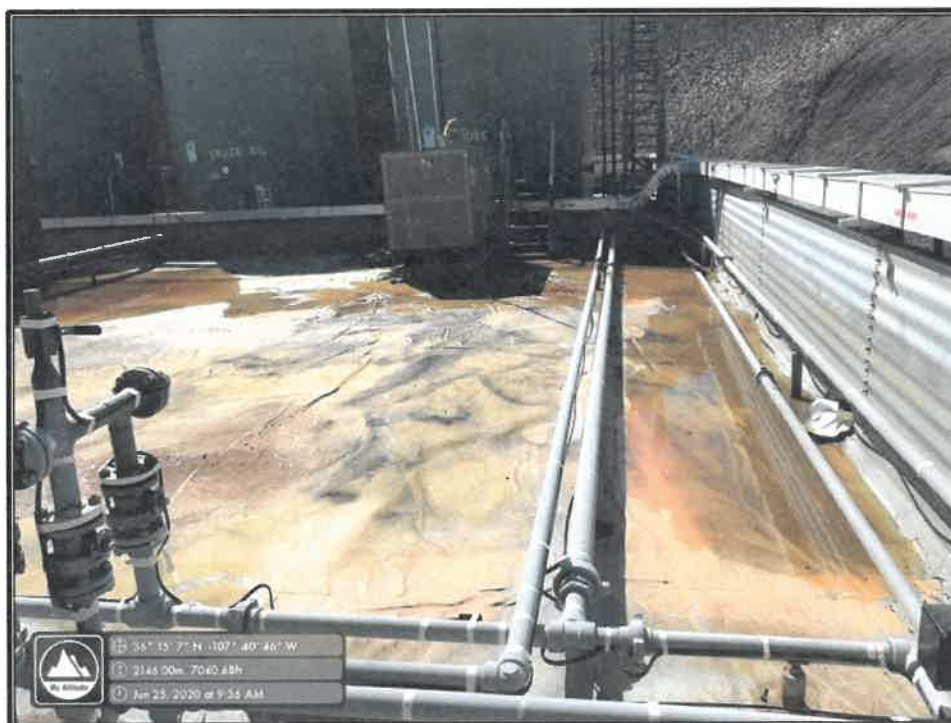
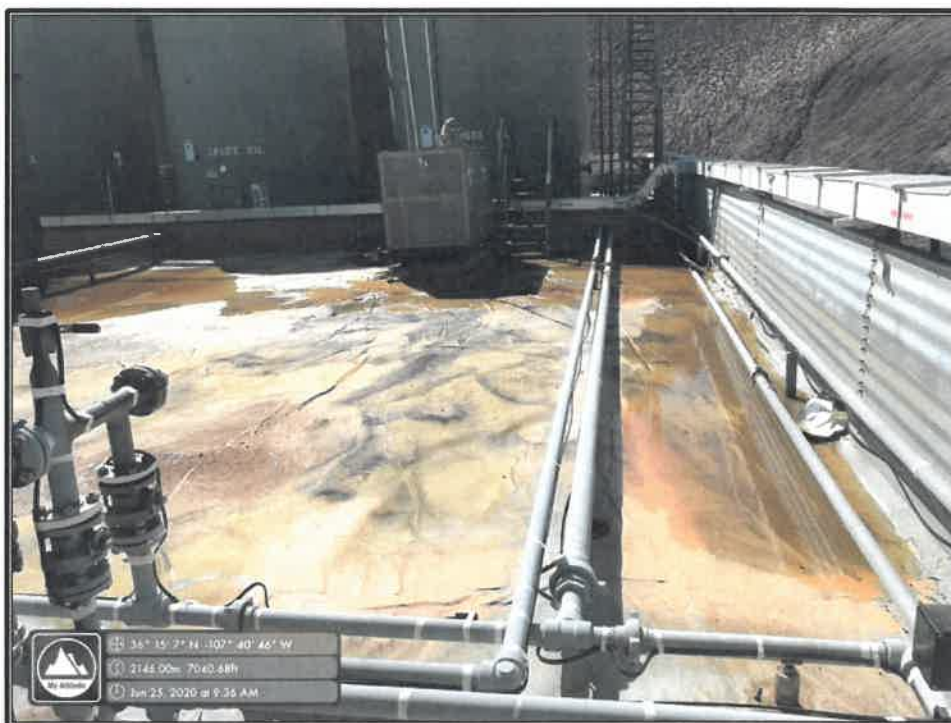
A water truck was on-site to recover the spilled water. 7 bbls of produced water was recovered off of the liner. Notification was submitted to Cory Smith, NMOCD, of the release, and to inform the NMOCD of the liner inspection that would take place on July 1, 2020.

Photo 2: View of Water on Liner

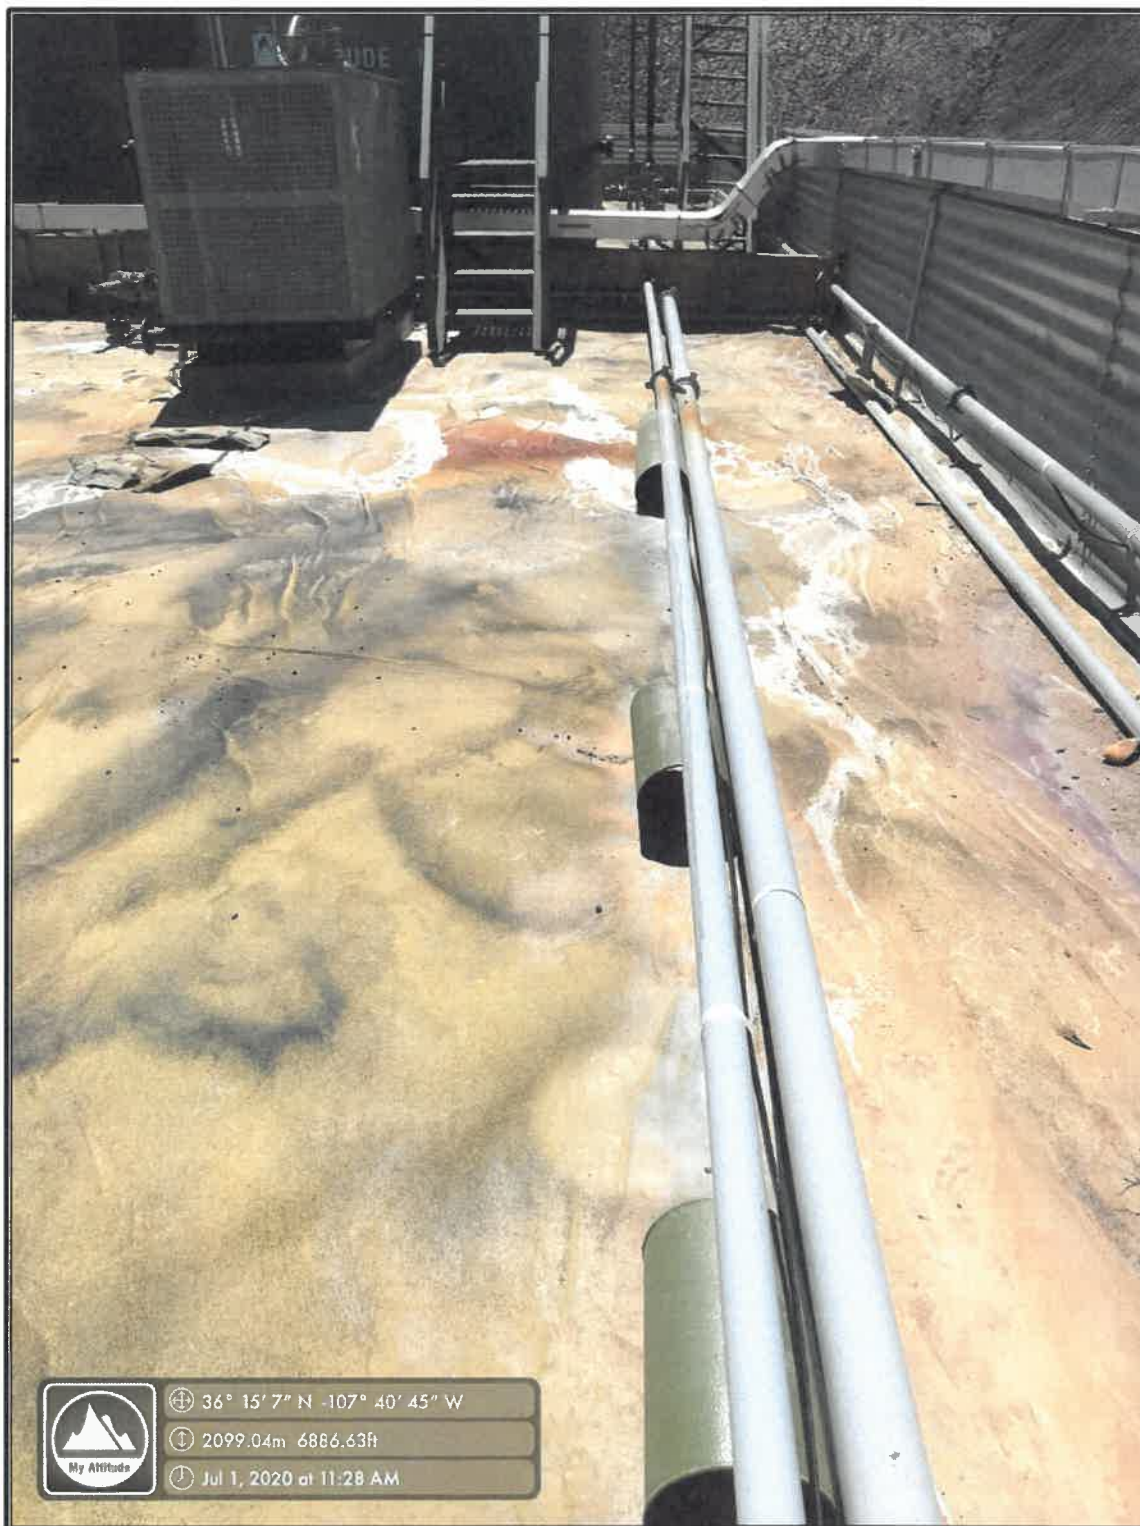
The Enduring HSE Supervisor was on-site at 11:30 AM to perform the liner inspection. A representative from the NMOCD was not present. The liner was inspected, and no evidence of a liner integrity issue was found during the inspection. Pictures were taken of the liner during inspection and are attached to the closure report for reference.

Photo 3: View of Liner after Cleanup
