Release Notification

Site Name	West Brushy Draw 33 1 Battery	Site Type	Well Location
Date Release Discovered	11/01/2019	API# (if applicable)	30-015-36971

**RE: Closure Request Addendum
West Brushy Draw 33 1 Battery
Incident Number NRM2001040198
Eddy County, New Mexico**

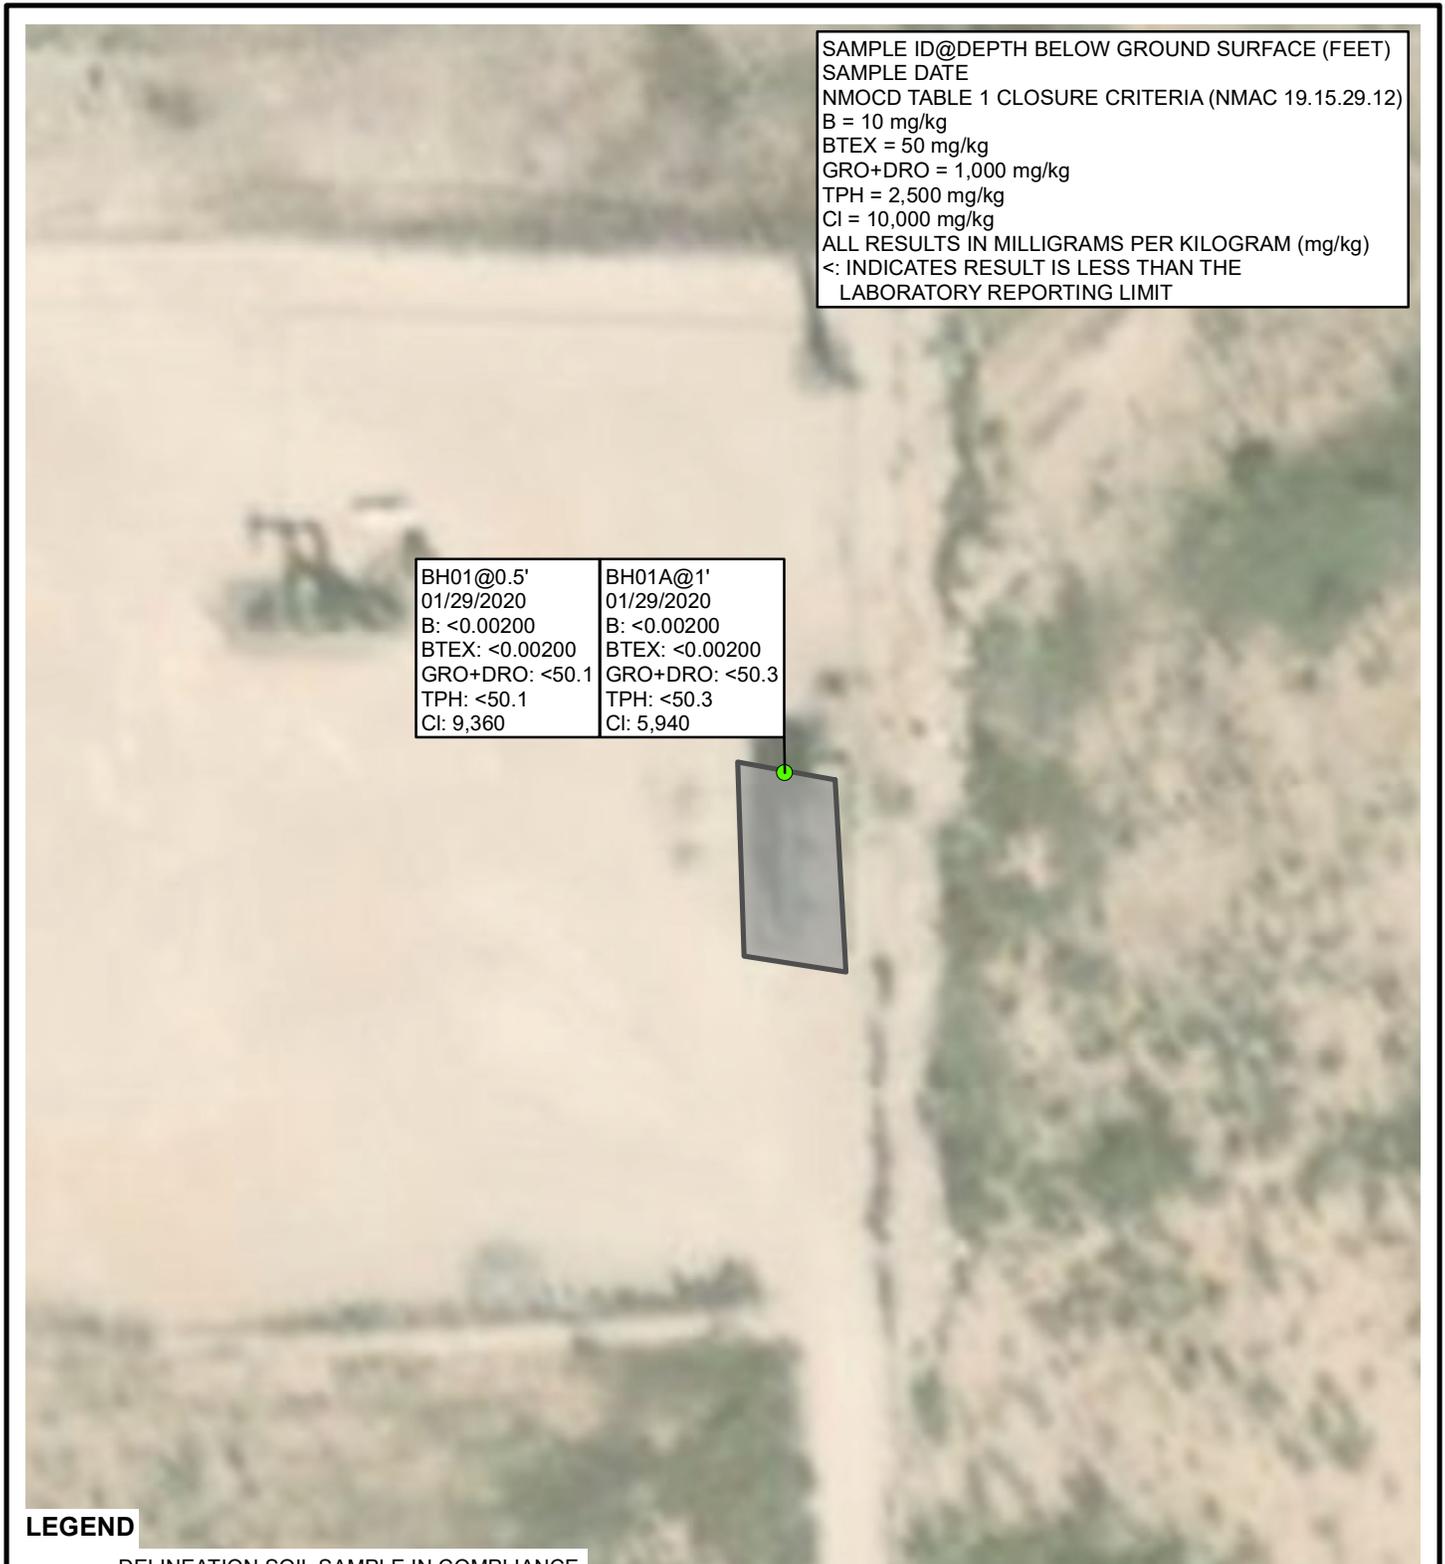
FIGURE 2
 DELINEATION SOIL SAMPLE LOCATIONS
 WEST BRUSHY DRAW 33 #1 BATTERY
 UNIT N SEC 33 T25S R29E
 EDDY COUNTY, NEW MEXICO
 XTO ENERGY, INC.

SAMPLE ID@DEPTH BELOW GROUND SURFACE (FEET)
 SAMPLE DATE
 NMOCD TABLE 1 CLOSURE CRITERIA (NMAC 19.15.29.12)
 B = 10 mg/kg
 BTEX = 50 mg/kg
 GRO+DRO = 1,000 mg/kg
 TPH = 2,500 mg/kg
 Cl = 10,000 mg/kg
 ALL RESULTS IN MILLIGRAMS PER KILOGRAM (mg/kg)
 <: INDICATES RESULT IS LESS THAN THE
 LABORATORY REPORTING LIMIT

DELINEATION SOIL SAMPLE IN COMPLIANCE WITH APPLICABLE CLOSURE CRITERIA

TANK BATTERY CONTAINMENT

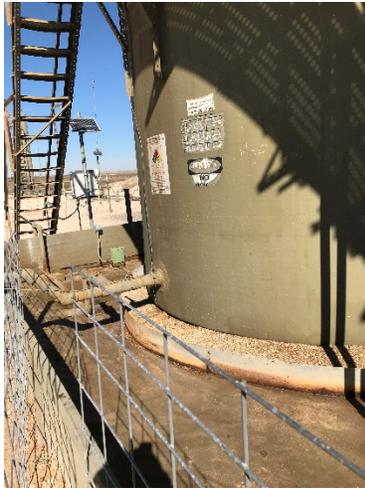
Photograph 1: View of point of release and surrounding impervious lined containment facing north-northeast.

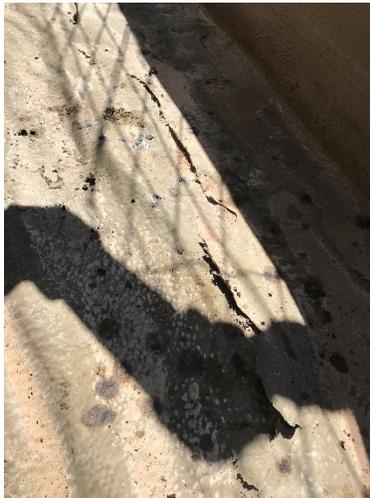
Photograph 2: View of area where liner was deemed insufficient on northern end of lined containment.

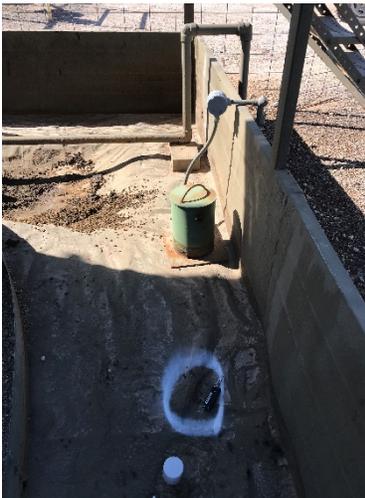
Photograph 3: View of area where liner was deemed insufficient facing west.

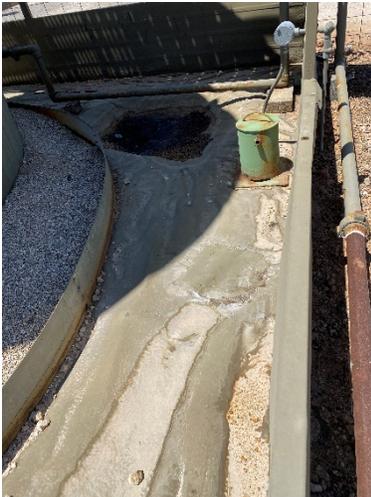
Photograph 4: View of patched liner facing west.

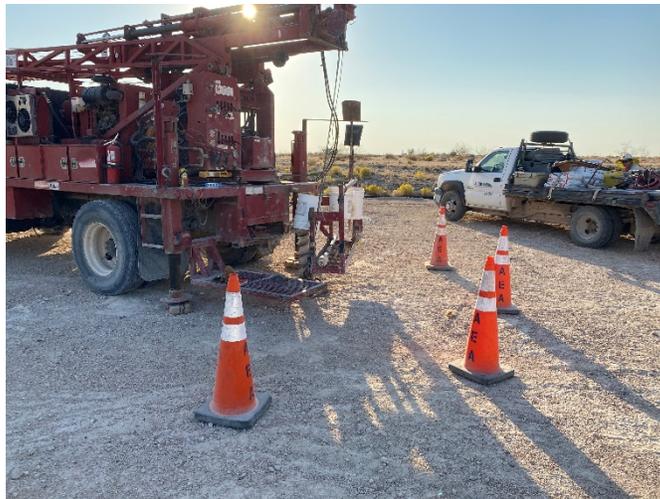
Photograph 5: View of BH02 location facing West.

In an effort to confirm the depth to groundwater determination, LTE installed a soil boring at the Site utilizing a truck-mounted hollow-stem auger rig. Soil boring BH02 was drilled to a depth of 17 feet bgs prior to encountering refusal. As such, LTE personnel relocate the drilling equipment by a few feet and drilled soil boring BH03 to a depth of 55 feet bgs. An LTE geologist logged and described soils continuously. No moisture or groundwater was encountered during drilling activities. The borehole lithologic/soil sampling logs are included in Attachment 1. The locations of the boreholes are provided on Figure 1. The boreholes were left open for over 72 hours to allow for potential slow infill of groundwater. After the 72-hour waiting period without observing groundwater, it was confirmed that groundwater beneath the Site is greater than 55 feet bgs. The boreholes were properly abandoned with drill cuttings and hydrated bentonite chips.

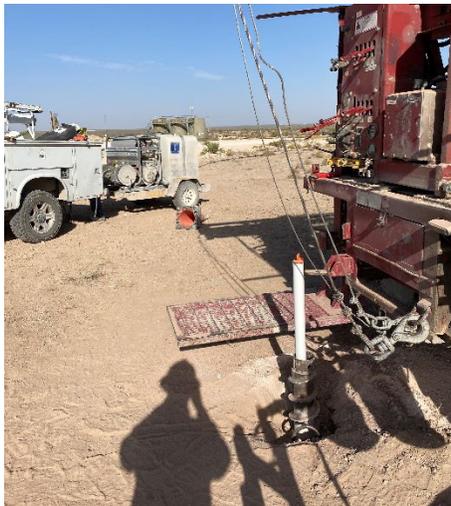
Photograph 6: View of BH03 location facing northeast.

Soil boring BH03 was advanced to 55 feet bgs at the Site. Groundwater was not encountered and no groundwater filled in during a 72-hour period. LTE confirmed a depth to groundwater greater than 55 feet at the Site, which correlates to the depth to groundwater of 98 feet in USGS well 320532104001701 and 75 feet in NMOSE well C03508. As such, the Table 1 Closure Criteria identified in the original Closure Request are applicable and appropriate for protection of groundwater at this Site.

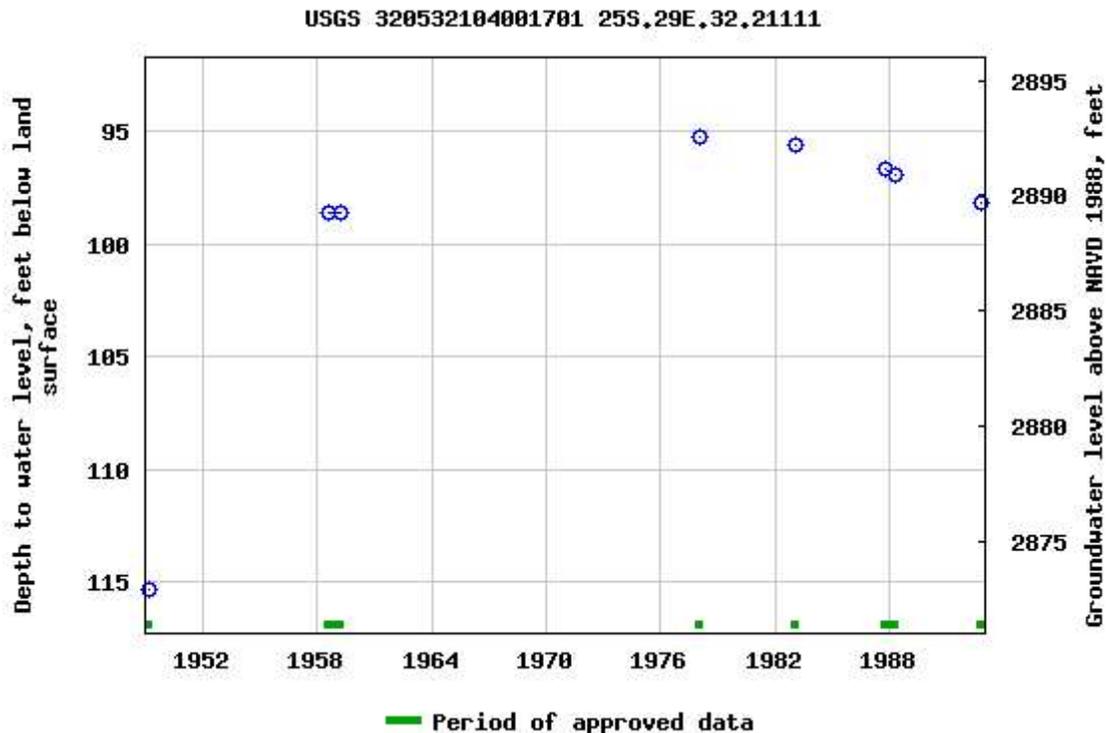
This well is completed in the Rustler Formation (312RSLR) local aquifer.

Breaks in the plot represent a gap of at least one year between field measurements.

The nearest permitted water well with depth to water data is United States Geological Survey (USGS) well 320532104001701, located approximately 1.1 miles northwest of the Site. The water well has a depth to groundwater of 98 feet and a total depth of 128 feet bgs. Ground surface elevation at the water well location is 2,988 feet above mean sea level (AMSL), which is approximately 5 feet lower in elevation than the Site. The next closest water well with depth to water data is NMOSE well C03508, located approximately 1.5 miles southwest of the Site. The water well has a depth to groundwater of 75 feet and a total depth of 140 feet bgs. Ground surface elevation at the water well location is 2,910 feet AMSL, which is approximately 83 feet lower in elevation than the Site. Referenced well records are included in Attachment 4.
