## Final Closure Report

**Grizzly Operating, LLC**  
**CS Caylor #3 Flowline Leak #2**  
**Lea County, New Mexico**  
**Unit Letter "H", Section 1, Township 17 South, Range 36 East**  
**Latitude 32.867105 North, Longitude 103.300916 West**  
**NMOCD Incident # NRM2032857772**

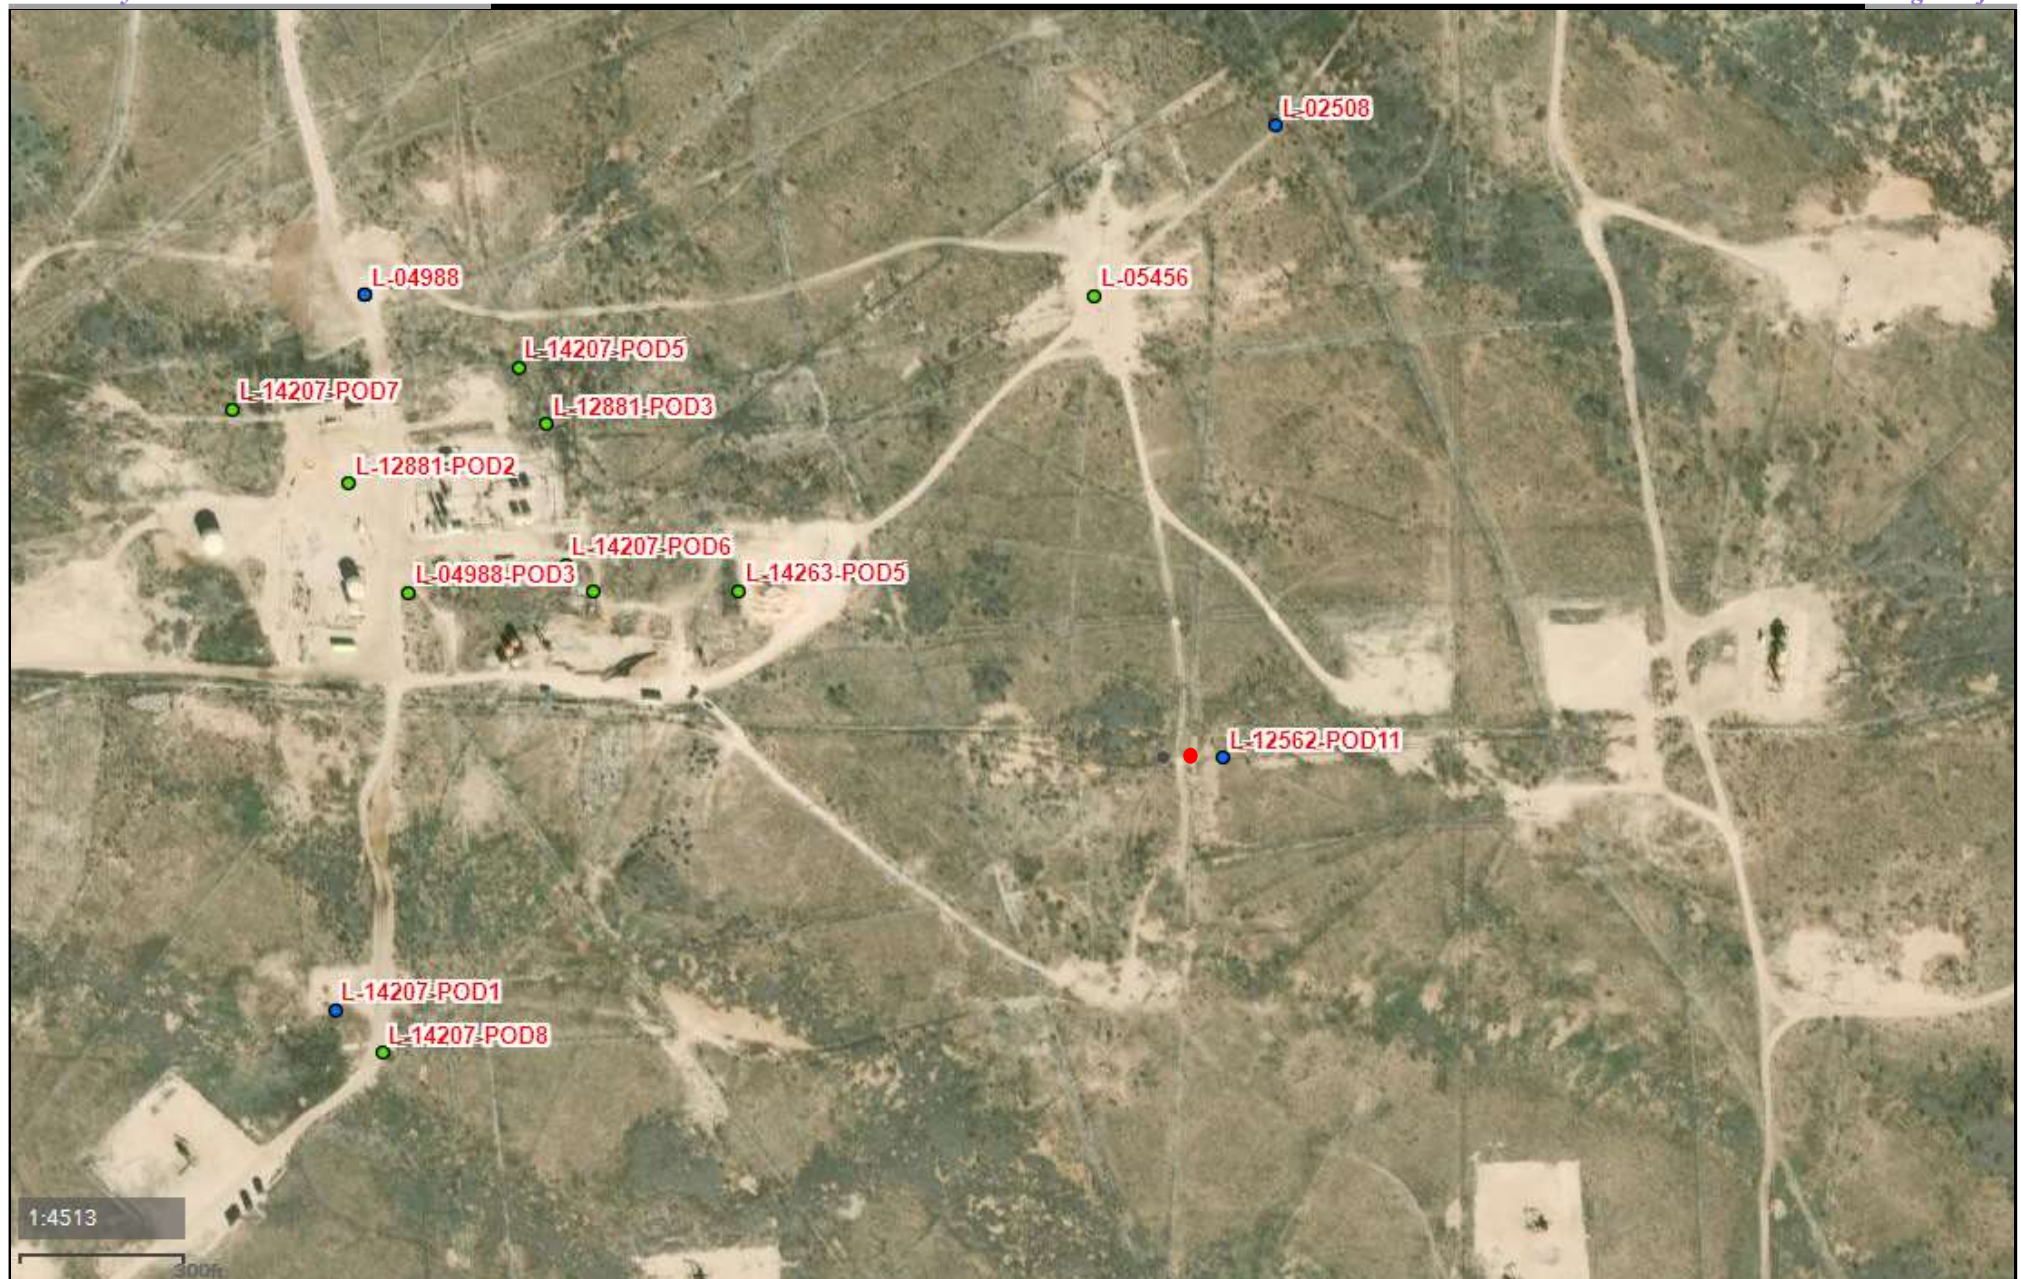
**Figure 2**

OSE POD Locations Map  
 Grizzly Energy  
 CS Caylor #3 Flowline Leak 2  
 GPS: 32.867105, -103.300916  
 Lea County

A search of the New Mexico Office of the State Engineer (NMOSE) and United States Geological Survey (USGS) groundwater databases was completed in an effort to determine the horizontal distance to known water sources within a half mile radius of the Release Site. Approximate depth to groundwater was determined using maintained and published water well data. Karst mapping indicates the site is not located in a designated Karst area. Depth to groundwater information is provided as Attachment II and the results are depicted on Figures 1 & 2.

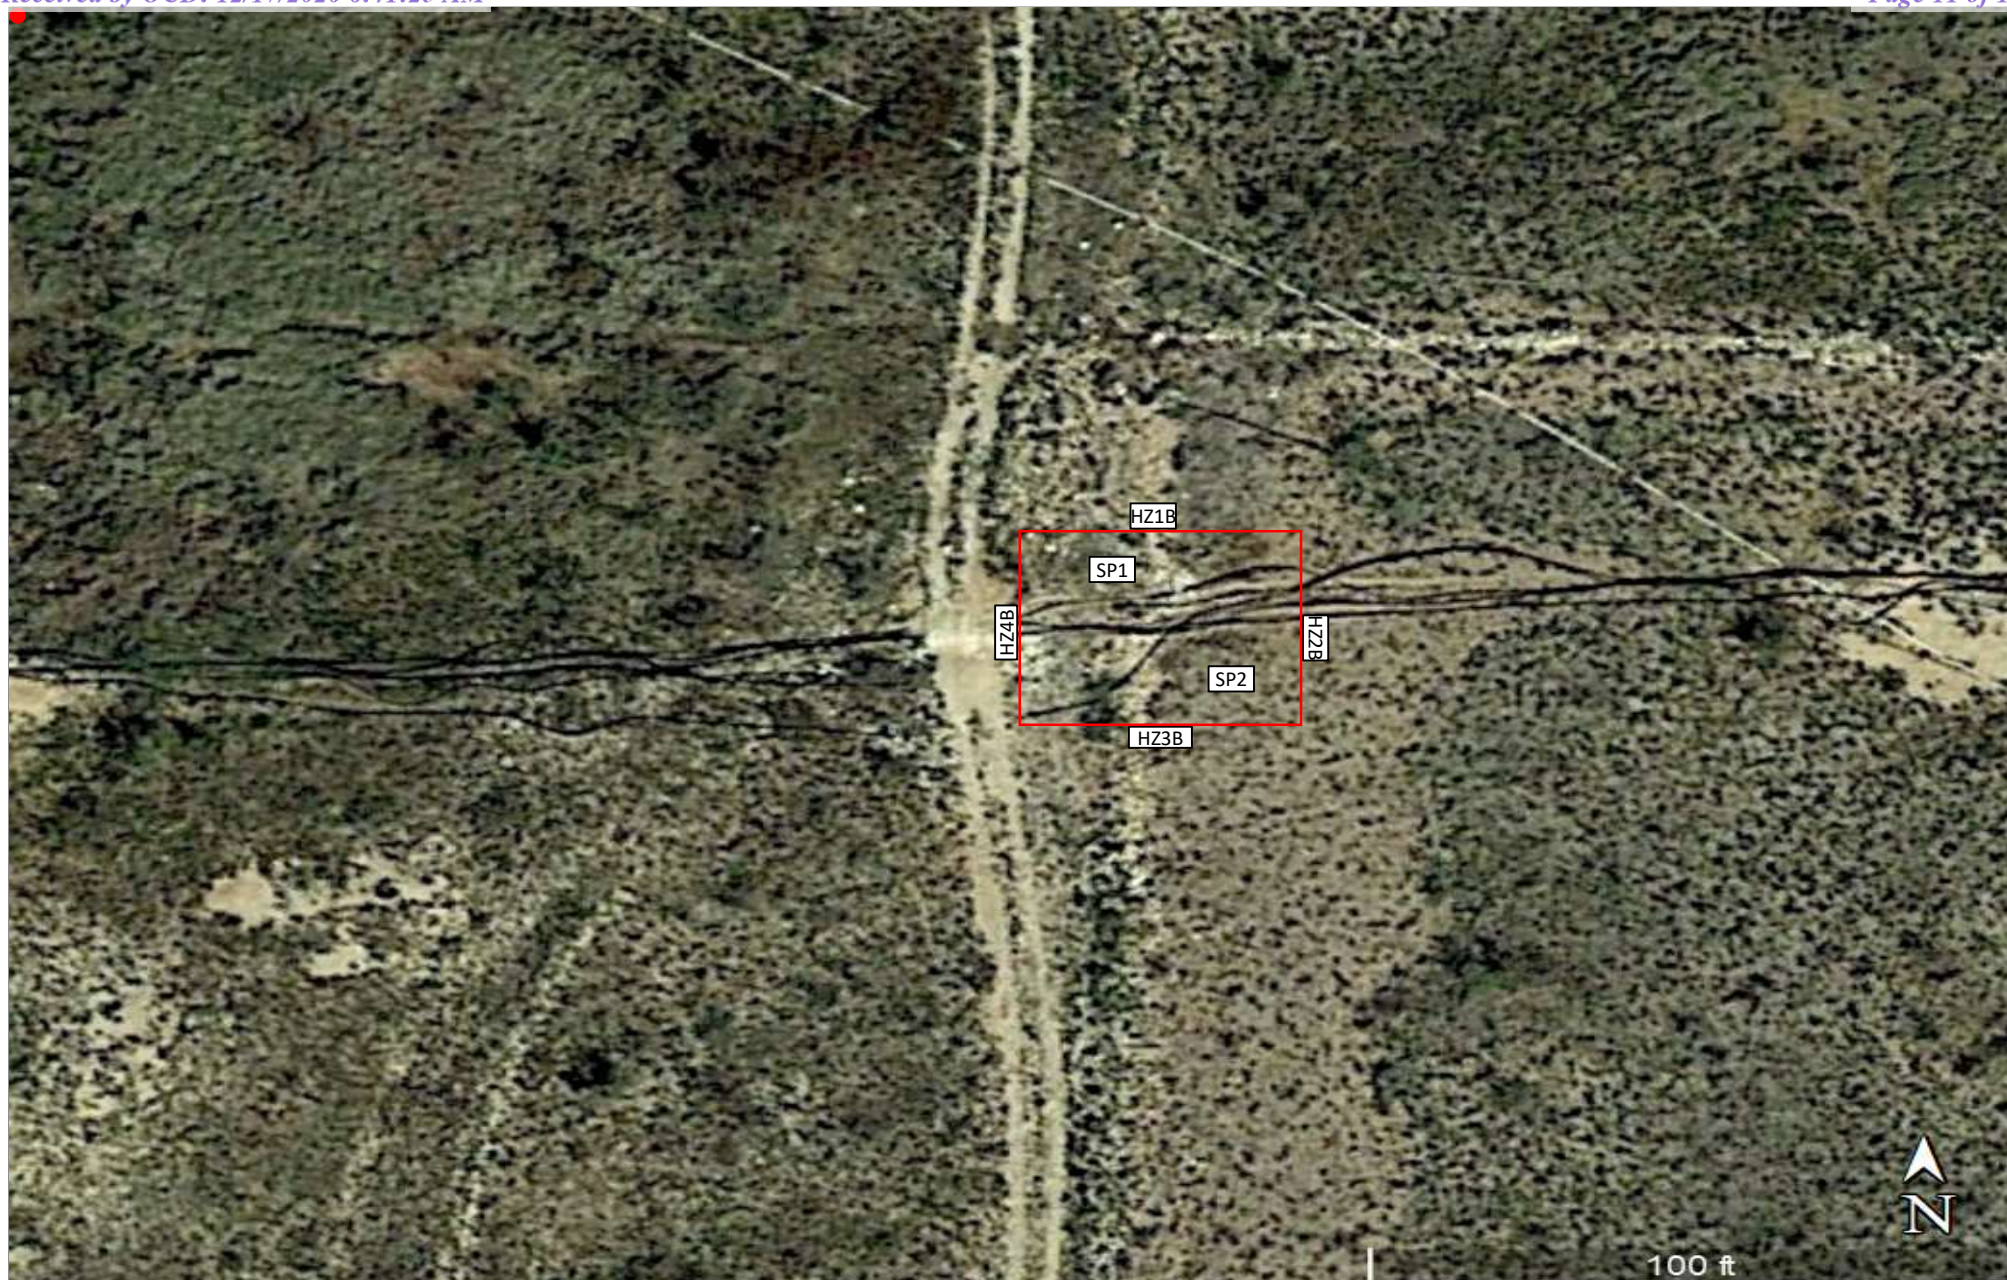
**Figure 4**

Delineation Sample Map  
Grizzly Energy  
CS Caylor #3 Flowline Leak 2  
GPS: 32.867105, -103.300916  
Lea County

A total of twelve (12) delineation soil samples, SP1, SP2, and HZ1 through HZ4, were submitted to the laboratory for analysis of BTEX, TPH, and Chloride. Two (2) soil samples from each test trench (highest observed contaminated and deepest depth investigated) were submitted for laboratory analysis. Laboratory analytical results indicated BTEX, TPH, and chloride concentrations were below the NMOCD Closure Criteria in each of the submitted soil samples with the exception of SP1 @ Surf, SP2 @ Surf, HZ1 @ Surf, HZ2 @ Surf, HZ3 @ Surf and HZ4 @ Surf, which exhibited TPH concentrations of 3,560mg/kg, 181 mg/kg, 2,570 mg/kg, 1,060 mg/kg, 17,200 mg/kg, and 4,590 mg/kg, respectively. Chloride concentrations were below the NMOCD Closure Criteria in each of the submitted samples with the exception of the surface samples at sample locations SP1, SP2, and HZ1, HZ2, HZ3, and HZ4, which exhibited chloride concentrations of 8,090 mg/kg, 4,090 mg/kg, 6,160 mg/kg, 6,020mg/kg, 6,280 mg/kg, and 4,250 mg/kg, respectively.

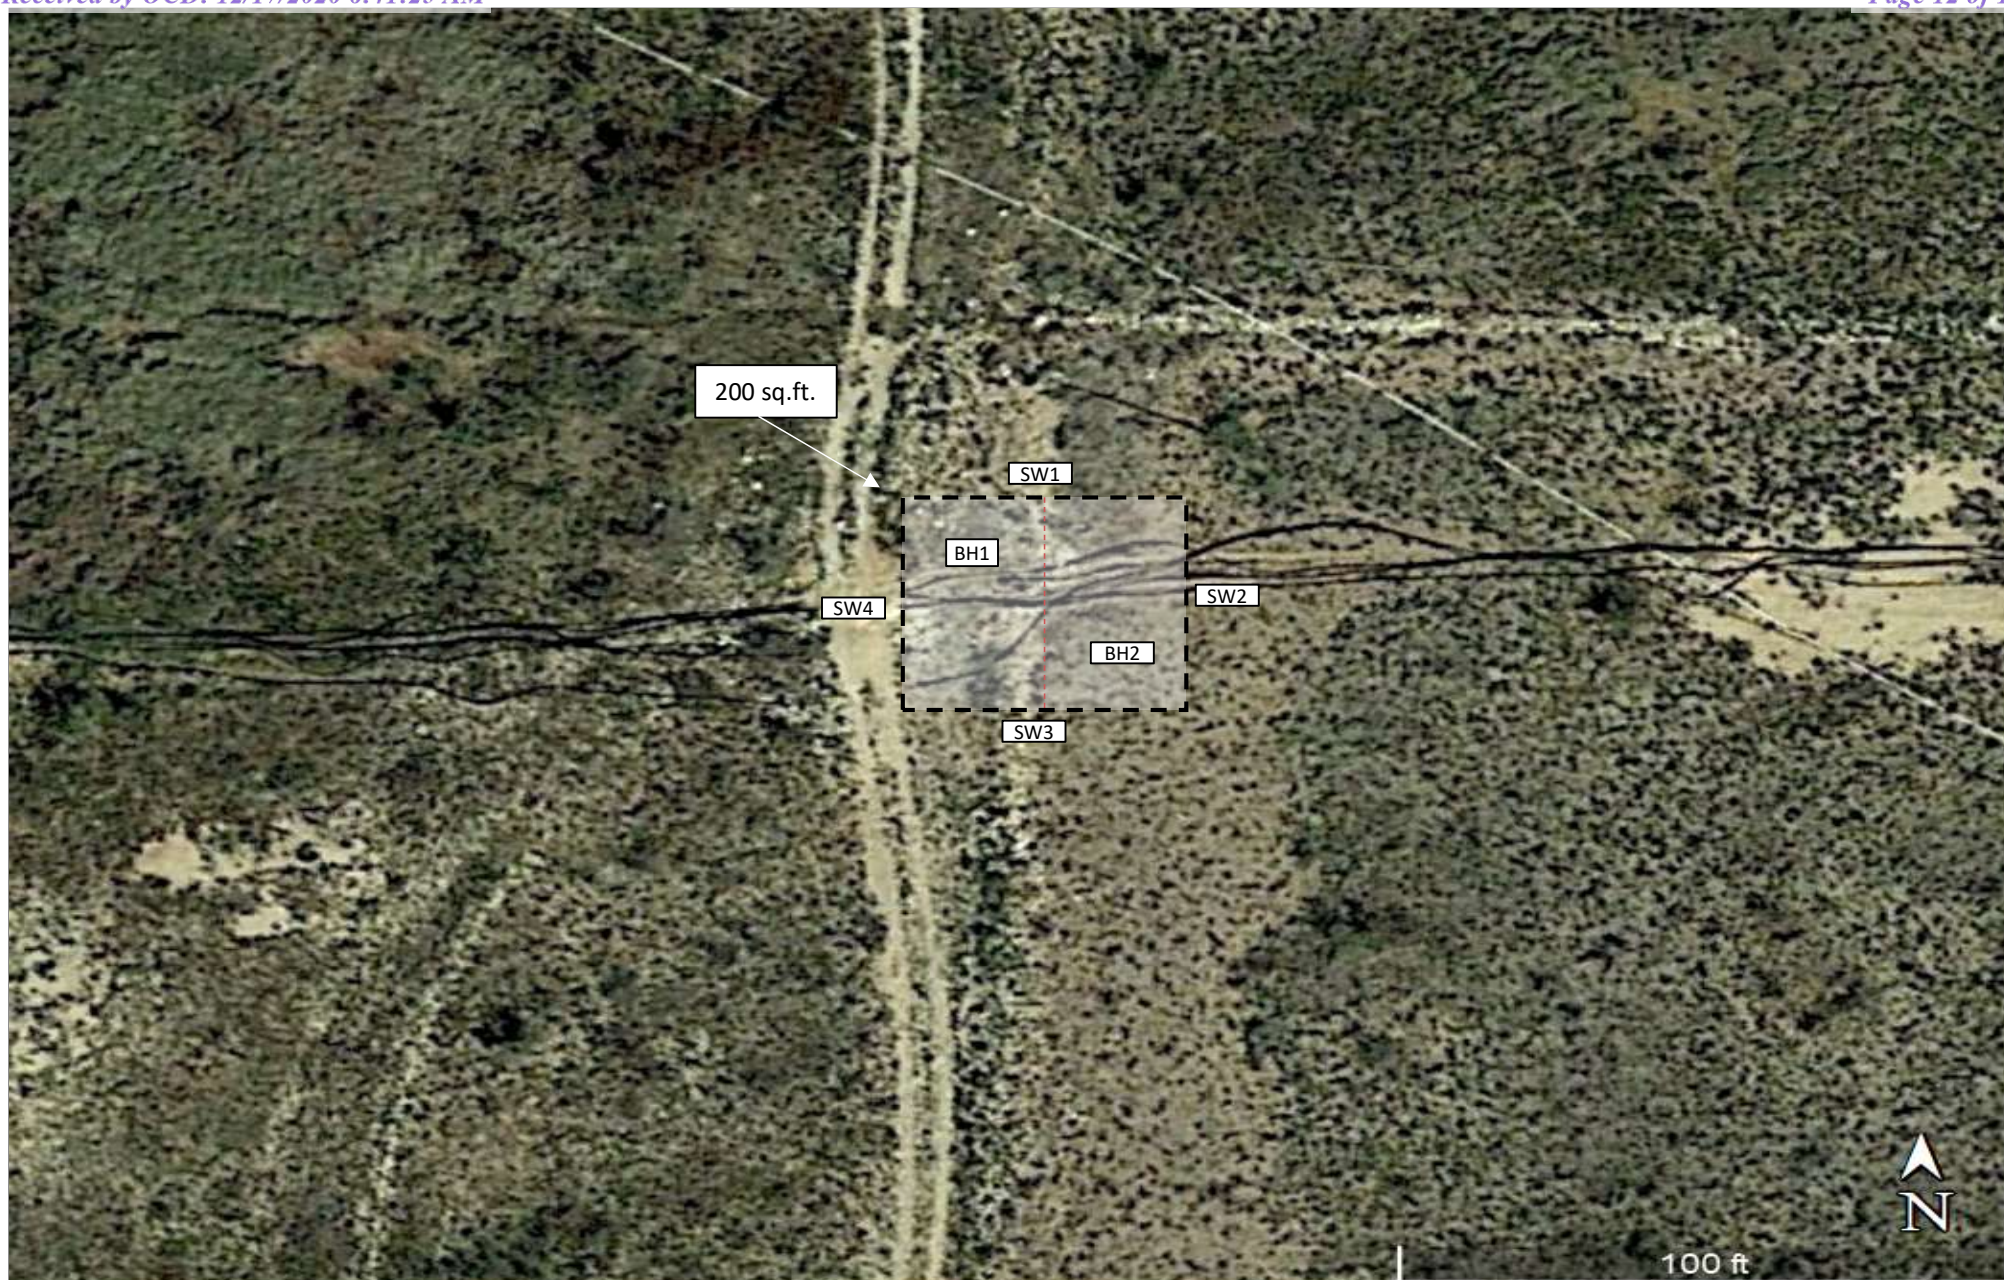
**Figure 5**

Excavation Sample Map
