Deferment Request

Re: Big Kick Battery

API# 30-025-36745

Case # 1RP-5237

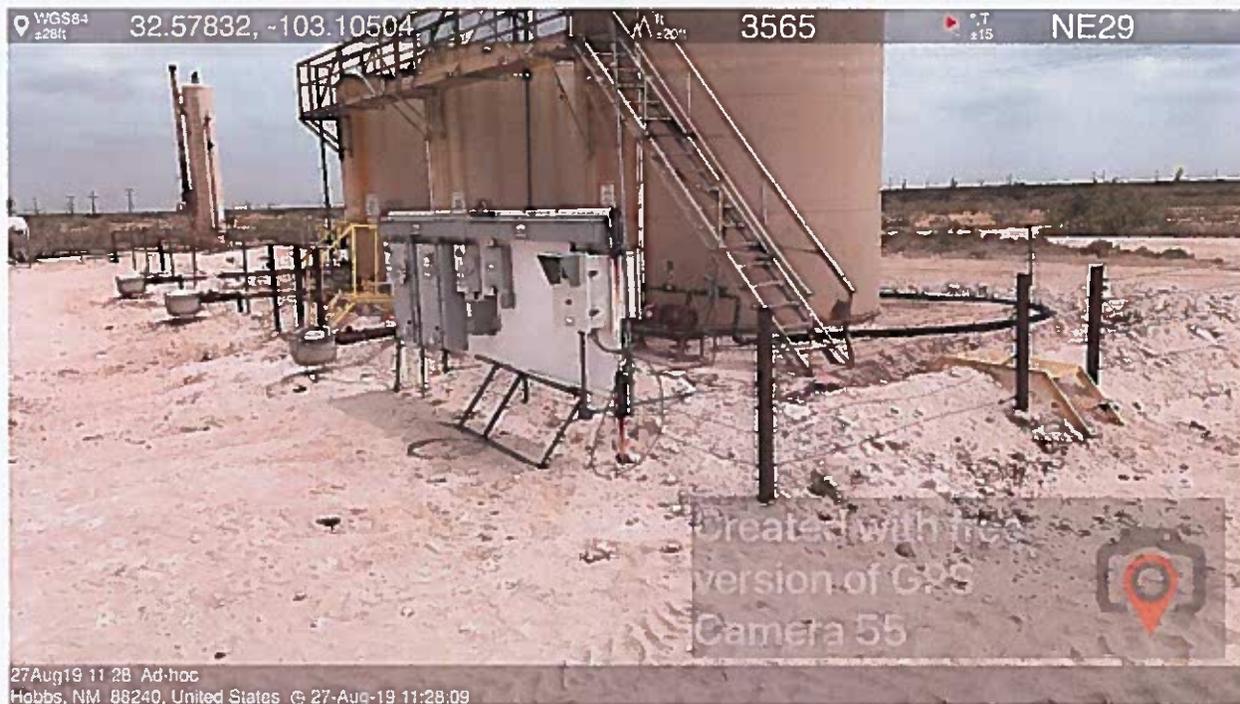
Area excavated with new installed berm

The area inside the secondary containment was excavated to a depth of 6 inches. A remediation plan was submitted and approved by NMOCD on 06/18/2019. The dirt berms utilized as the secondary containment walls were removed and the release area was further excavated an additional foot. After the excavation was complete final 5 point bottom and wall composite samples were collected not to exceed 200 square feet and submitted to a commercial laboratory for analysis of chloride, TPH, and BTEX. Bottom samples B2, B4, B7, and B10 were above chloride values of 600 mg/kg. B10 was excavated an additional 6 inches and another 5 point bottom composite sample was submitted to a commercial laboratory for analysis of chloride, TPH, and BTEX. B2, B4, and B7 were not further excavated due to the close proximity to the facility tanks. Wall samples W2, W4, W6, and W 11 were also above table one standards for releases less than 50 feet to groundwater. All the walls were extended laterally and 5 point wall composite samples were collected and submitted to a commercial laboratory. All excavated soil including the berms were disposed of at an NMOCD approved facility. The pad area was backfilled with clean imported caliche and the pad was restored. The pasture area east of the facility was backfilled with clean imported top soil and will be reseeded in consultation with the private surface owner.

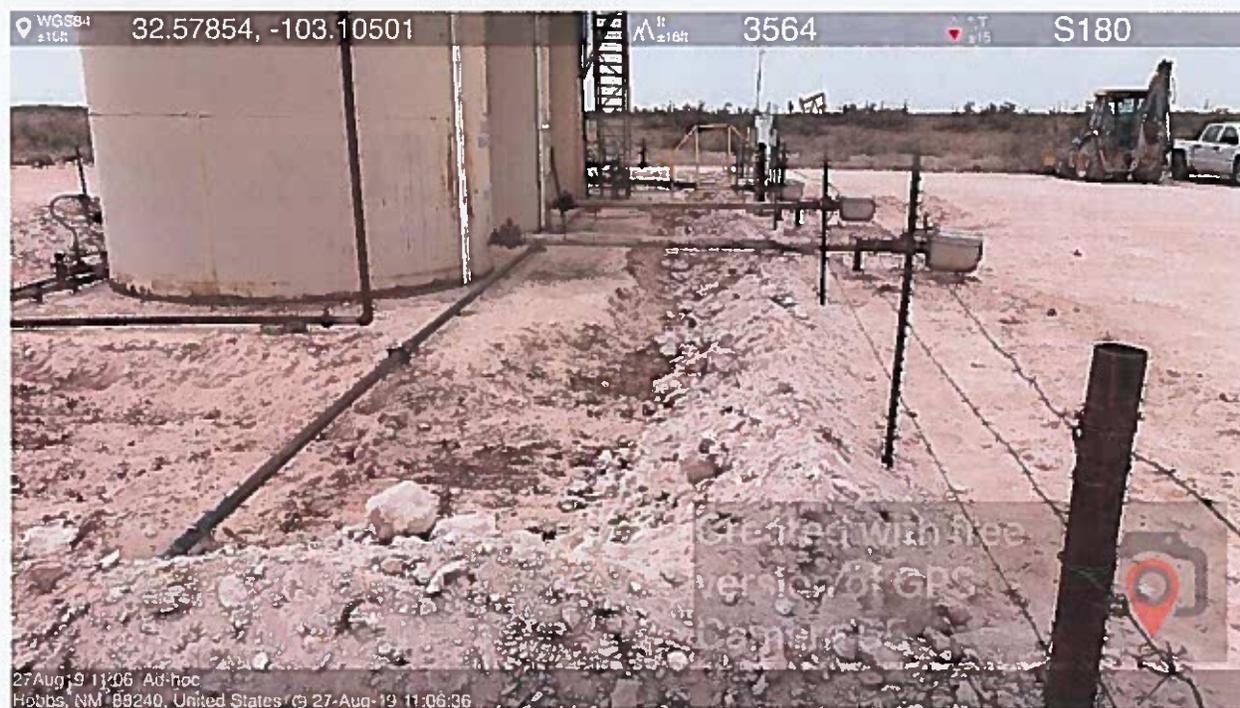
Area excavated with new installed berm

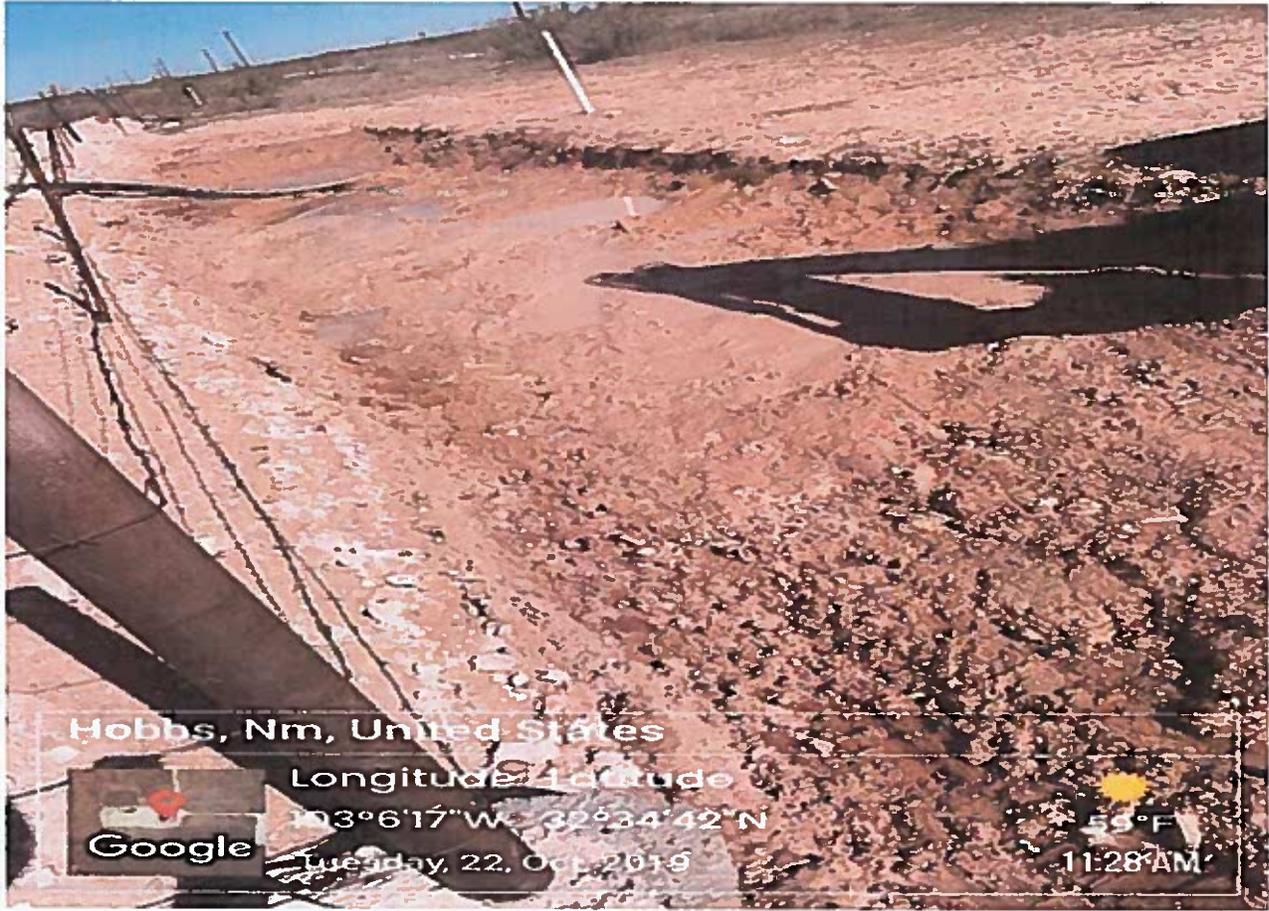
Pasture Excavation
