Release Notification

Site Name PLU 442/443 SWD Battery	Site Type Tank Battery
Date Release Discovered 5-22-2020	API# (if applicable)

**RE: Closure Request
PLU 442/443 SWD Battery
Incident Number NRM2016049766
Eddy County, New Mexico**

WSP USA, Inc. (WSP) (formerly LT Environmental, Inc.), on behalf of XTO Energy, Inc. (XTO), presents the following Closure Request detailing site assessment, excavation, and soil sampling activities at the Poker Lake Unit (PLU) 442/443 SWD Battery (Site) in Unit B, Section 30, Township 24 South, Range 30 East, in Eddy County, New Mexico (Figure 1). The purpose of the site assessment, excavation, and soil sampling activities was to address impacts to soil following a release of crude oil at the Site. Based on the field observations, field screening activities, and soil sample laboratory analytical results, XTO is submitting this Closure Request and requesting no further action (NFA) for Incident Number NRM2016049766.

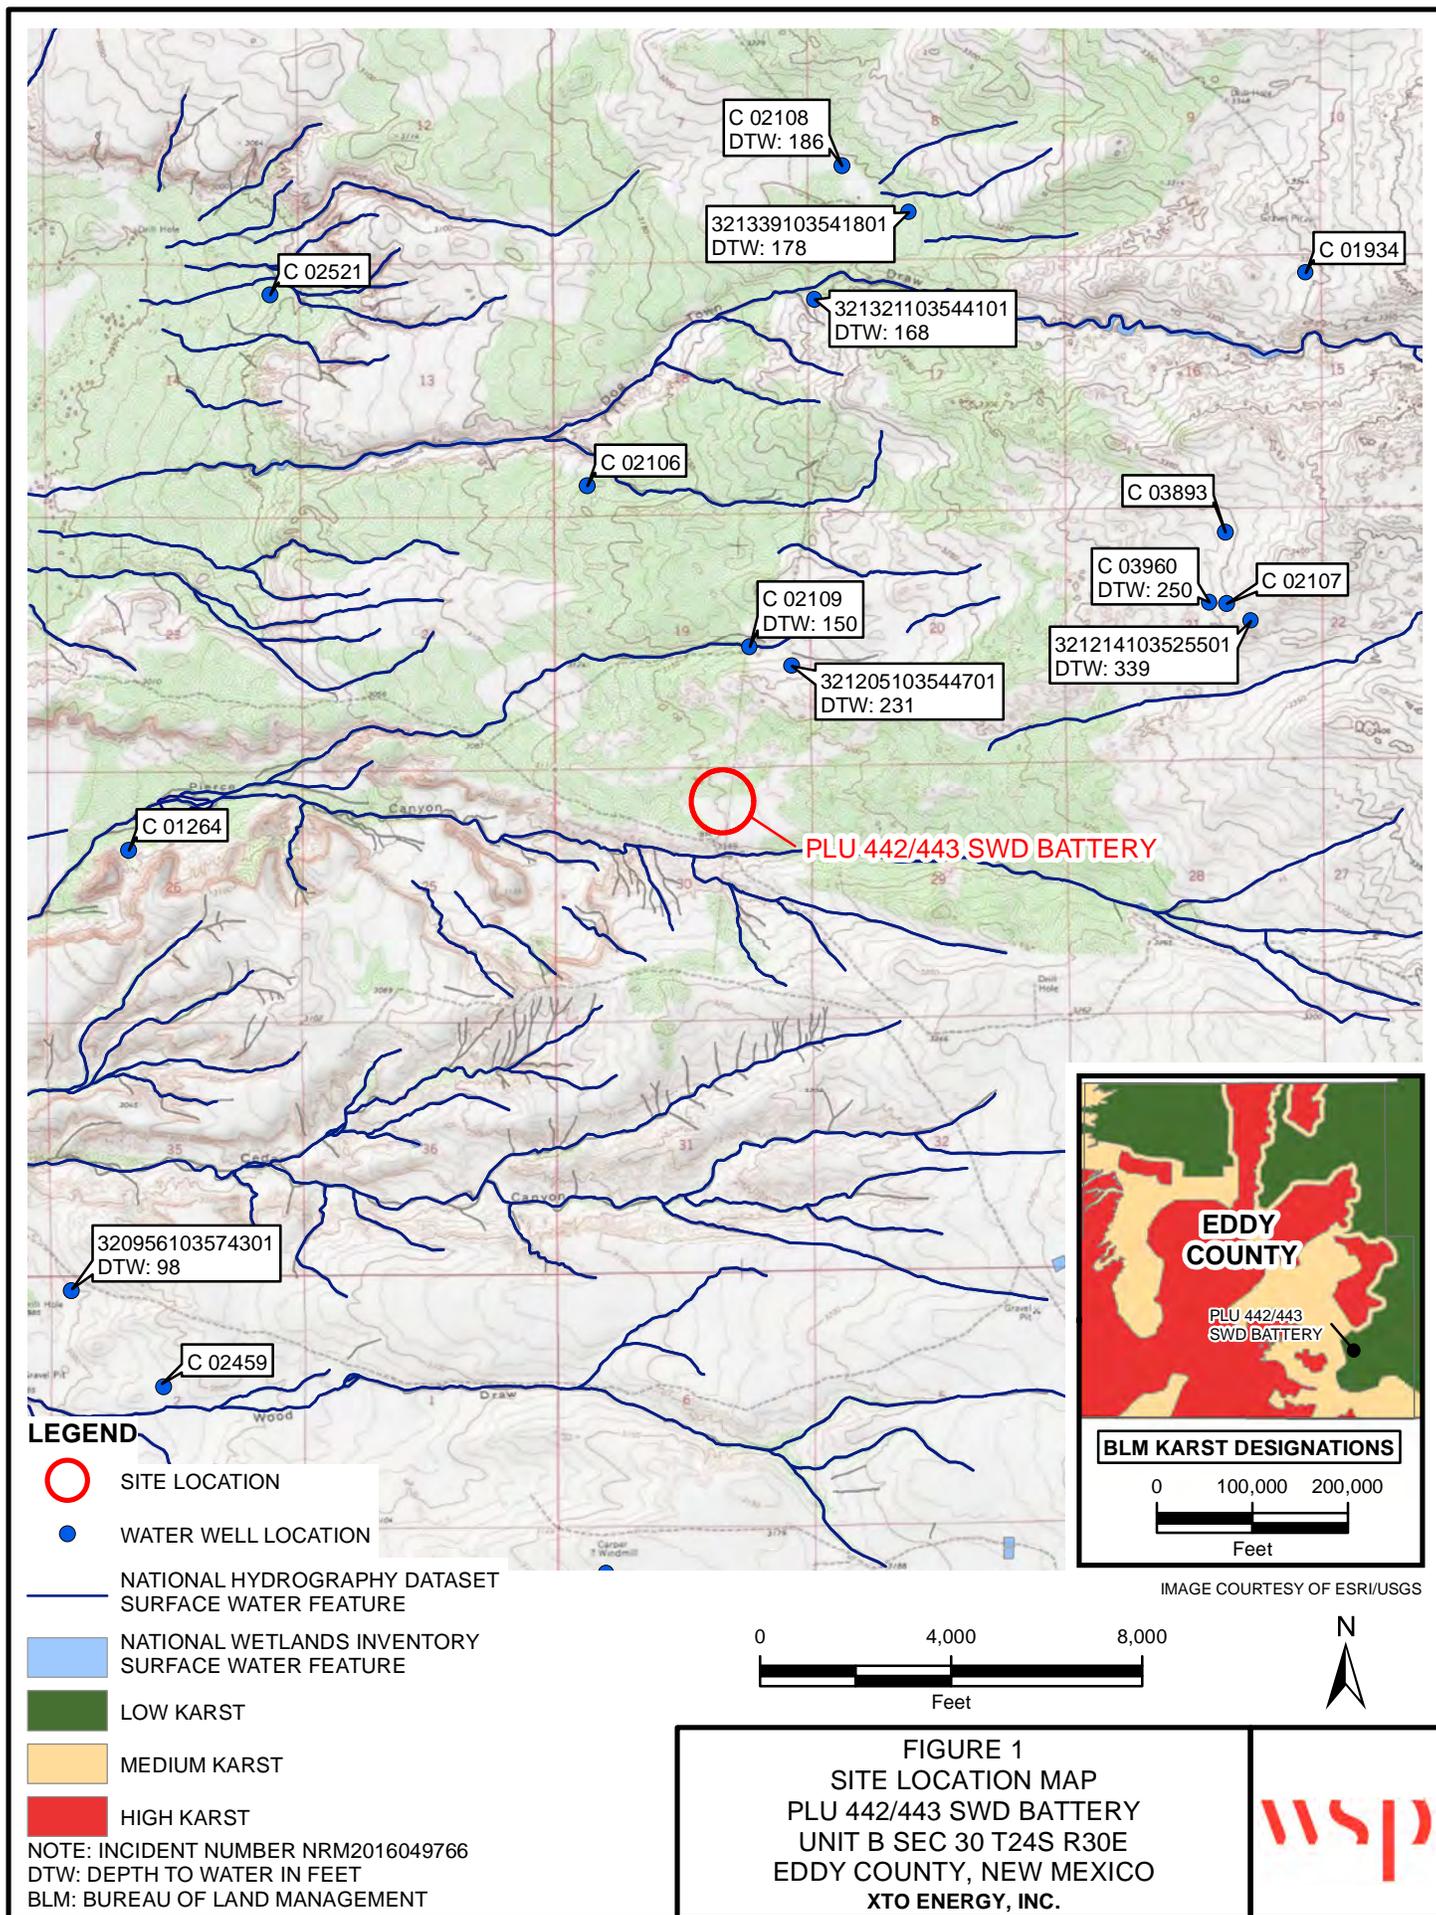
The closest continuously flowing or significant watercourse to the Site is an unnamed dry wash, located approximately 1,020 feet southeast of the Site. The Site is greater than 200 feet from a lakebed, sinkhole, or playa lake and greater than 300 feet from an occupied residence, school, hospital, institution, church, or wetland. The Site is greater than 1,000 feet to a freshwater well or spring and is not within a 100-year floodplain or overlying a subsurface mine. The Site is not underlain by unstable geology (low potential karst designation area). Site receptors are identified on Figure 1.

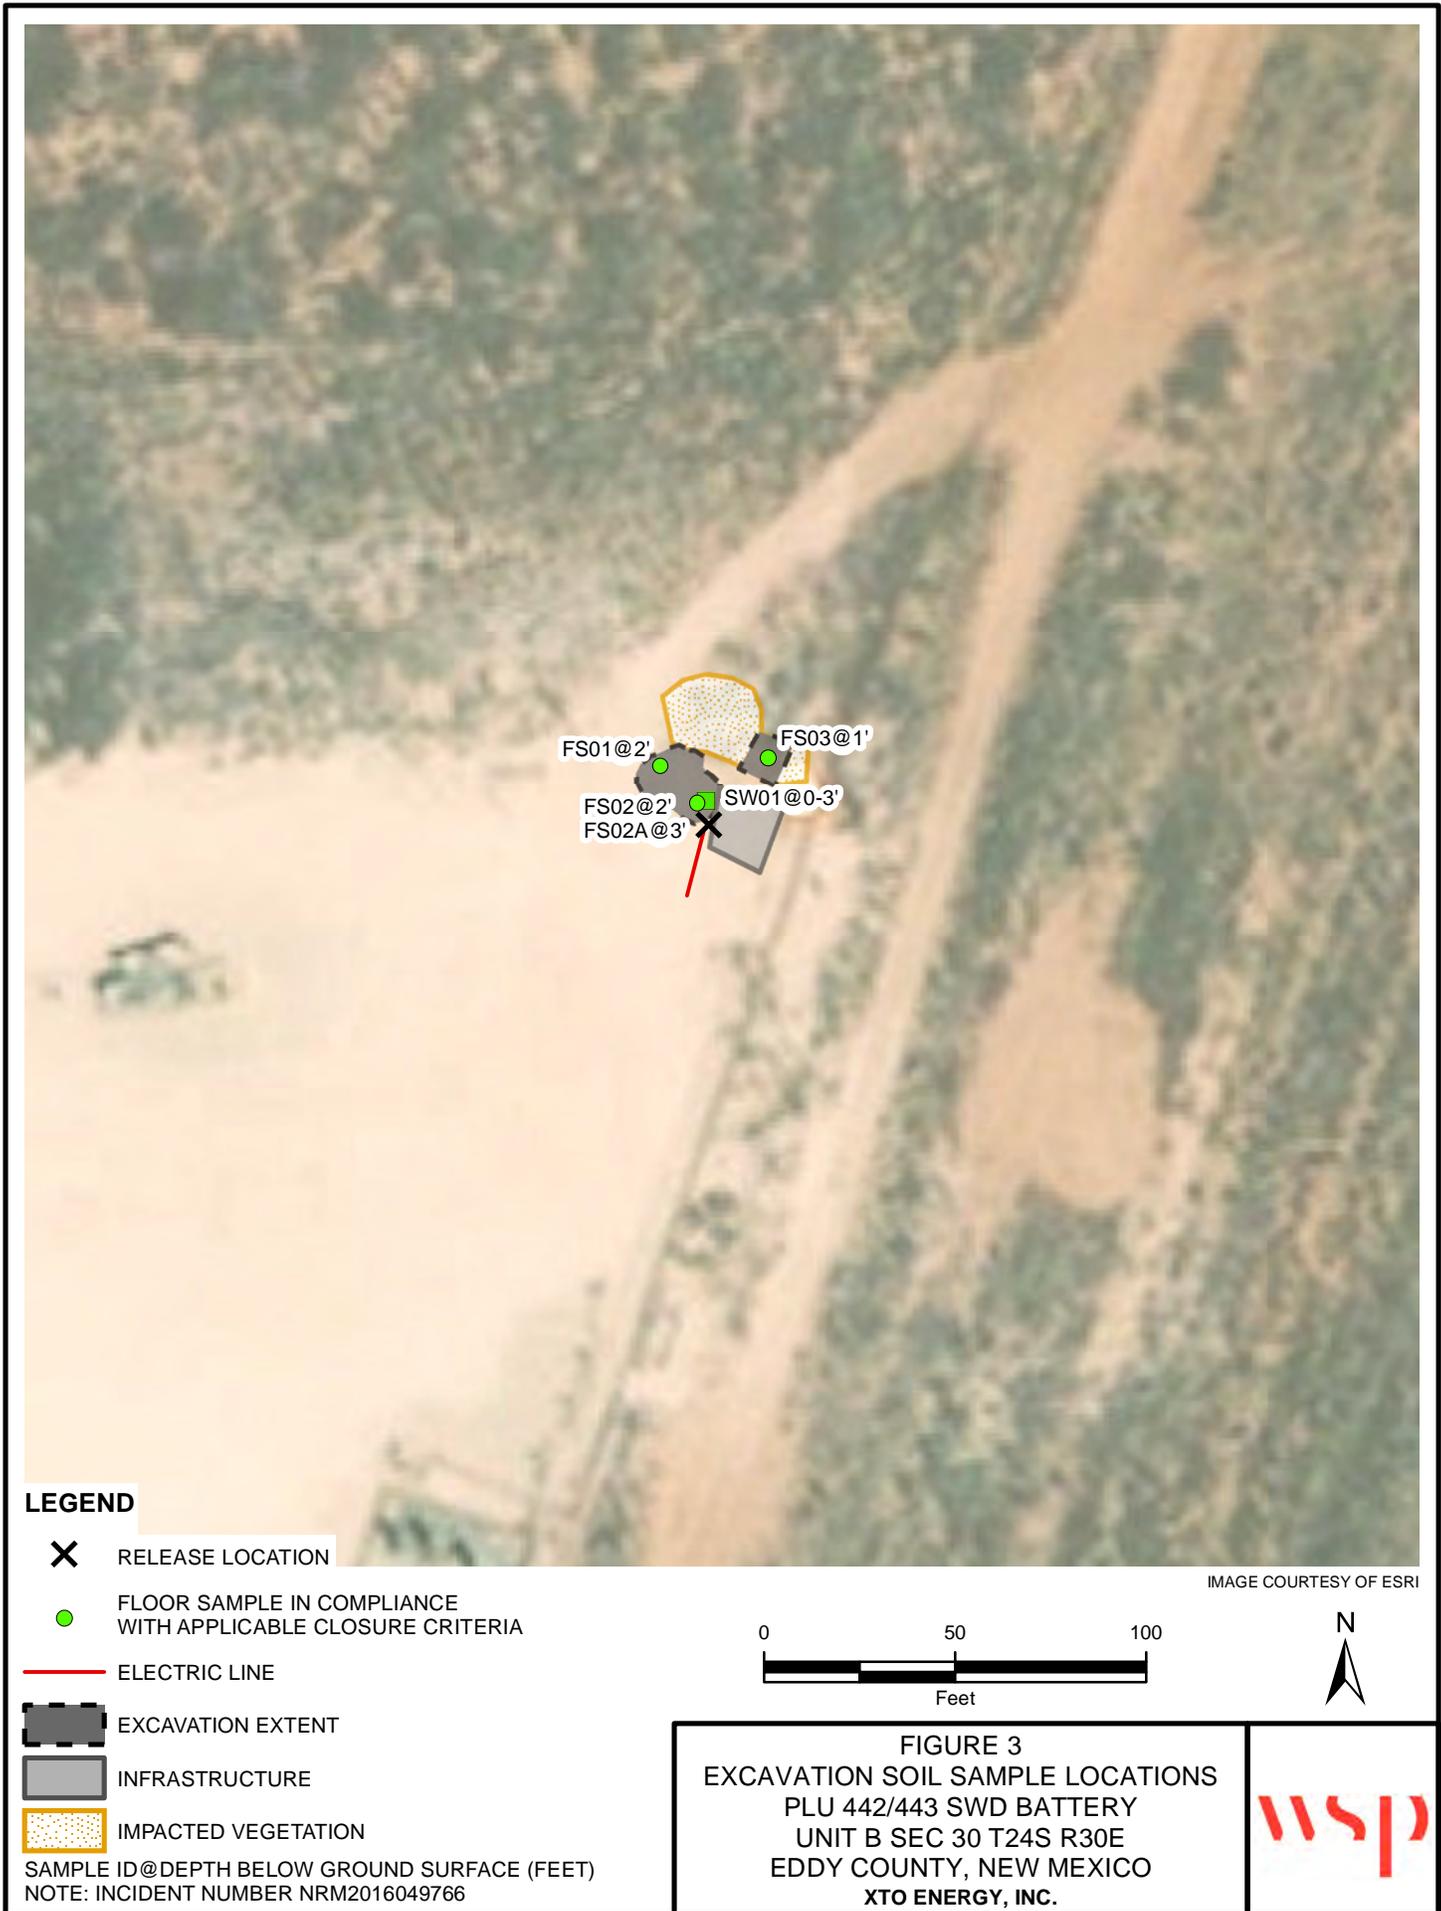
P:\XTO Energy\GIS\MXD\012920122_PLU 442 - 443 SWD BATTERY\012920122_FIG02_PRELIMINARY_2020.mxd

On August 12, 2020, WSP personnel visited the Site to evaluate the release extent based on information provided on the Form C-141 and visual observations. WSP personnel collected four preliminary soil samples (SS01 through SS04) within the release extent and the north of the flare. During the site assessment it was observed the area north of the flare was impacted due to overspray from the release. Stressed vegetation was noted during release response. The four preliminary soil samples were collected from a depth of approximately 0.5 feet bgs to assess the lateral extent of impacted soil. Soil from the preliminary soil samples were field screened for volatile aromatic hydrocarbons and chloride utilizing a calibrated photoionization detector (PID)

Laboratory analytical results for preliminary soil sample SS03 indicated that benzene, BTEX, TPH-GRO/TPH-DRO, TPH, and chloride concentrations were compliant with the Closure Criteria. Laboratory analytical results for preliminary soil sample SS01 indicated that TPH-GRO/TPH-DRO, TPH, and chloride concentrations exceeded the Closure Criteria and preliminary soil sample SS02 exceeded the Closure Criteria for chloride concentration. Additionally, chloride concentration exceeds 600 mg/kg in preliminary soil sample SS04 in the top four feet of the subsurface. Based on visible staining in the release area, elevated field screening results, and laboratory analytical results for the preliminary soil samples, excavation activities were warranted.

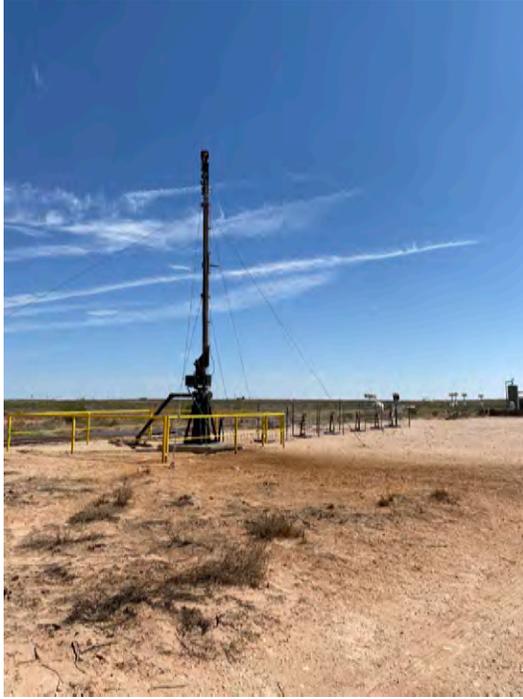
Photo No.	Date	
1	August 12, 2020

View facing southeast on pad and affected vegetation.

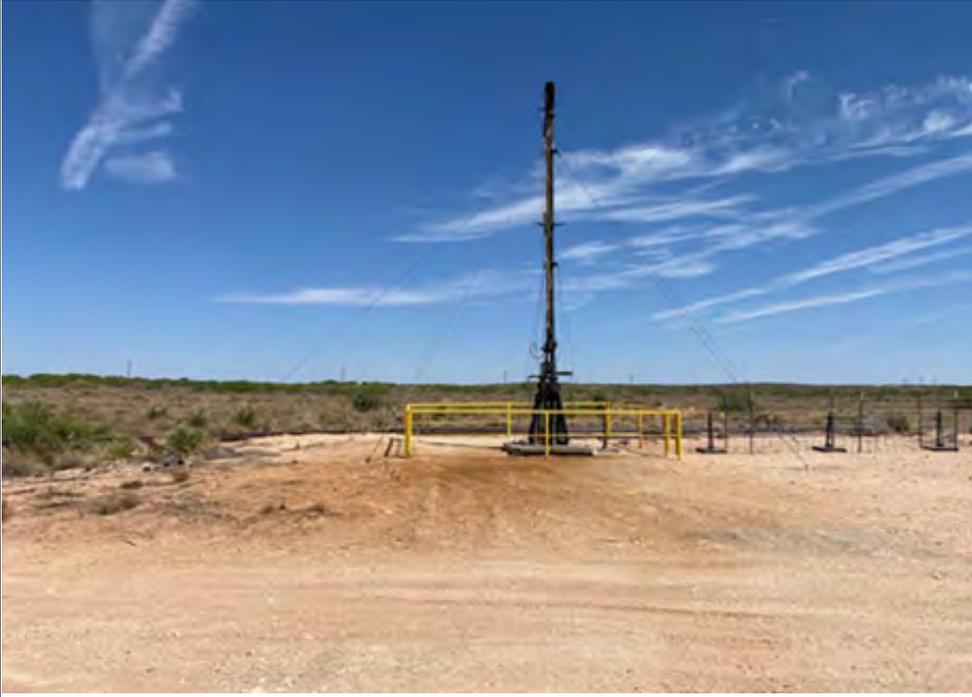
Photo No.	Date	
2	August 12, 2020

On May 22, 2020, fluid from the scrubber entered the gas line, causing a release of approximately 0.01 barrels (bbls) of crude oil through the flare stack which resulted in a small fire. The fire extinguished itself and there were no standing fluids to recover. XTO reported the release to the New Mexico Oil Conservation Division (NMOCD) on a Release Notification and Corrective Action Form C-141 (Form C-141) on June 5, 2020 and assigned Incident Number NRM2016049766.

View facing east of staining around flare stack.

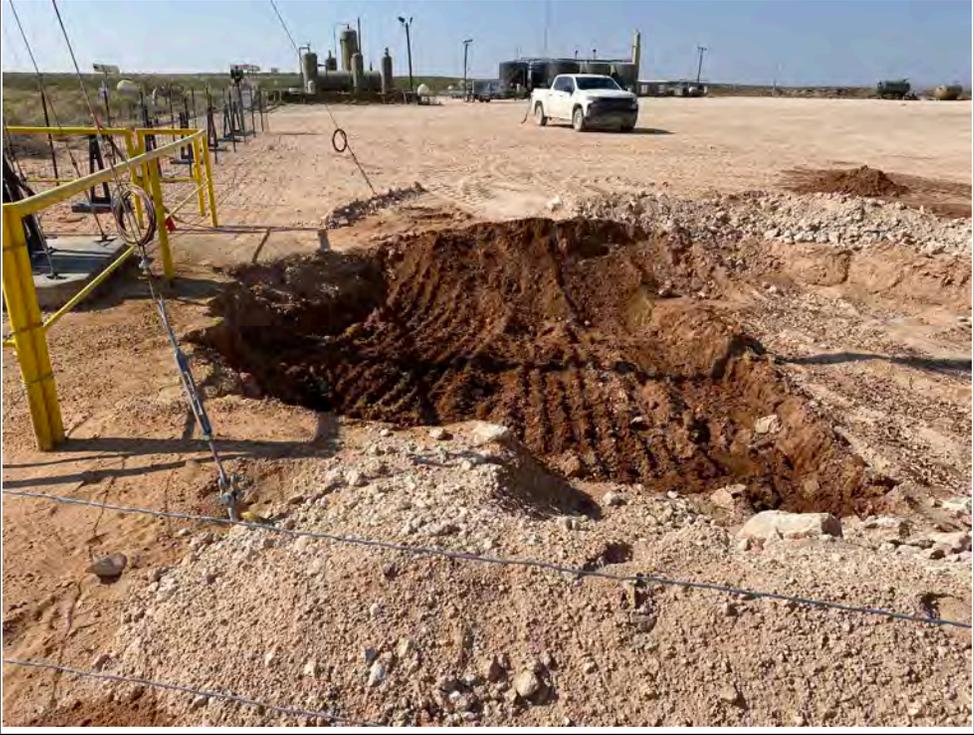
Photo No.	Date	
3	September 25, 2020

View facing south of pad excavation.

The excavation areas totaled approximately 423 square feet. A total of approximately 30 cubic yards of impacted soil was removed during the excavation activities. The impacted soil was transported and properly disposed of at the R360 Facility in Hobbs, New Mexico. After completion of confirmation sampling, the excavation was secured with fencing. The area north of the flare stack will be reseeded and backfilled with material purchased locally and recontour the Site to match pre-existing site conditions.

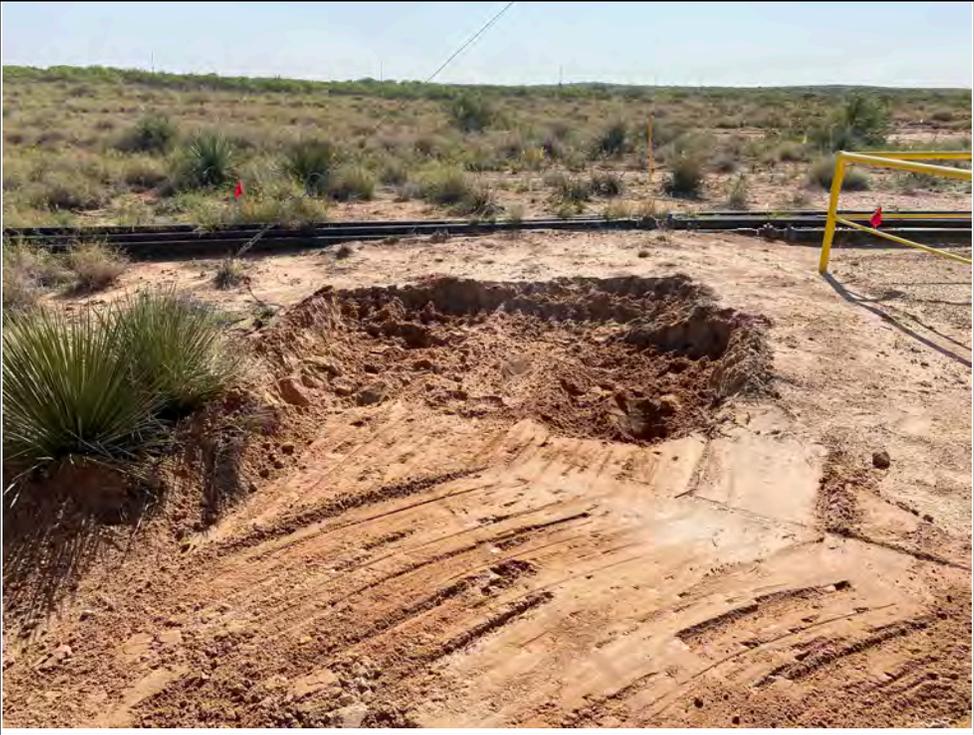
Photo No.	Date	
4	September 25, 2020

View facing east of pasture excavation.
