Closure Report

2 RP-5627

Site Name:	Federal 12 4 North CTB	Incident ID: NAB1927150997
Company:	Oxy USA, Inc.	
Legal Description:	U/L E, Sec 12, T22S, R31E	
County:	Eddy County, NM	
GPS Coordinates:	N 32.40786 W-103.73865

Oxy Federal 12 #4 North CTB

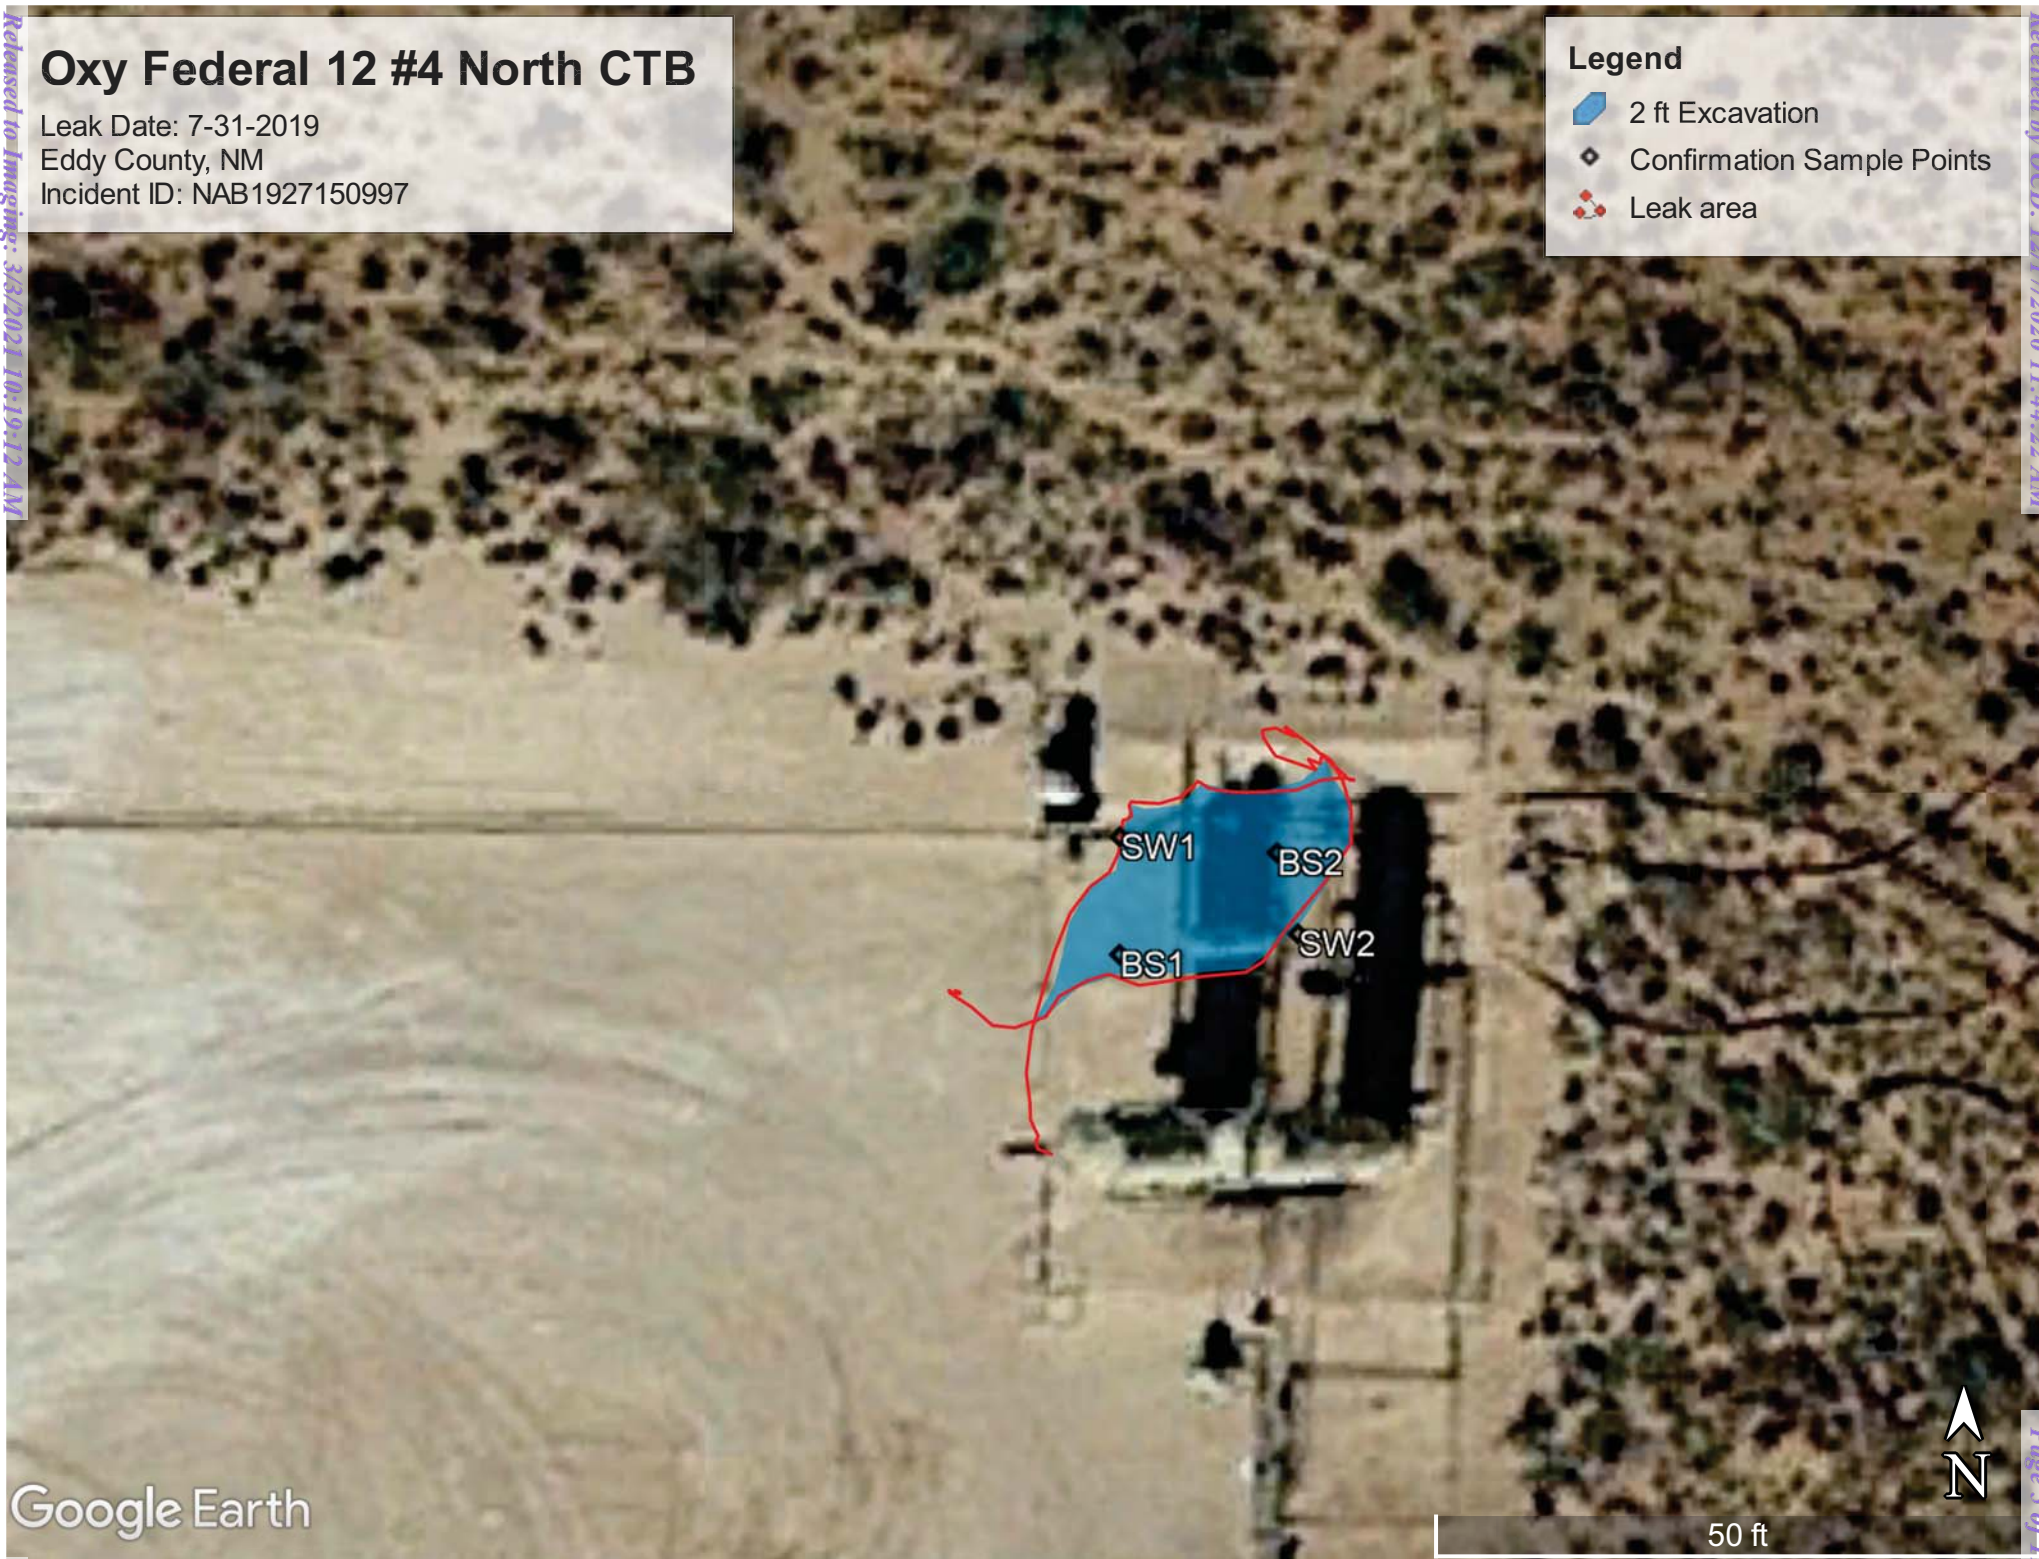
Legend

2 ft Excavation
-

Confirmation Sample Points
-

Leak area

Remediation Parameters:	Excavated the entire leak area to a depth of 2 feet. Collected confirmation samples every 50 feet. Entire site was backfilled with clean soil.
Remediation Activities:	10/1/20 to 11/13/20
