Incident ID	NRM2021846438
District RP	
Facility ID	
Application ID

On July 18, 2020, external corrosion of a buried flow line resulted in the release of approximately 37.46 bbls (barrels) of produced water and 7.13 bbls of crude oil onto the surrounding pasture area west of the well pad. A vacuum truck was dispatched to the Site to recover the free-standing fluid; approximately 0.4 bbls of produced water and 0.08 bbls of crude oil were recovered. XTO immediately reported the release to the New Mexico Oil Conservation Division (NMOCD) via email on July 18, 2020 and subsequently submitted a Release Notification and Corrective Action Form C-141 (Form C-141) on July 31, 2020. The release was assigned Incident Number NRM2021846438.

PHOTOGRAPHIC LOG		
XTO Energy	PLU CVX JV BS 013 Eddy County, New Mexico	012920112 NRM2021846438

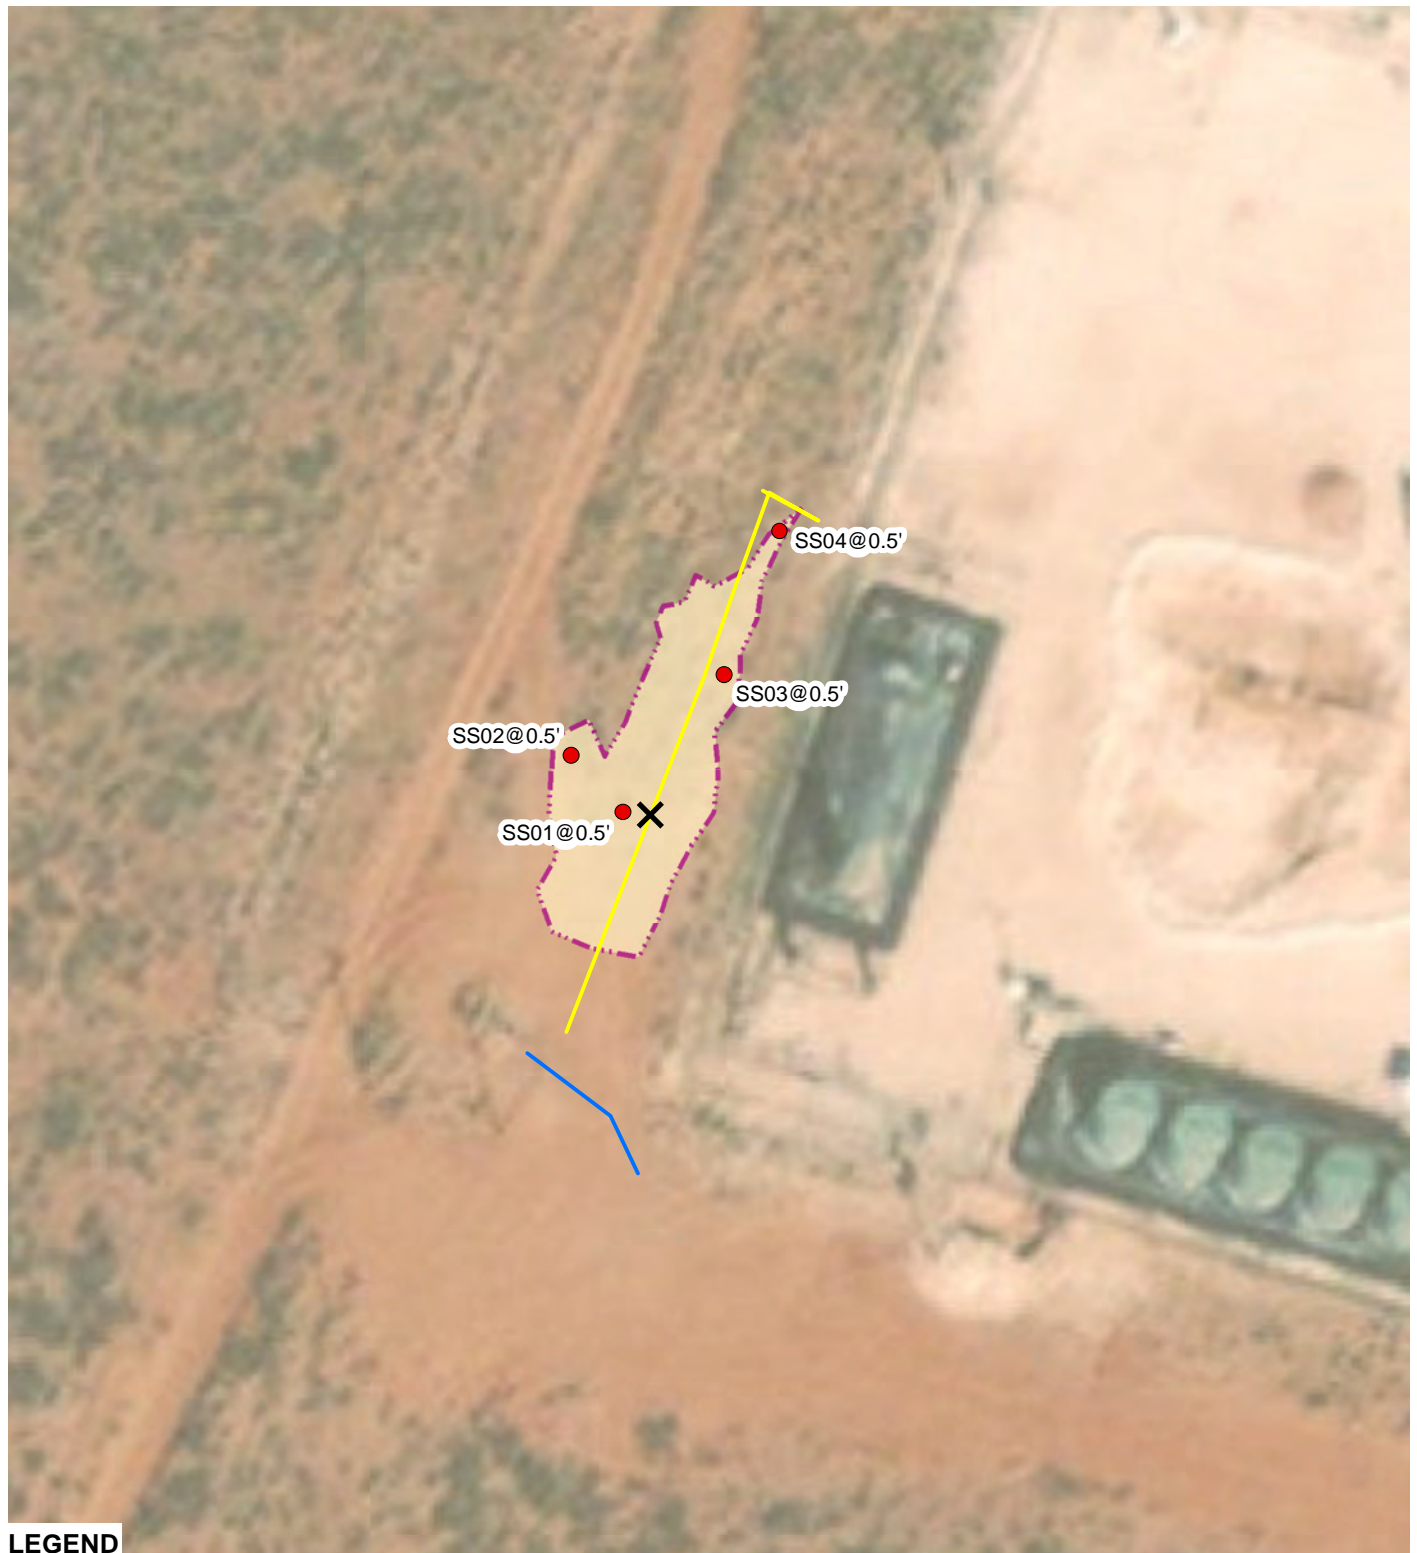
- X** RELEASE LOCATION
- PRELIMINARY SOIL SAMPLE WITH CONCENTRATIONS EXCEEDING APPLICABLE CLOSURE CRITERIA
- GAS LINE
- WATER LINE
- RELEASE EXTENT

Based on the laboratory analytical results for preliminary soil samples SS01 through SS04, excavation of impacted soil was required. Photographic documentation was conducted during the Site visit. A photographic log is included in Attachment 3. Based on visible staining in the release area, elevated field screening results, and laboratory analytical results for the preliminary soil samples, excavation activities were warranted.

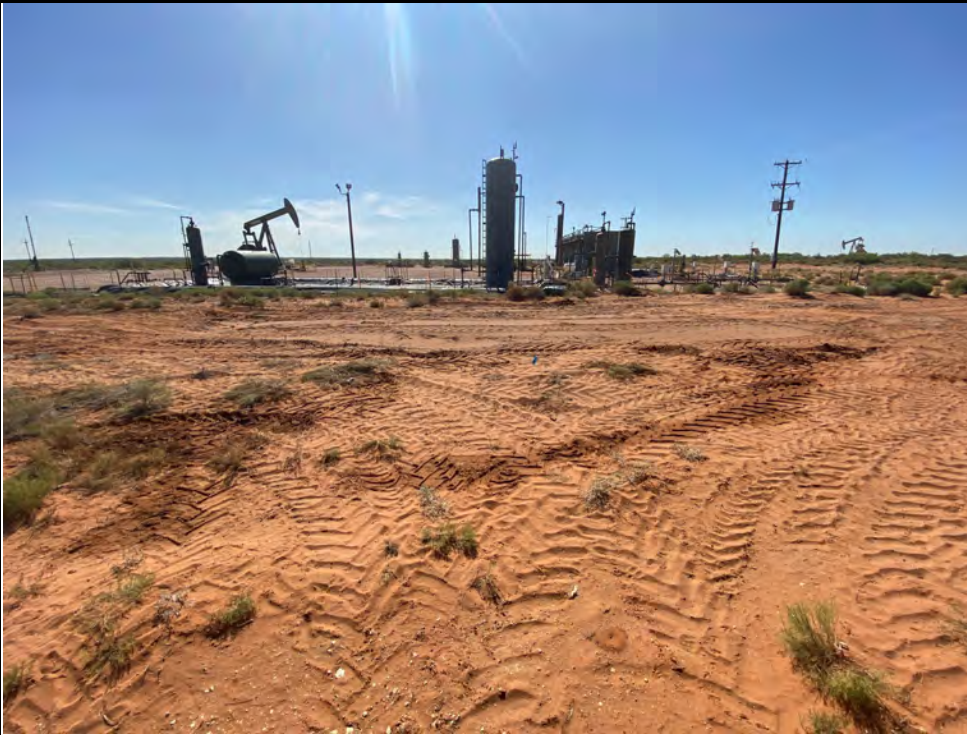
Photo No.	Date

1	July 28, 2020	
View of staining in pasture along pipeline right of way facing East.

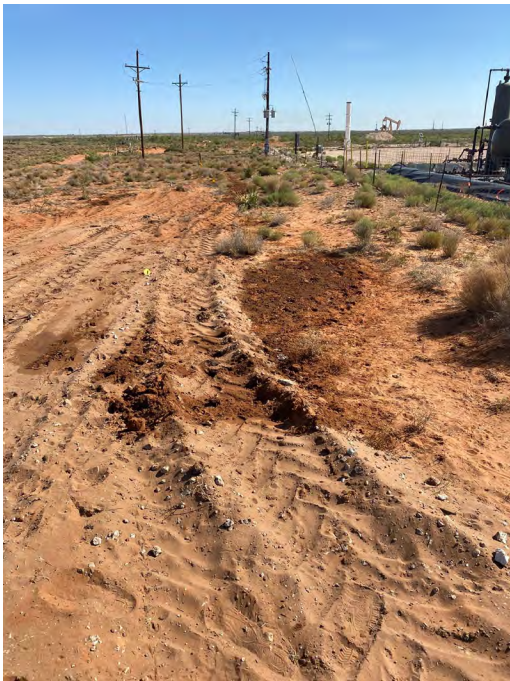
Photo No.	Date

2	July 28, 2020	
View of staining in pasture along pipeline right of way facing North.

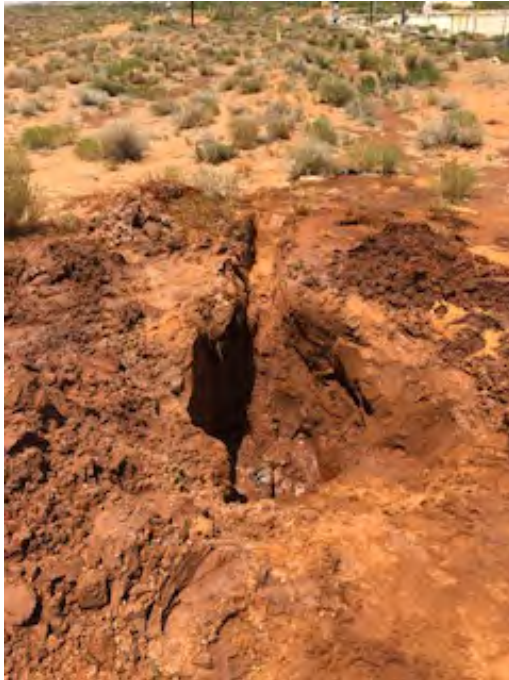
Photo No.	Date	
3	July 27, 2020	
View of exposed point of release in pasture facing North.

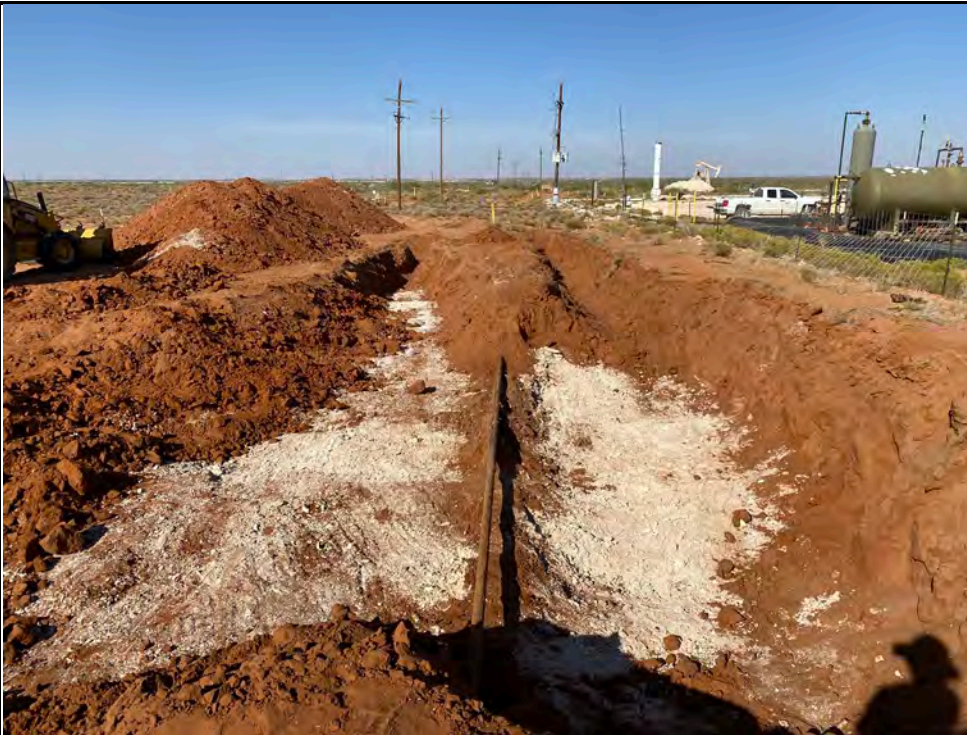
Photo No.	Date	
4	October 10, 2020	
View of excavation and exposed pipeline facing North.

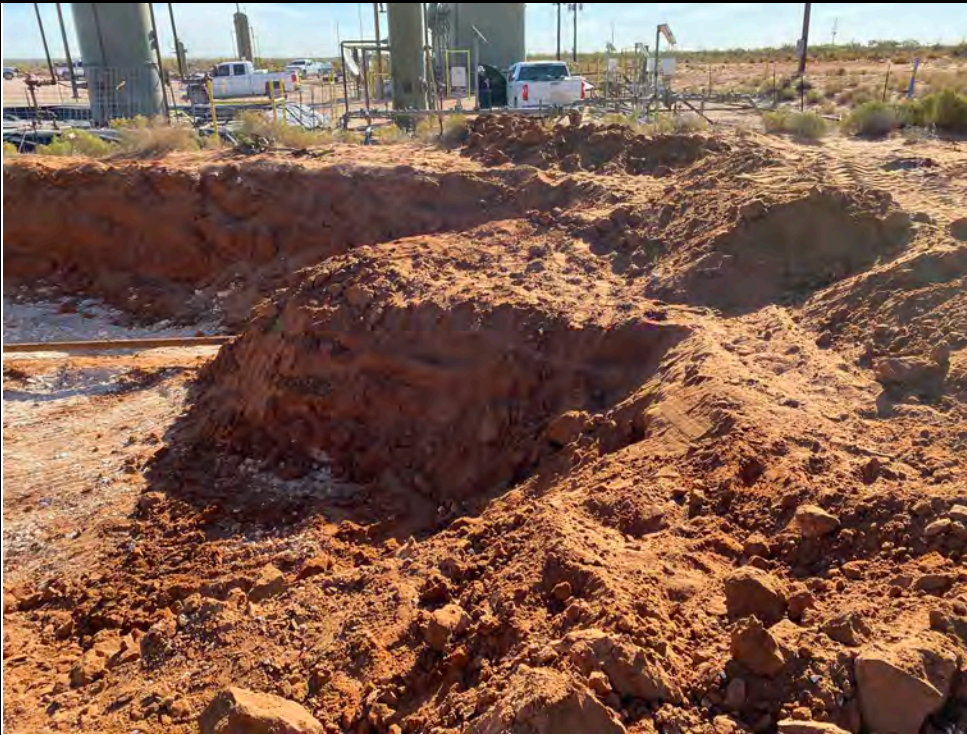
Photo No.	Date	
5	November 4, 2020	
View of further excavation to remediate failing SW04 sample

A photograph showing a large, deep excavation pit in a dry, arid landscape. The soil is reddish-brown and rocky. In the background, there are industrial structures, including a large green storage tank and various pipes and valves. A white pickup truck is parked near the excavation.

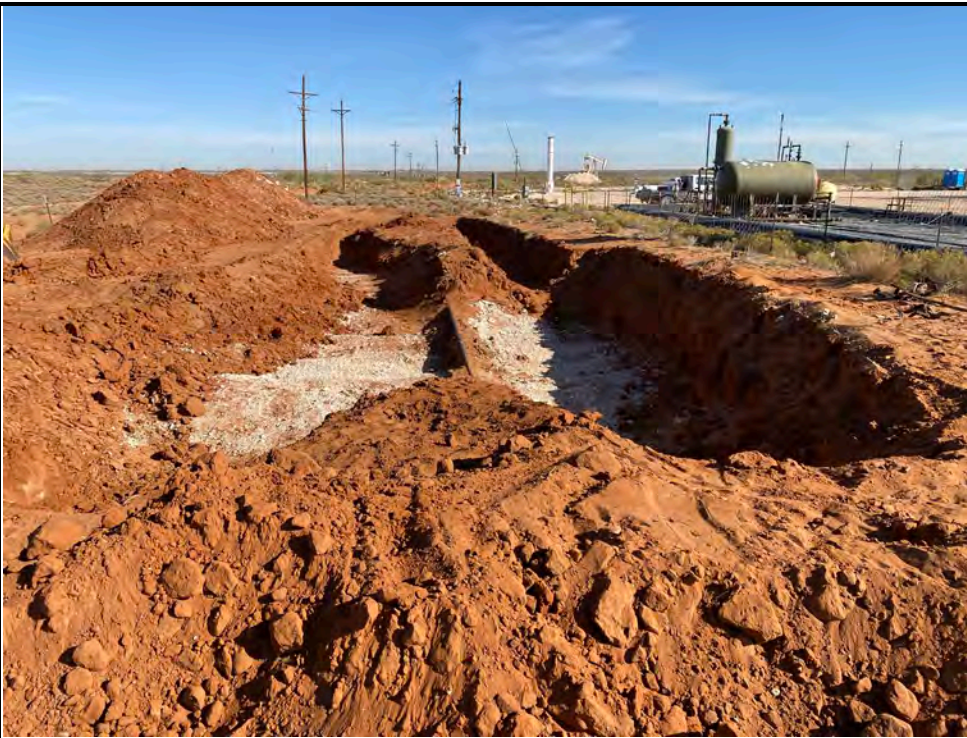
Photo No.	Date	
6	November 4, 2020	
View of excavation extent facing North during remediation activities.

A photograph showing a wide view of the excavation site from a distance. The excavation is a large, irregular pit filled with reddish-brown soil and rocks. In the background, there are several tall utility poles and a large green storage tank. The sky is clear and blue.
