## Release Notification

| Site Name PLU 129 Flowline | Site Type Flow line |

On September 3, 2020, a flow line leak developed due to corrosion and resulted in the release of approximately 0.02 barrels (bbls) of crude oil and 6.12 bbls of produced water onto the well pad surface and into the adjacent pasture. A vacuum truck was immediately dispatched to the Site to recover freestanding fluids, of which approximately 0.01 bbls of crude oil and 1.99 bbls of produced water were recovered. XTO reported the release to the New Mexico Oil Conservation Division (NMOCD) and submitted a Release Notification and Corrective Action Form C-141 (Form C-141) on September 14, 2020. The release was assigned Incident Number NRM2026531591.

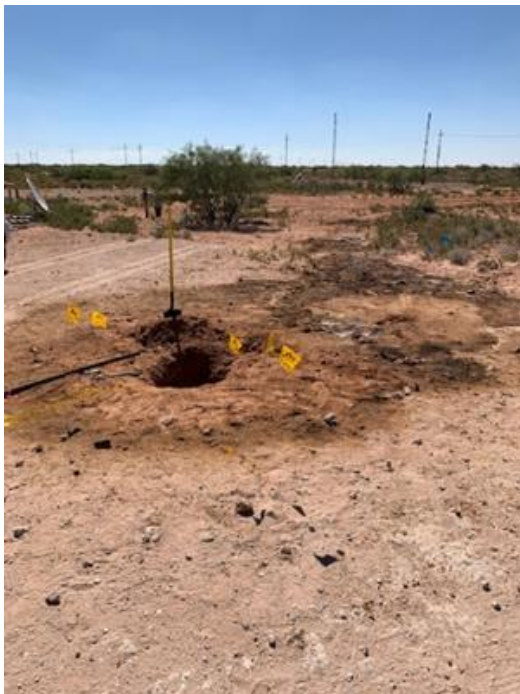
| <b>Photo No.</b> | <b>Date</b> | |
|---|---|---|
| Southeast view of the point of release courtesy of XTO. | | A photograph showing a dry, sandy area with sparse vegetation. A small, dark, circular hole or depression is visible in the center, surrounded by yellow caution tape. In the background, there are utility poles and a clear blue sky. |

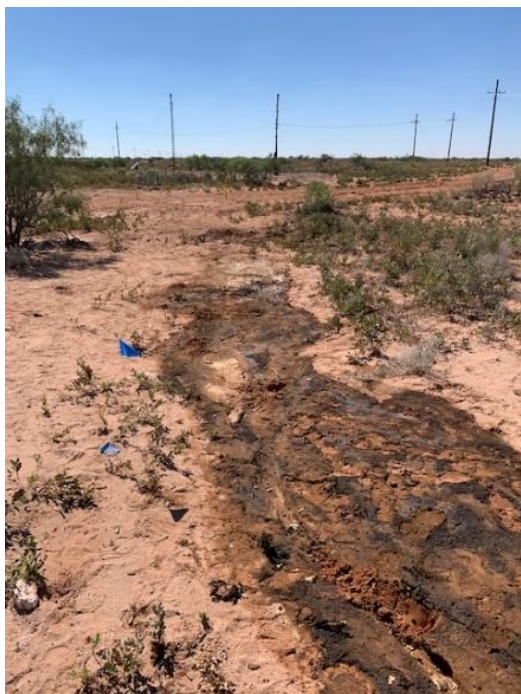
| <b>Photo No.</b> | <b>Date</b> | |
|---|---|---|
| Southeast view of the release area courtesy of XTO. | | A photograph showing a dry, sandy area with sparse vegetation. A large, dark, irregularly shaped area of soil is visible in the foreground, possibly indicating a release or spill. In the background, there are utility poles and a clear blue sky. |

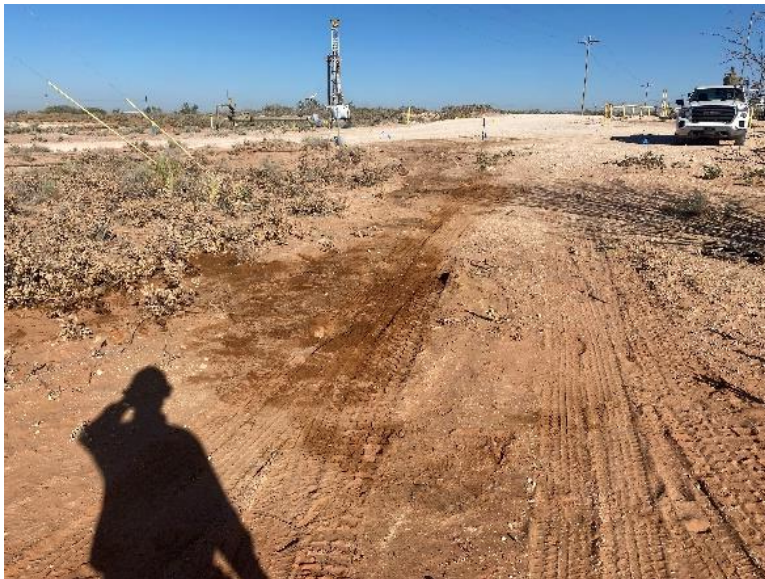
| Photo No. | Date | |
|---|---|---|
| Northwest view of the release area. | | A photograph showing a dirt road or path leading towards a drilling rig in the distance. The ground is reddish-brown and appears to be disturbed. A white truck is parked on the right side of the road. The shadow of the person taking the photo is visible in the foreground. |

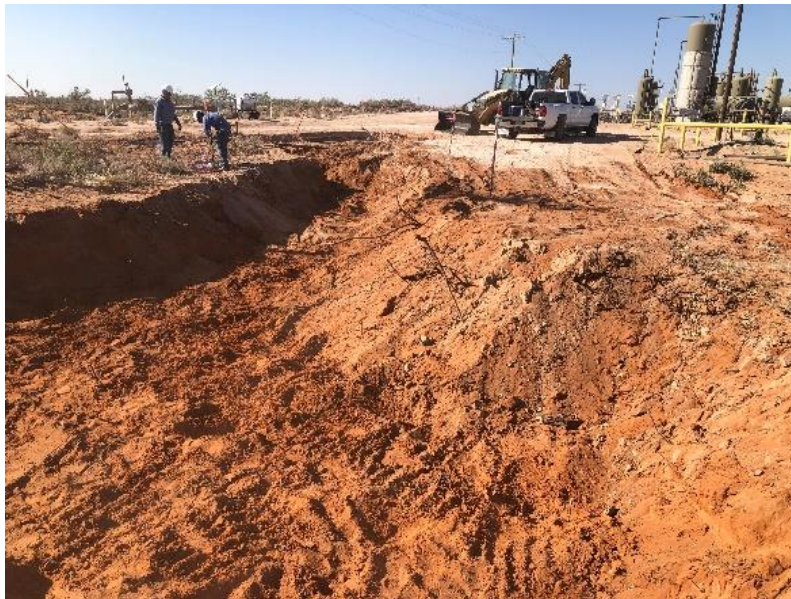
| Photo No. | Date | |
|---|---|---|
| Northern view of the final excavation extent. | | A photograph showing a large, deep excavation pit with reddish-brown soil. Two workers in blue uniforms are standing on the left side of the pit. In the background, there is a white pickup truck, a yellow excavator, and industrial equipment including a large storage tank and piping. |

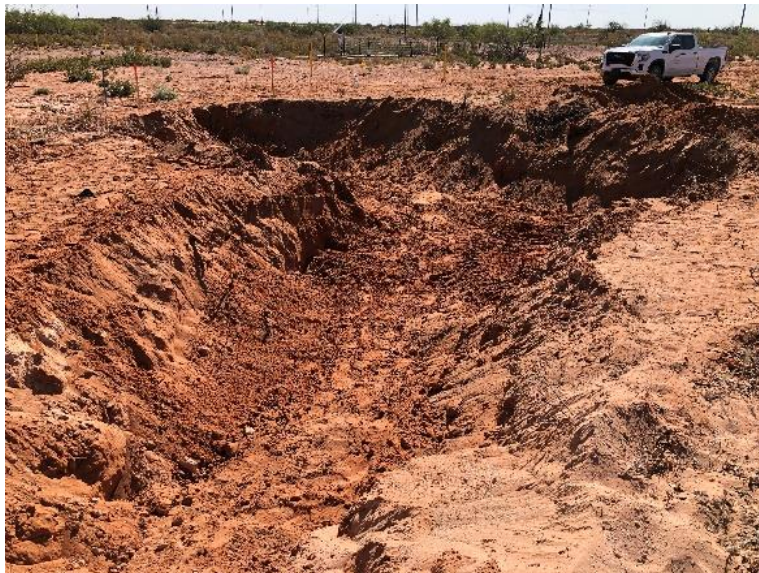
| Photo No. | Date | |
|---|---|---|
| Southern view of the final southern excavation extent. | | A photograph showing a deep excavation pit with reddish-brown soil. A white pickup truck is parked on the right side of the pit. The background shows a flat, arid landscape with some sparse vegetation and a clear sky. |

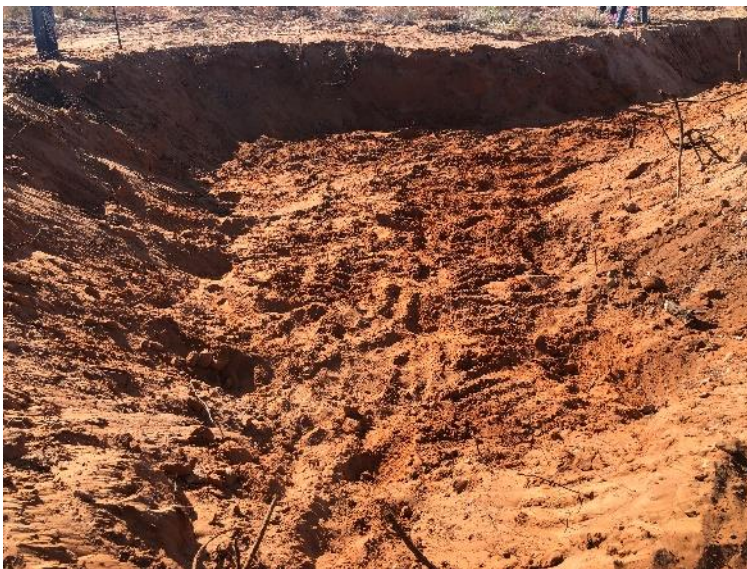
| Photo No. | Date | |
|---|---|---|
| 7 | September 4 –<br>October 21, 2020 | |

| Photo No. | Date | |
|---|---|---|
| Western view of the final southern excavation extent. | | |

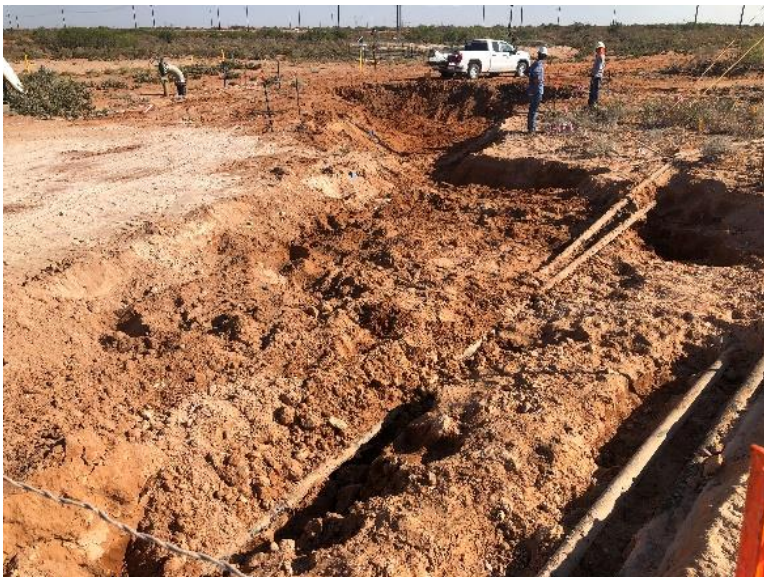
| Photo No. | Date | |
|---|---|---|
| 8 | September 4 –<br>October 21, 2020 | |

| Photo No. | Date | |
|---|---|---|
| Southern view of the final excavation extent. | | |
