Request For Incident Closure

Re: Remediation Activities & Closure Report
Emerald PWU 20 #1H
API No. 30-015-38338
GPS: Latitude 32.6525154 Longitude -104.1045456
UL "D," Sec. 20, T19S, R29E
Eddy County, NM
NMOCD Ref. No. 2RP-779; 2RP-4281; 2RP-5167; 2RP-5377

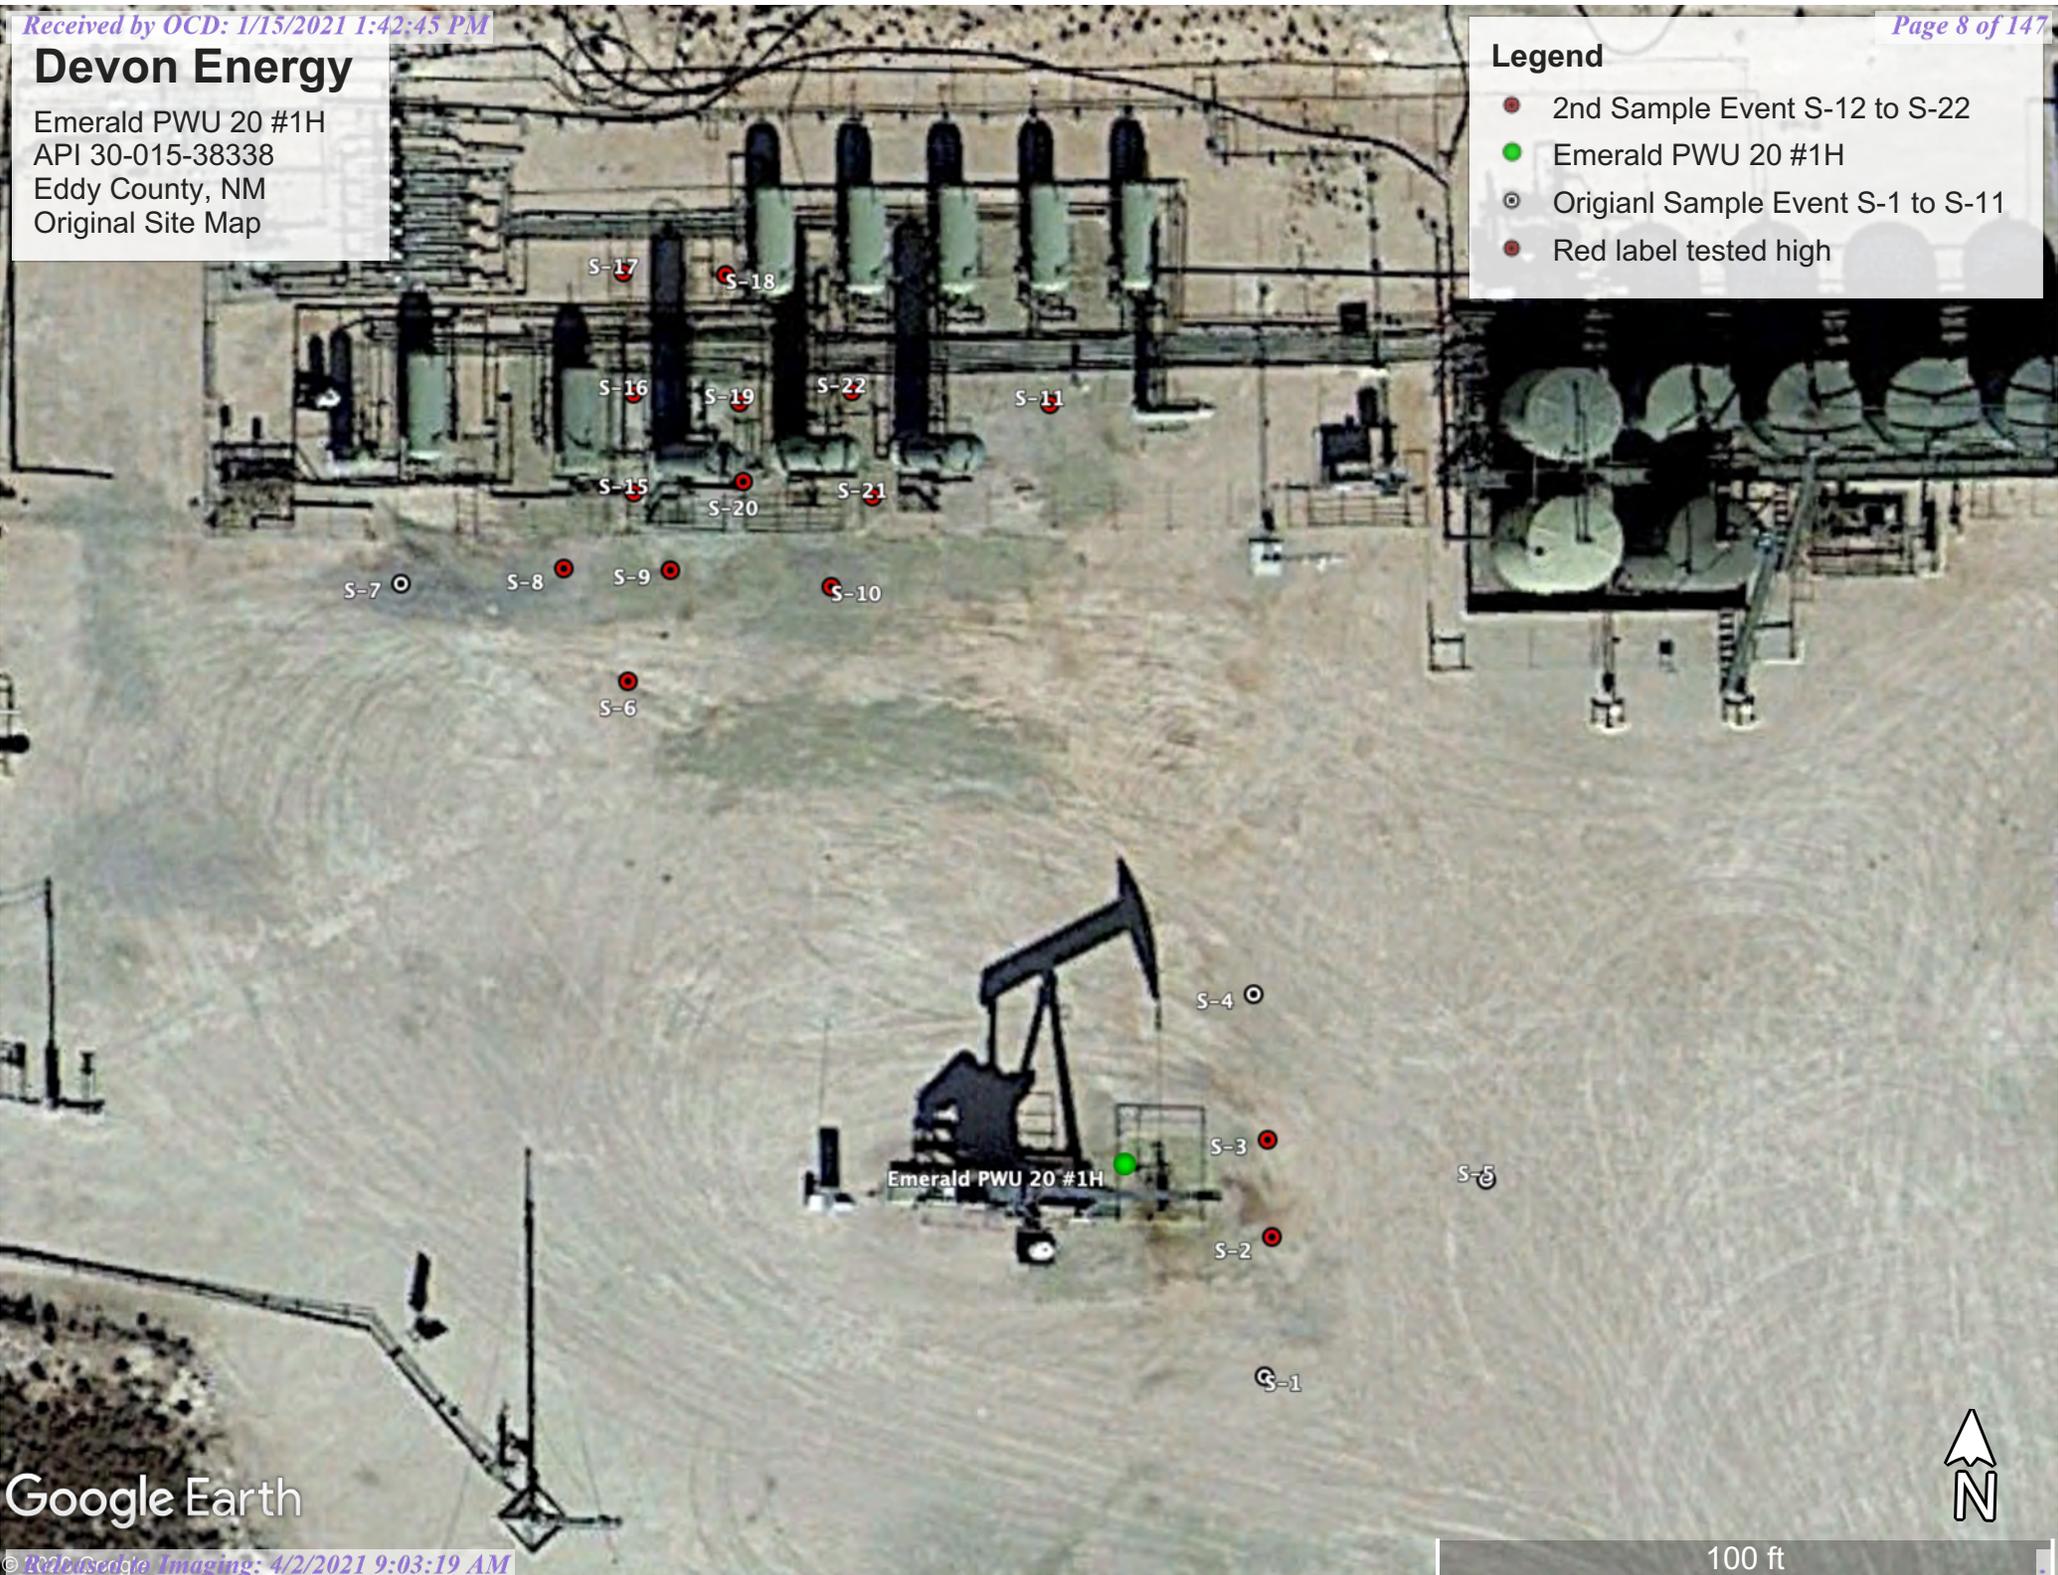
- 2nd Sample Event S-12 to S-22
- Emerald PWU 20 #1H
- Original Sample Event S-1 to S-11
- Red label tested high

On July 7, 2020, Pima Environmental mobilized to the site to conduct a site assessment and obtain soil samples. Upon first look, there was no visual staining from any of the releases. We followed previously outlined diagrams and descriptions from C-141's to track the spills' vicinity and sampled in various random locations. The laboratory results of this sampling event can be found in the following data table. Pima submitted a work plan that would address all open RP's and was approved by the NMOCD.

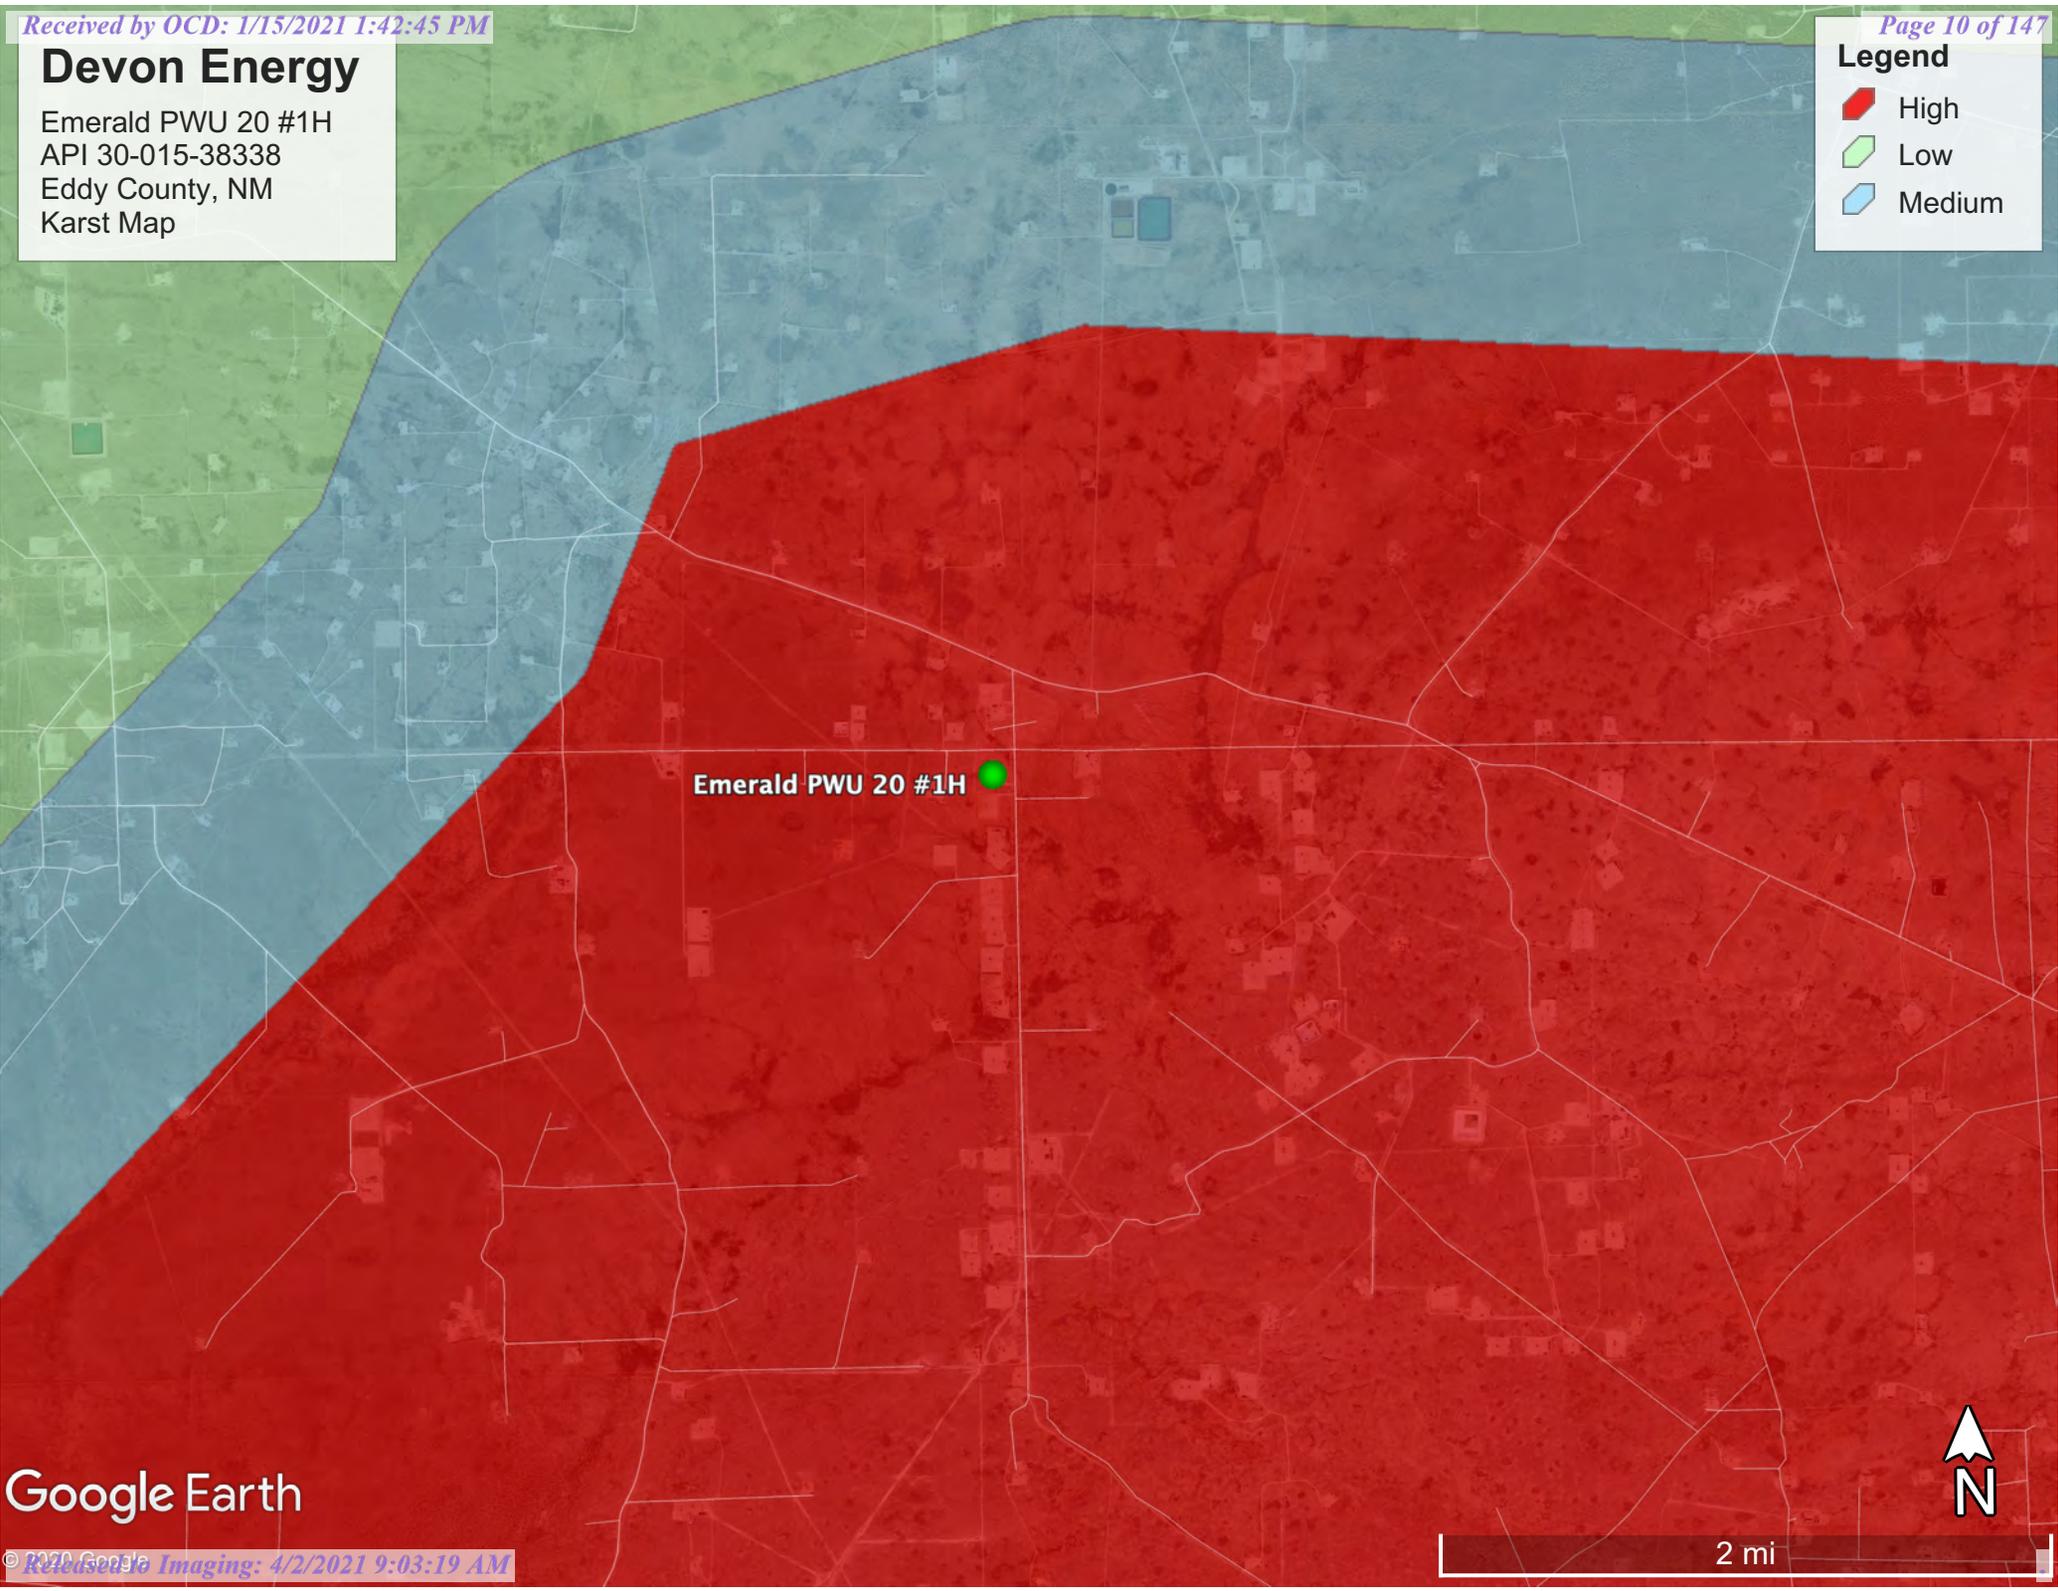
Per the New Mexico Bureau of Geology and Mineral Resources, the geology is in the Quaternary Formation Eolian and piedmont deposits (Holocene to middle Pleistocene)-interlayed eolian sands and piedmont-slope deposits (QEP). According to the United States Department of Agriculture Natural Resources Conservation Service soil survey, the soil in this area comprises Simona-Bippus complex, 0 to 5 percent slopes (Appendix B). The drainage courses in this area are well-drained. There is a high potential for karst geology in the Emerald area (Figure 3).

- High
- Low
- Medium

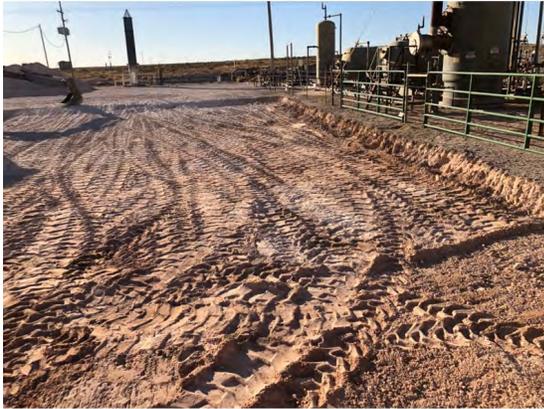
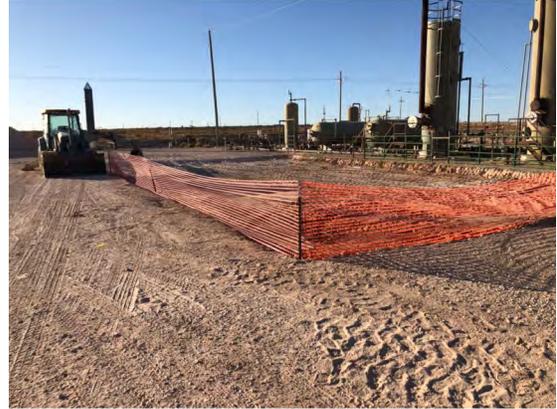
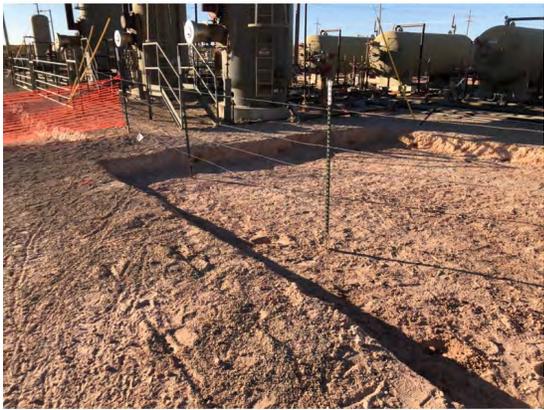
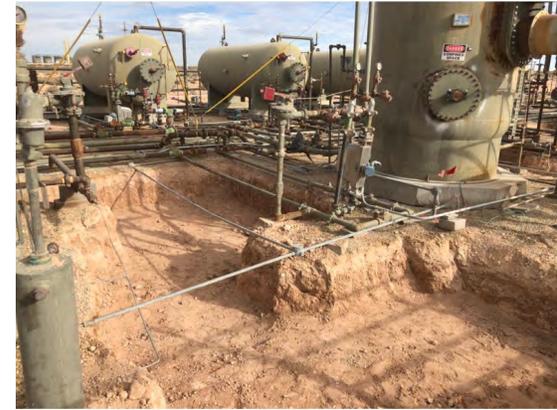
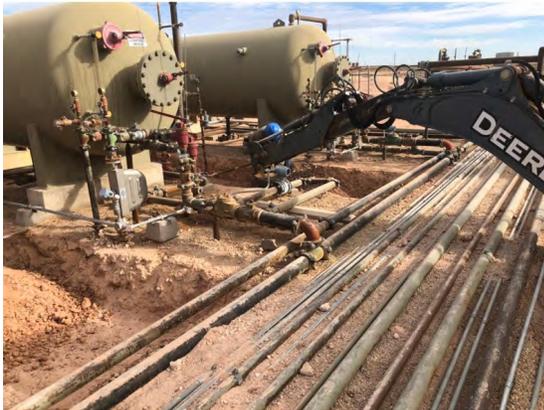
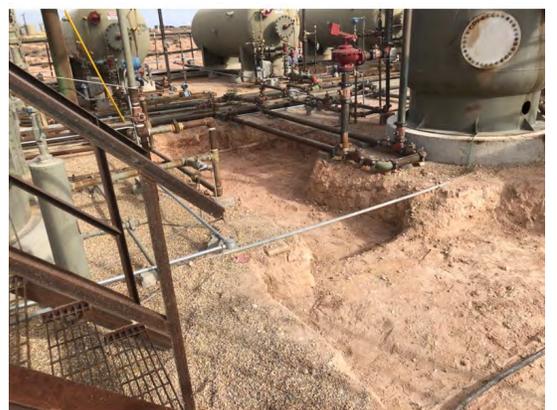
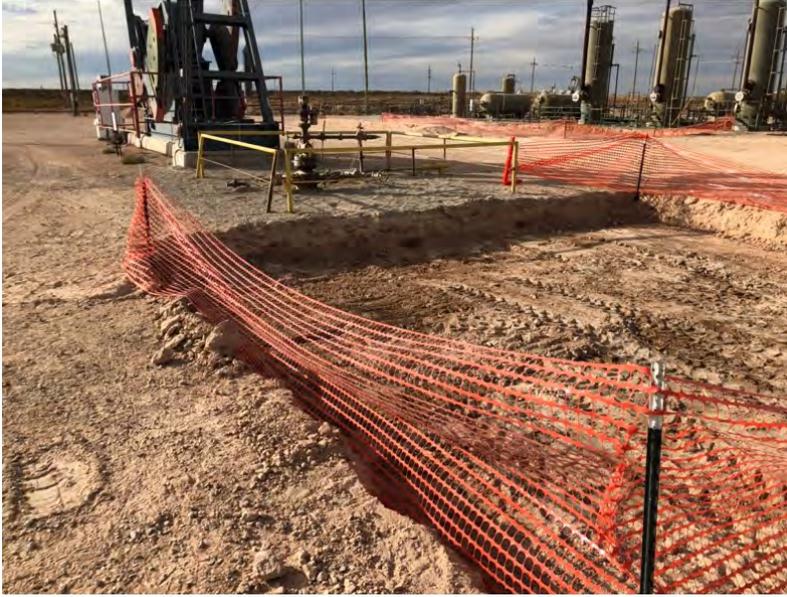
Tank Battery Area

2RP-4281: On June 28, 2017, repairs were being made to the three-phase separator, gas, and sand cut the water dump resulting in a release of 0.5 bbls of oil and 4.5 bbls of produced water. The wells were shut-in, repairs were made to contain the leak. No fluids were recovered in this area.

2RP-5167: On November 10, 2018, a gasket failed on the heater treater resulting in a release of 20 bbls of oil and 10 bbls of produced water. The treater was isolated, and repairs were made. A vac truck was able to recover app 5 bbls of oil.

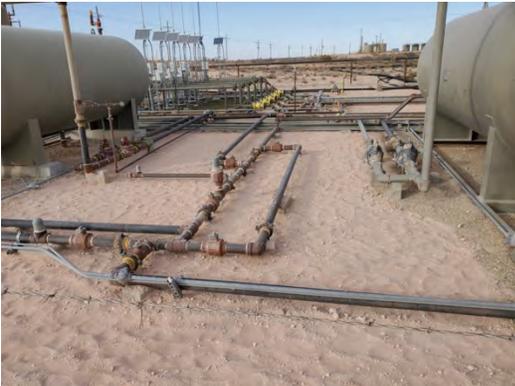
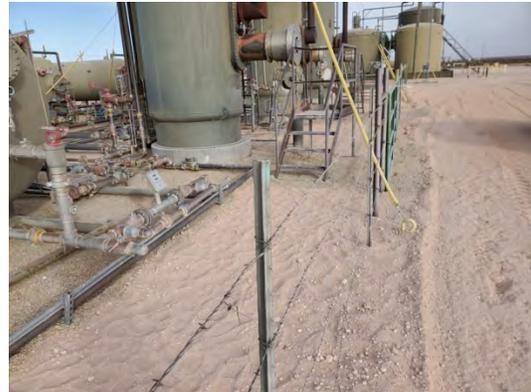
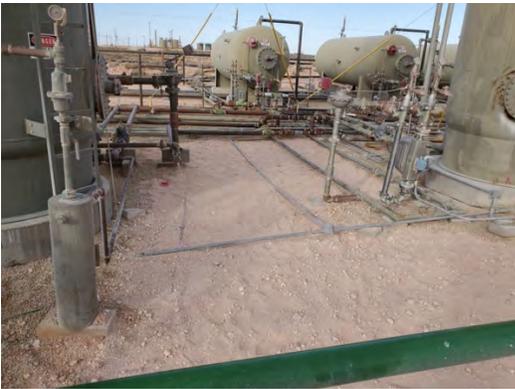
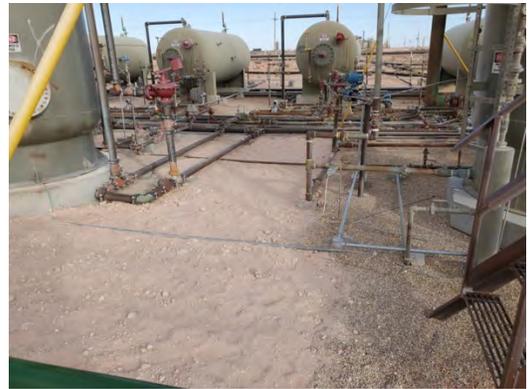
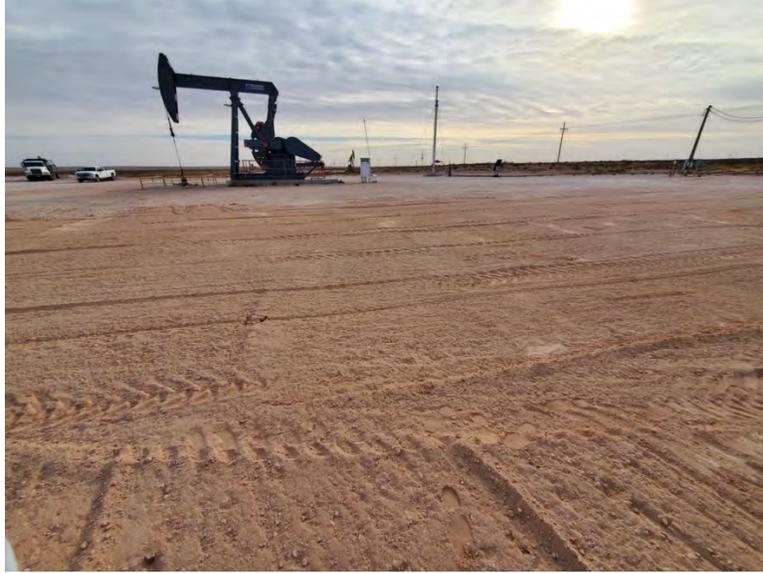
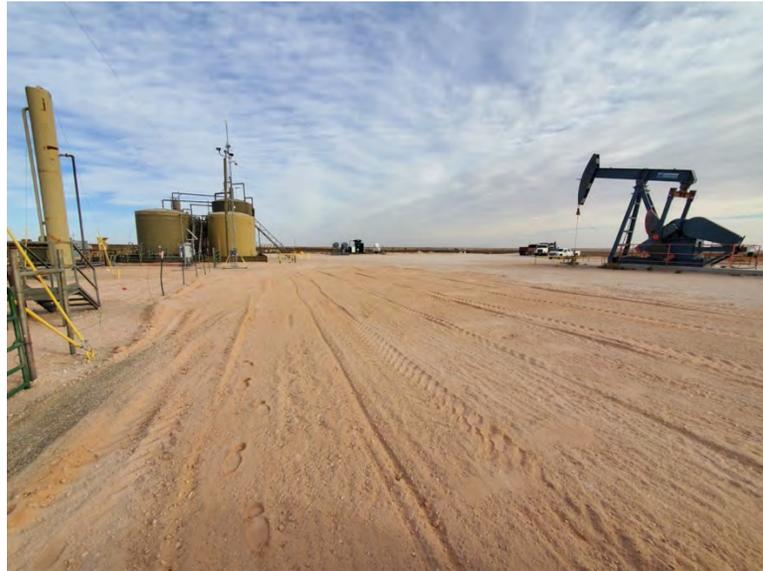
In Front of Wellhead for 2RP-5377

2RP-5377: On November 13, 2018, oil was found spraying out of the wellhead resulting in a release of 7 bbls of oil with no fluids being recovered.

Completed & Backfilled
