Remediation and Closure Report

Klein 33 Federal Com 11H
Eddy County, New Mexico
30-015-42183
Incident #Nrm2030944647

Subject: **Remediation and Closure Report**
Klein 33 Federal Com 11H
Eddy County, NM
API 30-015-42183
Incident #Nrm2030944647

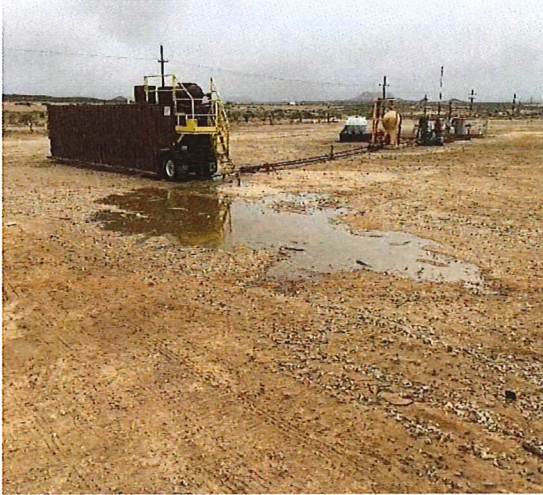
On October 26, 2020, A sand dump frac tank filled up and shut the well in. The tuning forks (safety device) on the frac tank were set too high due to human error. The tuning forks were lowered and reset to 6" in order to prevent a reoccurrence. Approximately 8 bbl. of produced water were released. Approximately 7 bbl. were recovered. The release occurred on the pad area and no fluid traversed to the pasture area. The site map is presented in [Appendix I](#).

Spill Event

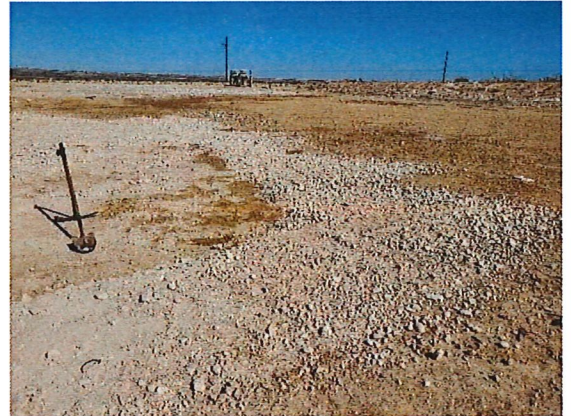
Aerial of Site (staining)

- Frac tanks were removed, and all surface impact as well as staining was excavated and disposed of at a NMOCD approved solid waste disposal facility.
- Confirmation soil samples were collected and verified analyte levels were below NMOCD and BLM remediation guidelines,
- Fresh caliche, similar in grade was used to backfill the location. The pad area was packed and restored to surrounding grade.

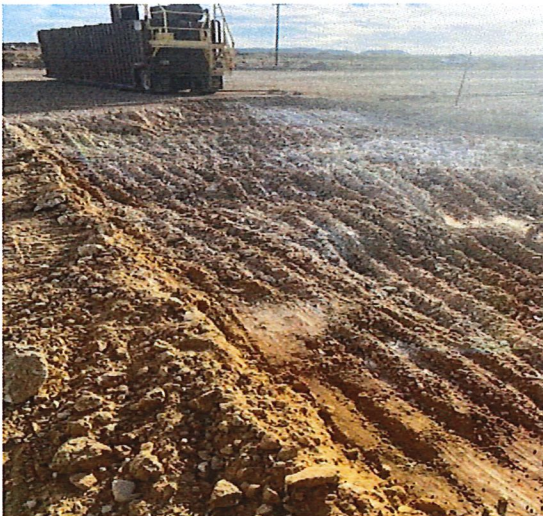
Excavation at Source

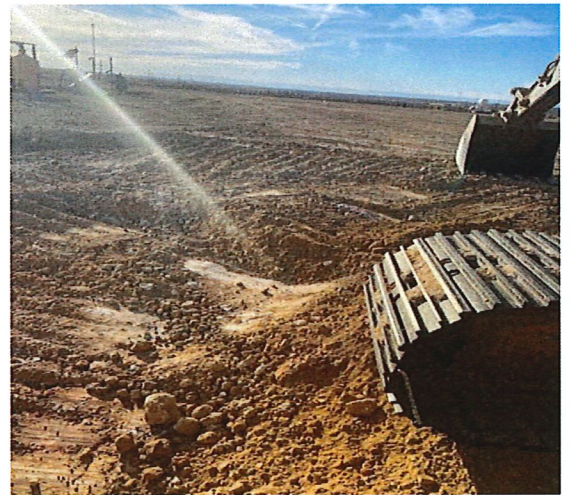
Excavation of Spill Run

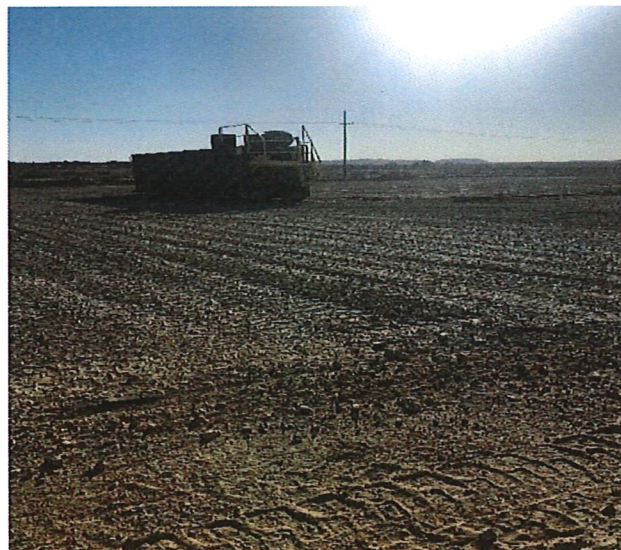
Excavation backfilled to grade
