## Release Notification WLPCF-190904-C-1410

| Site Name: Longview Federal 12-15H | Site Type: Production Facility |

On July 21, 2020, WPX was notified of the Remediation Work Plan (Work Plan) approval associated with Incident Numbers NAB1927160599 and NAB1927729096. The Work Plan was received by the New Mexico Oil Conservation Division (NMOCD) on July 21, 2020. This Closure Request only includes field summaries relevant to fulfilling the conditions of approval issued by NMOCD. All previous data and summaries can be referenced in the original Work Plan.

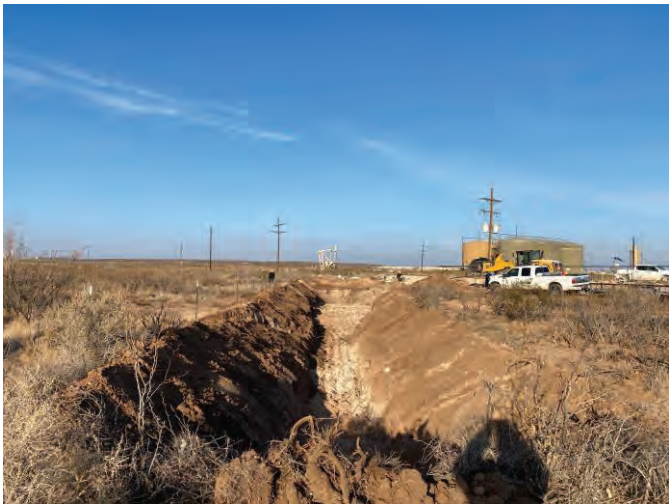
| Photo No. | Date | |
|---|---|---|
| Northeast view of the excavation in the pasture. | | A photograph showing a deep, narrow excavation in a dry, brownish field. In the background, there are several utility poles and a yellow construction vehicle. The sky is clear and blue. |

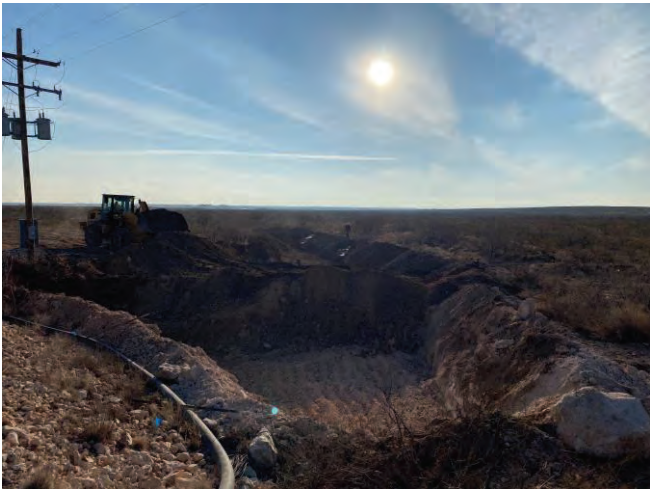
| Photo No. | Date | |
|---|---|---|
| Southwest view of the excavation in the pasture. | | A photograph showing a deep, narrow excavation in a dry, brownish field. In the background, there are several utility poles and a yellow construction vehicle. The sky is clear and blue. |

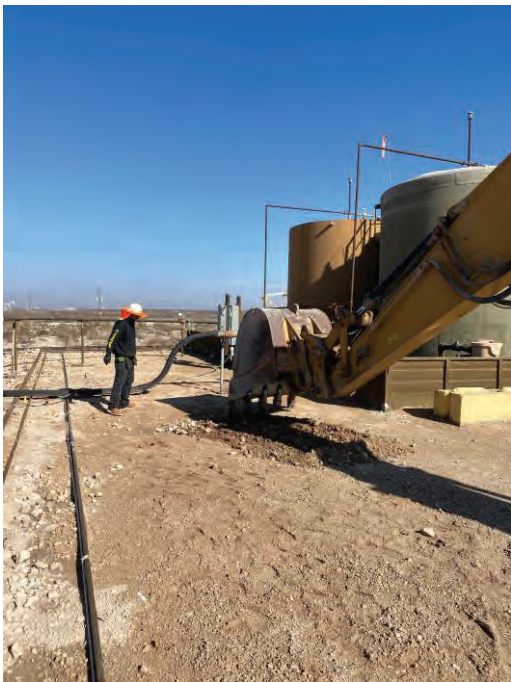
| Photo No. | Date | |
|---|---|---|
| North view of the release during excavation activities. | | A photograph showing a worker in a hard hat and safety gear standing near a large yellow excavator. The excavator is positioned next to a large, cylindrical storage tank. The ground is dirt and gravel, and the sky is clear blue. |

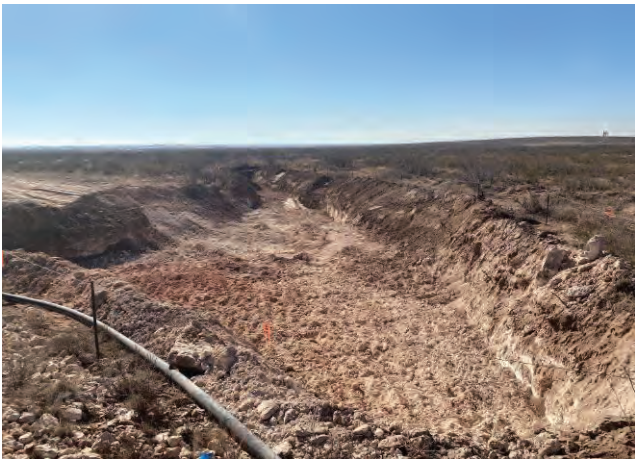
| Photo No. | Date | |
|---|---|---|
| Southwest view of the final excavation extent in the pasture. | | A photograph showing a deep, wide excavation pit in a dry, hilly landscape. The pit is filled with dirt and rocks. A large pipe or hose runs along the edge of the pit. The sky is clear blue. |
