Closure Report

February 3, 2021

Re: Lockhart A-17 #2 Tank Battery
Case # NRM2008658076

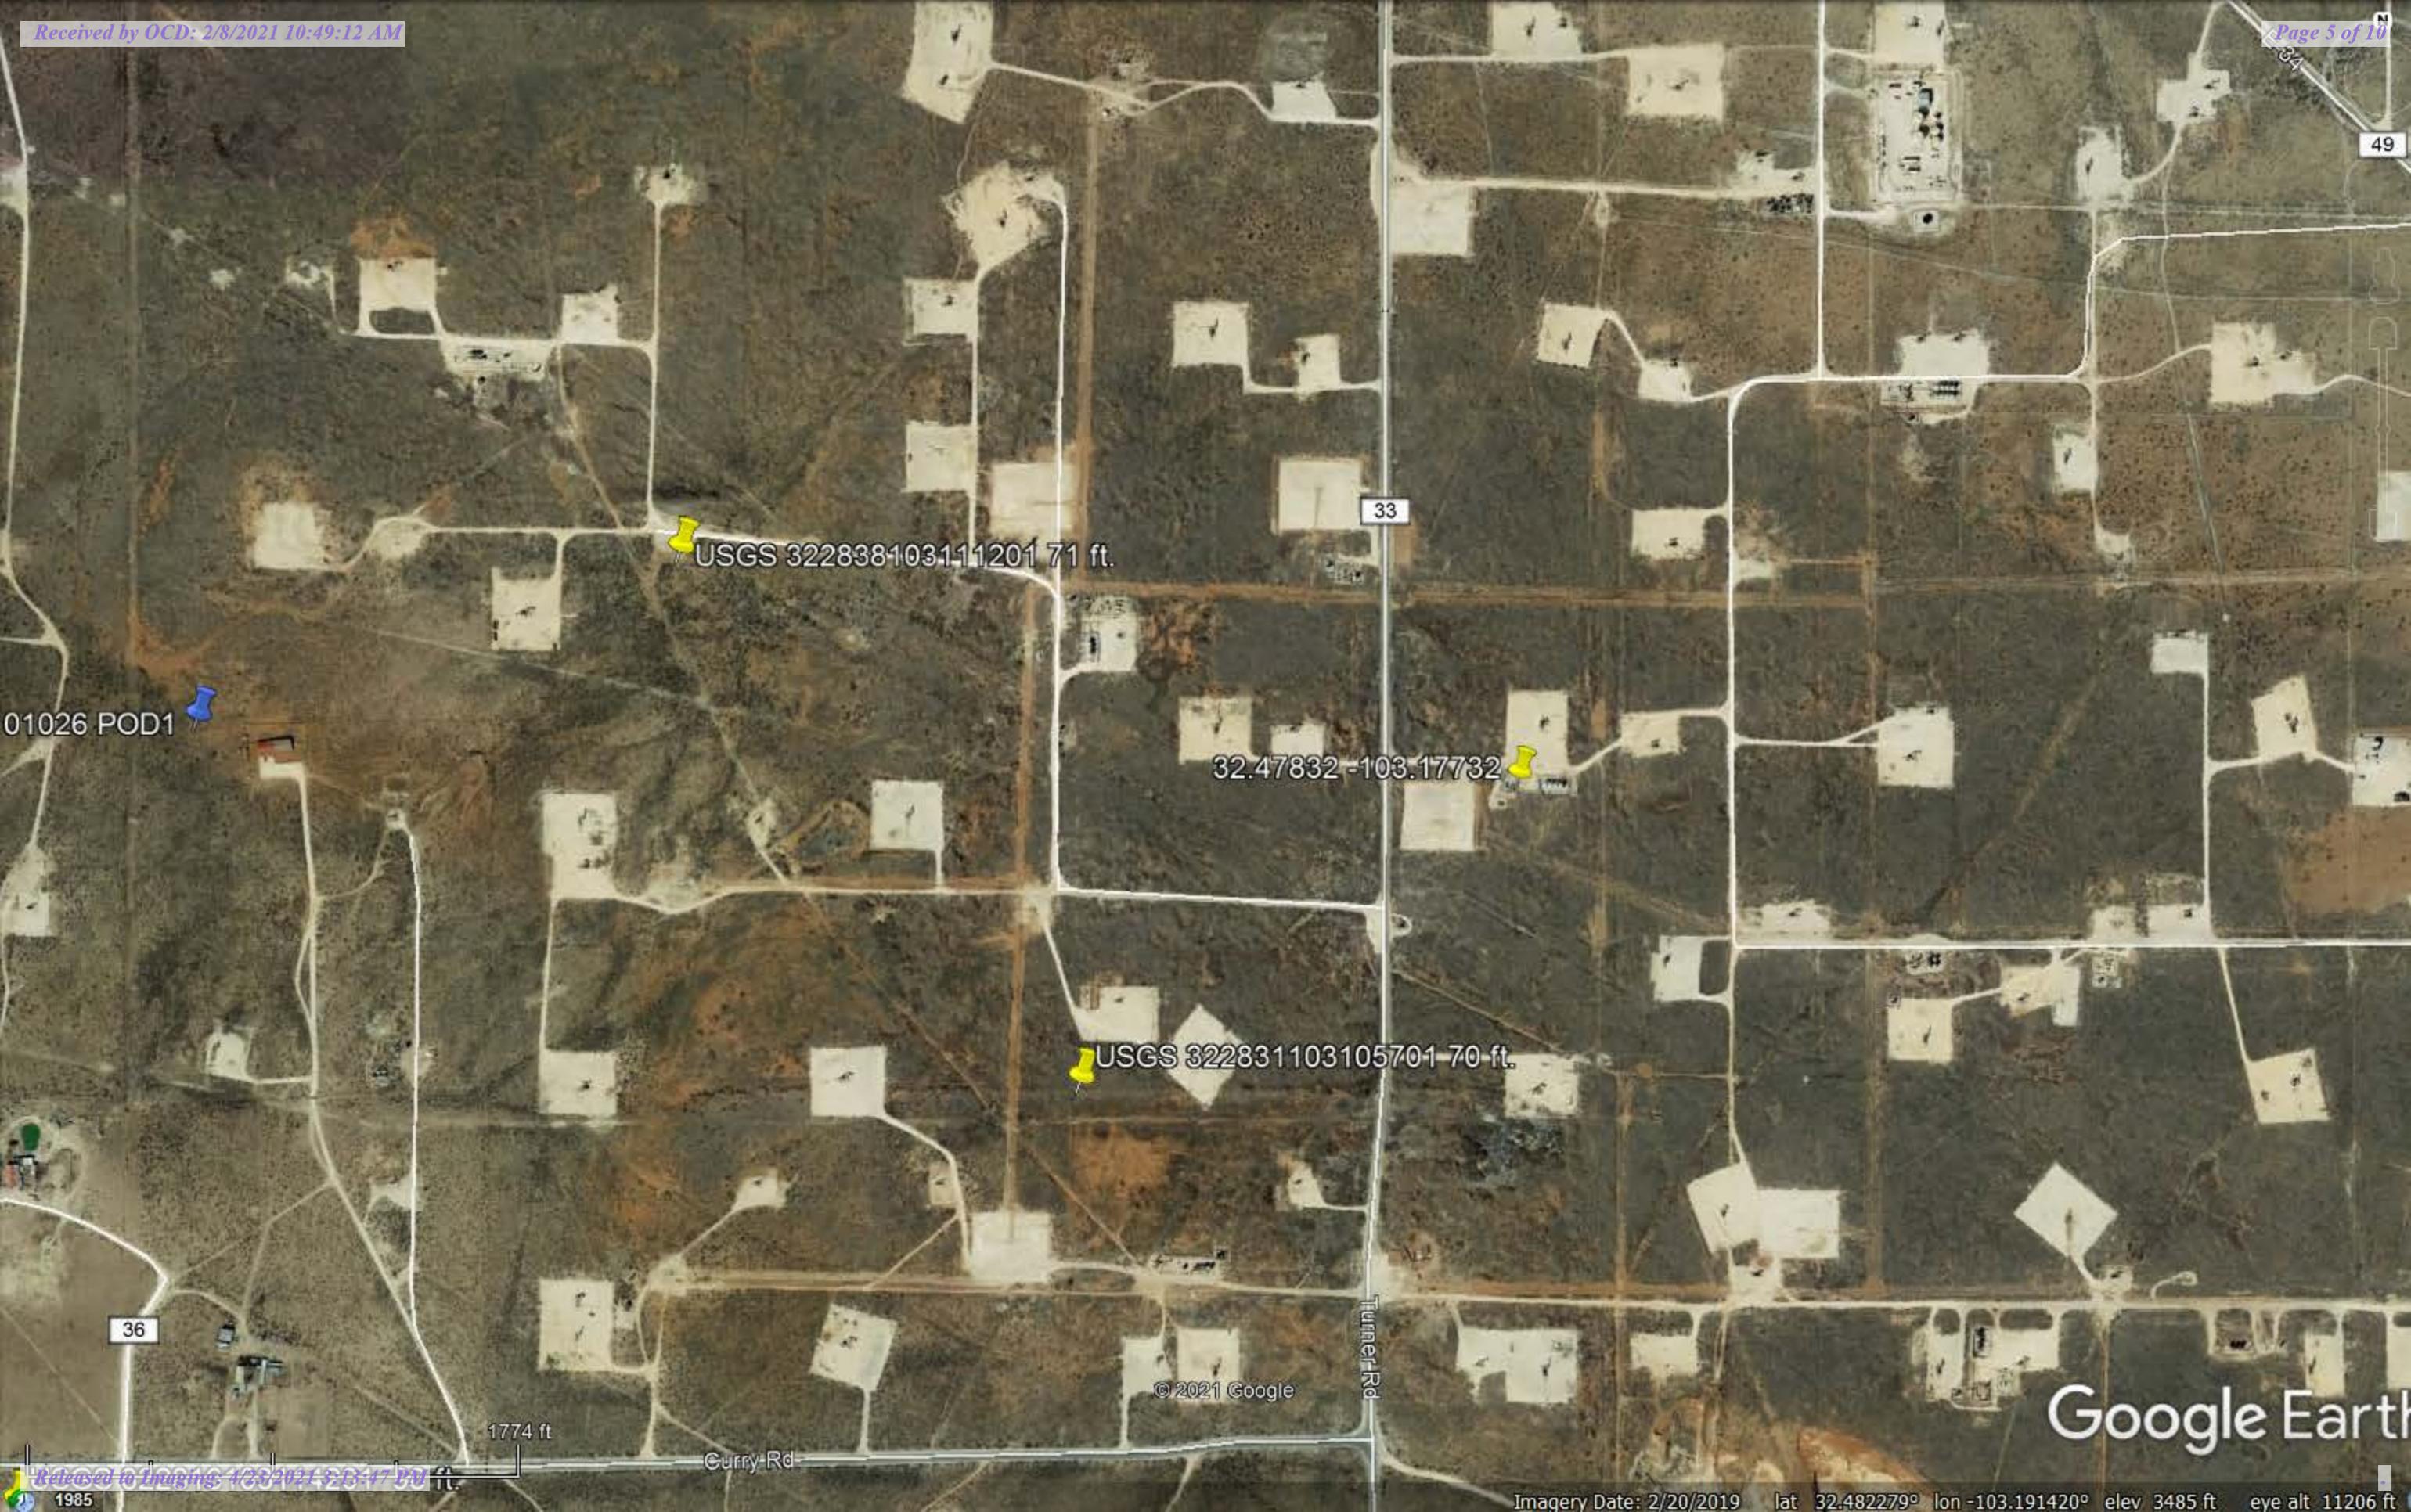
USGS 322838103111201 71 ft.

32.47832 -103.17732

USGS 322831103105701 70 ft.

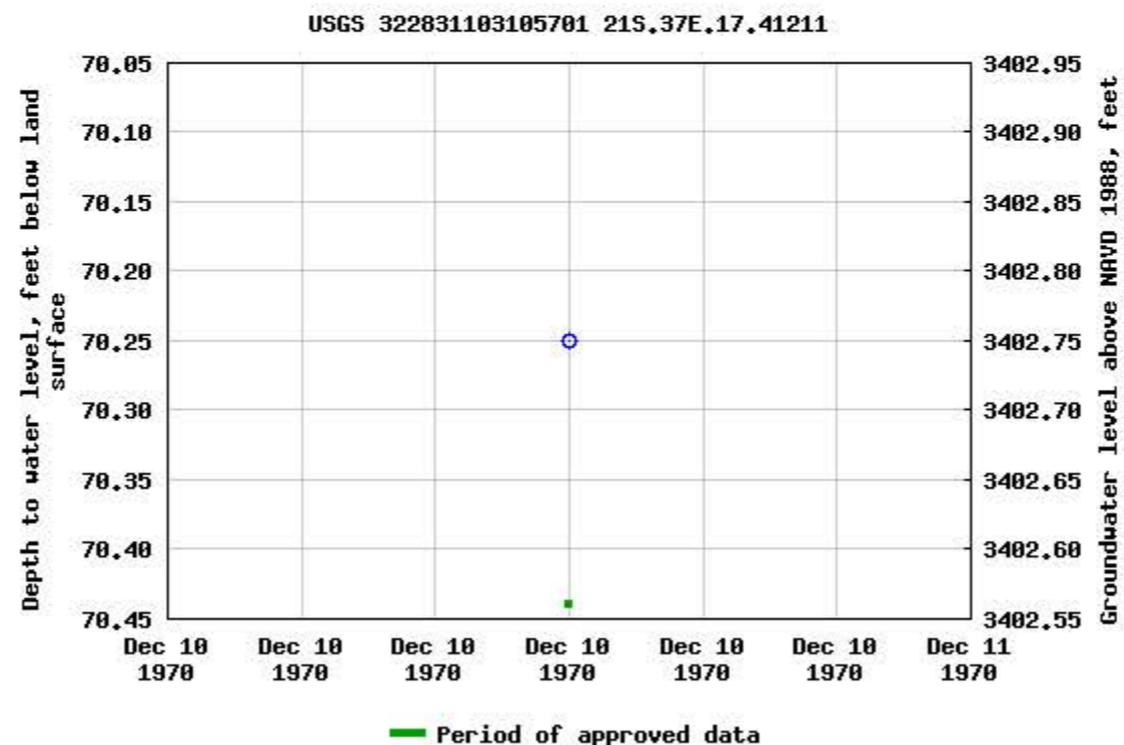
Lea County, New Mexico
 Hydrologic Unit Code 13070007
 Latitude 32°28'31", Longitude 103°10'57" NAD27
 Land-surface elevation 3,473 feet above NAVD88
 The depth of the well is 120 feet below land surface.
 This well is completed in the Alluvium, Bolson Deposits and Other Surface Deposits (110AVMB) local aquifer.

Breaks in the plot represent a gap of at least one year between field measurements.

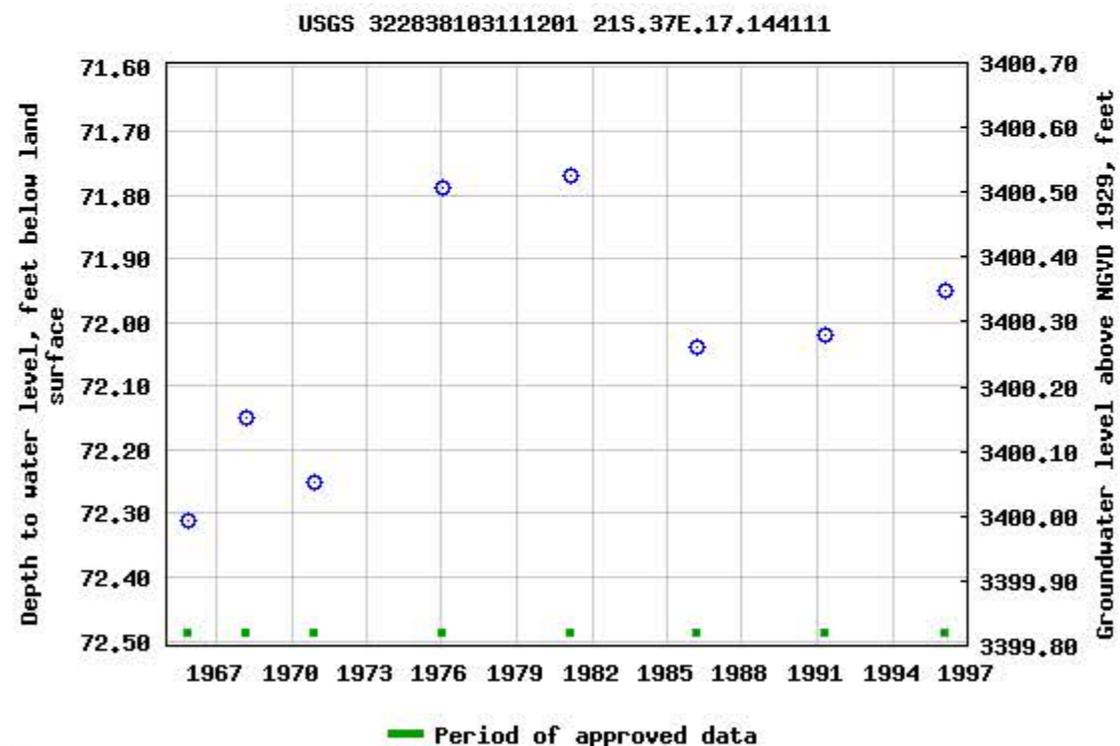
Lea County, New Mexico
 Hydrologic Unit Code 13070007
 Latitude 32°28'50", Longitude 103°11'14" NAD27
 Land-surface elevation 3,472.30 feet above NGVD29
 The depth of the well is 96 feet below land surface.
 This well is completed in the Alluvium, Bolson Deposits and Other Surface Deposits (110AVMB) local aquifer.

Breaks in the plot represent a gap of at least one year between field measurements.

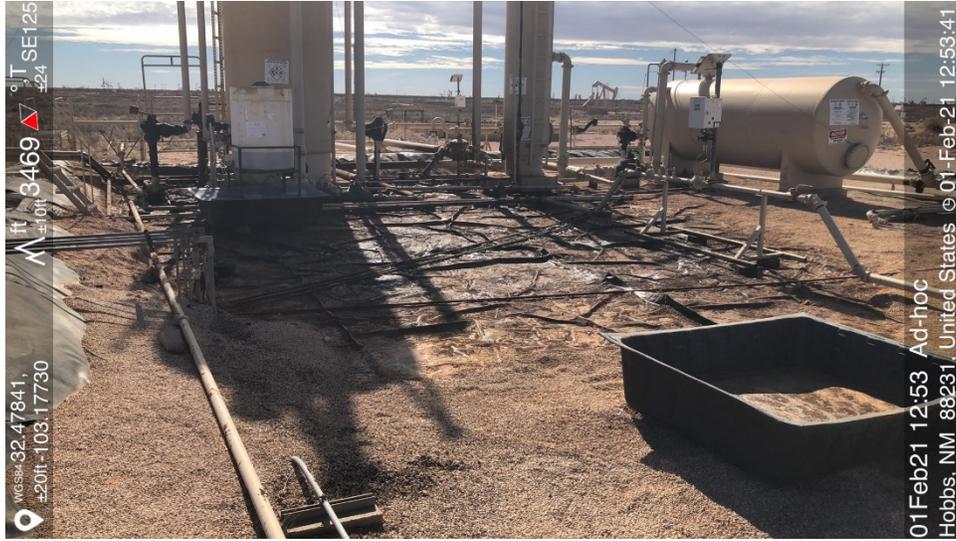
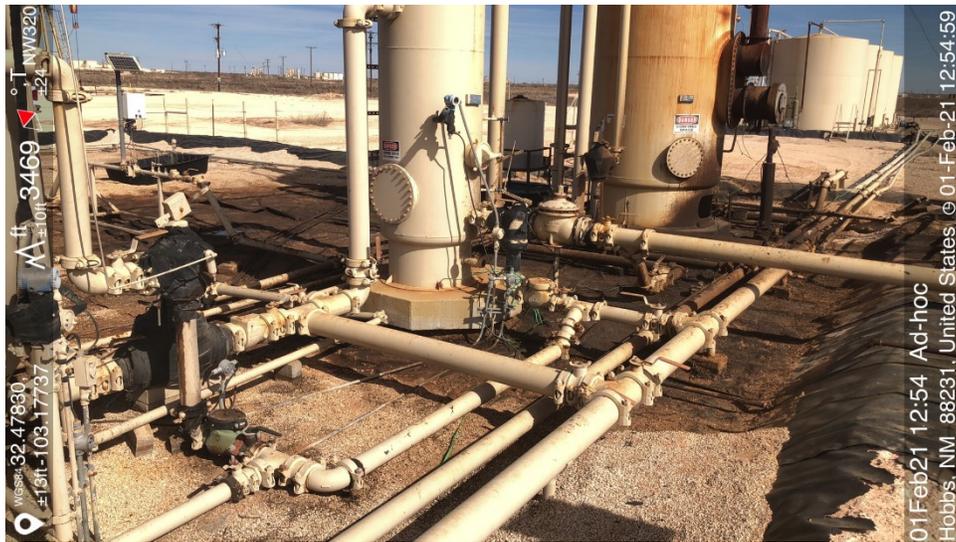
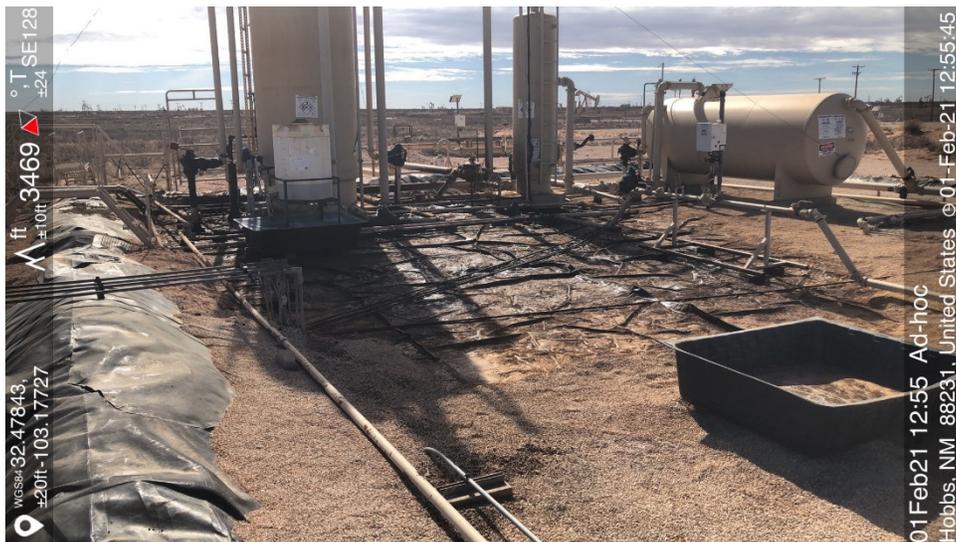
The gravel inside the secondary containment in the release area was removed and hauled to an OCD approved disposal facility. On 2/1/2021 a liner inspection was conducted by Apache Personal. The liner integrity was fully intact.
