Site Assessment Report and Proposed Remediation Workplan

Legacy Reserves Operating, LP Lea South Tank Battery

Lea County, New Mexico
Unit Letter G, Section 24, Township 20 South, Range 34 East
Latitude 32.560443 North, Longitude 103.511642 West
NMOCD Reference No. nAPP2035647738

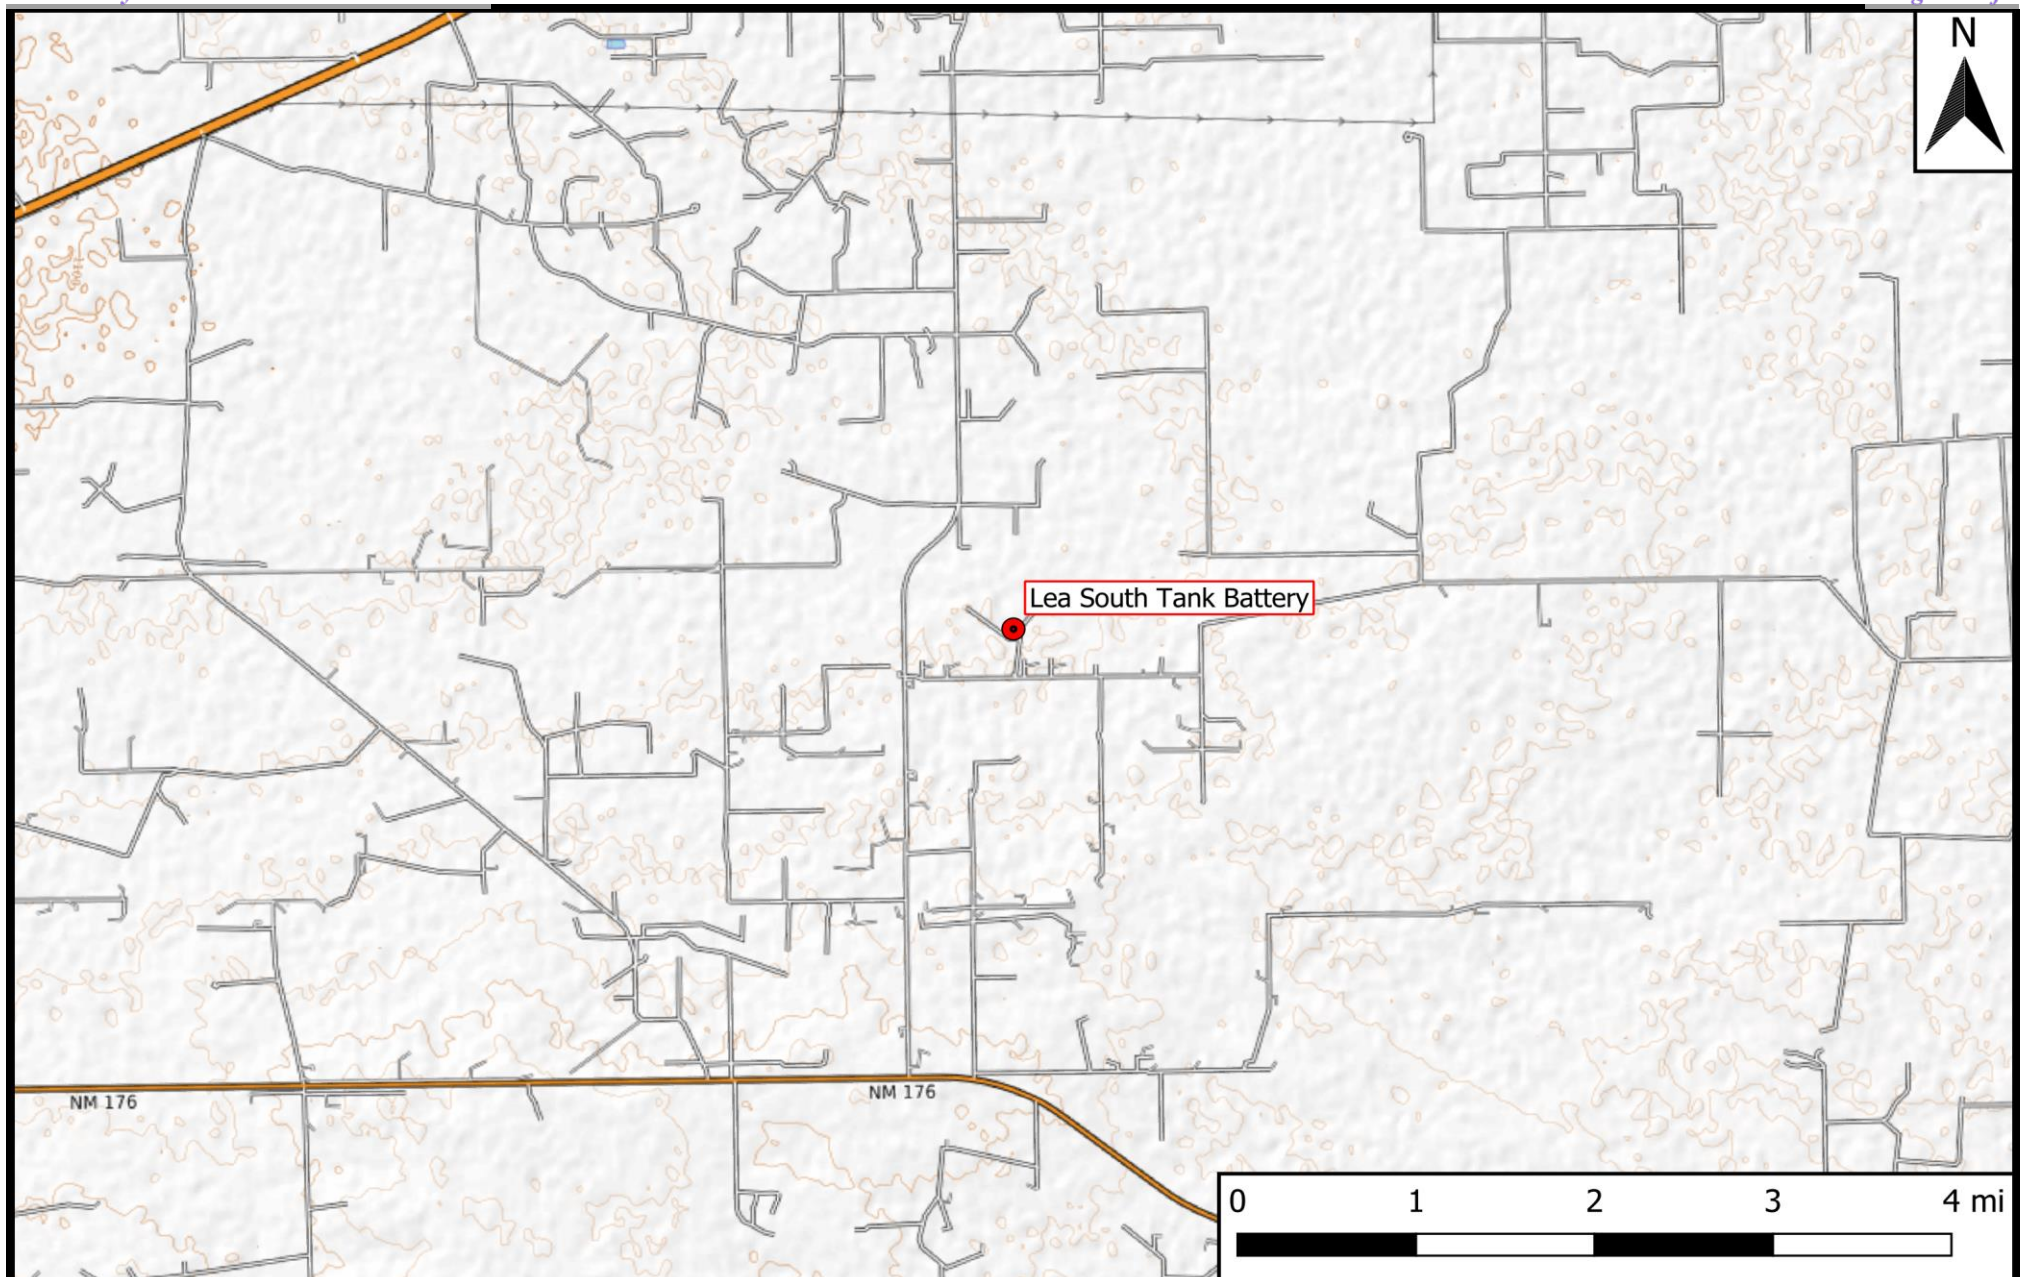
Figure 1

Topographic Map

Topographic Map
Legacy Reserves Operating, LP
Lea South Tank Battery
GPS: 32.560443, -103.511642
Lea County

NMOCD Siting Criteria data was gathered from available resources including Bureau of Land Management (BLM) shapefiles; topographic maps; NMOSE and USGS databases; and aerial imagery. The results are depicted on Figures 1, 2, 4 and 5.

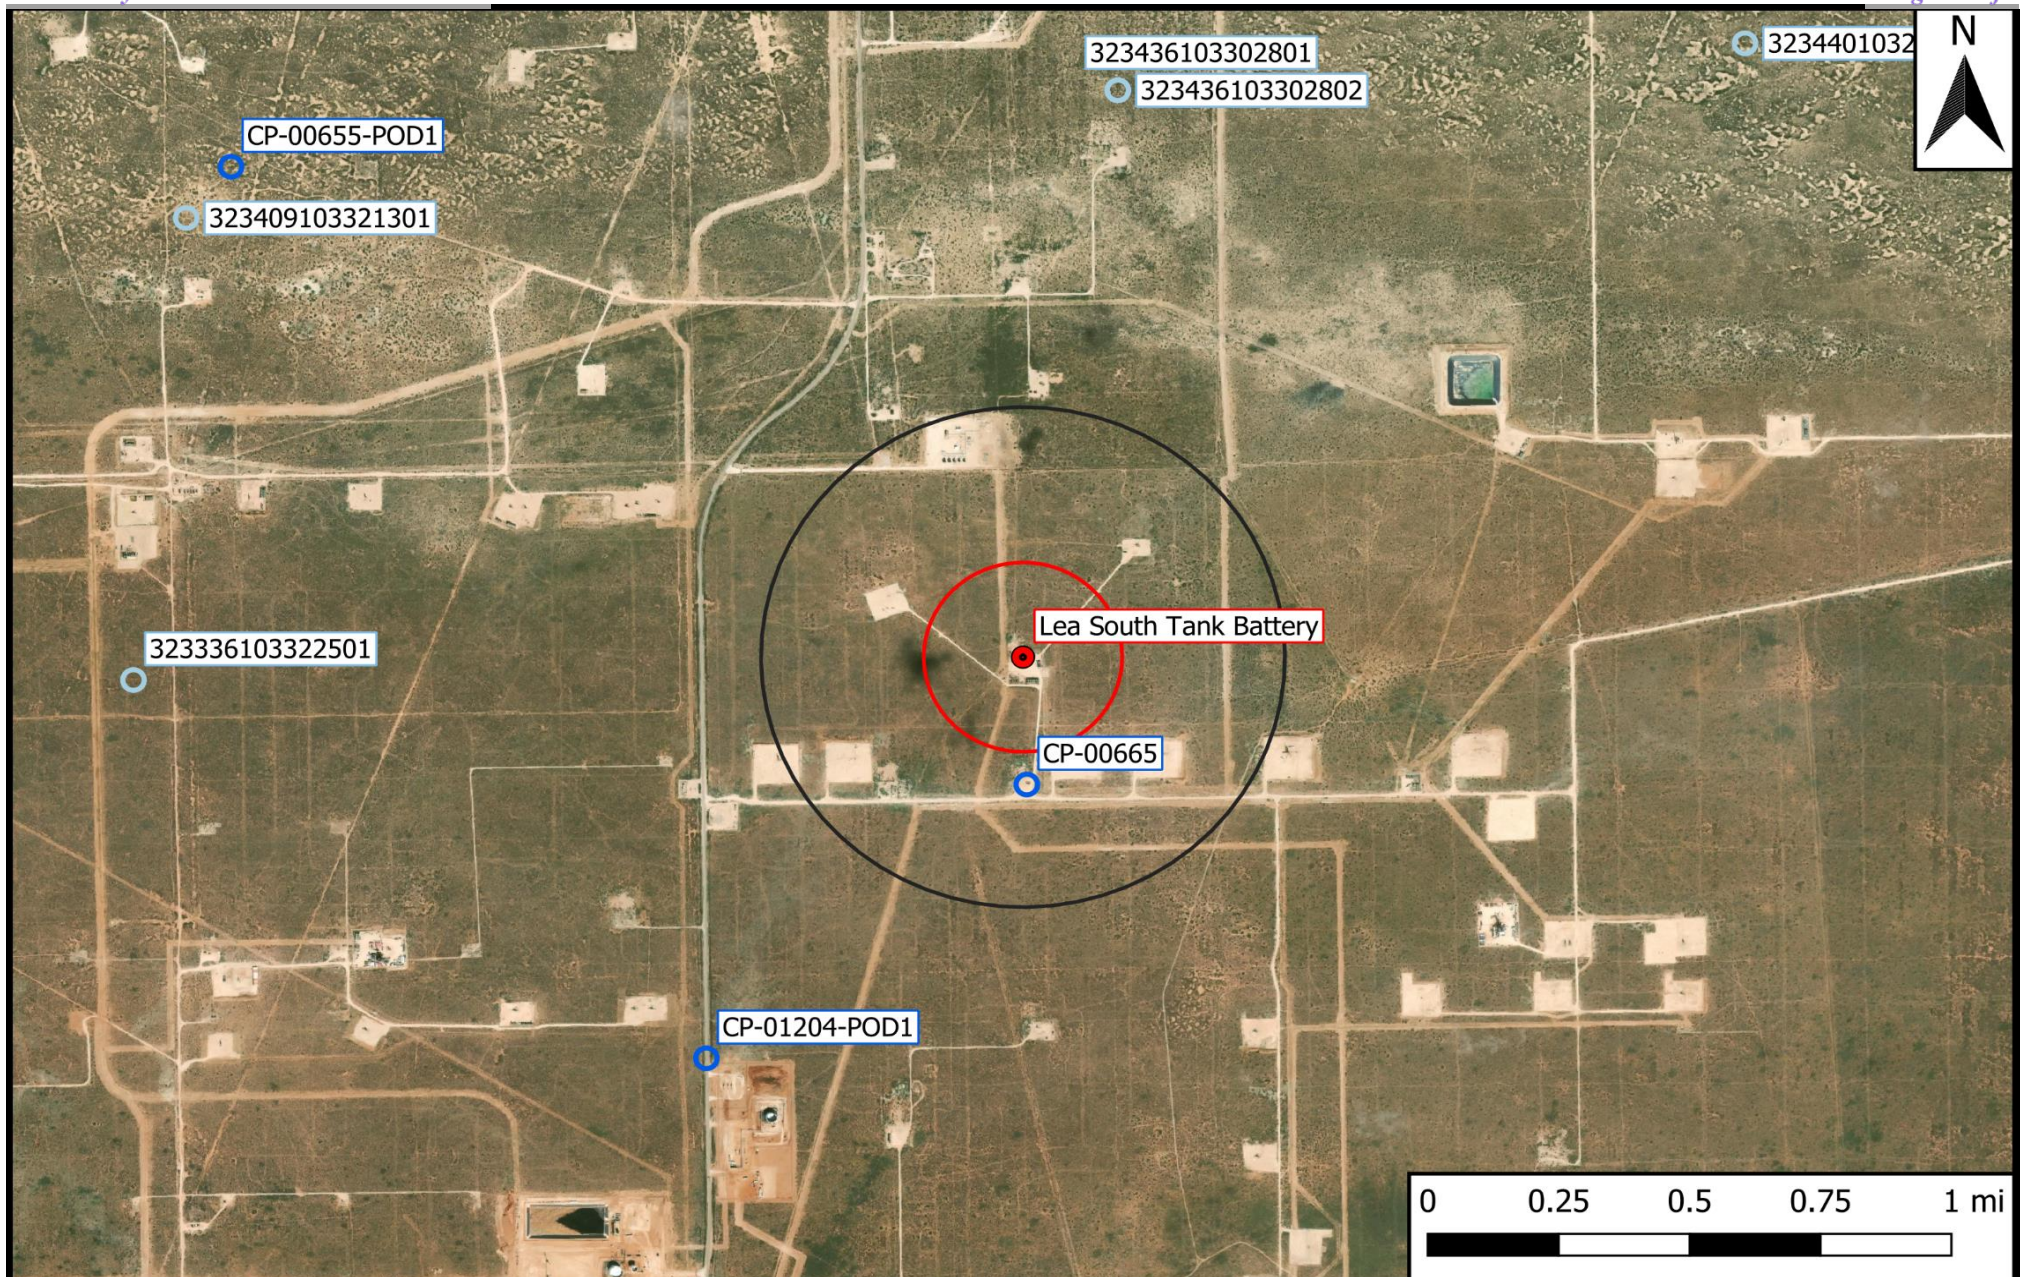
Aerial Proximity Map

Figure 2
Aerial Proximity Map
Legacy Reserves Operating, LP
Lea South Tank Battery
GPS: 32.560443, -103.511642
Lea County

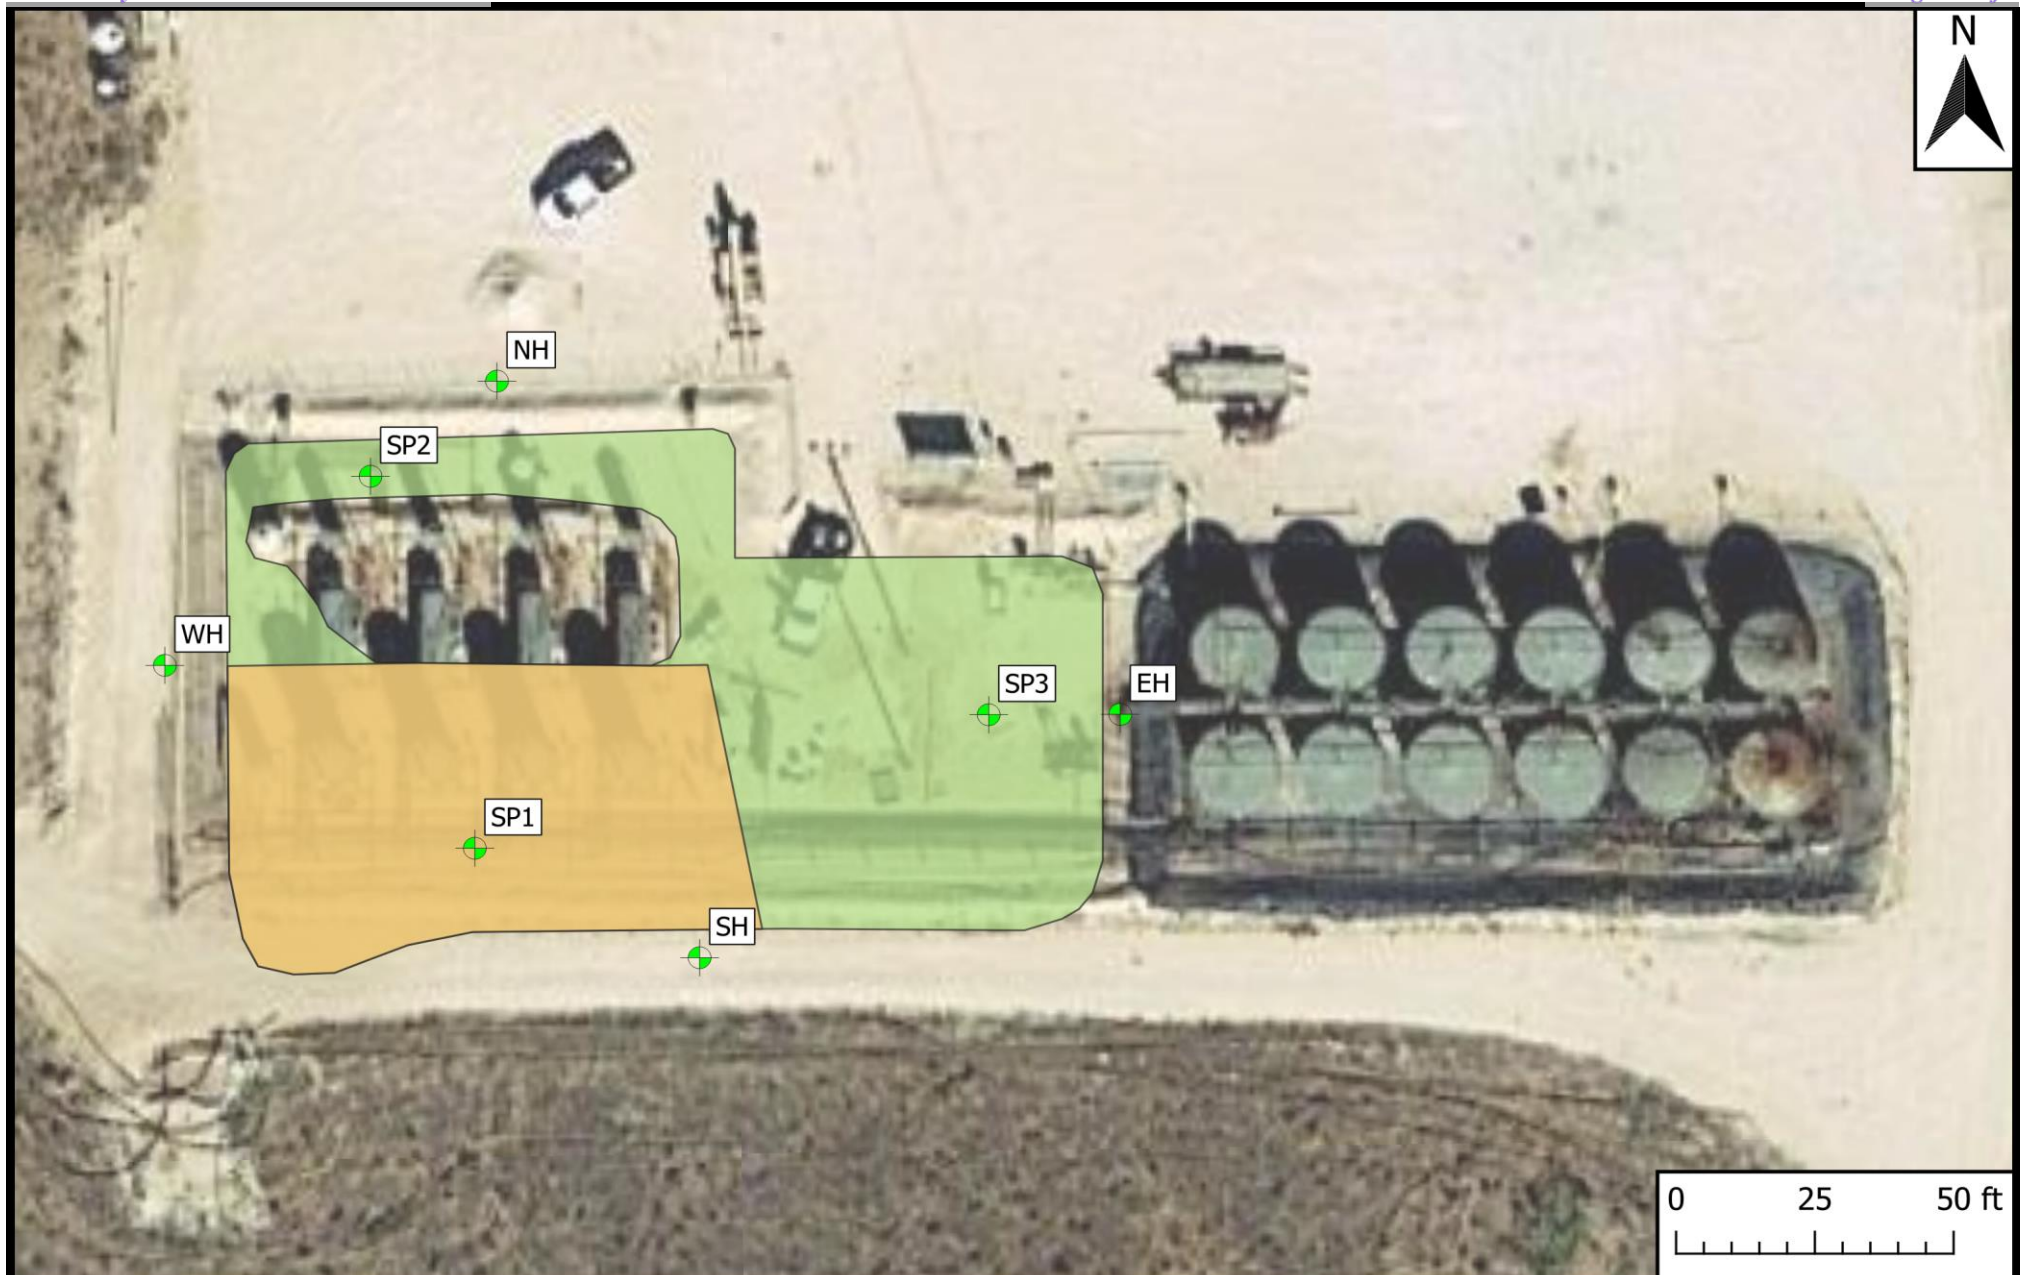
Figure 3

Site and Sample Location Map

- Sample Point
- Spill Area - 11,150 Sq Ft
- Proposed Excavation - 4,754 Sq Ft

A site and sample location map is provided as Figure 3. Field data and soil profile logs are provided as Appendix B. A soil chemistry table is provided as Table 1. Laboratory analytical reports are provided in Appendix C.

- Utilizing mechanical equipment and/or hand tools, excavate impacted soil affected above the NMOCD Closure Criteria characterized by sample point SP1 @ Surface to an estimated depth of one (1) foot BGS.

Remediation activities are expected to be completed within 90 days of receiving necessary approval(s) of the *Site Assessment Summary and Proposed Remediation Workplan*. Based on laboratory analytical results, site characteristics, and field observations made during the initial site assessment, it is estimated that approximately 176 cubic yards of impacted soil is in need of removal.

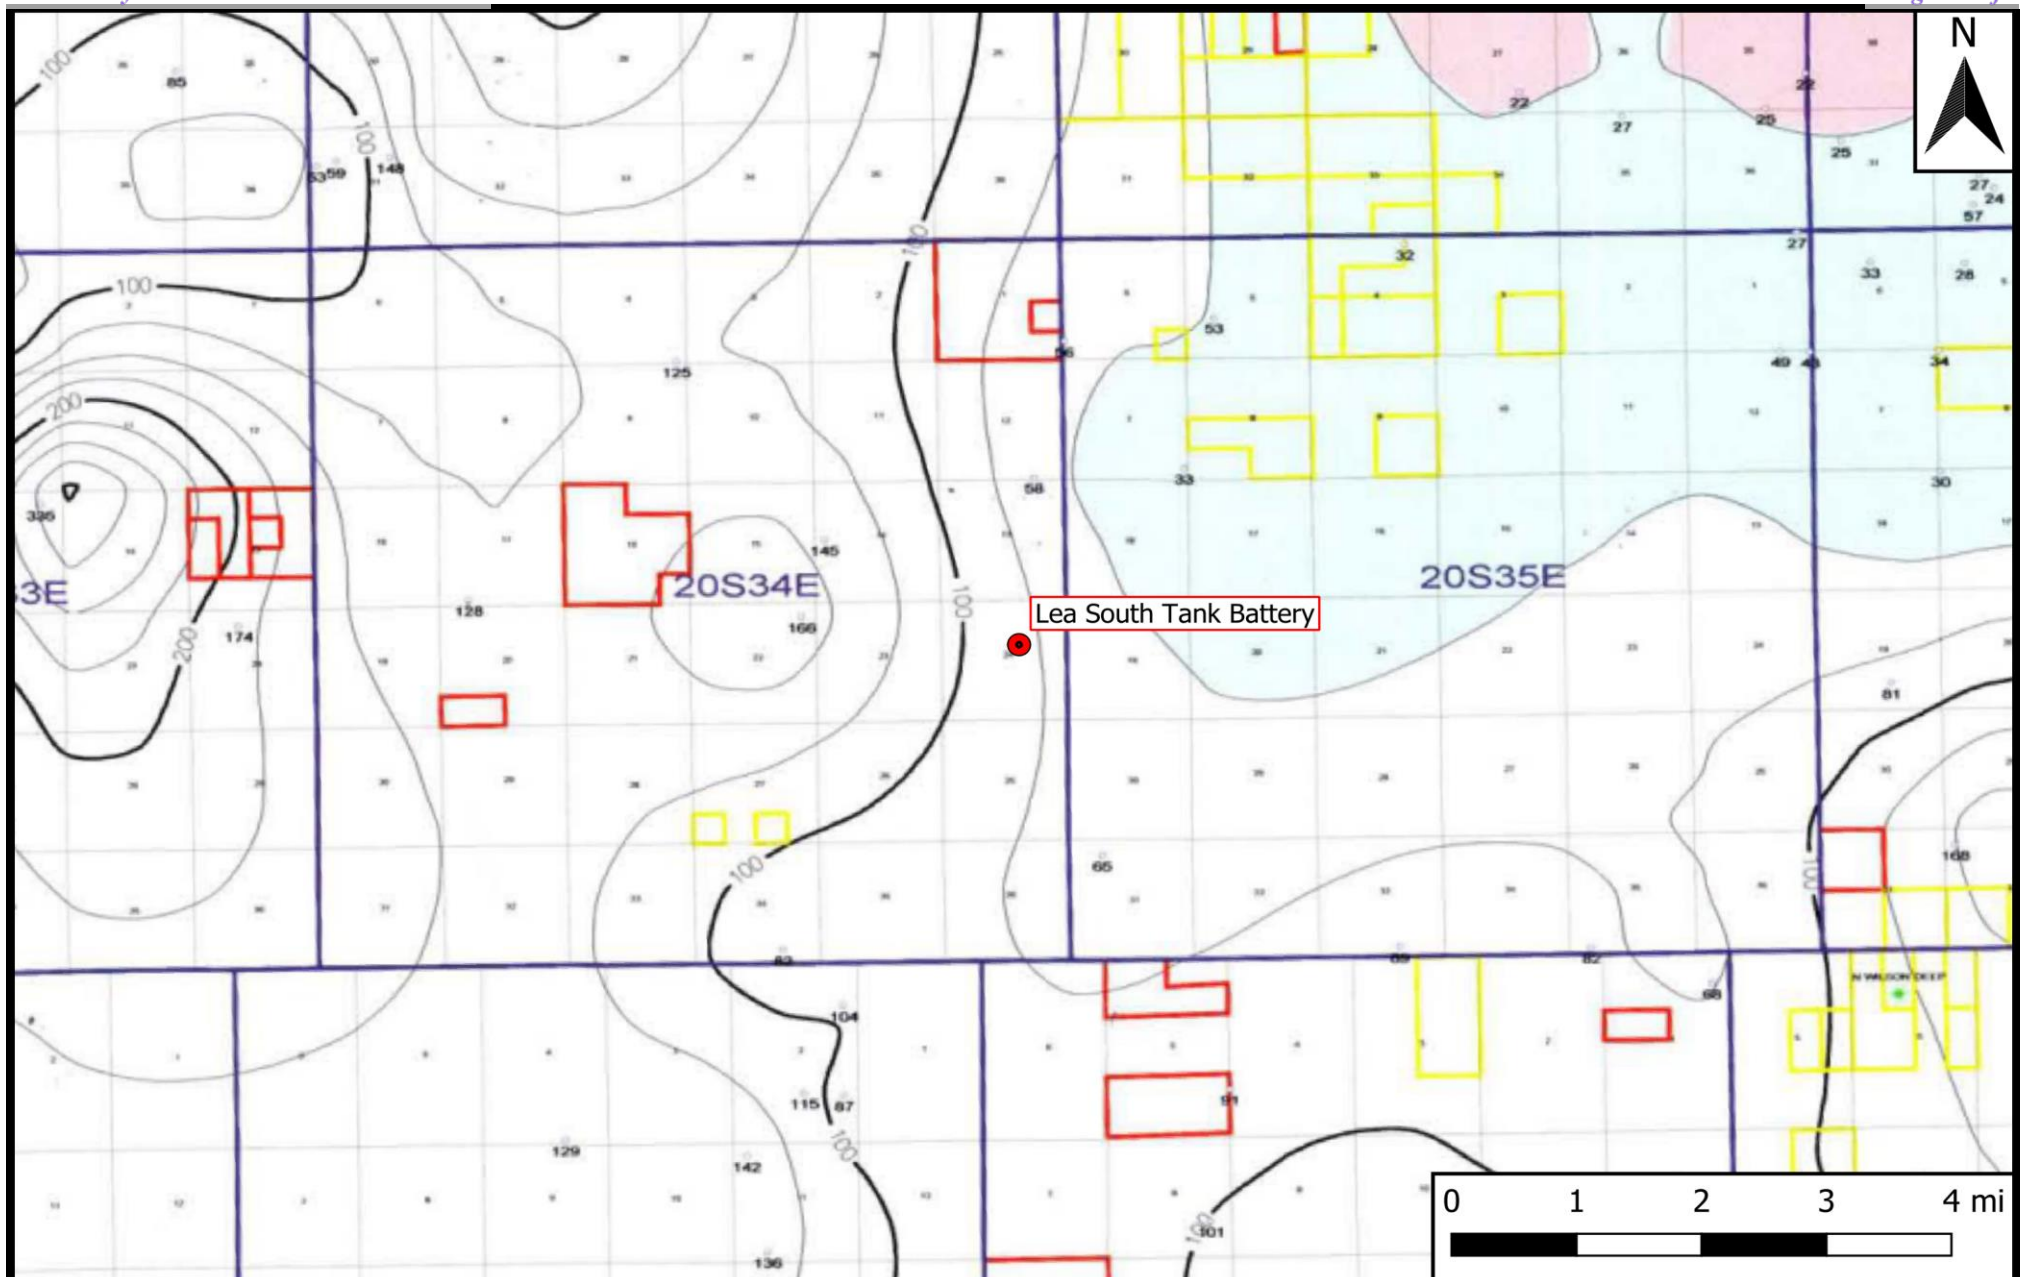
Figure 4

Inferred Depth to Groundwater Trend Map
 Legacy Reserves Operating, LP
 Lea South Tank Battery
 GPS: 32.560443, -103.511642
 Lea County

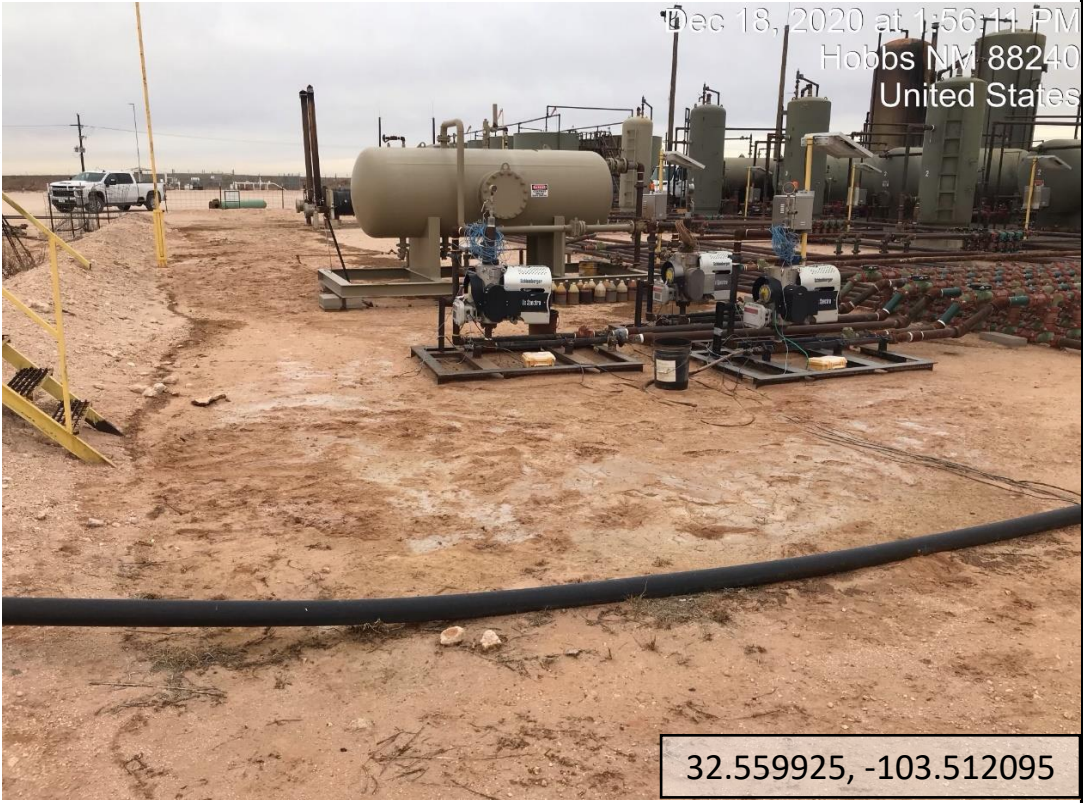
Photo Number: 1

<p>Dec 18, 2020 at 1:56:11 PM Hobbs NM 88240 United States</p> <p>32.559925, -103.512095</p>
Photo Direction: East	
Photo Description: North side of release area.

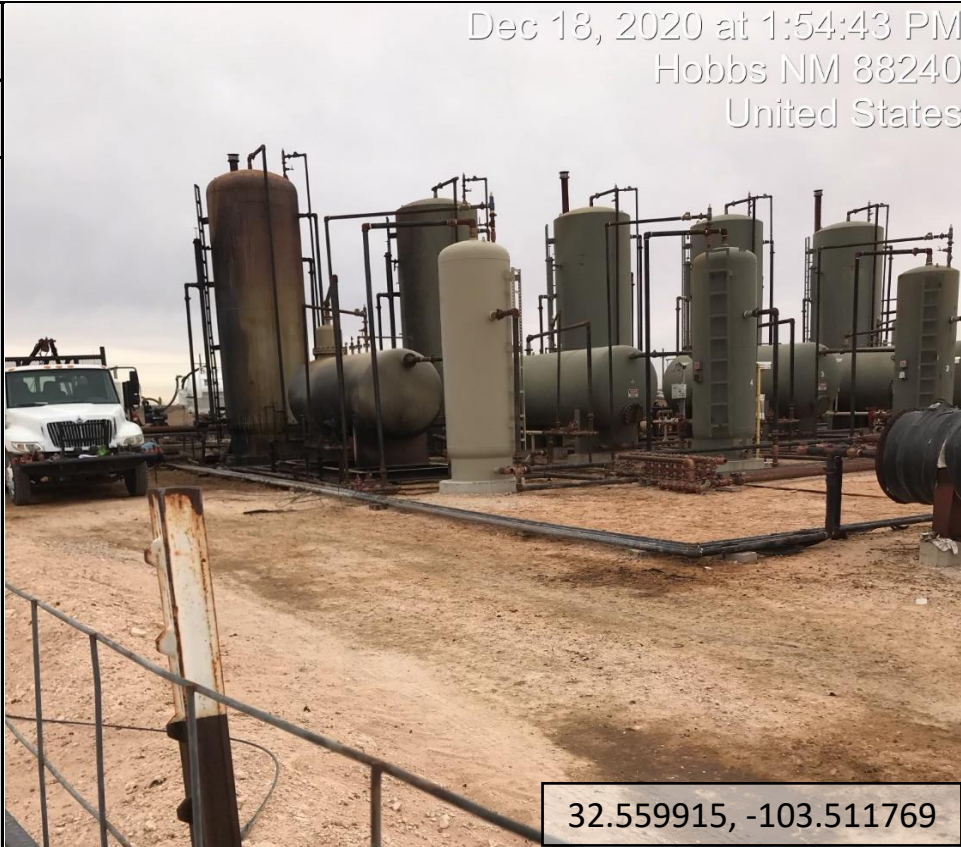
Photo Number: 4

<p>Dec 18, 2020 at 1:54:43 PM Hobbs NM 88240 United States</p> <p>32.559915, -103.511769</p>
Photo Direction: South-Southwest	
Photo Description: East side of release area.
