Form C-141

State of New Mexico
Oil Conservation Division

Incident ID	nAPP2035221813
District RP	
Facility ID	
Application ID

Failure of a 4-inch nozzle on tank

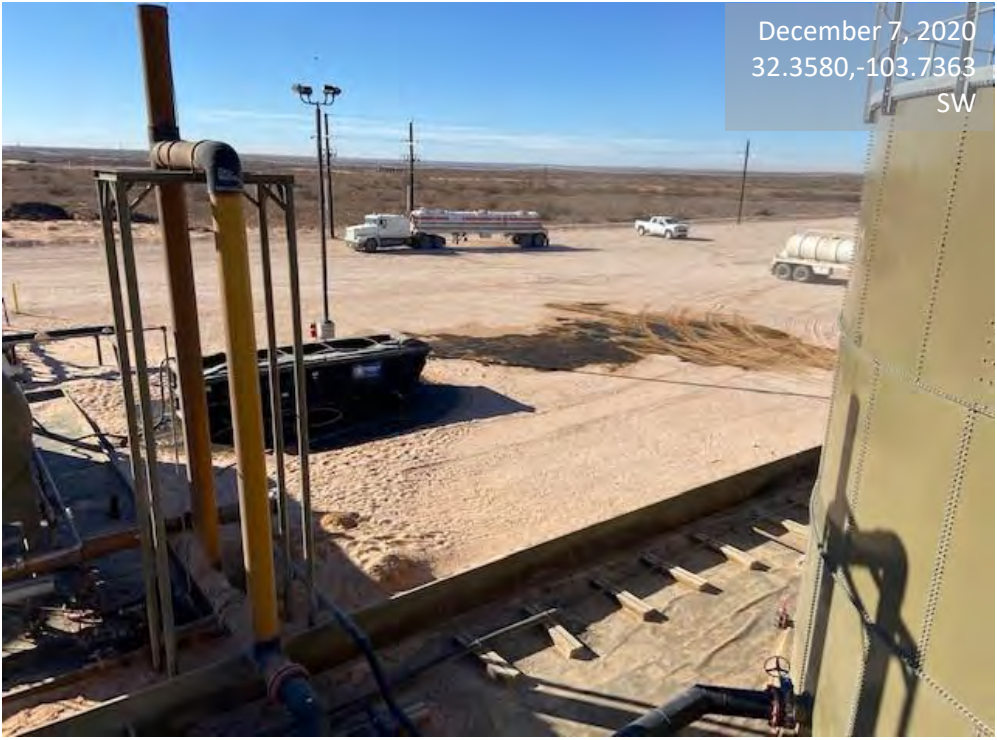
Photo Number: 5

<p>December 7, 2020 32.3580,-103.7363 SW</p>
Photo Direction: Southwest	
Photo Description: Release

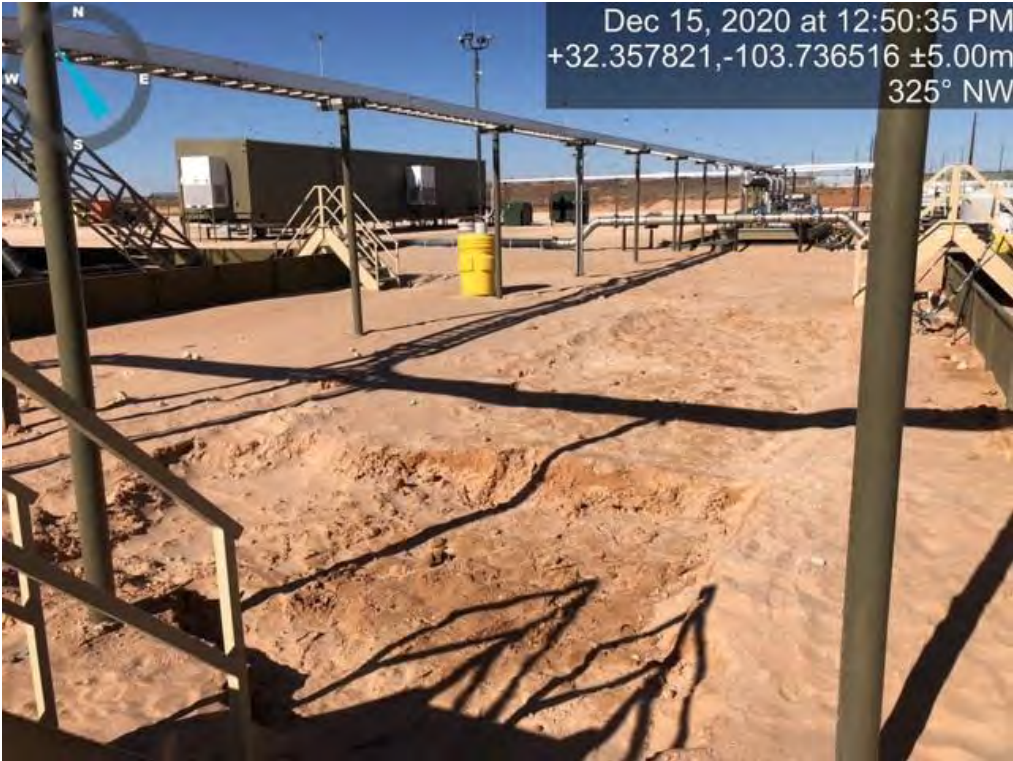
Photo Number: 11

Photo Direction: Northwest	
Photo Description: Excavation

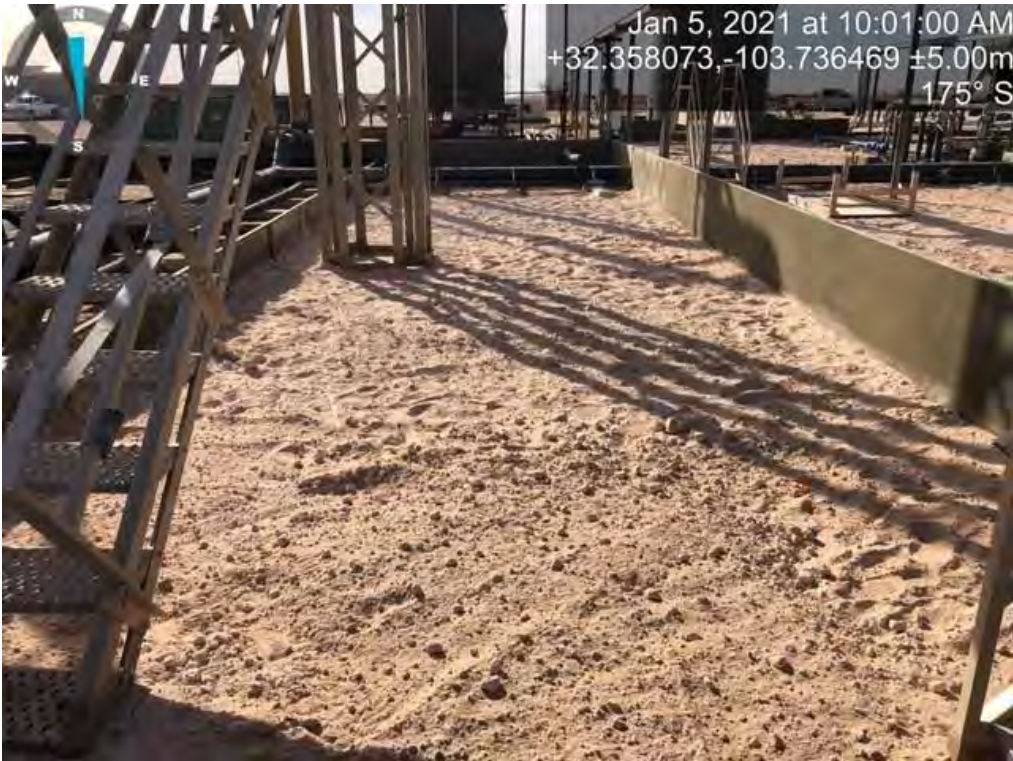
Photo Number: 18

Photo Direction: South	
Photo Description: Backfilled Excavation

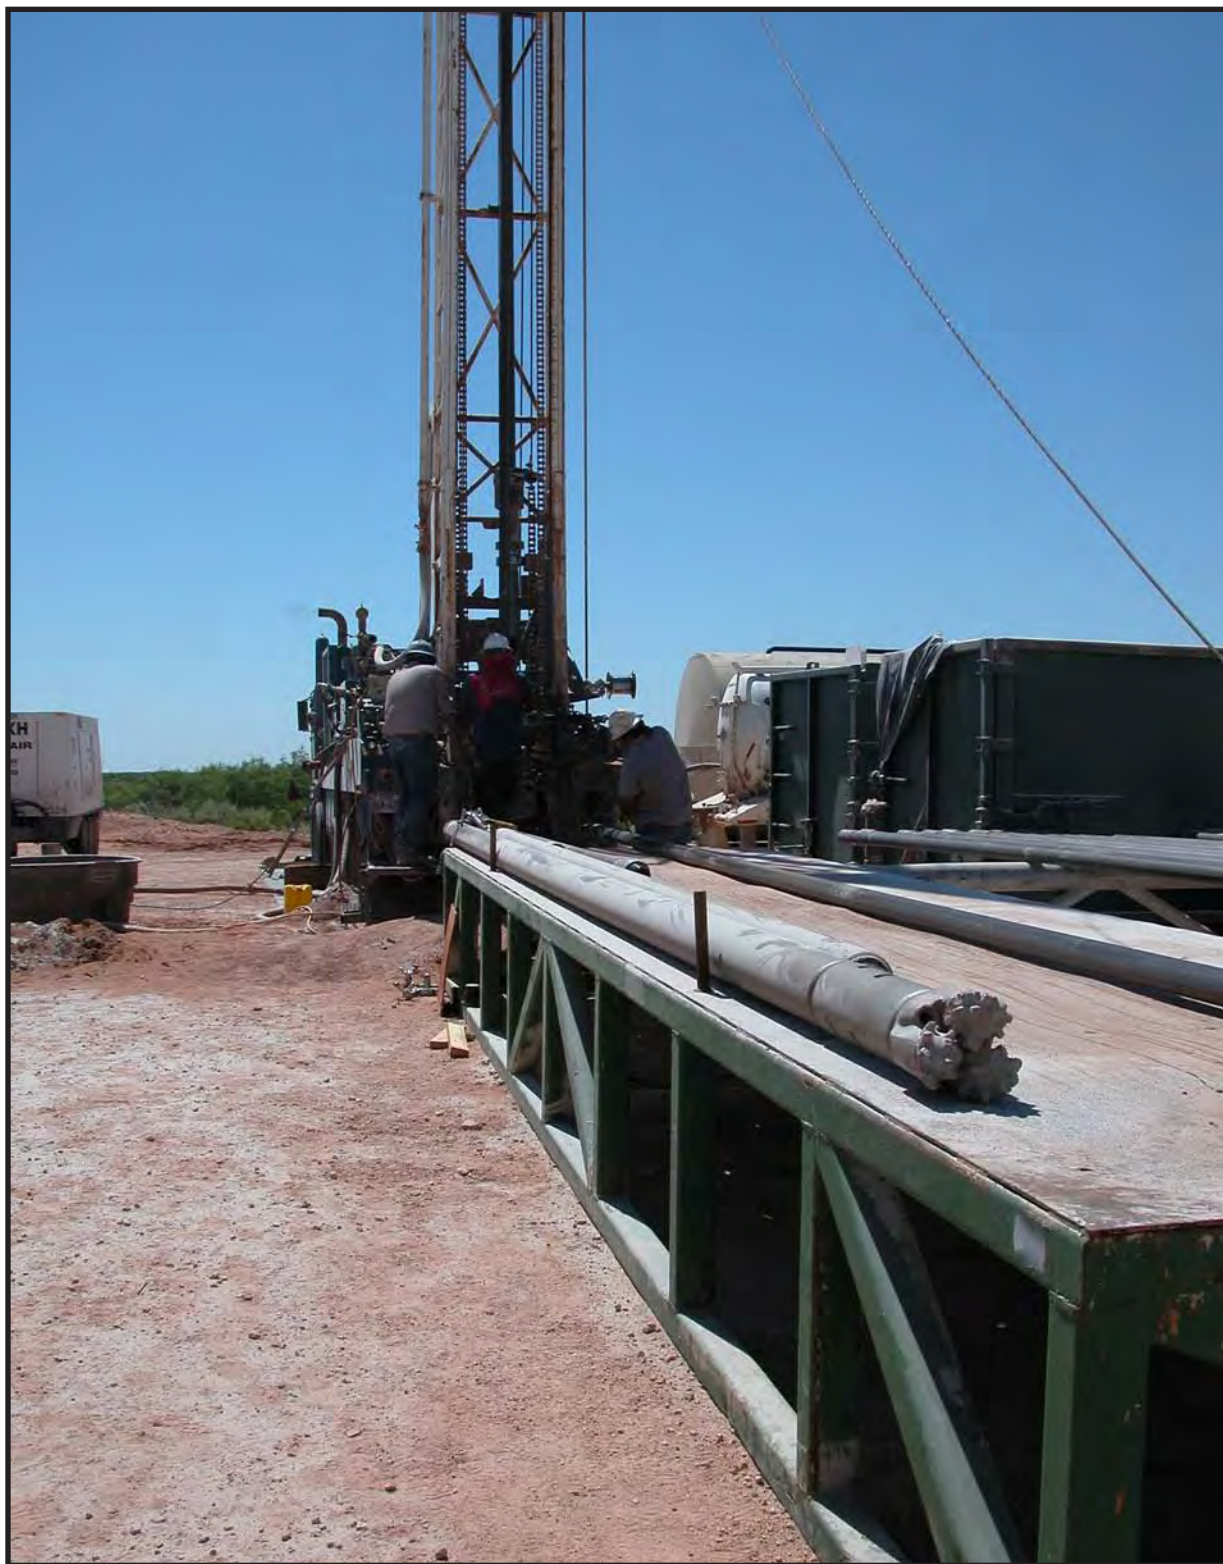
West Texas Water Well Service, Rig #15 at SNL-15, viewed toward the west. The 7.875-inch rotary bit has been laid down, and the crew is tripping in to begin coring using compressed air. Photo taken June 5, 2005, by Dennis W. Powers.

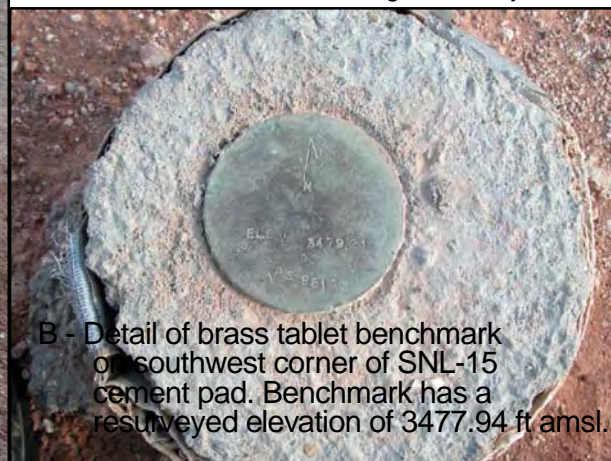
Figure 1-5 SNL-15 Surface Configuration and Elevations (6/11/07)

A - Surface casing for SNL-15 with cap and padlock.

Note: benchmark was punched with an elevation of 3479.21 ft amsl based on original survey.

surface benchmark is an accessible reference point for future measurements if the well configuration is changed.

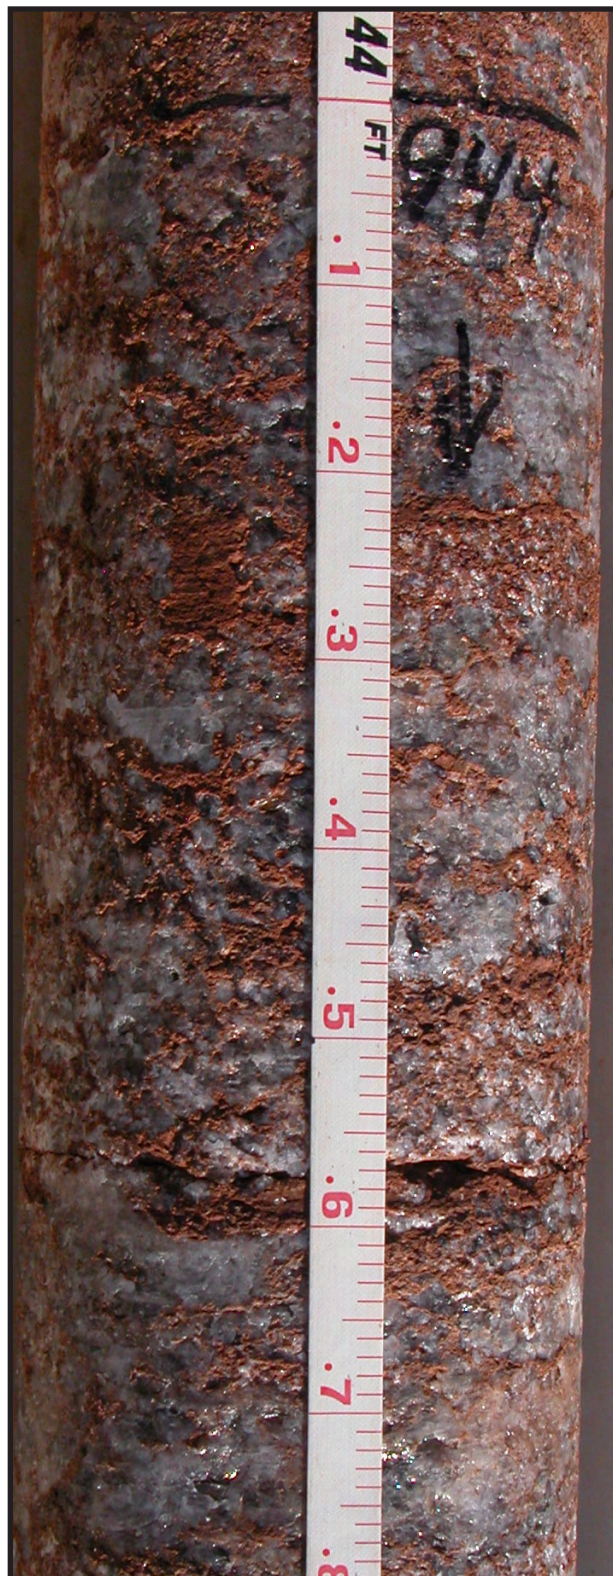
Figure 2-3. Coarse Halite with Reddish-Brown Mudstone, Upper H-2

Thin, silty claystone at 938.2 ft overlies a very thin sulfate and includes probable claystone clasts. Some thin sulfate marks the boundary with gray claystone.

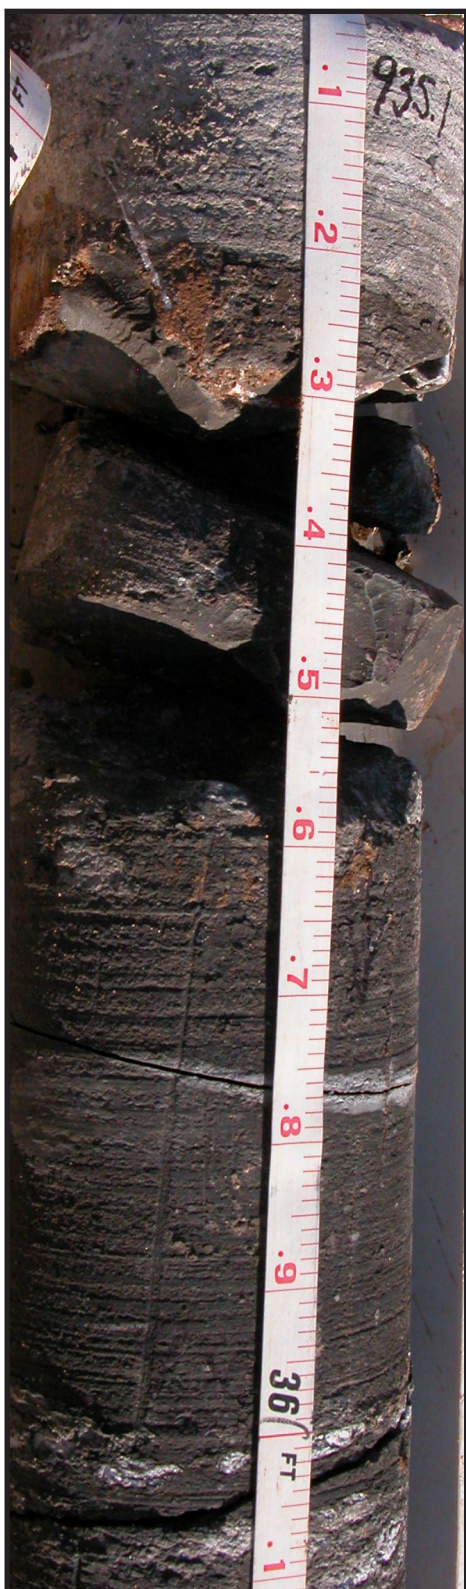
Figure 2-4. Gray Claystone (M-2) and Overlying Culebra Dolomite

The upper 2.9 ft of M-2 consists of gray (5Y5/1) to dark gray claystone (5Y4/1) (Fig. 2-4) that shows evidence of thin bedding and laminae that are approximately horizontal. A narrow fracture from 936–937 ft is filled with gypsum and, possibly, halite. Slickensides in some of the claystone are ~50 degrees from horizontal. The contact at 935.4 ft with the Culebra is sharp and undeformed.

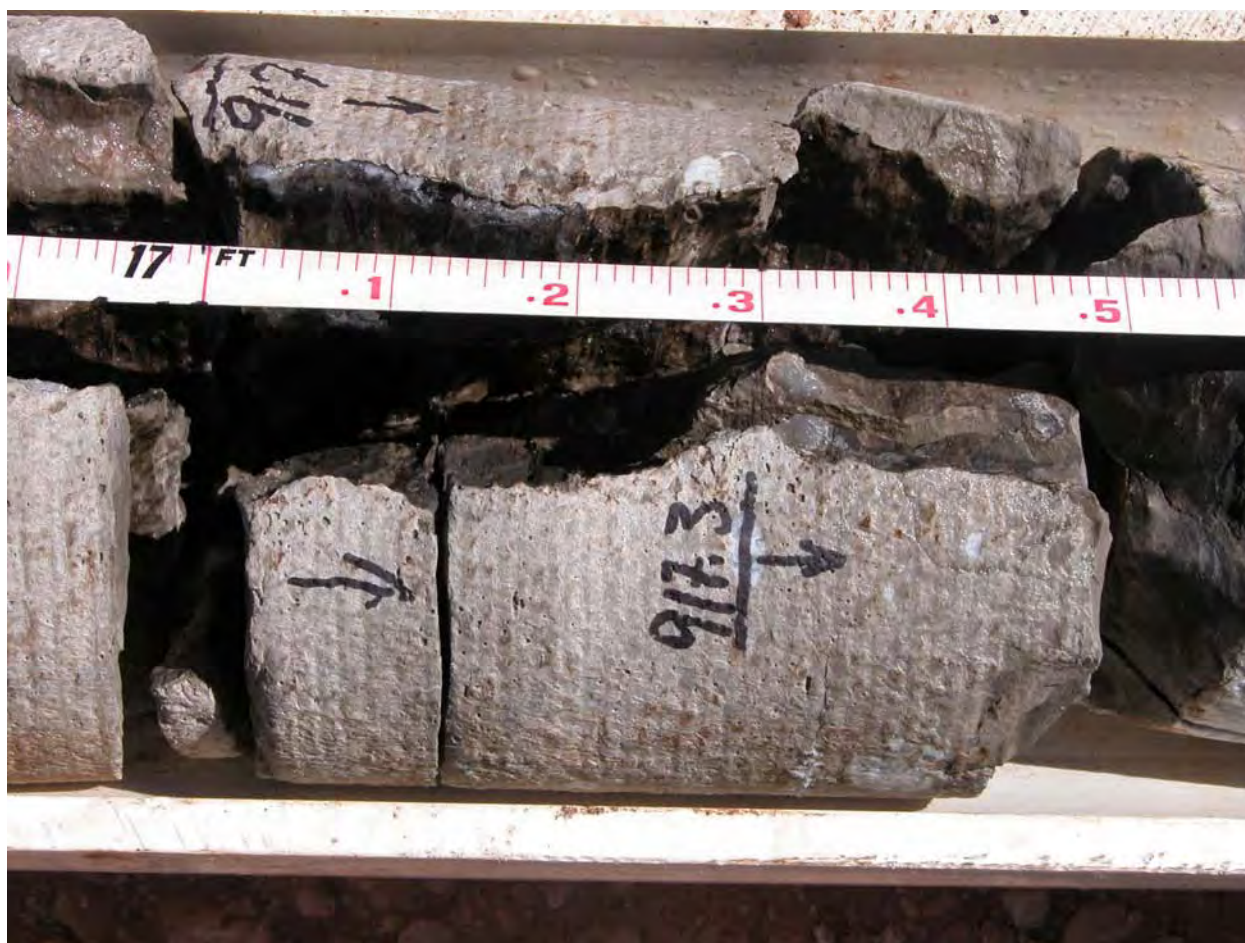
Figure 2-6. Halite on Fracture in Culebra Dolomite. The fracture shows black staining under the clear halite that coats much of the surface. Core has a 4-inch diameter.

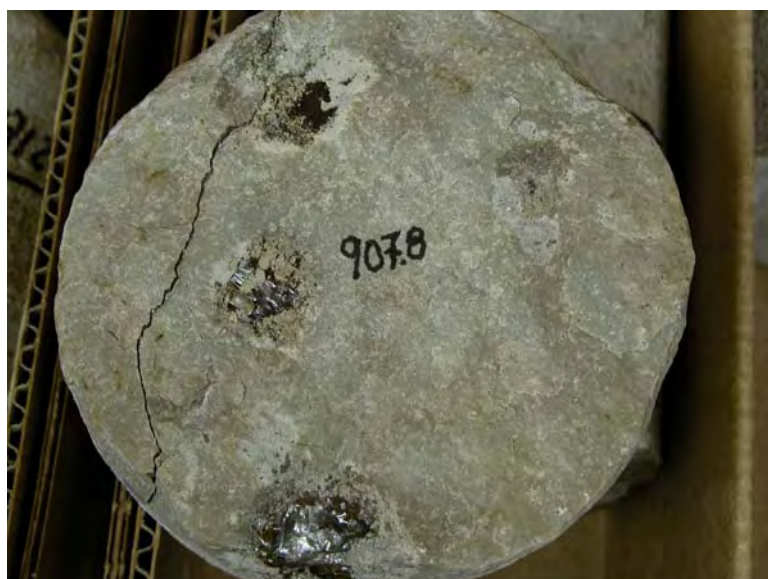
Figure 2-7. Halite in Culebra at 907.8 ft. Halite (dark, clear

Core is 4 inches across.

Subvertical fractures occur mainly between ~917 and 925 ft, and they are filled with halite (Fig. 2-7). The fractures generally have separations less than 0.25 inch.

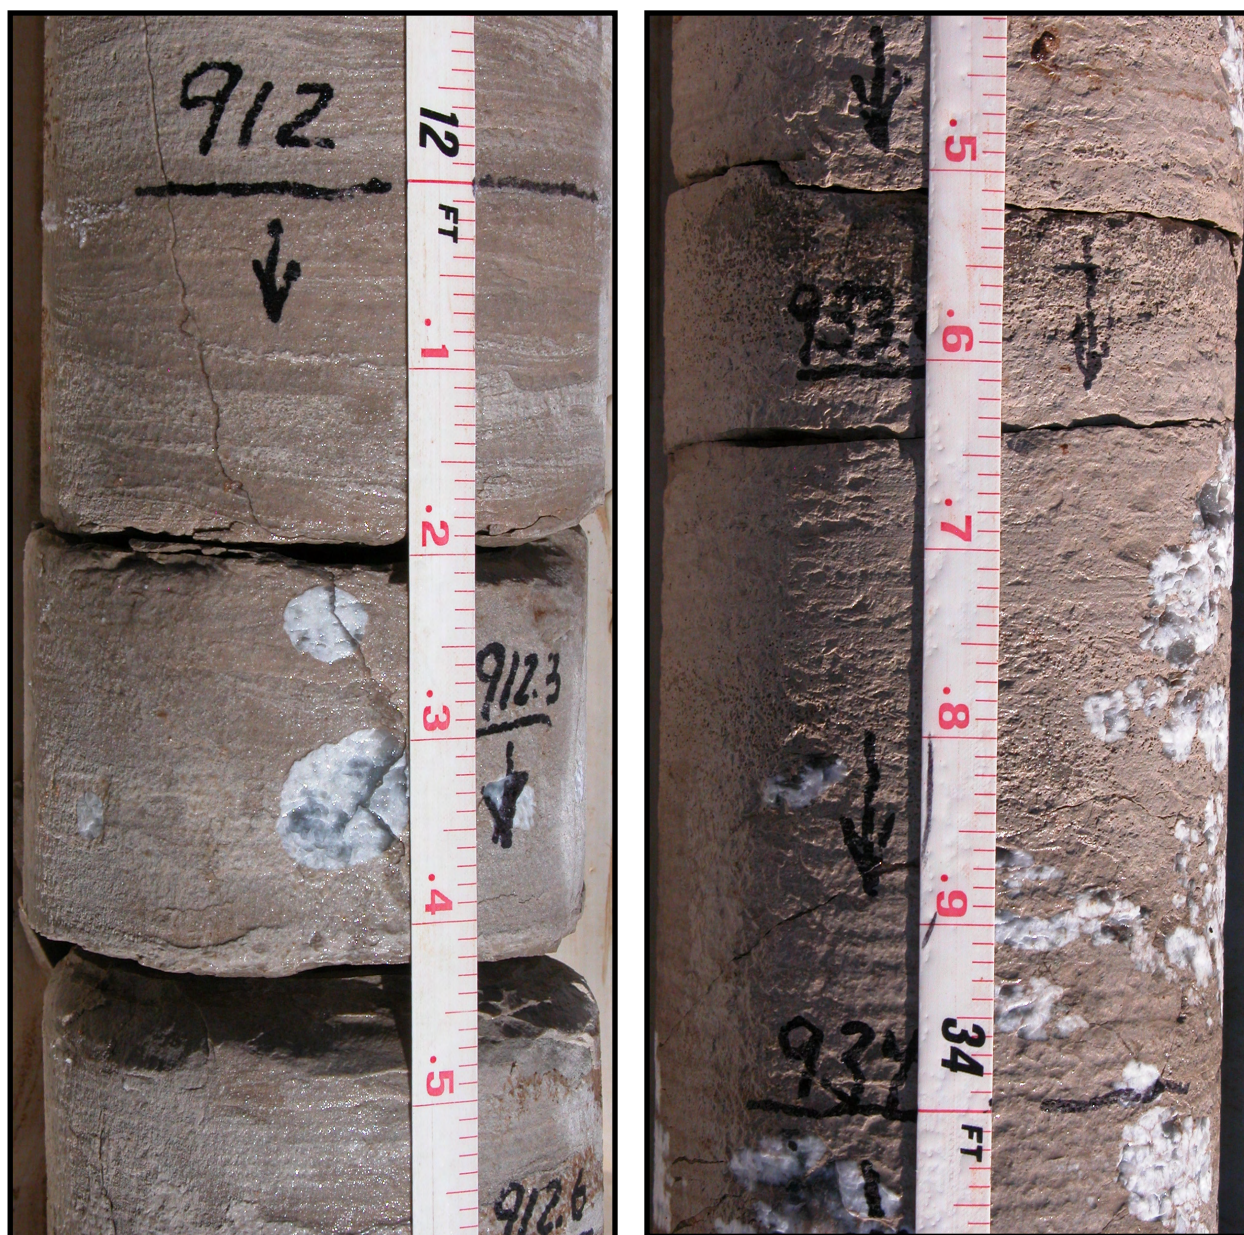
Core photographs of Culebra Dolomite from SNL-15 representing middle (left) and lower (right) portions of the member, which has very low permeability. V

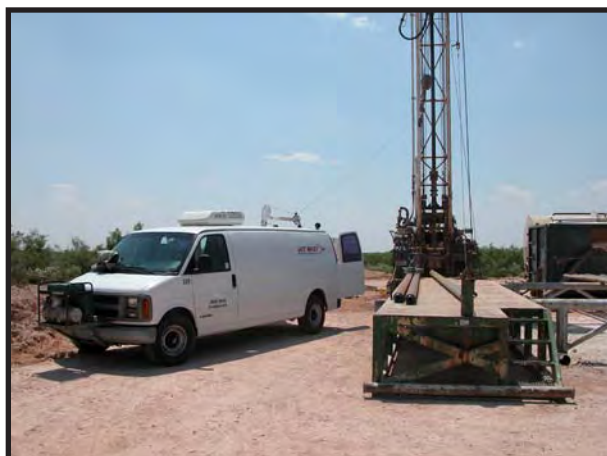
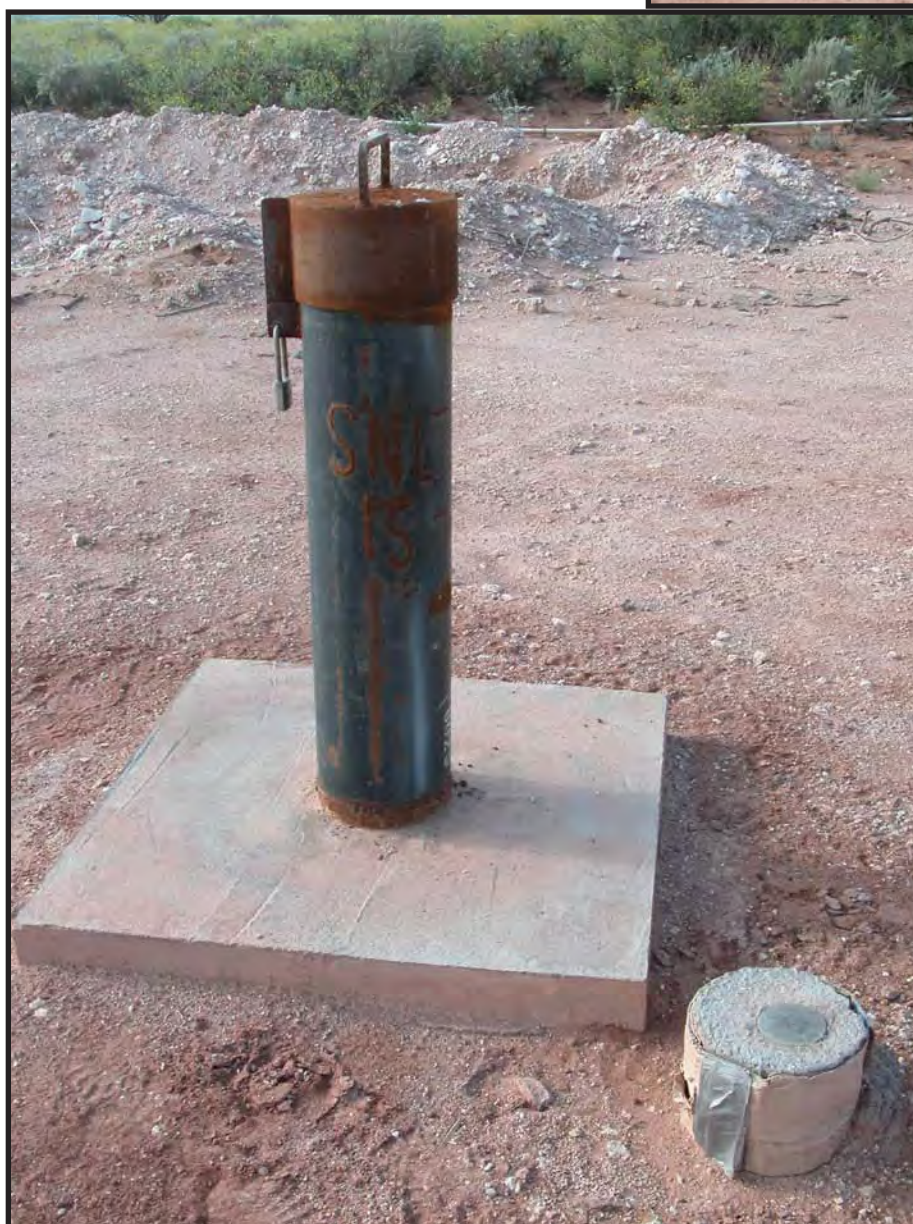
Jet West Geophysical Services logging vehicle (right) set up and logging SNL-15 on June 6, 2005. The top of the connector (below) is the reference point (0 ft depth) for logging and setting casing. The photo below taken September 10, 2005, shows the connector.
