Release Notification

Site Name: <i>Bagley</i>	Site Type: <i>7" Steel Pipeline</i>
Date Release Discovered: <i>08/03/2020</i>	API# <i>(if applicable)</i>

A leak was discovered on a Targa, 7-inch steel pipeline. This leak was the result of internal corrosion. Upon discovery of the leak Targa Resources isolated the leak until permanent repairs could be made. Targa determined that a section of pipe would be removed and replaced. During this event, Targa proceeded to isolate the section of pipe and replace the section of pipe with new pipe. After the line was verified to be safe to operate, Targa put the line back into service.

Based on laboratory analytical results and field activities conducted to date, Etech recommends Targa Midstream Services, LLC, provide copies of this *Remediation Summary & Soil Closure Request* to the appropriate agencies and request closure be granted to the Site.

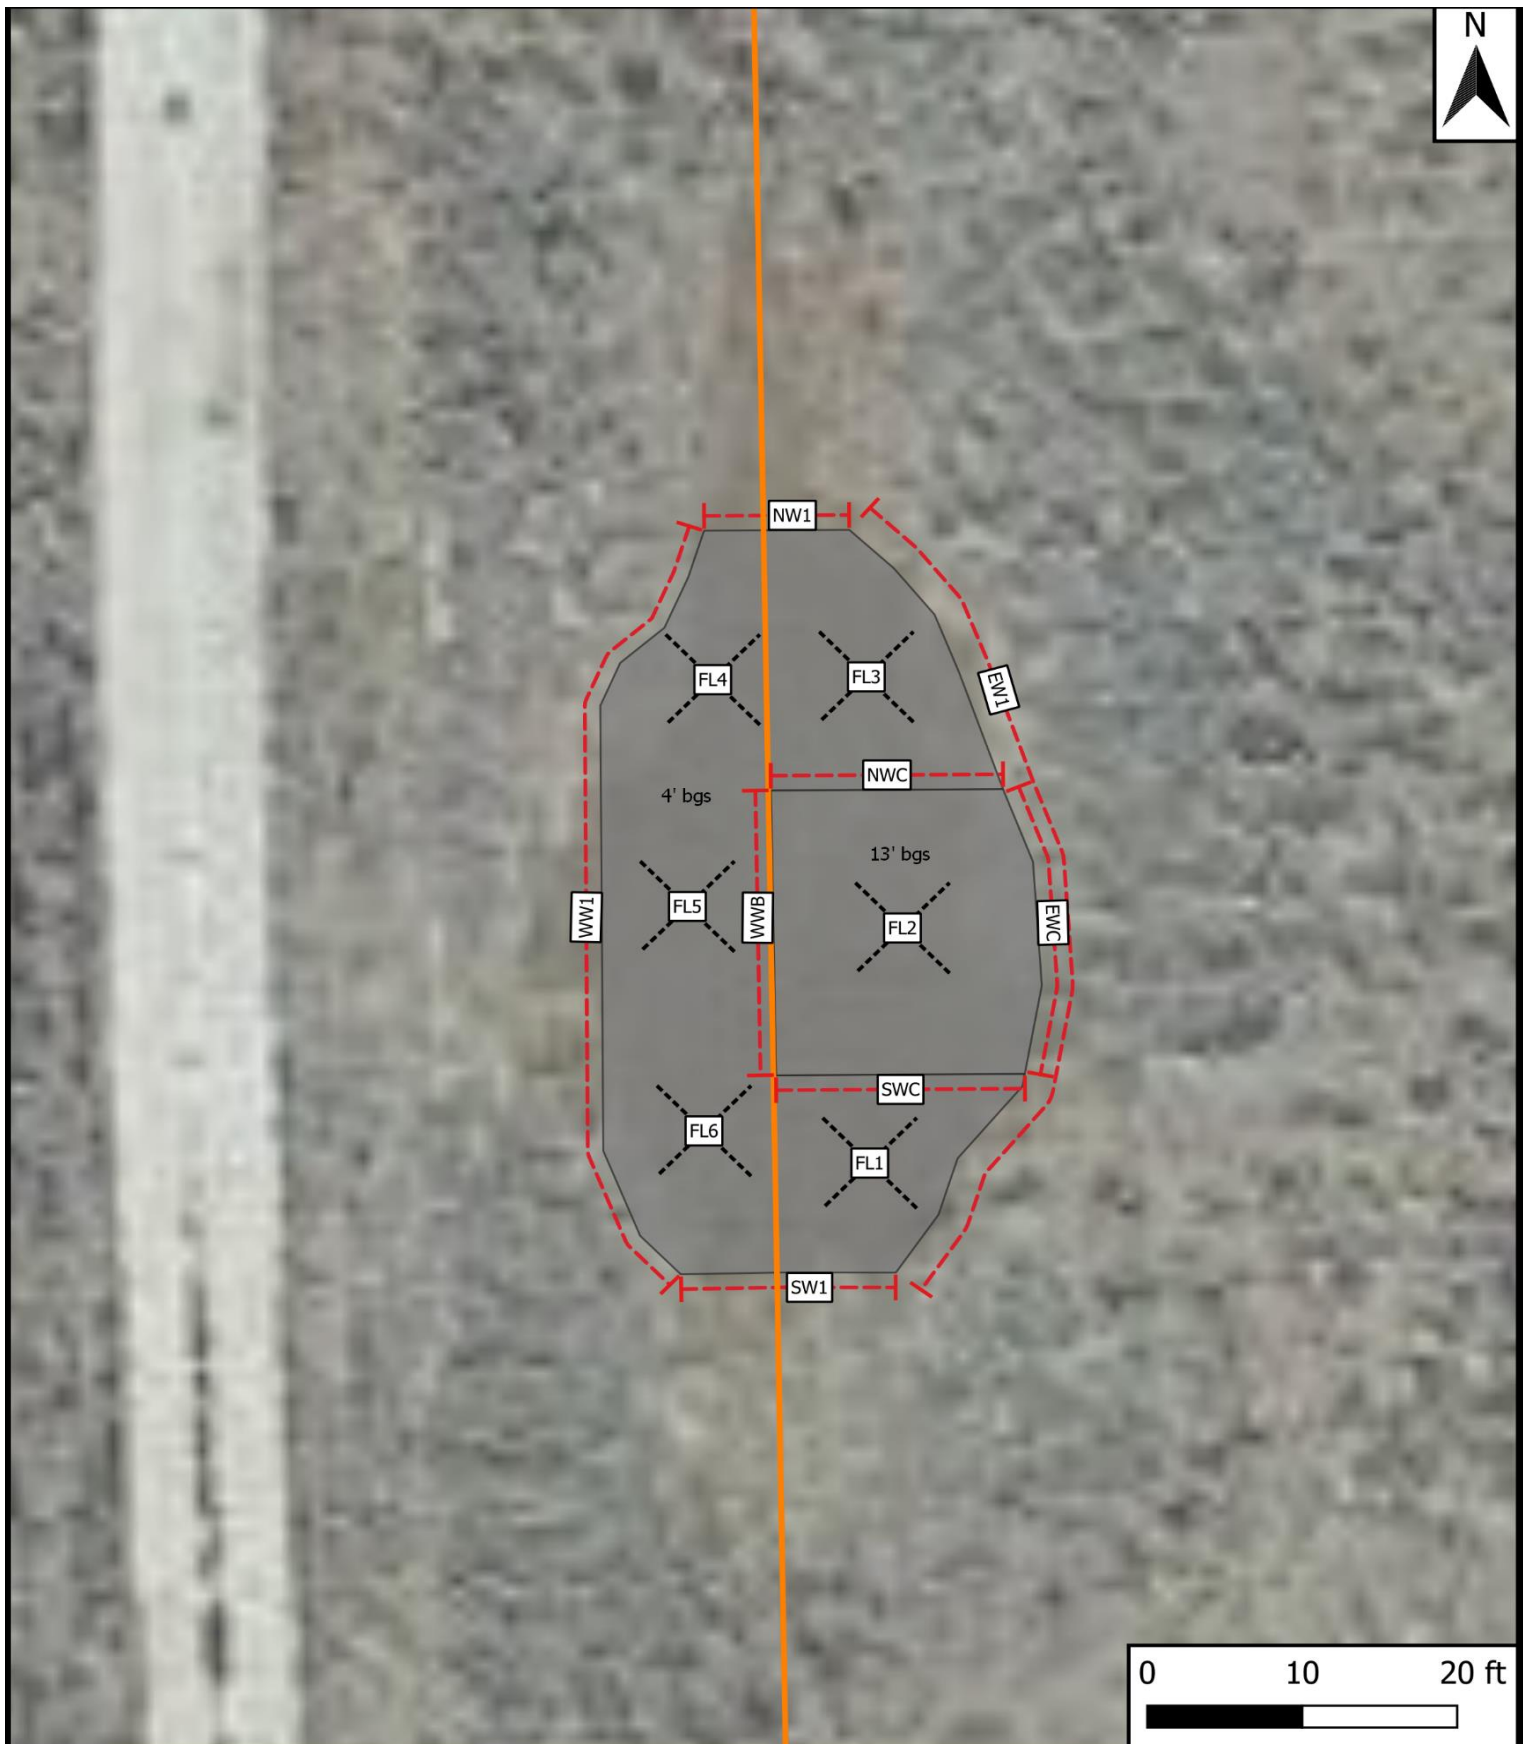
Figure 3

Site & Sample Location Map

- Excavation Extent
- X Composite Floor Sample
- [] Composite Wall Sample
- Pipeline

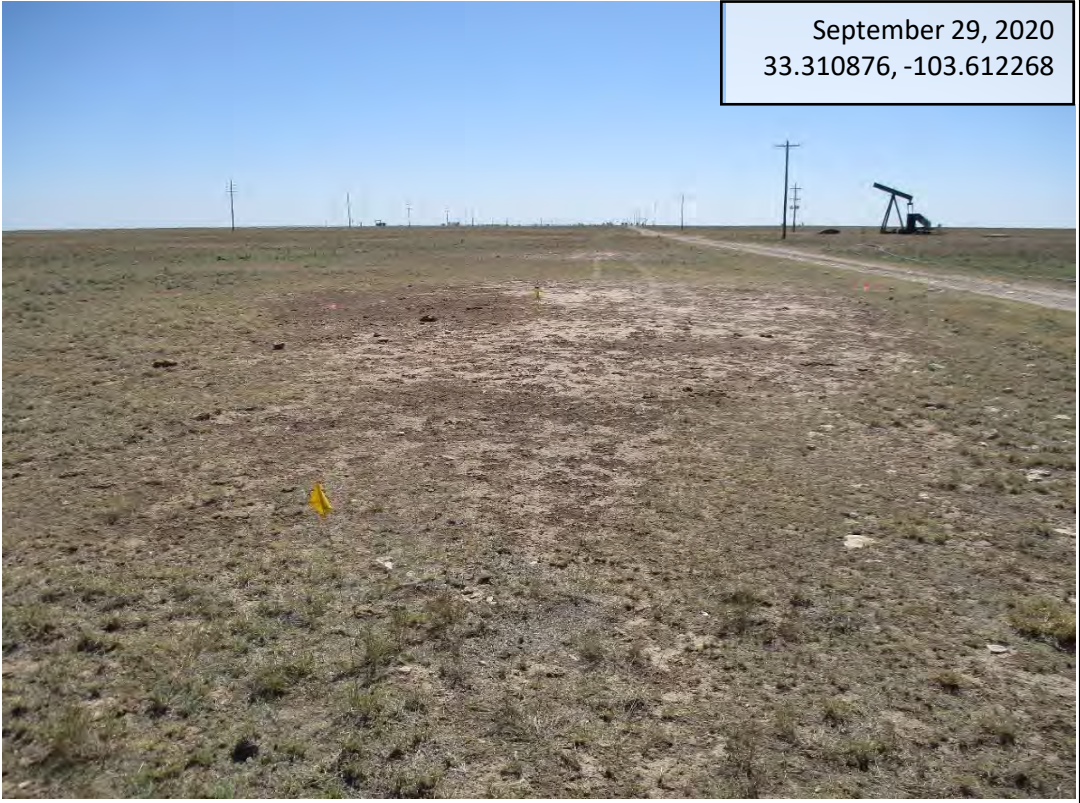
Photo Number: 1

September 29, 2020 33.310876, -103.612268
Photo Direction: South		
Photo Description: View of Impacted Area

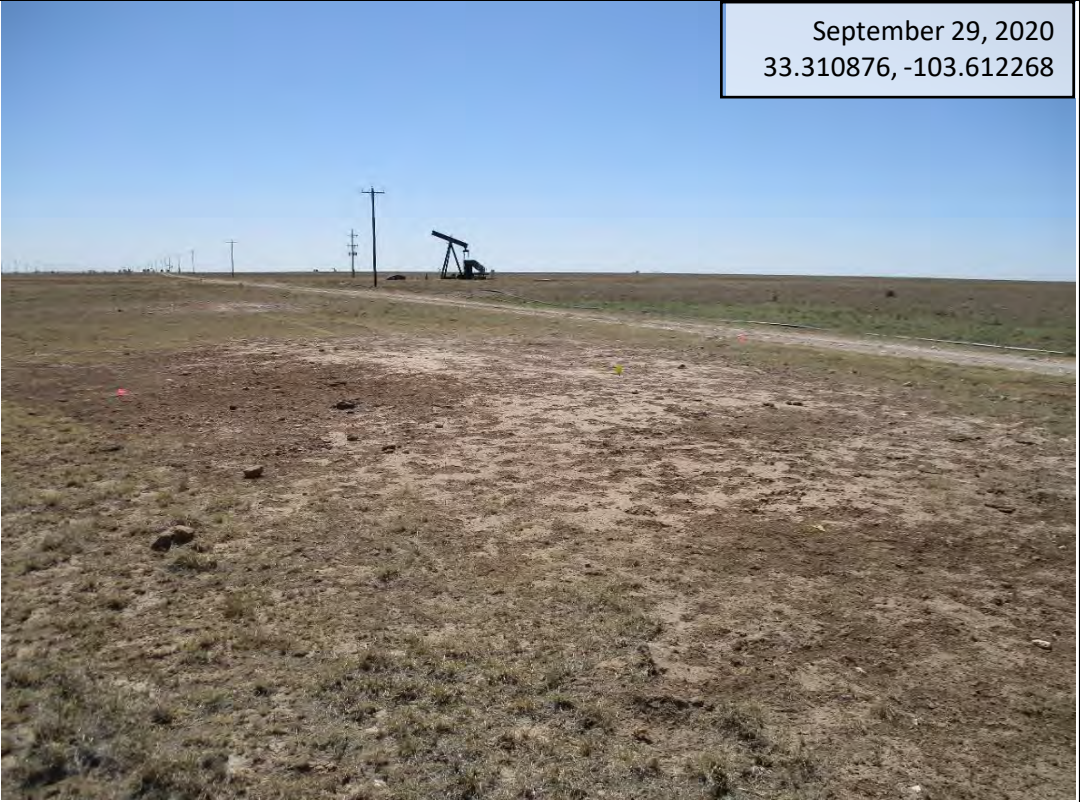
Photo Number: 2

September 29, 2020 33.310876, -103.612268
Photo Direction: Southwest		
Photo Description: View of Impacted Area

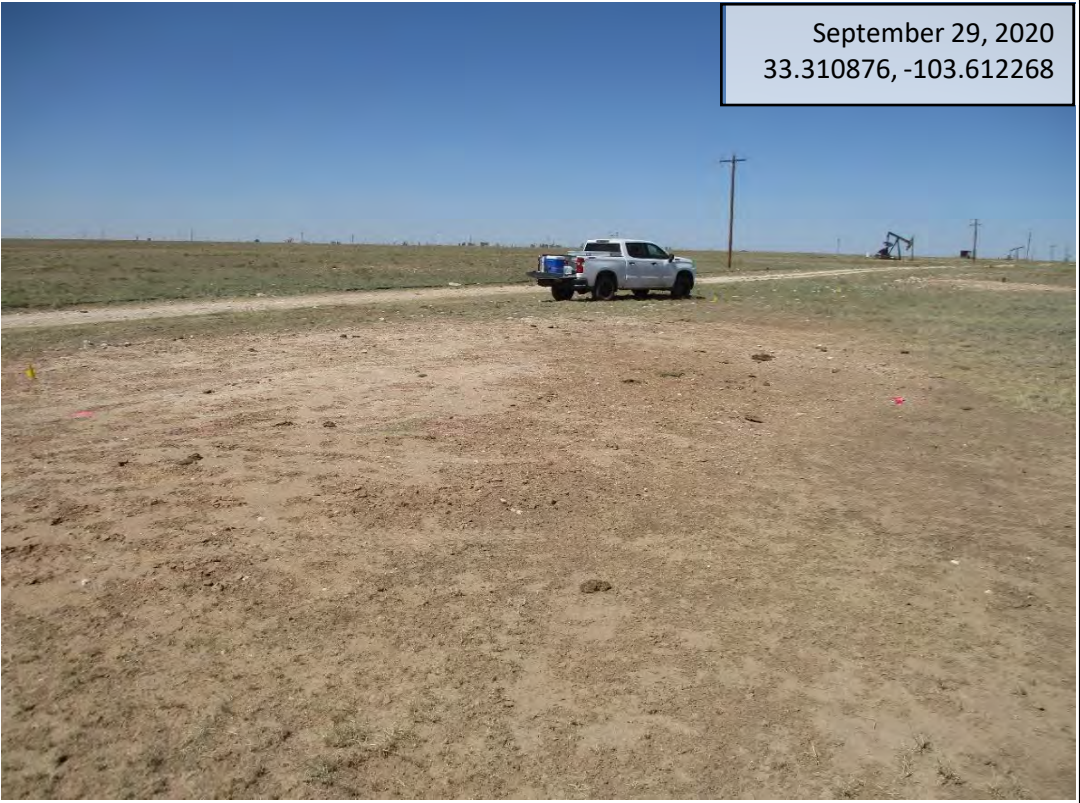
Photo Number: 3

September 29, 2020 33.310876, -103.612268
Photo Direction: Northwest		
Photo Description: View of Impacted Area

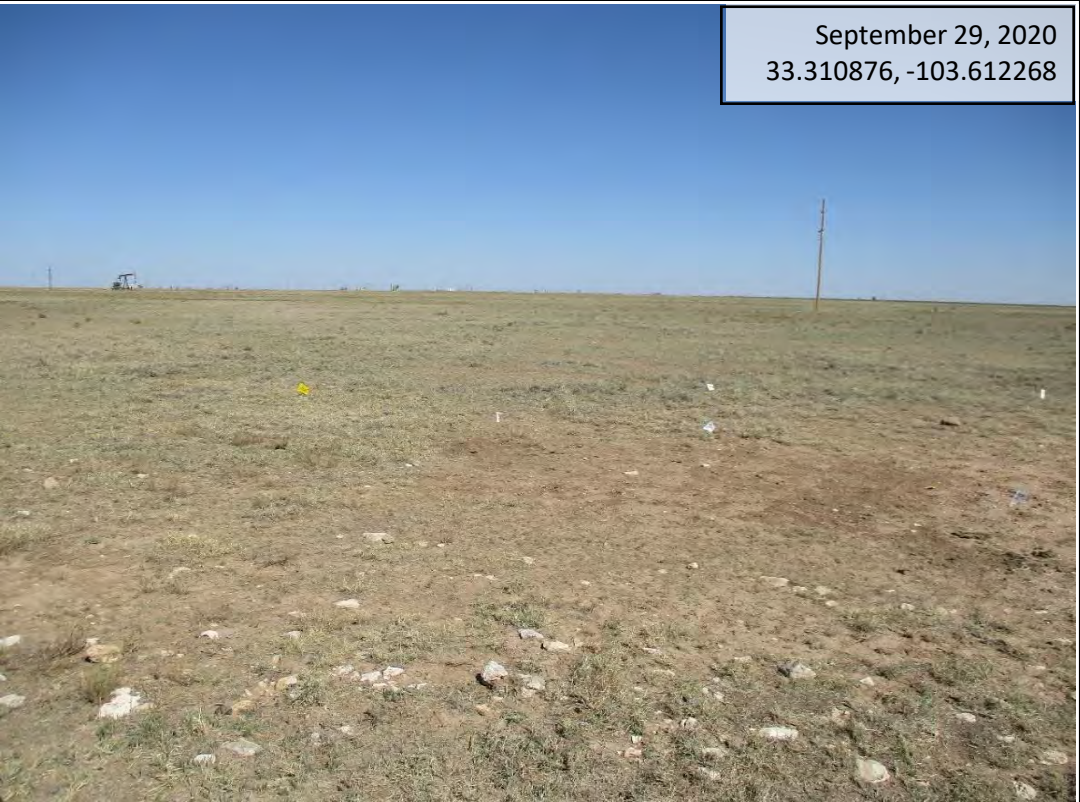
Photo Number: 4

September 29, 2020 33.310876, -103.612268
Photo Direction: East		
Photo Description: View of Impacted Area

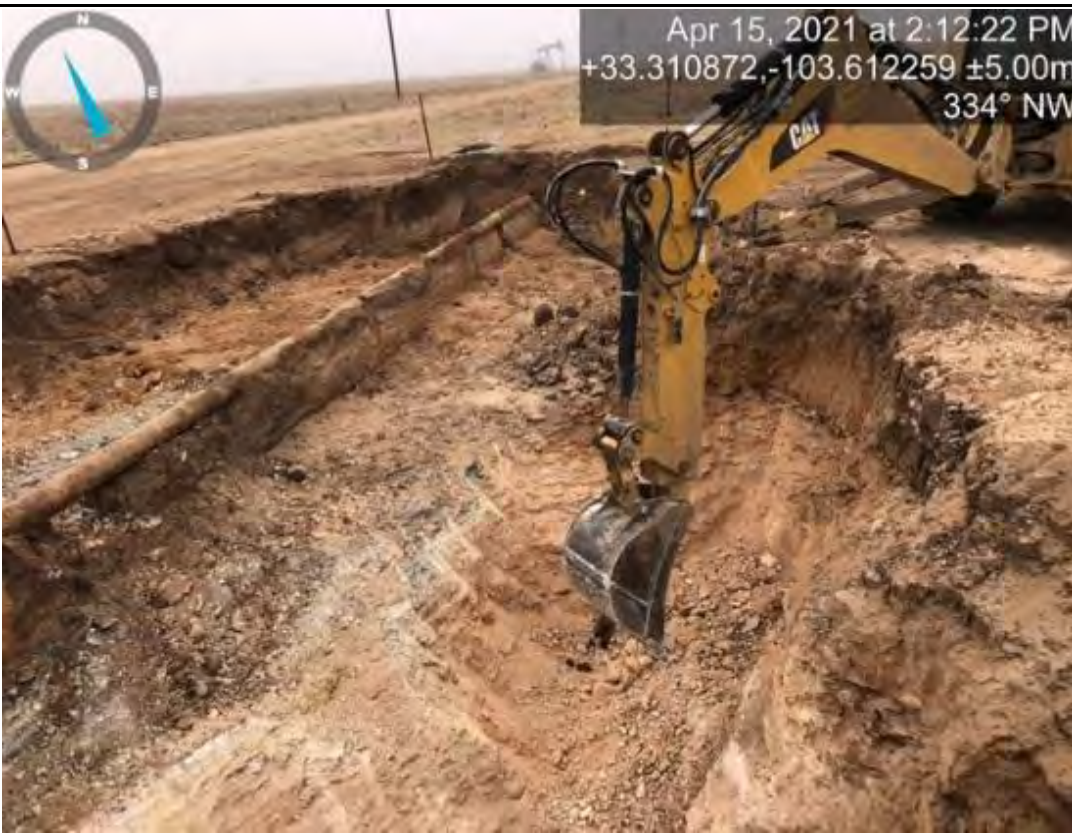
Photo Number: 7

Photo Direction: Northwest	
Photo Description: View of Excavated Area

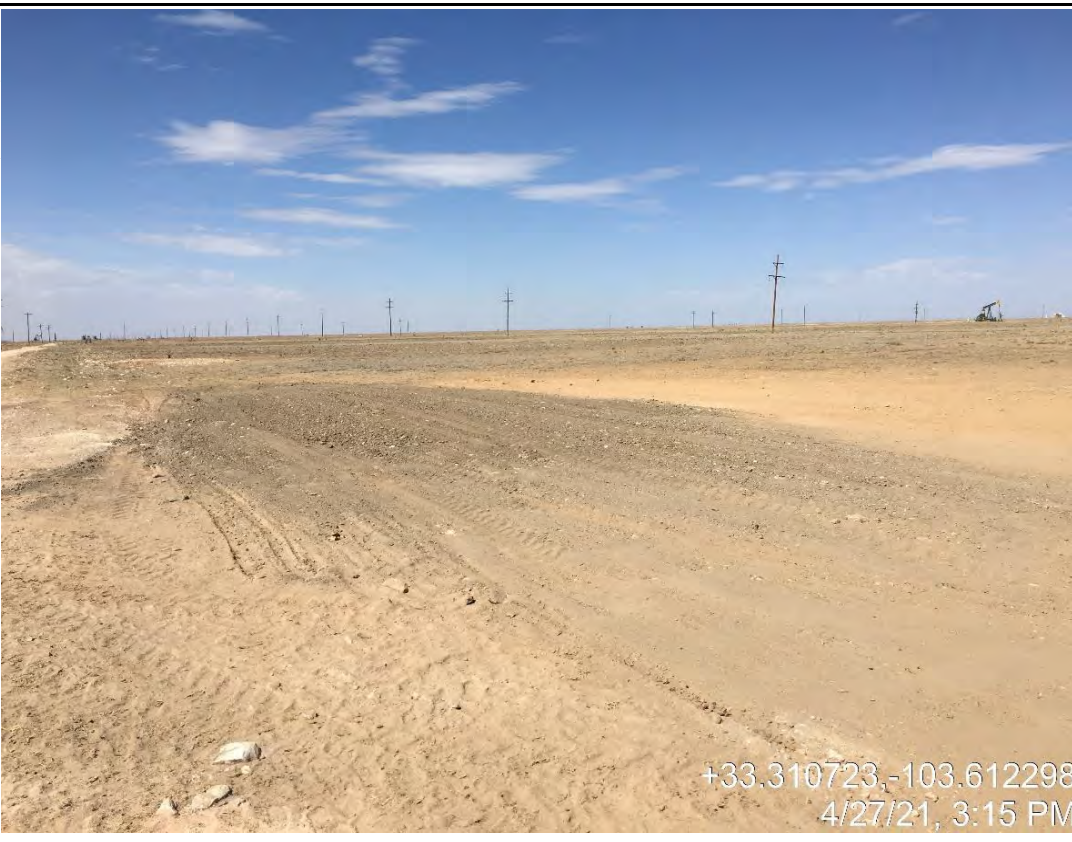
Photo Number: 8

Photo Direction: Northeast	
Photo Description: View of Remediated Area After Backfilling & Regrading
