## Release Notification

**Re: Closure Request  
Remuda 100  
Incident Number nAPP2111850266  
Eddy County, New Mexico**

**Soil Analytical Results**  
**Remuda 100**  
**Incident Number NAPP2111850266**  
**Eddy County, New Mexico**

## PHOTOGRAPHIC LOG

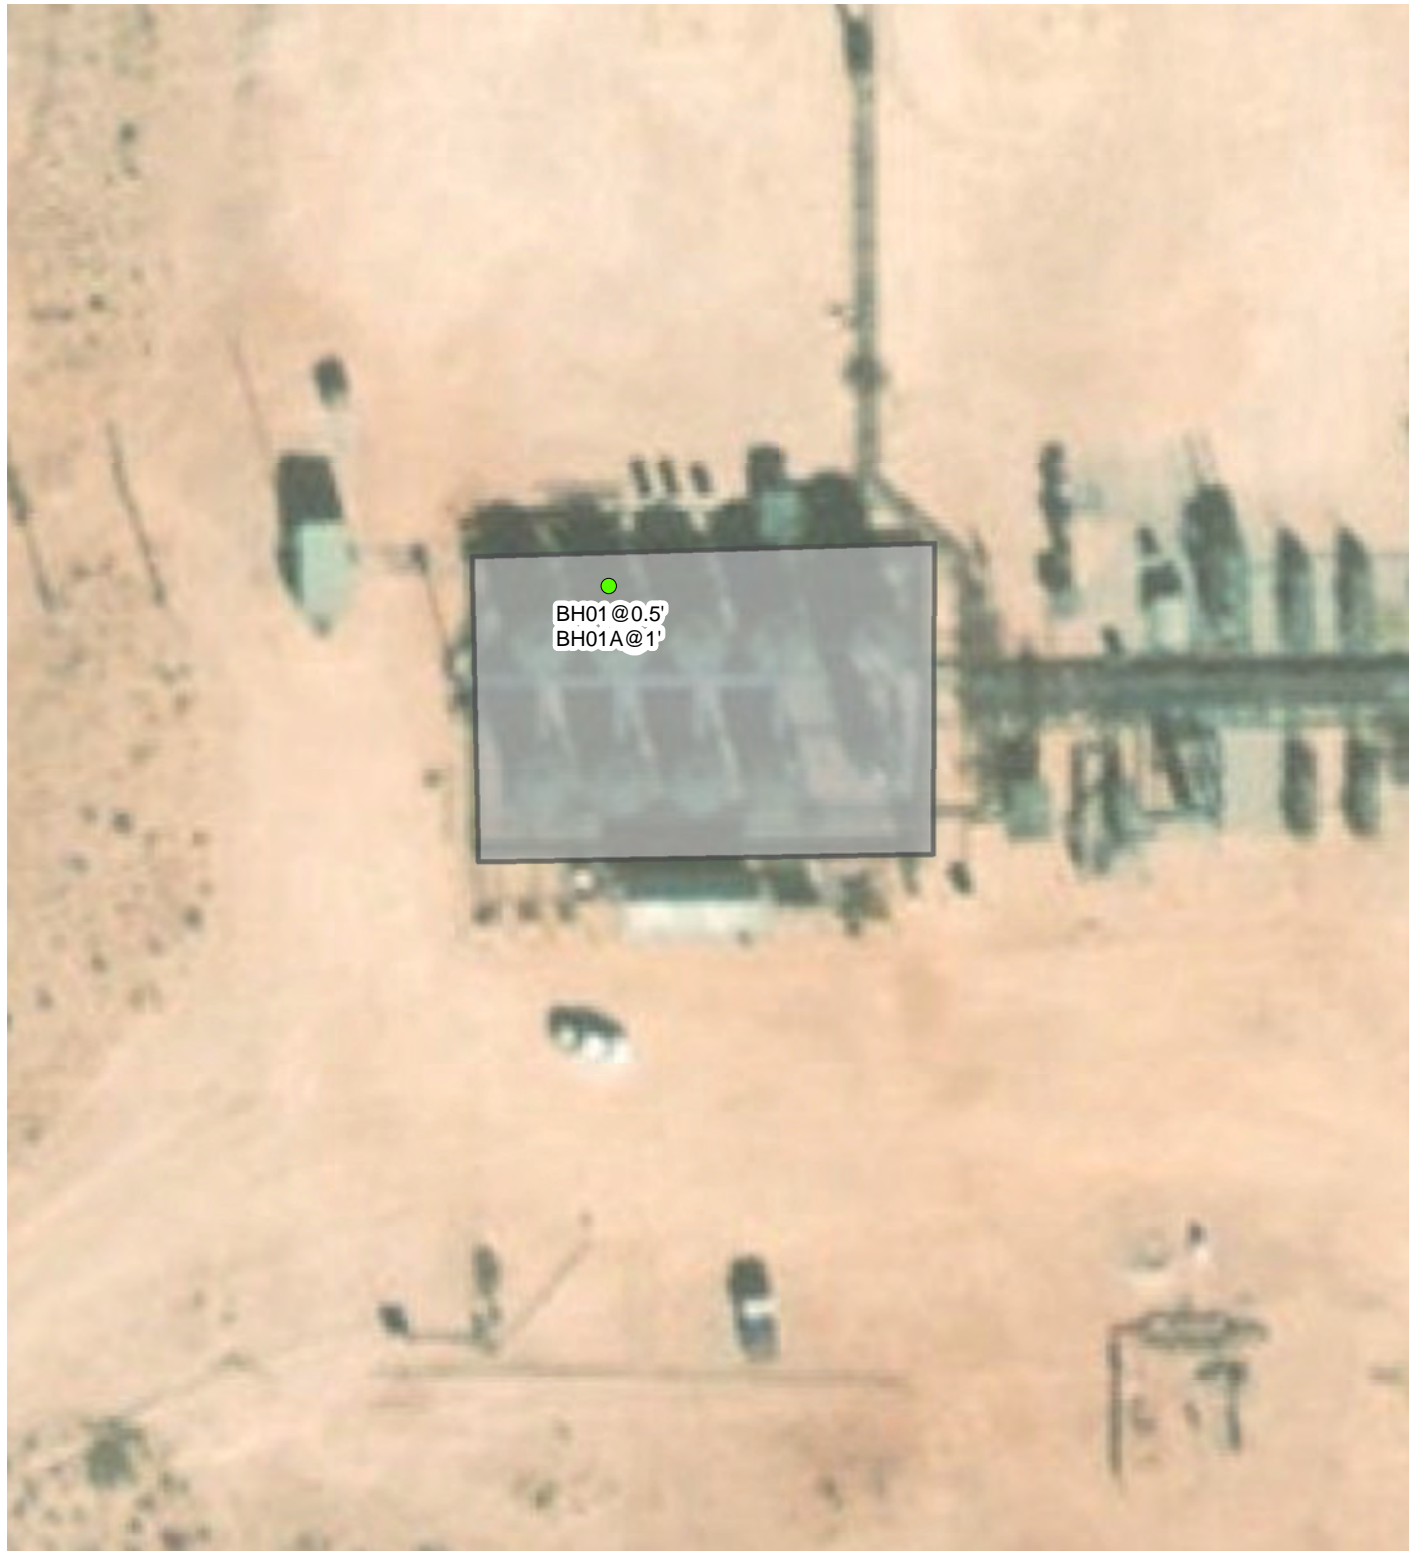
**FIGURE 2**  
**DELINEATION SOIL SAMPLE LOCATIONS**  
**REMUDA 100**  
**UNIT E SEC 25 T23S R29E**  
**EDDY COUNTY, NEW MEXICO**  
**XTO ENERGY, INC.**

On May 17, 2021, WSP personnel were at the Site to evaluate the release extent based on information provided on the Form C-141 and visual observations. WSP personnel advanced one borehole (BH01) via hand-auger at the location of the tear in the liner identified during the liner integrity inspection. Two soil samples were collected from borehole BH01 at depths of approximately 0.5 feet and 1-foot bgs. Soil from the borehole was field screened for volatile aromatic hydrocarbons and chloride utilizing a calibrated photo-ionization detector (PID) and Hach® chloride QuanTab® test strips, respectively. Field screening results and observations from the borehole were documented on a lithologic/soil sampling log which is included as Attachment 2. The borehole was backfilled with the soil removed and XTO repaired the tear in the liner. The borehole delineation soil sample location is depicted on Figure 2. Photographic documentation was conducted during the Site visit. The photographic log is included in Attachment 3.

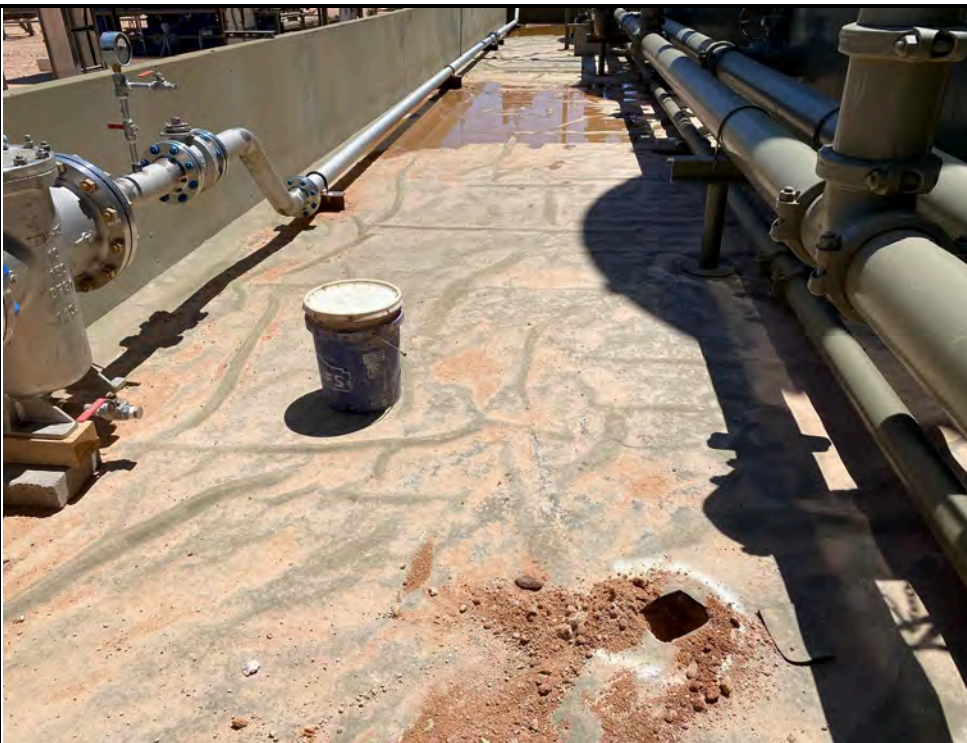
A photograph showing a concrete surface with a large, irregularly shaped area of reddish-brown soil or sediment. A blue bucket is placed on the concrete near the center of the area. In the background, there are industrial pipes and valves. The scene is outdoors, and the ground is wet, reflecting the sky.

Photo No.	Date	
4	May 17, 2021	
View of final delineation with borehole backfilled with soil removed.		  A photograph showing a close-up view of a concrete surface. A blue bucket is placed on the concrete, and a small, circular area of reddish-brown soil is visible. The scene is outdoors, and the ground is wet, reflecting the sky. The shadow of the person taking the photo is visible in the bottom right corner.

Following the failed liner integrity inspection at the Site, WSP personnel advanced one borehole (BH01) at the location of the tear in the liner to assess for the presence or absence of soil impacts resulting from the April 14, 2021 produced water release within lined containment. Two delineation soil samples were collected from borehole BH01 at depths of approximately 0.5 feet and 1-foot bgs. Laboratory analytical results indicated that benzene, BTEX, TPH-GRO/TPH-DRO, TPH, and chloride concentrations were compliant with the Closure Criteria. Additionally, field screening of soil from the borehole indicated no elevated volatile aromatic hydrocarbons or chloride concentrations beneath the tear in the liner. The release was contained laterally by the lined containment and all released fluids were recovered during initial response activities. The tear in the liner was subsequently repaired.
