# **Remediation Plan Resubmittal**

*Re: WP Byrd Tank Battery Case nRM2010837524*

# **Remediation Plan**

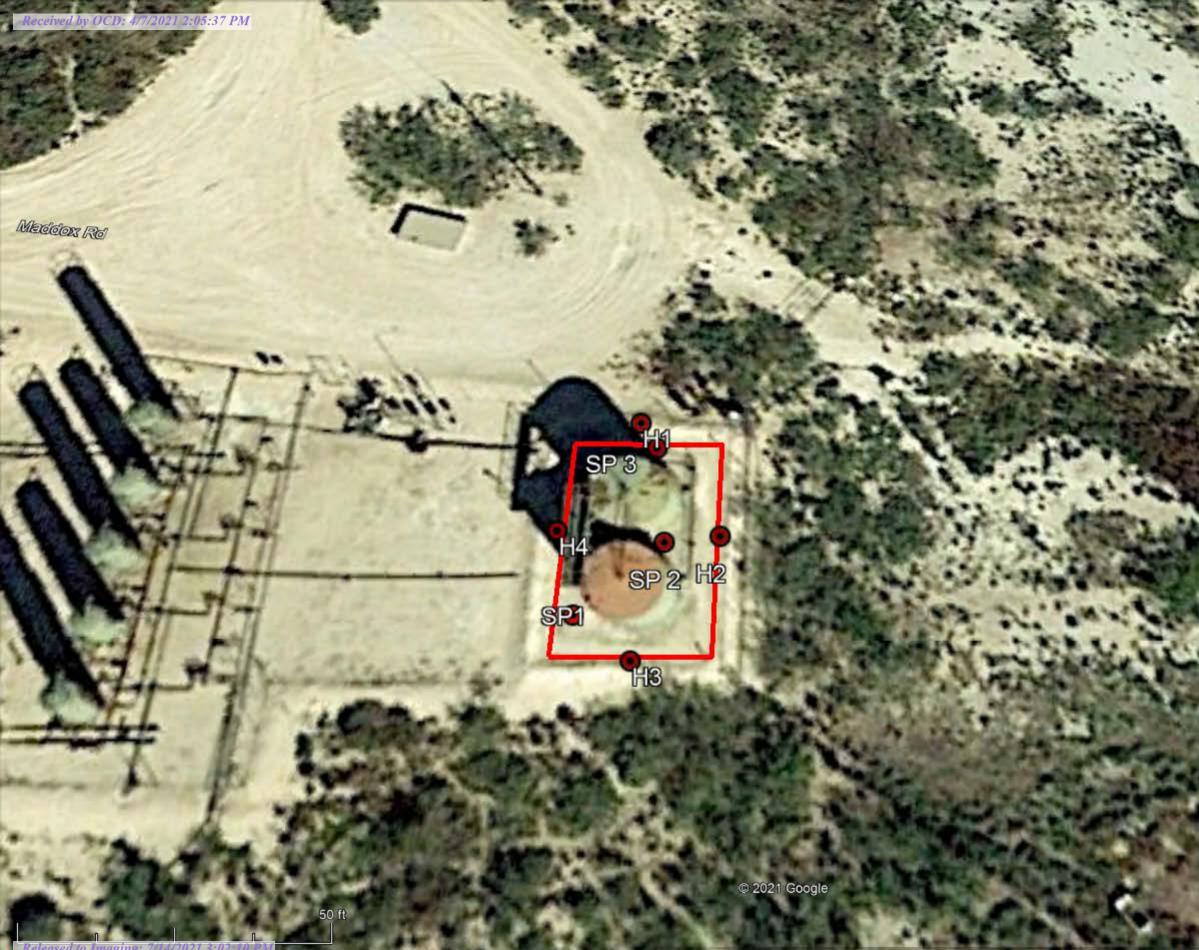
Google Earth

Imagery Date: 11/2/2017 lat 32.591700° lon -103.307846° elev 3561 ft eye alt 3787 ft

Sample Date	Sample ID	Depth	Chloride	Benzene	Toulene	Ethybenzene	Total Xylenes	Total BTEX	GRO	DRO	EXT DRO	GPS Coordinates
Dute							Ayrenes	DIEX				32.591293
7/10/2020	SP1	S	<16.0	<0.200	0.573	<0.200	8.170	8.74	707	24600	5340	-103.307384
7/10/2020	SP1	1'		< 0.050	2.29	< 0.500	14.70	17.00	717	1910	105	
7/10/2020	SP1	2'		<0.200	0.301	< 0.200	2.990	3.29	96.9	616	53.1	
7/16/2020	SP1	3'		< 0.050	< 0.050	< 0.050	0.381	0.381	41.5	791	143	
7/16/2020	SP1	4'		< 0.050	<0.050	<0.050	<0.150	< 0.300	<10.0	<10.0	<10.0

32.591330
2/4/2021	SP2	S	32	< 0.050	<0.050	0.218	0.267	0.485	<50.0	12200	4030	-103.307351
2/4/2021	SP2	1'	32	0.179	2.6	<0.050	19.600	22.4	711	4680	1050	
2/4/2021	SP2	2'	<16.0	< 0.050	<0.050	0.08	<0.150	<0.300	<10.0	31.7	39.2	
2/4/2021	SP2	3'	<16.0	< 0.050	<0.050	0.078	<0.150	<0.300	<10.0	83.2	84.6	
2/4/2021	SP2	4'	16	< 0.050	<0.050	0.307	0.342	0.649	60.1	1730	587	
2/22/2021	SP2	5'		<0.050	<0.050	<0.050	<0.150	<0.300	<10.0	23.2	13	
2/22/2021	SP2	6'		<0.050	<0.050	<0.050	<0.150	<0.300	<10.0	32.4	<10.0

32.591370
2/4/2021	SP3	S	<16.0	<0.050	<0.050	<0.050	0.627	0.627	75.6	11300	3020	-103.307340
2/4/2021	SP3	1'	16	<0.050	0.381	2.24	7.980	10.6	697	6890	1580	
2/4/2021	SP3	2'	<16.0	<0.050	0.331	1.81	6.940	9.9	293	2630	641	
2/4/2021	SP3	3'	<16.0	<0.050	<0.050	0.167	0.658	0.825	37.5	781	217	
2/4/2021	SP3	4'	<16.0	<0.050	<0.050	<0.050	<0.150	<0.300	10.6	451	112	
2/22/2021	SP3	5'		<0.050	<0.050	<0.050	<0.150	<0.300	<10.0	281	60.5	
2/22/2021	SP3	6'		<0.050	<0.050	<0.050	<0.150	<0.300	<10.0	23.9	<10.0

32.591404
2/4/2021	HC1	S	<16.0	<0.050	<0.050	<0.050	<0.150	<0.300	<10.0	12.3	<10.0	-103.307351
												32.591336
2/4/2021	HC2	S	<16.0	<0.050	<0.050	<0.050	<0.150	<0.300	<10.0	<10.0	<10.0	-103.307300

32.591269
2/4/2021	HC3	S	<16.0	<0.050	<0.050	<0.050	<0.150	<0.300	<10.0	<10.0	<10.0	-103.307349
												32.591339
2/4/2021	HC4	S	<16.0	<0.050	<0.050	<0.050	<0.150	<0.300	<10.0	<10.0	<10.0	-103.307398

Apache Corporation proposes that the in-situ remediation proposed is the best course of action in an attempt to treat the contamination to the best extent possible due to the close proximity to infrastructure. The soil inside the berm will be tilled to loosen the top two feet and the product will be applied see the attached plan for further details of the process. The remediation will be completed within 90 days of OCD approval of the plan.

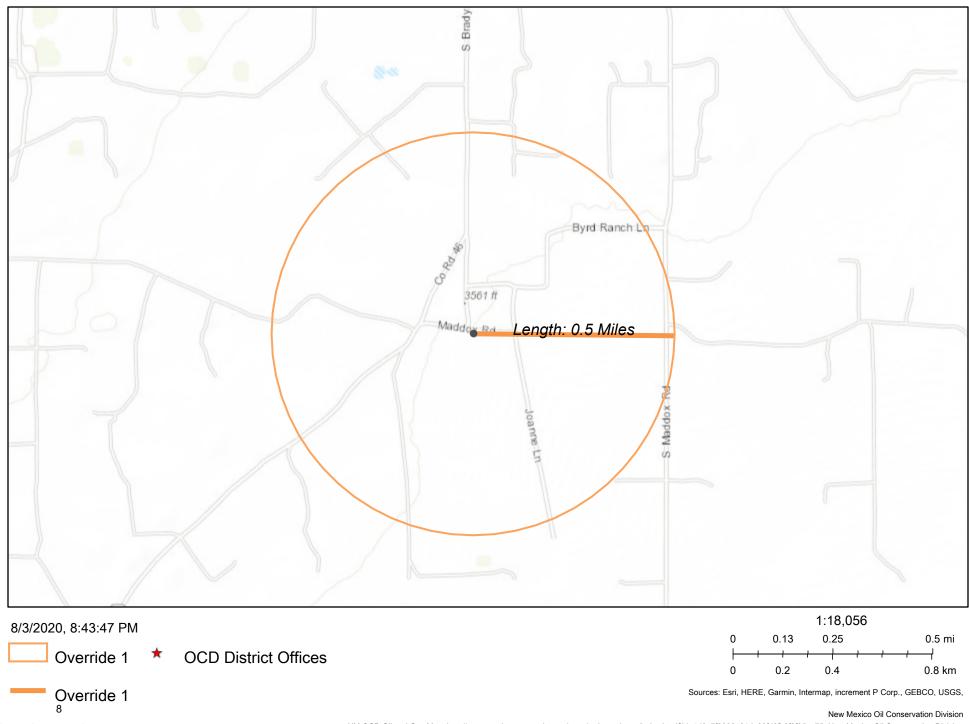
# Figure 4 - Hydrology Map

NM OCD Oil and Gas Map. http://nm-emnrd.maps.arcgis.com/apps/webappviewer/index.html?id=4d017f2306164de29fd2fb9f8f35ca75: New Mexico Oil Conservation Division

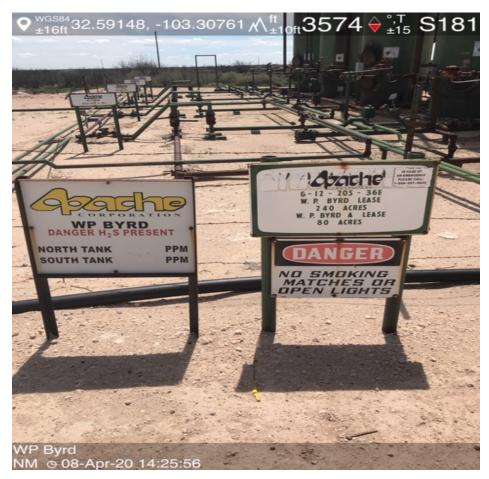
Backside of Battery

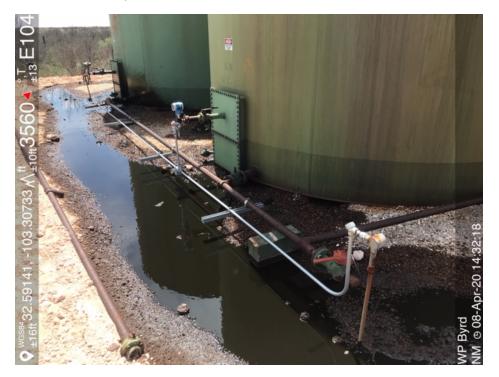
Backside of Battery

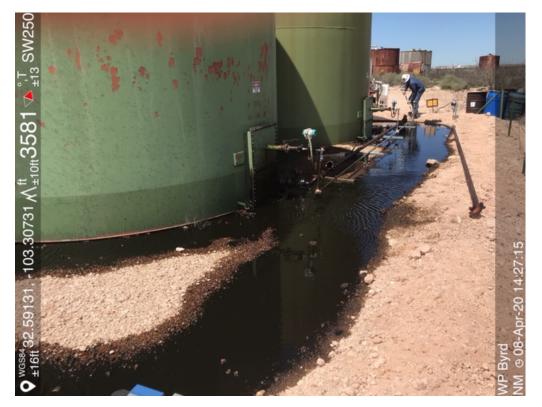
Front of Battery

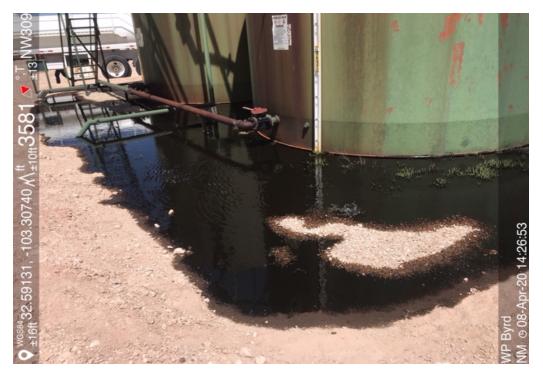
Front of Battery
