**2RP-1133
DEFERRAL REPORT
Red Lake 36 Battery
Crude Oil and Produced Water Spill
Lea County, New Mexico**

Latitude: N 32.79508°
Longitude: W 104.23330°

LAI Project No. 19-0112-29

July 23, 2019

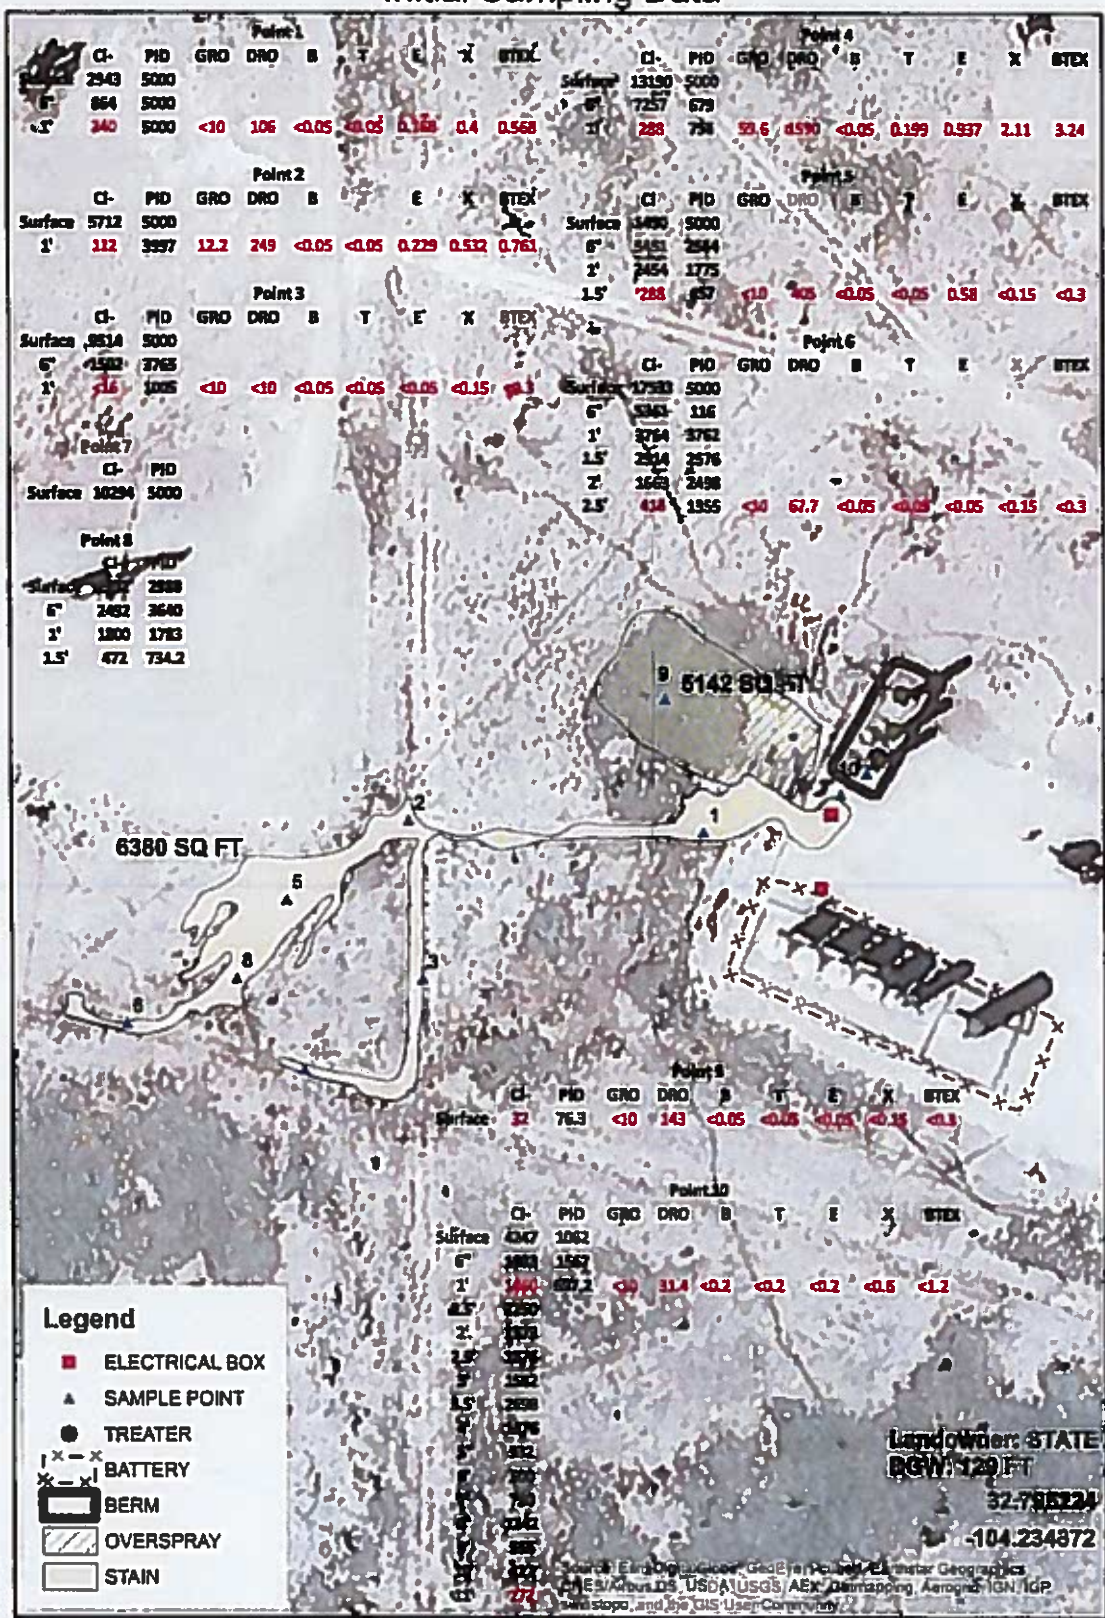
Figure 1

While delineating the second release at Red Lake 36 Battery, RECS collected a soil sample inside the berm area of the battery labeled as point 10. Samples were taken every six (6) inches to 4 feet below ground surface (bgs) and then at every foot to 11 feet bgs. Chloride was reported below the delineation requirement of 600 milligrams per kilogram (mg/Kg) at 9 feet bgs (566 mg/Kg). Chloride reported below the remediation level of 10,000 mg/Kg in all samples. BTEX and TPH were reported below the remediation levels of 50 mg/Kg and 2,500 mg/Kg, respectively, at point 10, 1 foot bgs (<1.2 mg/Kg and 31.4 mg/Kg).

**APACHE
RED LAKE #36
C STATE BATTERY**

UL C SECTION 36
T-17-S R-27-E
EDDY COUNTY, NM

Due to the proximity of sample point 10 to production equipment inside the battery containment, Apache requests deferral to complete remediation for 2RP-1133 until abandonment.
