Based on laboratory analytical results and field activities conducted to date, Etech recommends COG Operating, LLC, provide copies of this Remediation Summary and Soil Closure Request to the appropriate agencies and request closure be granted to the Van Gogh 101H Site.

### Photographic Log

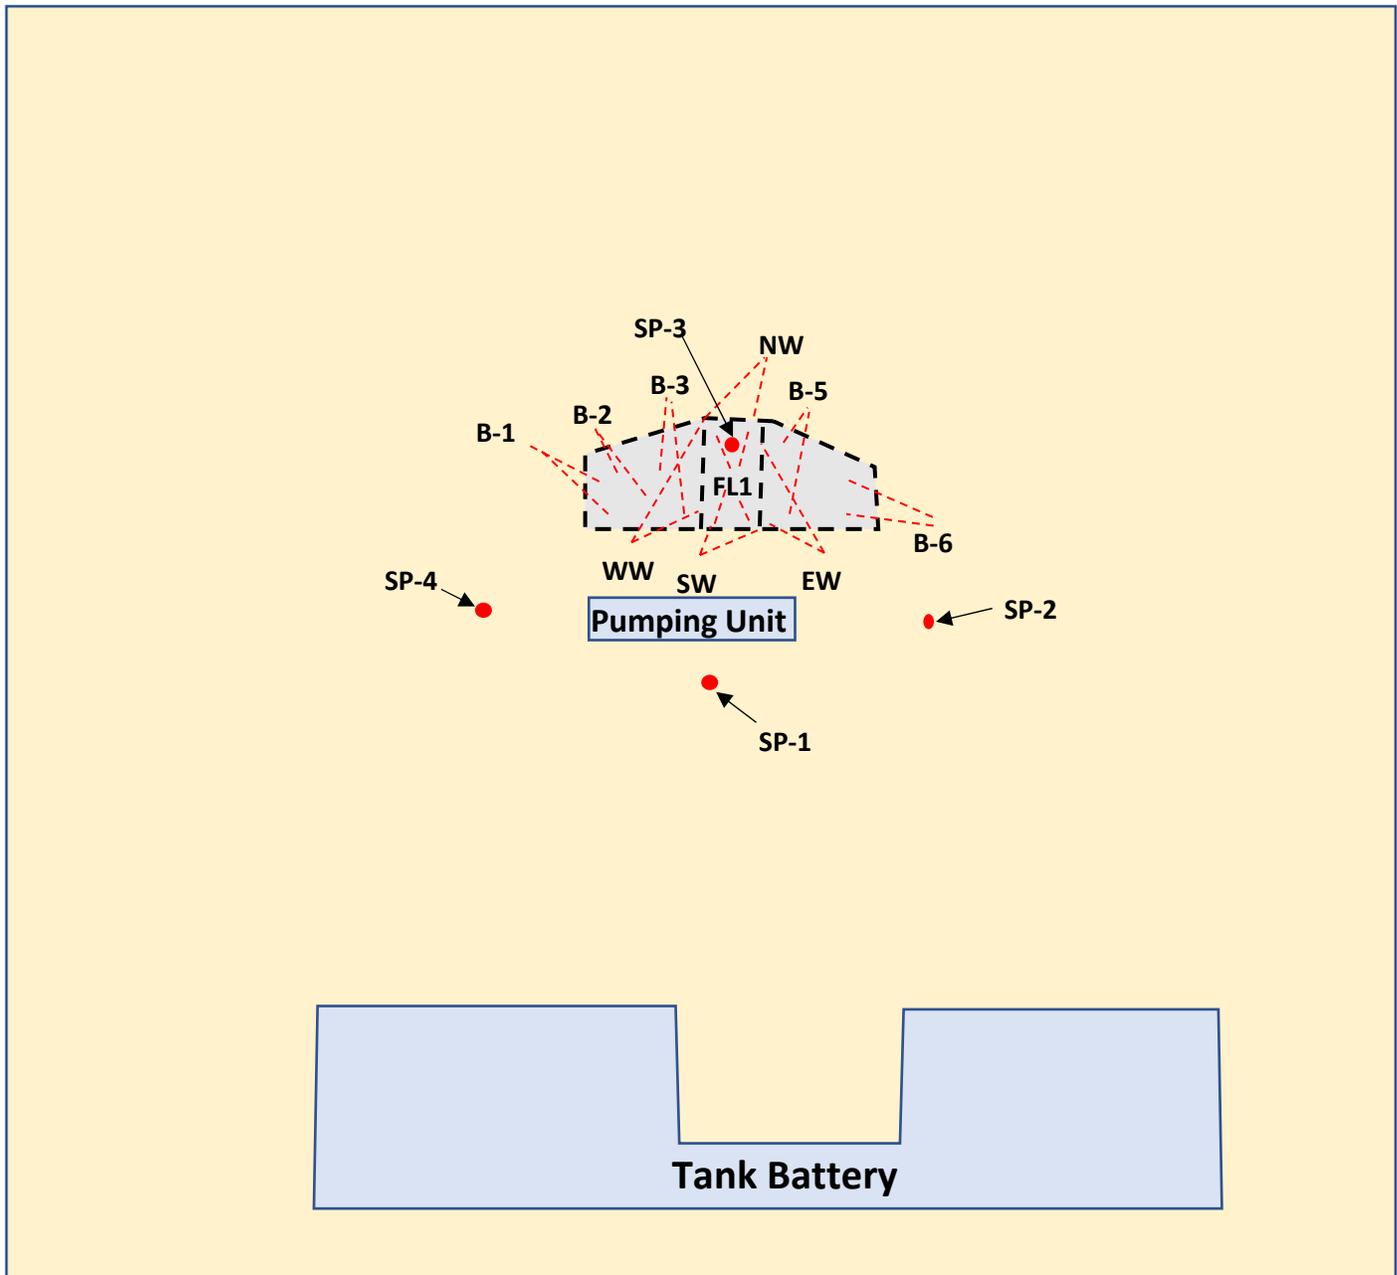
## **Figure 3**

- Legend:**
- Composite Sample Location
  - Caliche Well Pad
  - Equipment
  - Sample Point

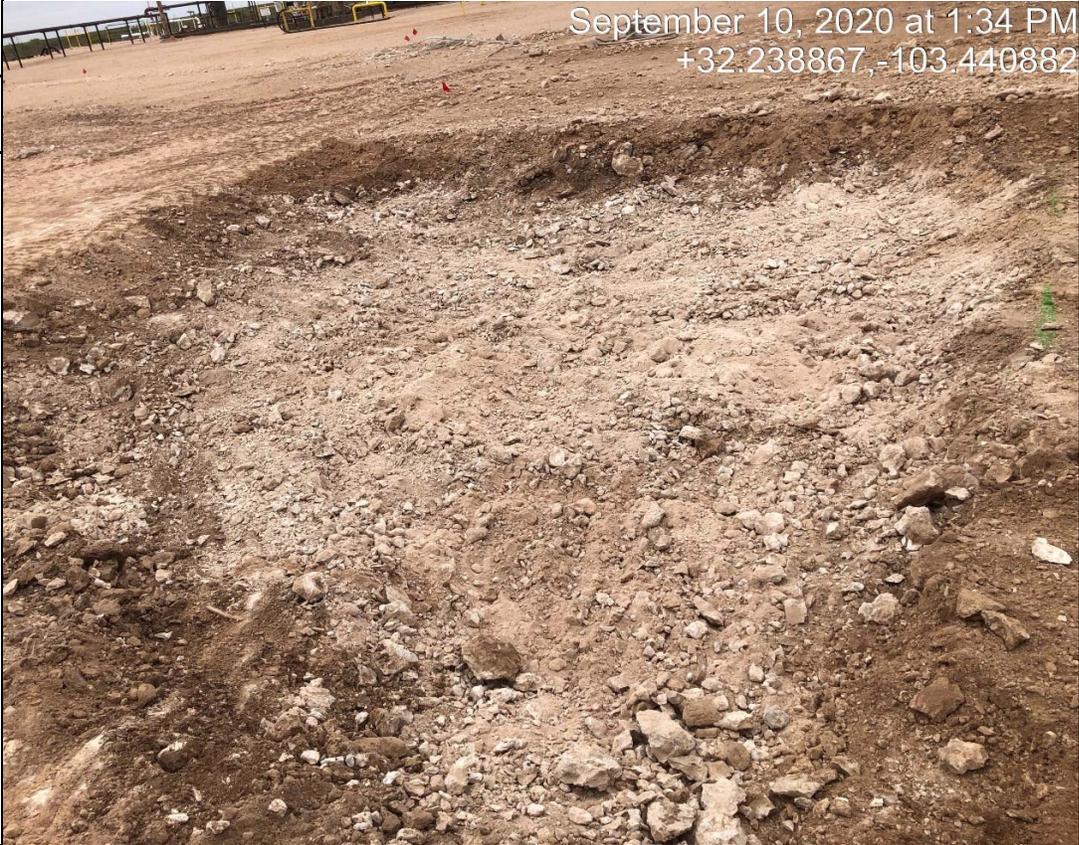
<b>Photo Number:</b> 1

<p>September 10, 2020 at 1:34 PM +32.238867,-103.440882</p>
<b>Photo Direction:</b> Southeast	
<b>Photo Description:</b> View of portion of the excavated area.

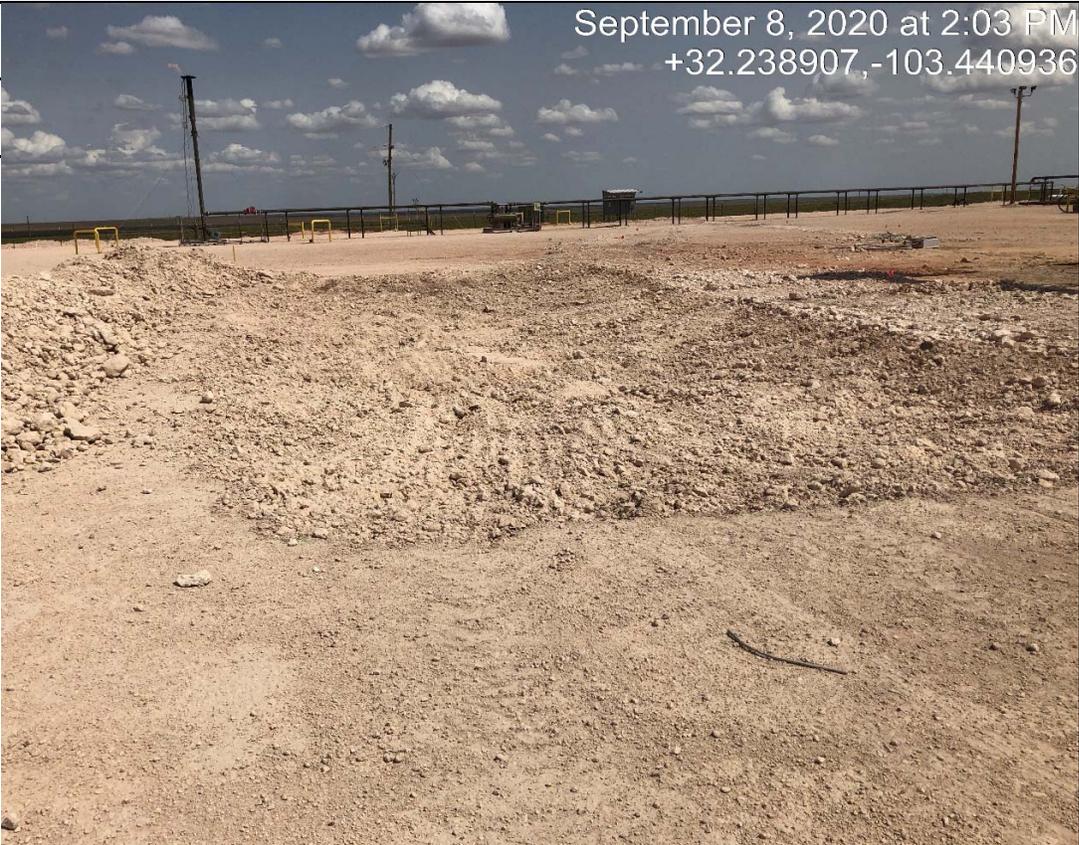
<b>Photo Number:</b> 2

<p>September 8, 2020 at 2:03 PM +32.238907,-103.440936</p>
<b>Photo Direction:</b> East	
<b>Photo Description:</b> View of portion of the excavated area.

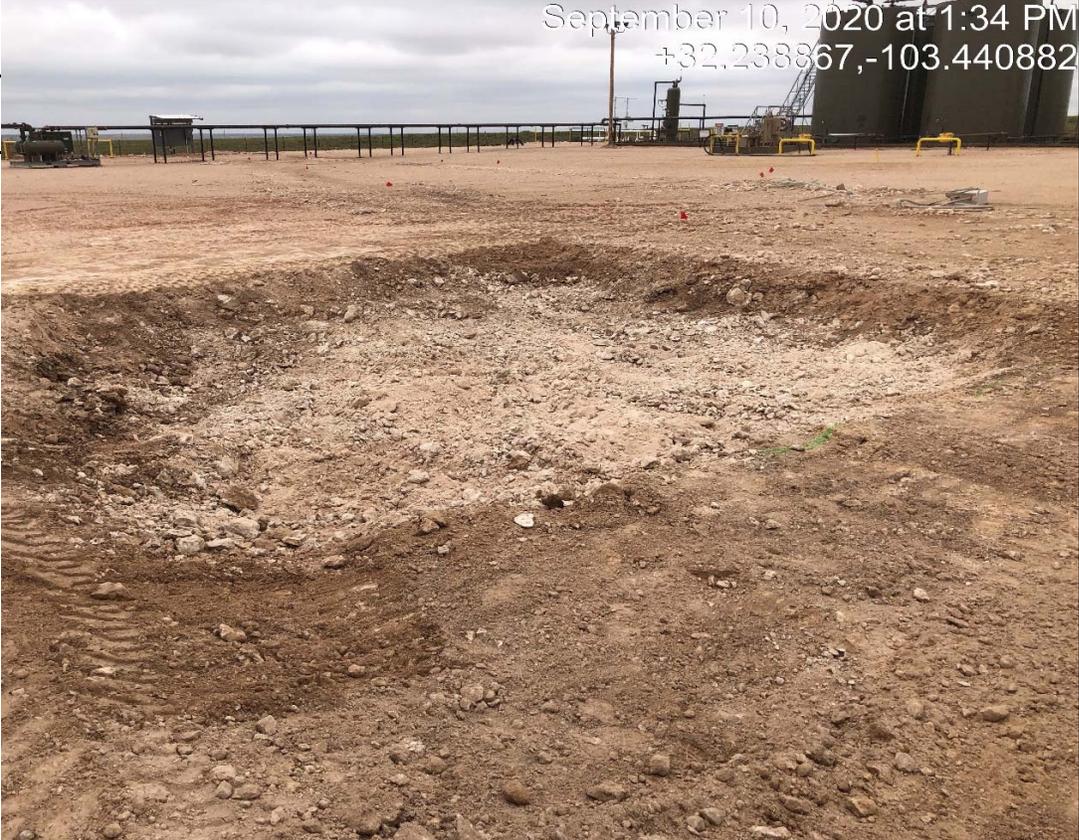
<b>Photo Number:</b> 3

<p>September 10, 2020 at 1:34 PM +32.238867, -103.440882</p>
<b>Photo Direction:</b> Southeast	
<b>Photo Description:</b> View of portion of the excavated area.

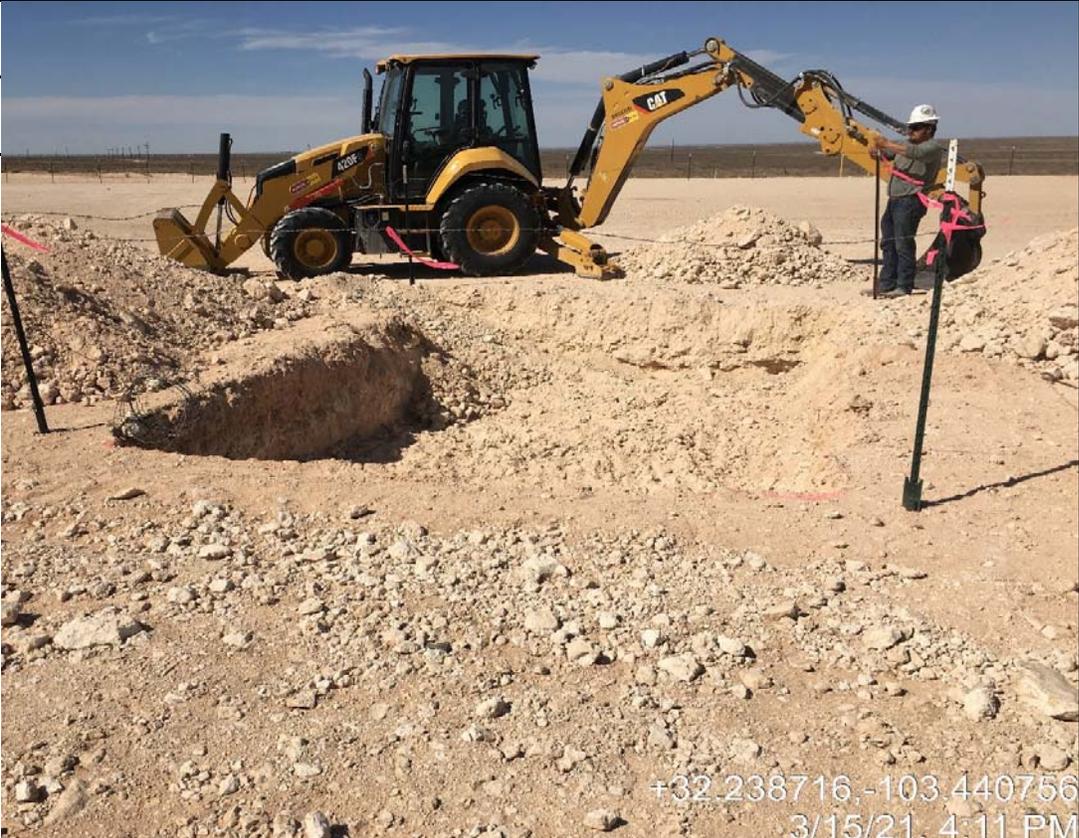
<b>Photo Number:</b> 4

<p>+32.238716, -103.440756 3/15/21, 4:11 PM</p>
<b>Photo Direction:</b> North	
<b>Photo Description:</b> View of affected area after additional excavation activities.

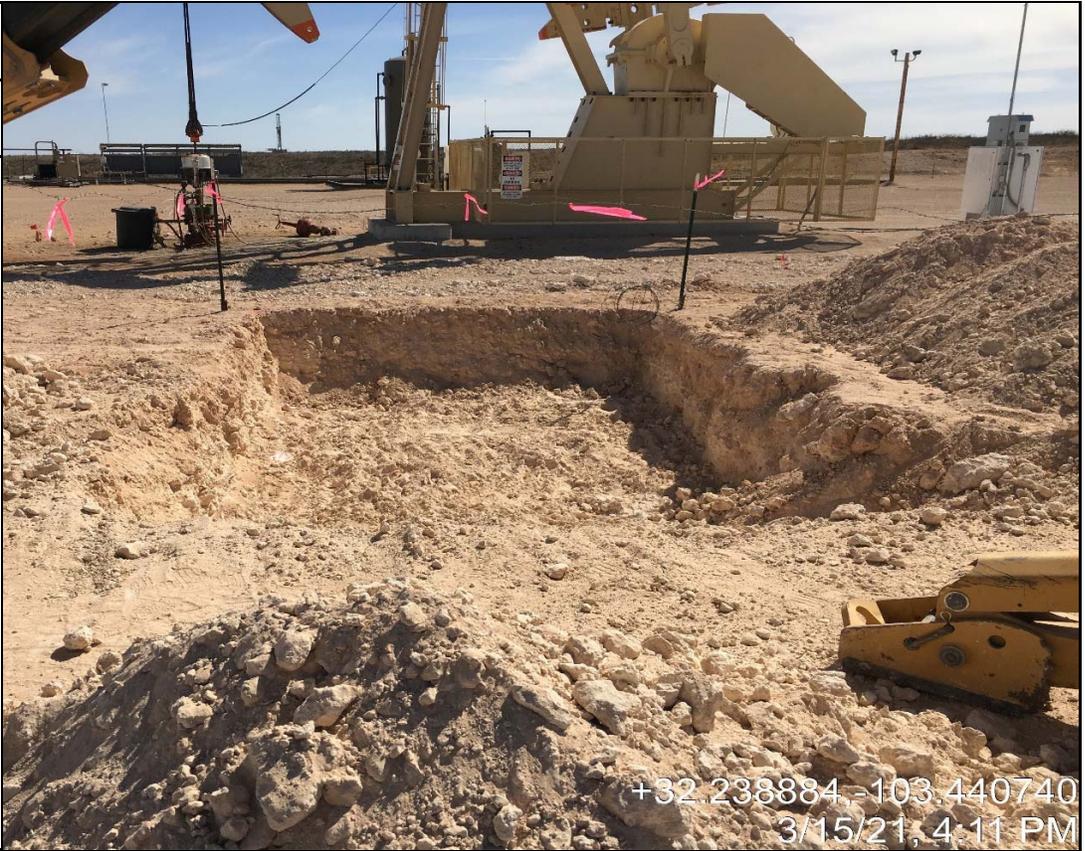
<b>Photo Number:</b> 5

<p data-bbox="1031 955 1485 1029">+32.238884,-103.440740 3/15/21, 4:11 PM</p>
<b>Photo Direction:</b> South	
<b>Photo Description:</b> View of affected area after additional excavation activities.

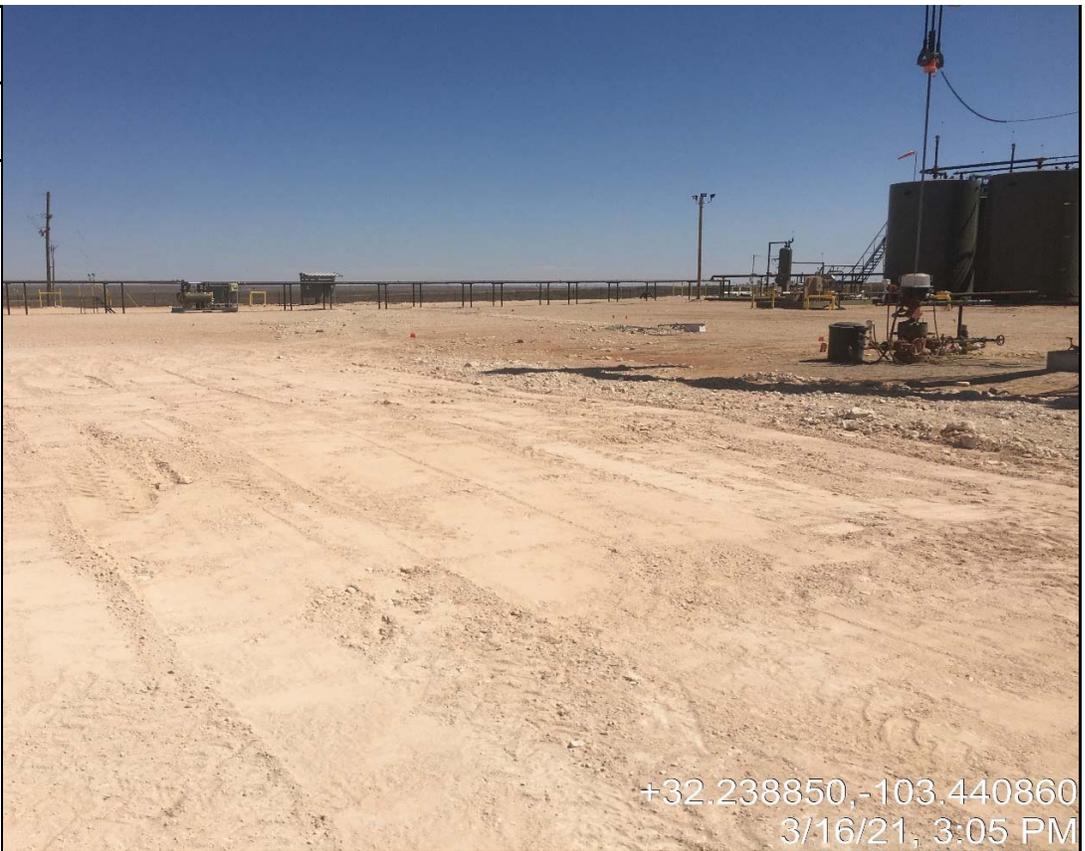
<b>Photo Number:</b> 6

<p data-bbox="1031 1837 1485 1911">+32.238850,-103.440860 3/16/21, 3:05 PM</p>
<b>Photo Direction:</b> East	
<b>Photo Description:</b> View of affected area after remediation activities.
