Re: Torrington ZK #1
30-015-24906
J-8-18S-26E
Eddy County, NM
Incident #NRM2035042548

**Torrington ZK #1
Remediation Work Plan
30-015-24906
J-8-18S-26E
Eddy County, NM
March 29, 2021
NRM2035042548**

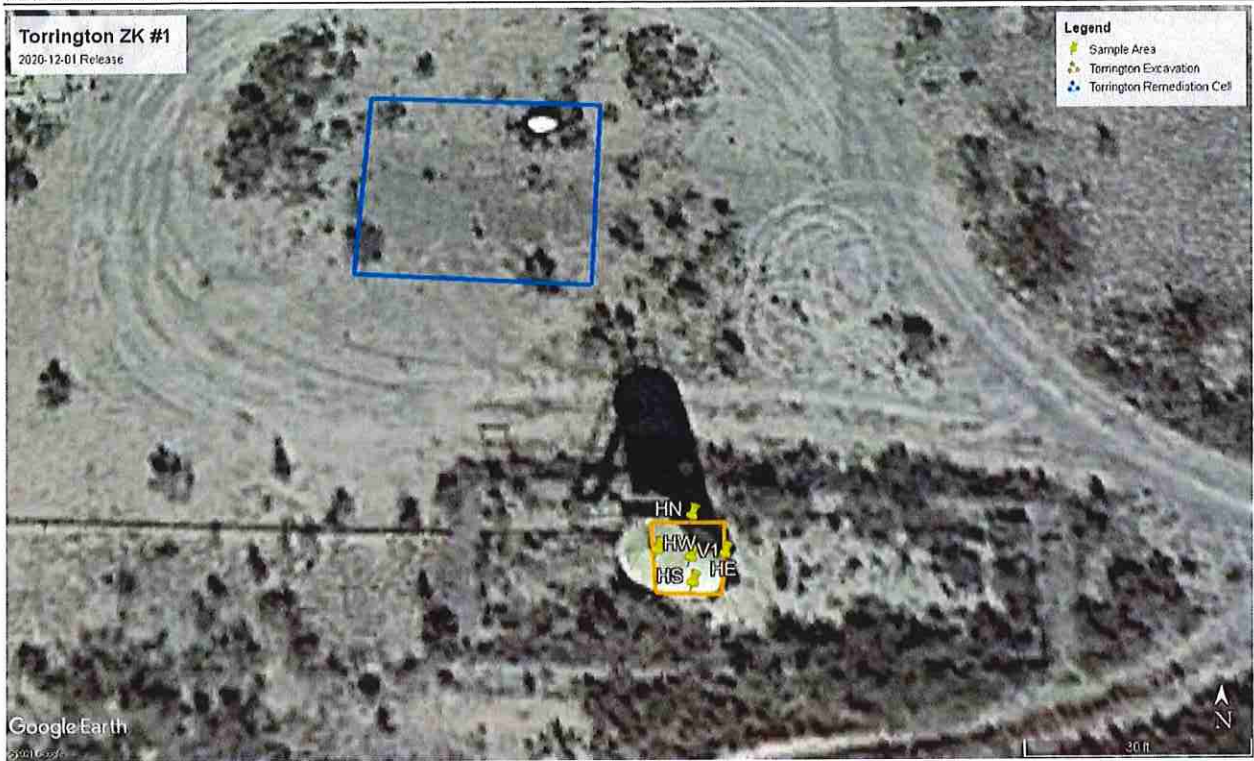
Figure 1

Site Map with Sample Points
