Final Closure Report

**Grand Banks Energy Co
Anderson Ranch Unit #14
Lea County, New Mexico**

NMOCD Incident # NAPP2035233416

API# 30-025-00365

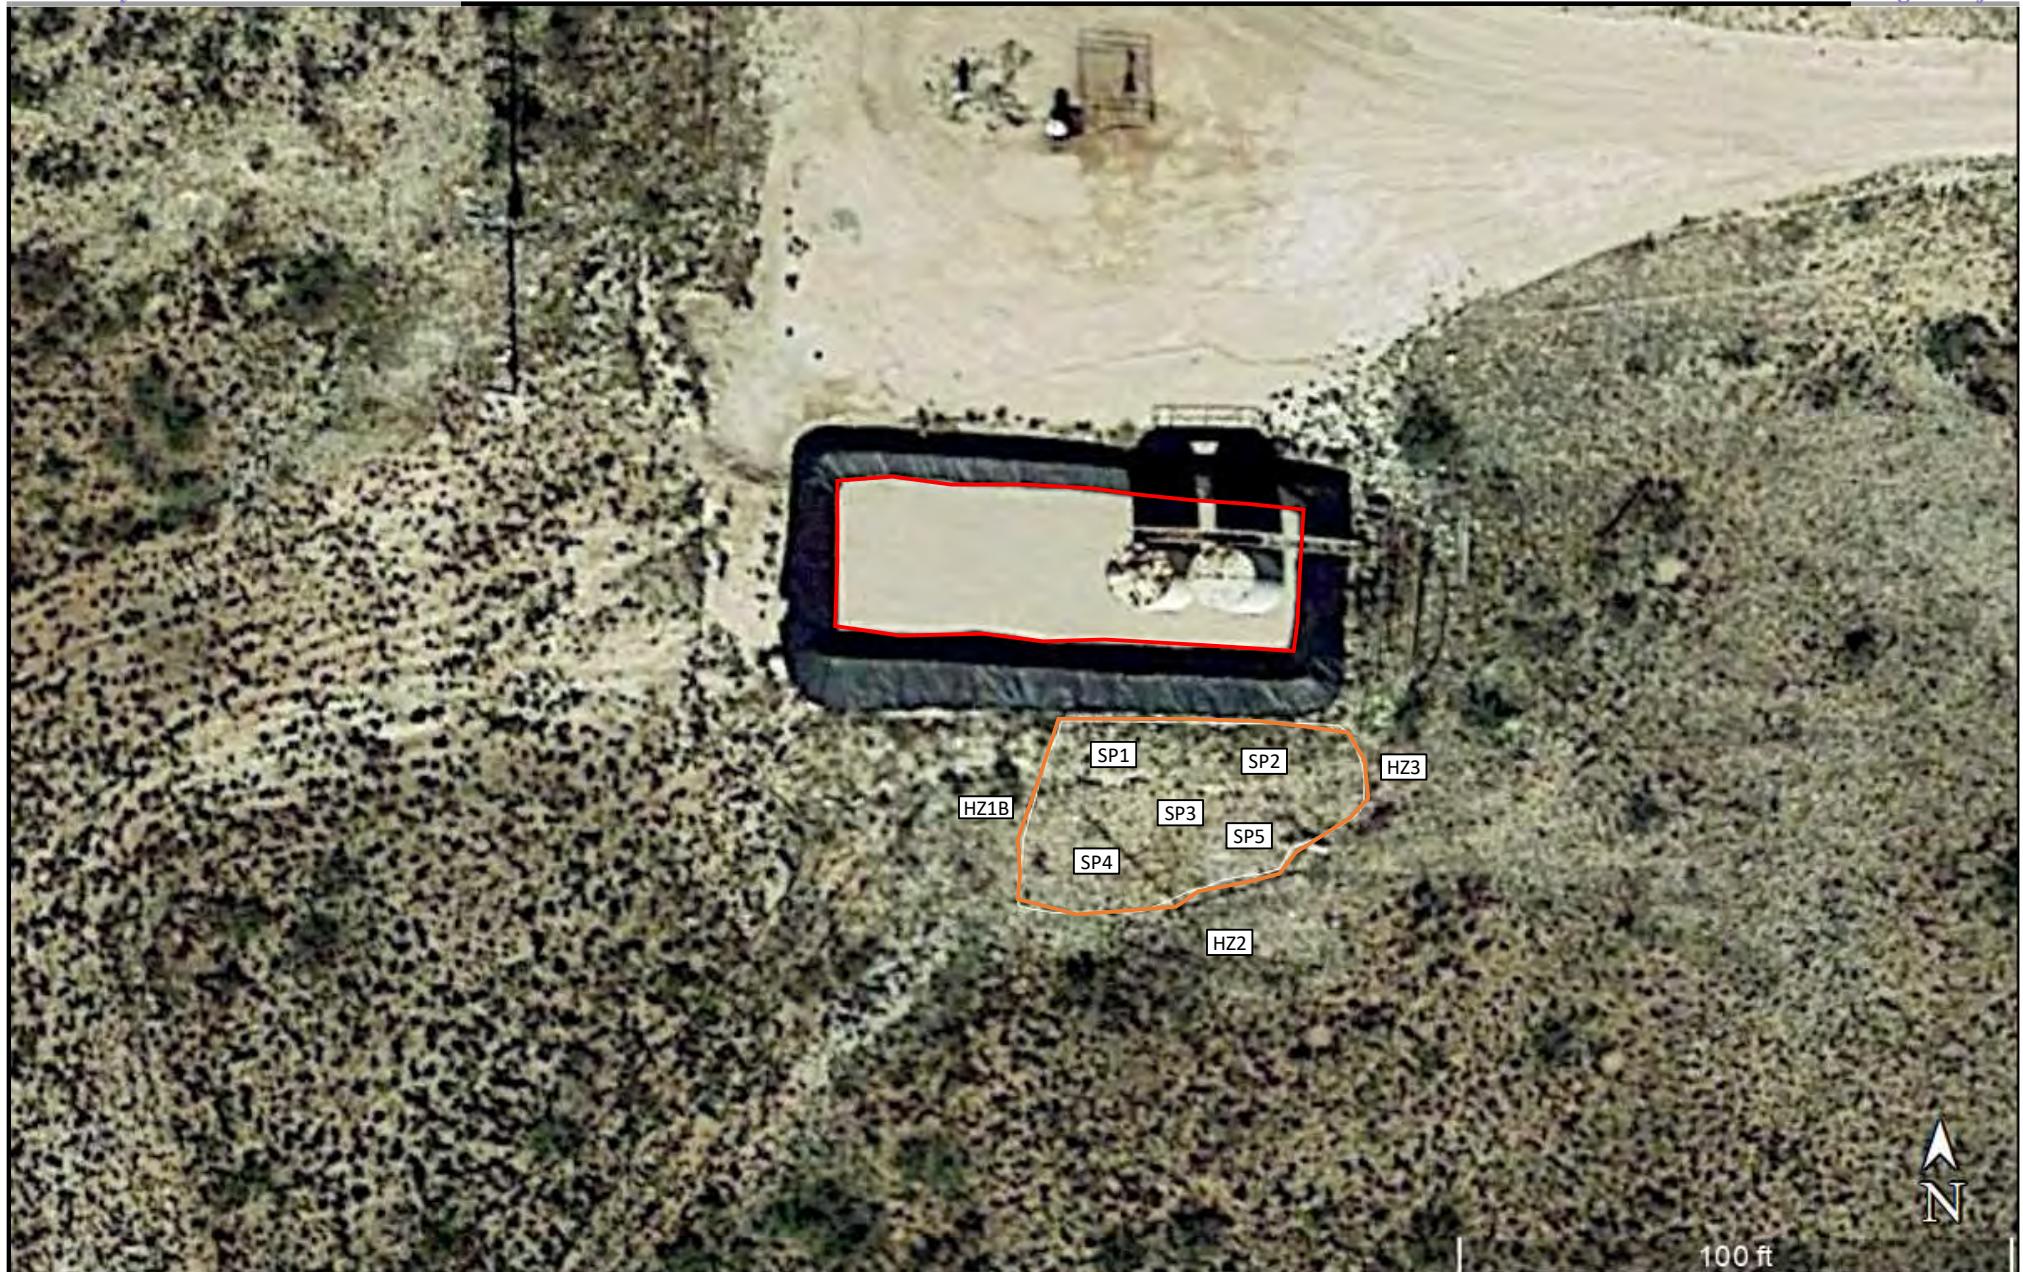
**Figure 4**

Delineation Sample Map
Grand Banks Energy
Anderson Ranch Unit #14
GPS: 32.94858, -103.73068
Lea County

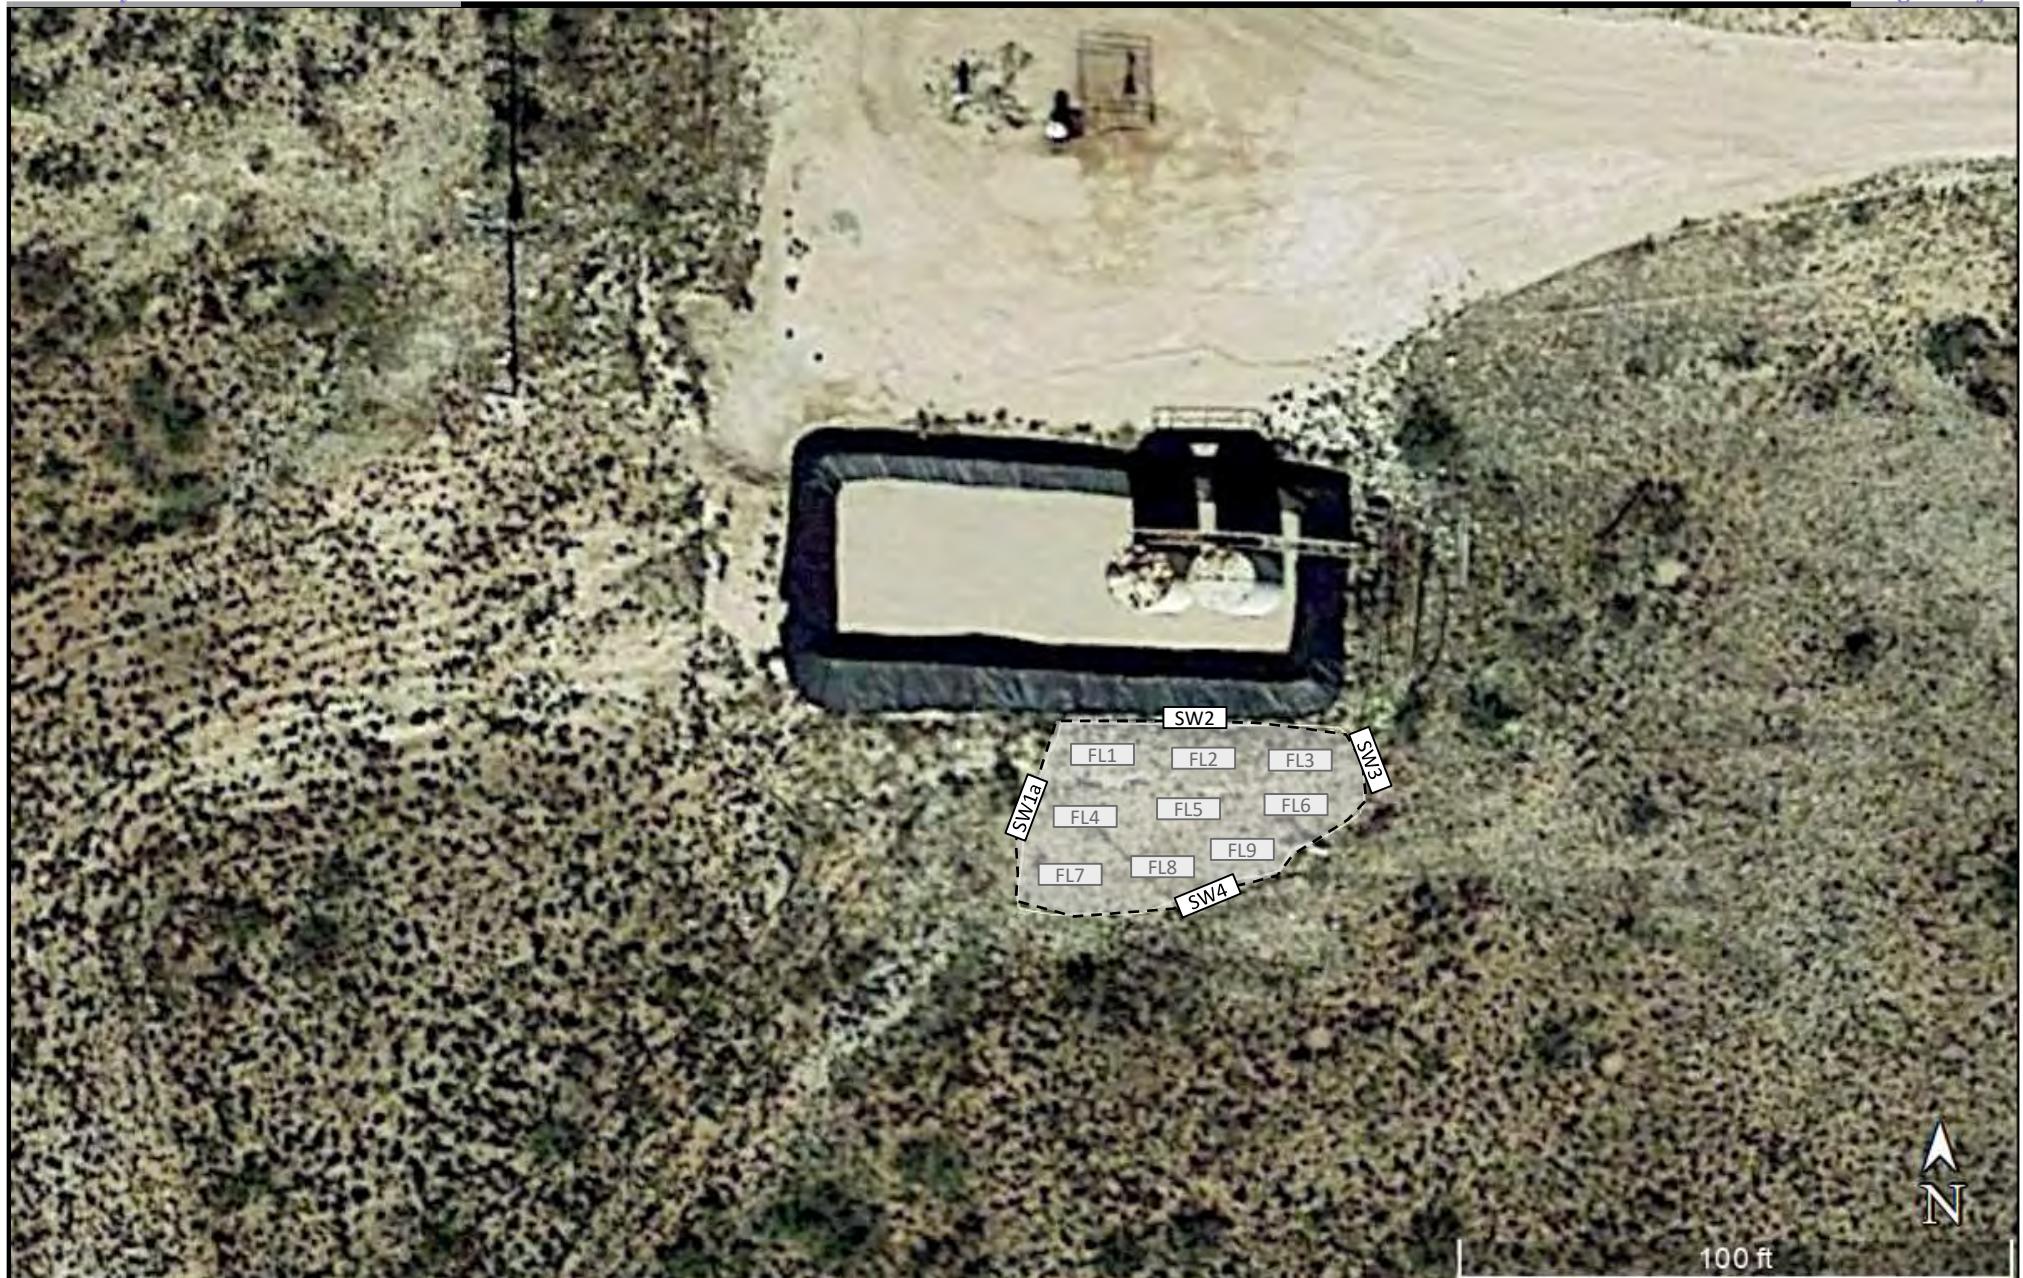
**Figure 5**

Excavation Sample Map
Grand Banks Energy
Anderson Ranch Unit #14
GPS: 32.94858, -103.73068
Lea County

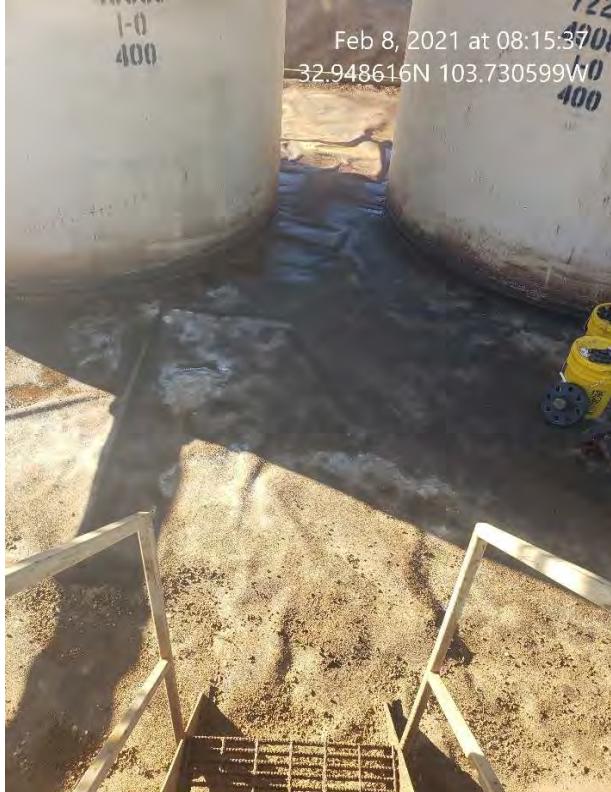
Photo: 7

Direction: South	
Description: Liner inspection.

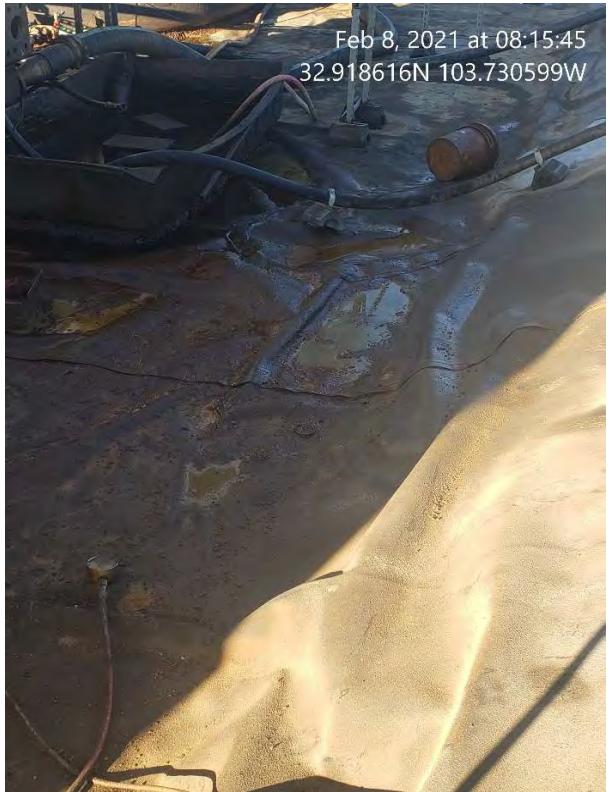
Photo: 8

Direction: West	
Description: Liner inspection.

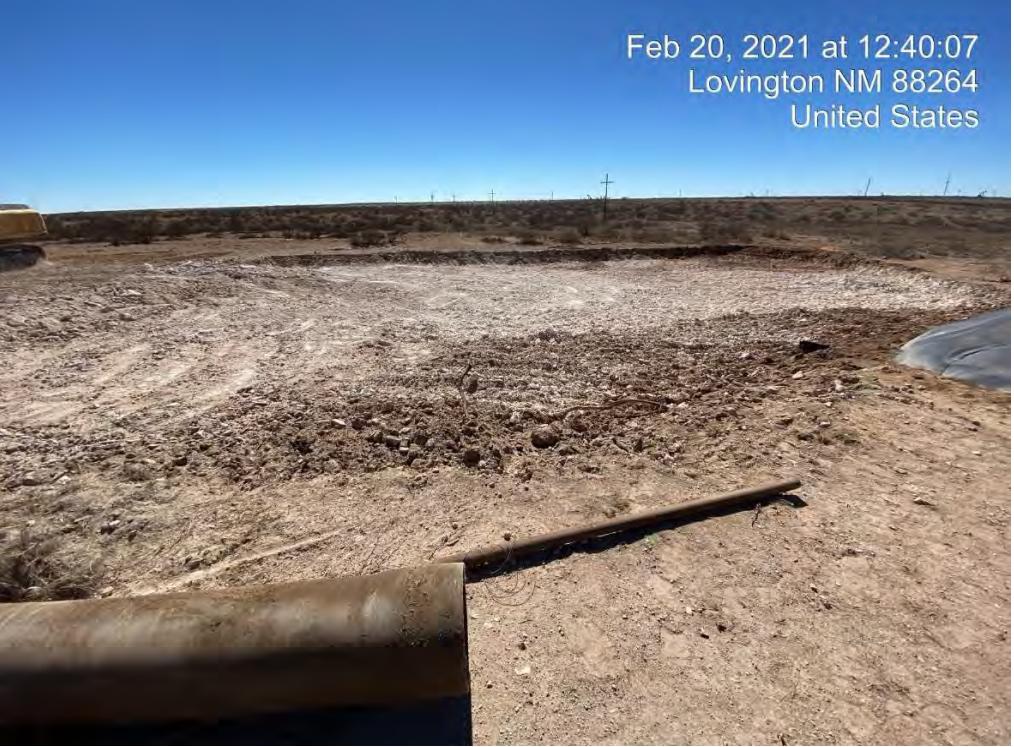
Photo: 15	
Direction: Southwest	
Description: Excavation activities complete.

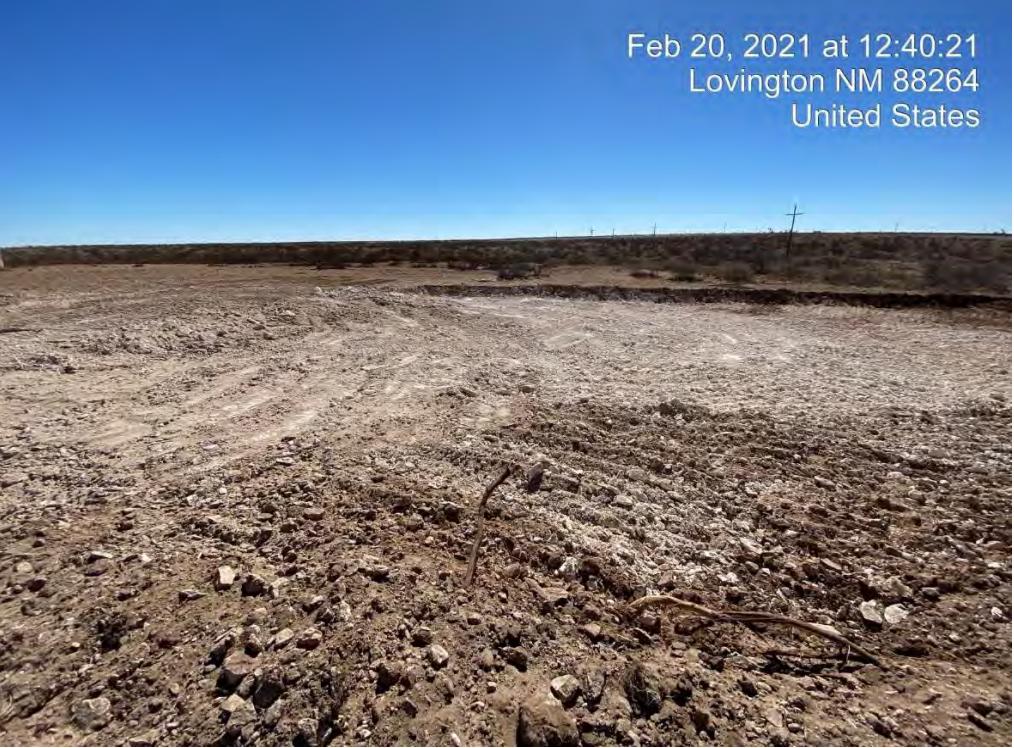
Photo: 16	
Direction: South	
Description: Excavation activities complete.
