Remediation Summary & Soil Closure Request

COG Operating, LLC Huckleberry State Com 507H

Lea County, New Mexico
Unit Letter D, Section 27, Township 21 South, Range 33 East
Latitude 32.4566 North, Longitude 103.5652 West
NMOCD Reference No. NRM2030929244

Etech Environmental & Safety Solutions, Inc.

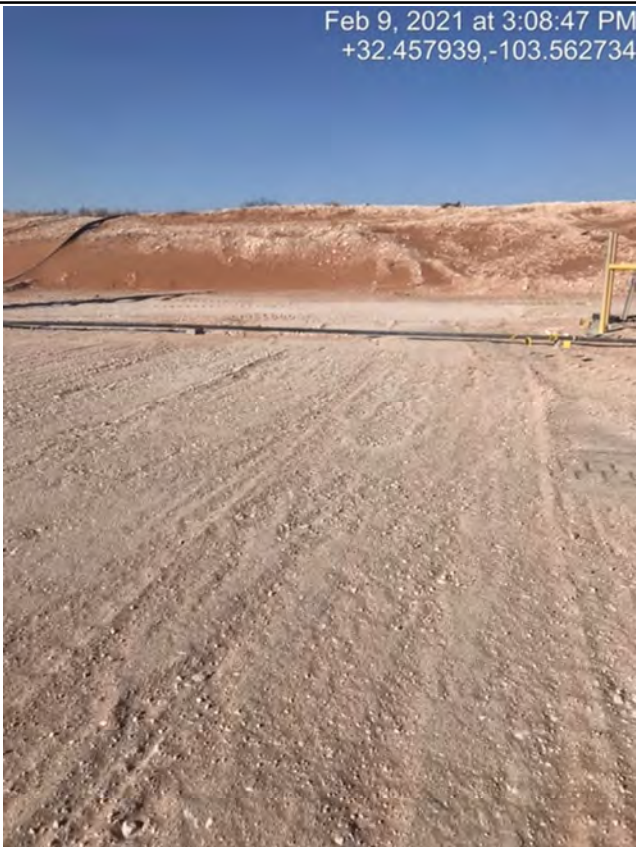
Photo Number: 4

Photo Direction: North	
Photo Description: Remediated Area (After Backfilling & Regrading)

Upon receiving laboratory analytical results from confirmation soil samples, excavated areas were backfilled with locally sourced, non-impacted, "like" material placed at or near original relative positions. The affected area was contoured and compacted to fit the needs of the facility and achieve erosion control, stability, and/or preservation of surface water flow to the extent practicable. Affected areas not on the production pad will be reseeded with an agency and/or landowner-approved seed mixture free of noxious weeds during the first favorable growing season following closure of the Site.

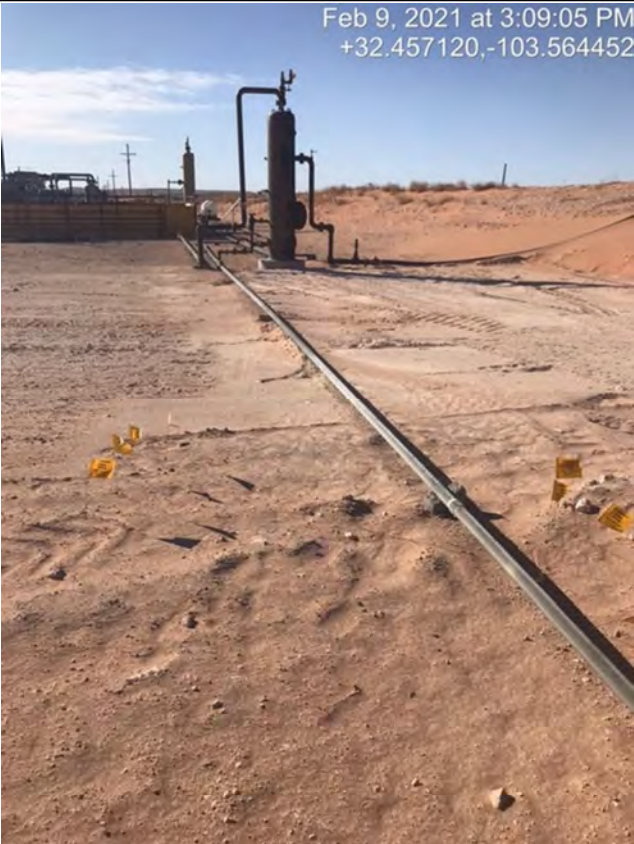
Photo Number: 5

Photo Direction: West-Northwest	
Photo Description: Remediated Area (After Backfilling & Regrading)

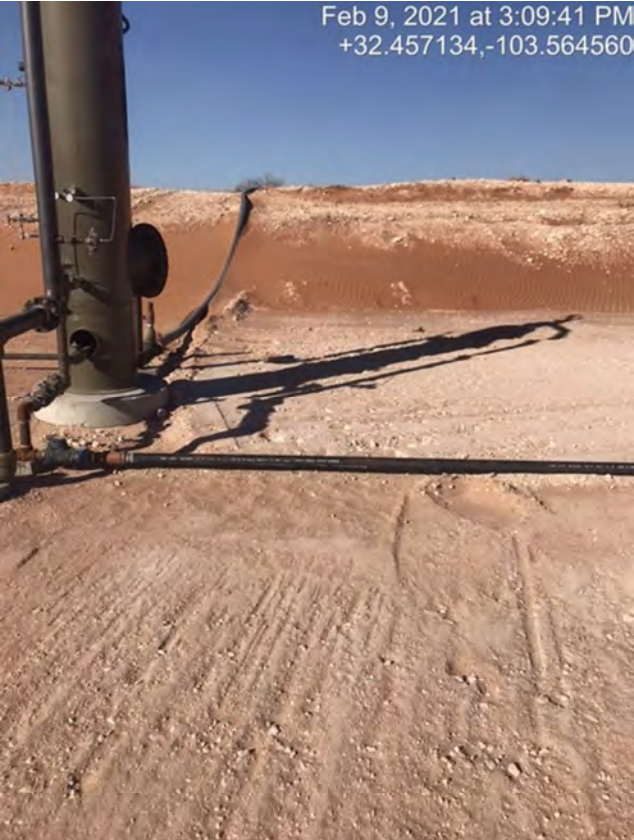
Photo Number: 6

Photo Direction: North	
Photo Description: Remediated Area (After Backfilling & Regrading)
