### Report Type: Closure Report - NRM2006937434

<b>Site:</b>	Klondike Reuse Water Pit					
<b>Company:</b>	EOG Resources					
<b>Section, Township and Range</b>	Unit H	Sec. 32	T 24S	R 34E		
<b>County:</b>	Lea County					
<b>GPS:</b>	32.177393			-103.4871000		
<b>Surface Owner:</b>

<b>Date Released:</b>	10/2/2019
<b>Type Release:</b>	Failed Header
<b>Source of Contamination:</b>	Reuse Water
<b>Fluid Released:</b>	100 bbls RW
<b>Fluids Recovered:</b>	0 bbls PW

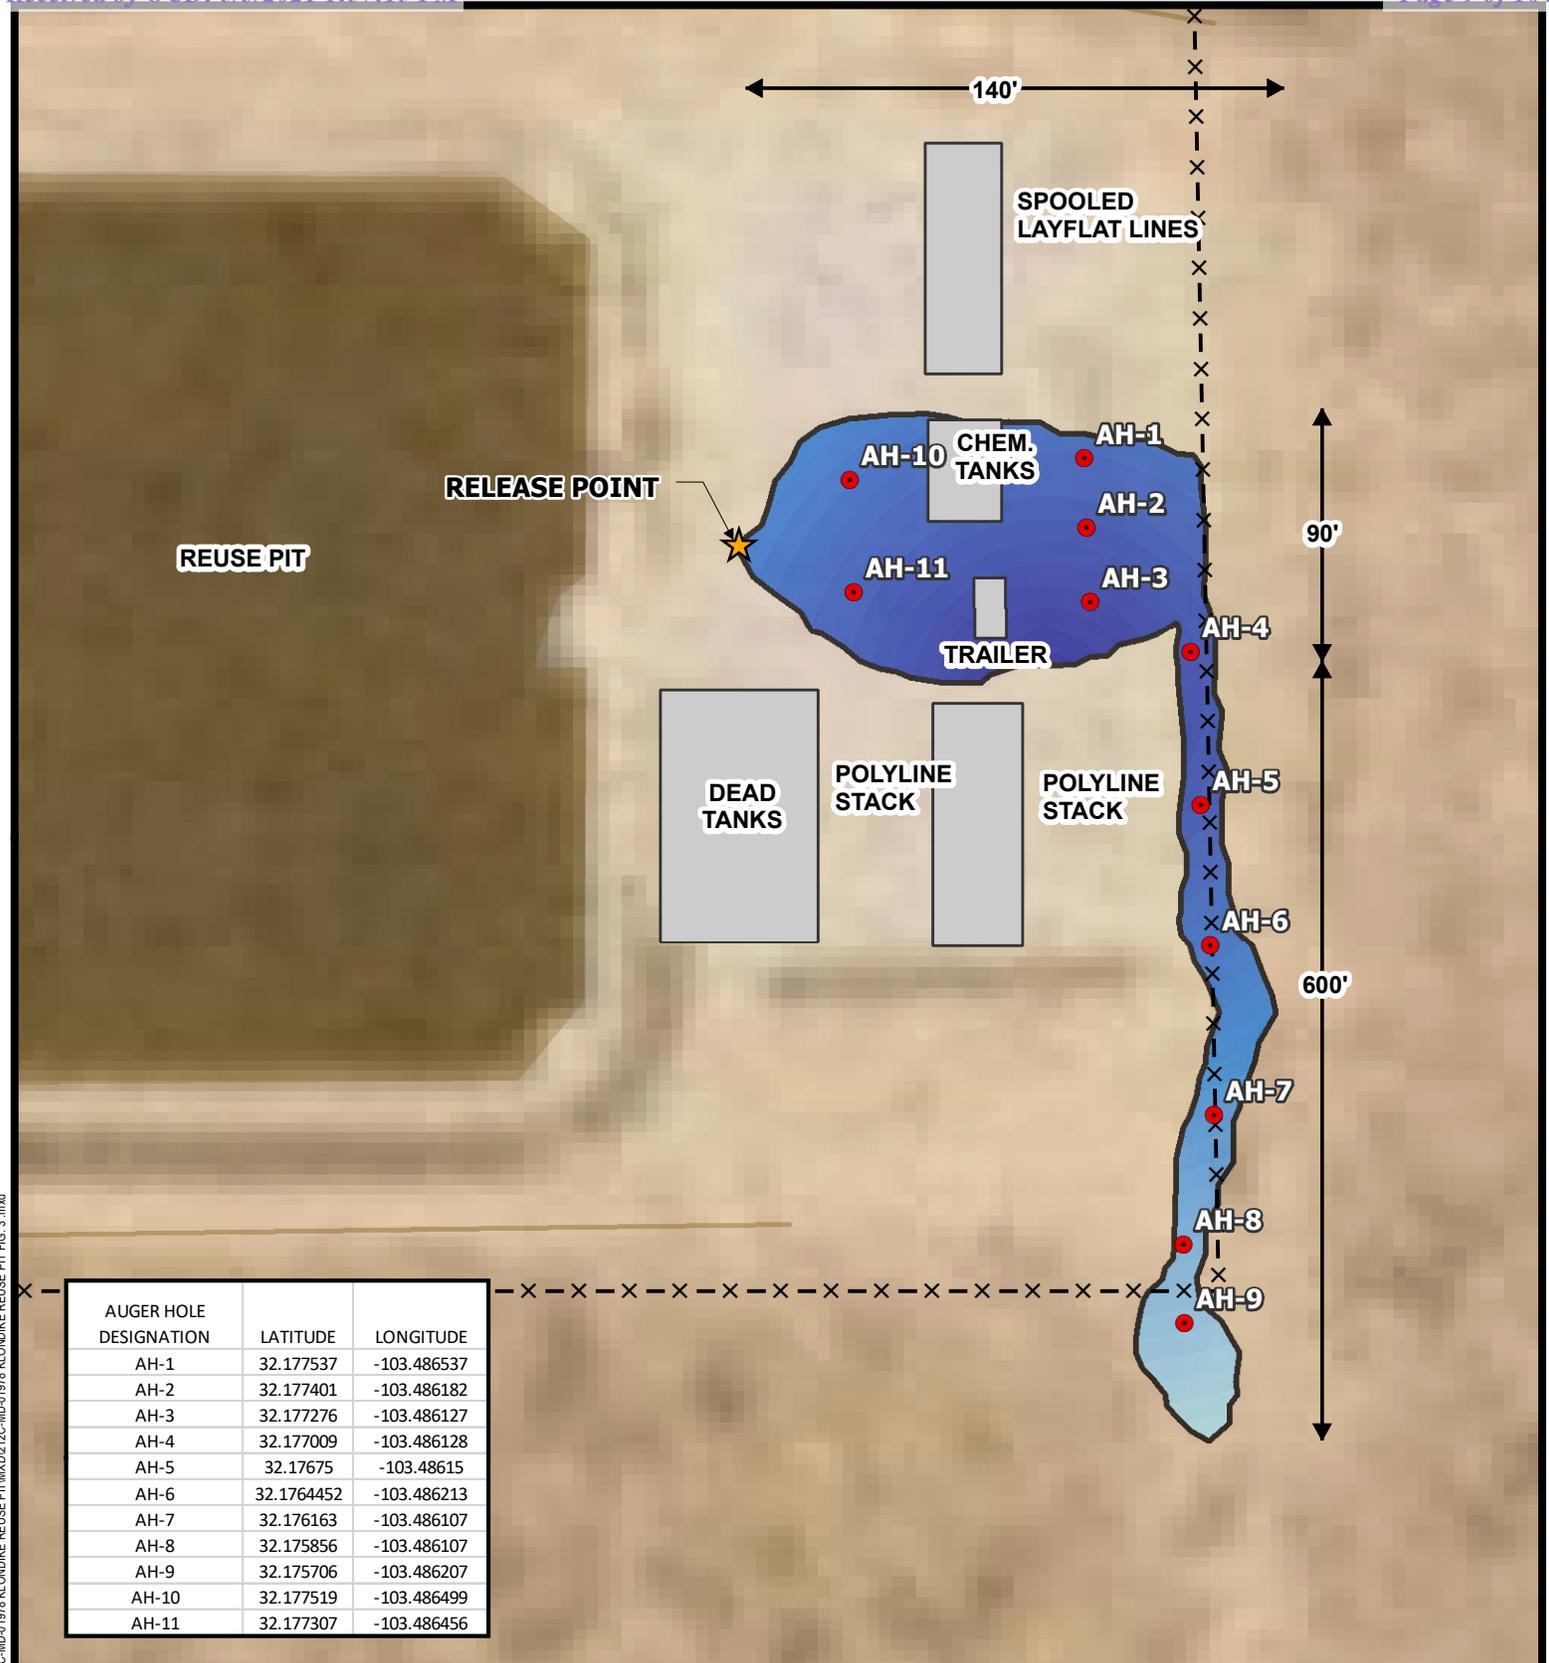
**FIGURE**  
3

AUGER HOLE DESIGNATION	LATITUDE	LONGITUDE
AH-1	32.177537	-103.486537
AH-2	32.177401	-103.486182
AH-3	32.177276	-103.486127
AH-4	32.177009	-103.486128
AH-5	32.17675	-103.48615
AH-6	32.1764452	-103.486213
AH-7	32.176163	-103.486107
AH-8	32.175856	-103.486107
AH-9	32.175706	-103.486207
AH-10	32.177519	-103.486499
AH-11	32.177307	-103.486456

- AUGERHOLE SAMPLE LOCATIONS
- ★ RELEASE POINT
- FENCELINE
- EQUIPMENT
- AFFECTED SPILL AREA

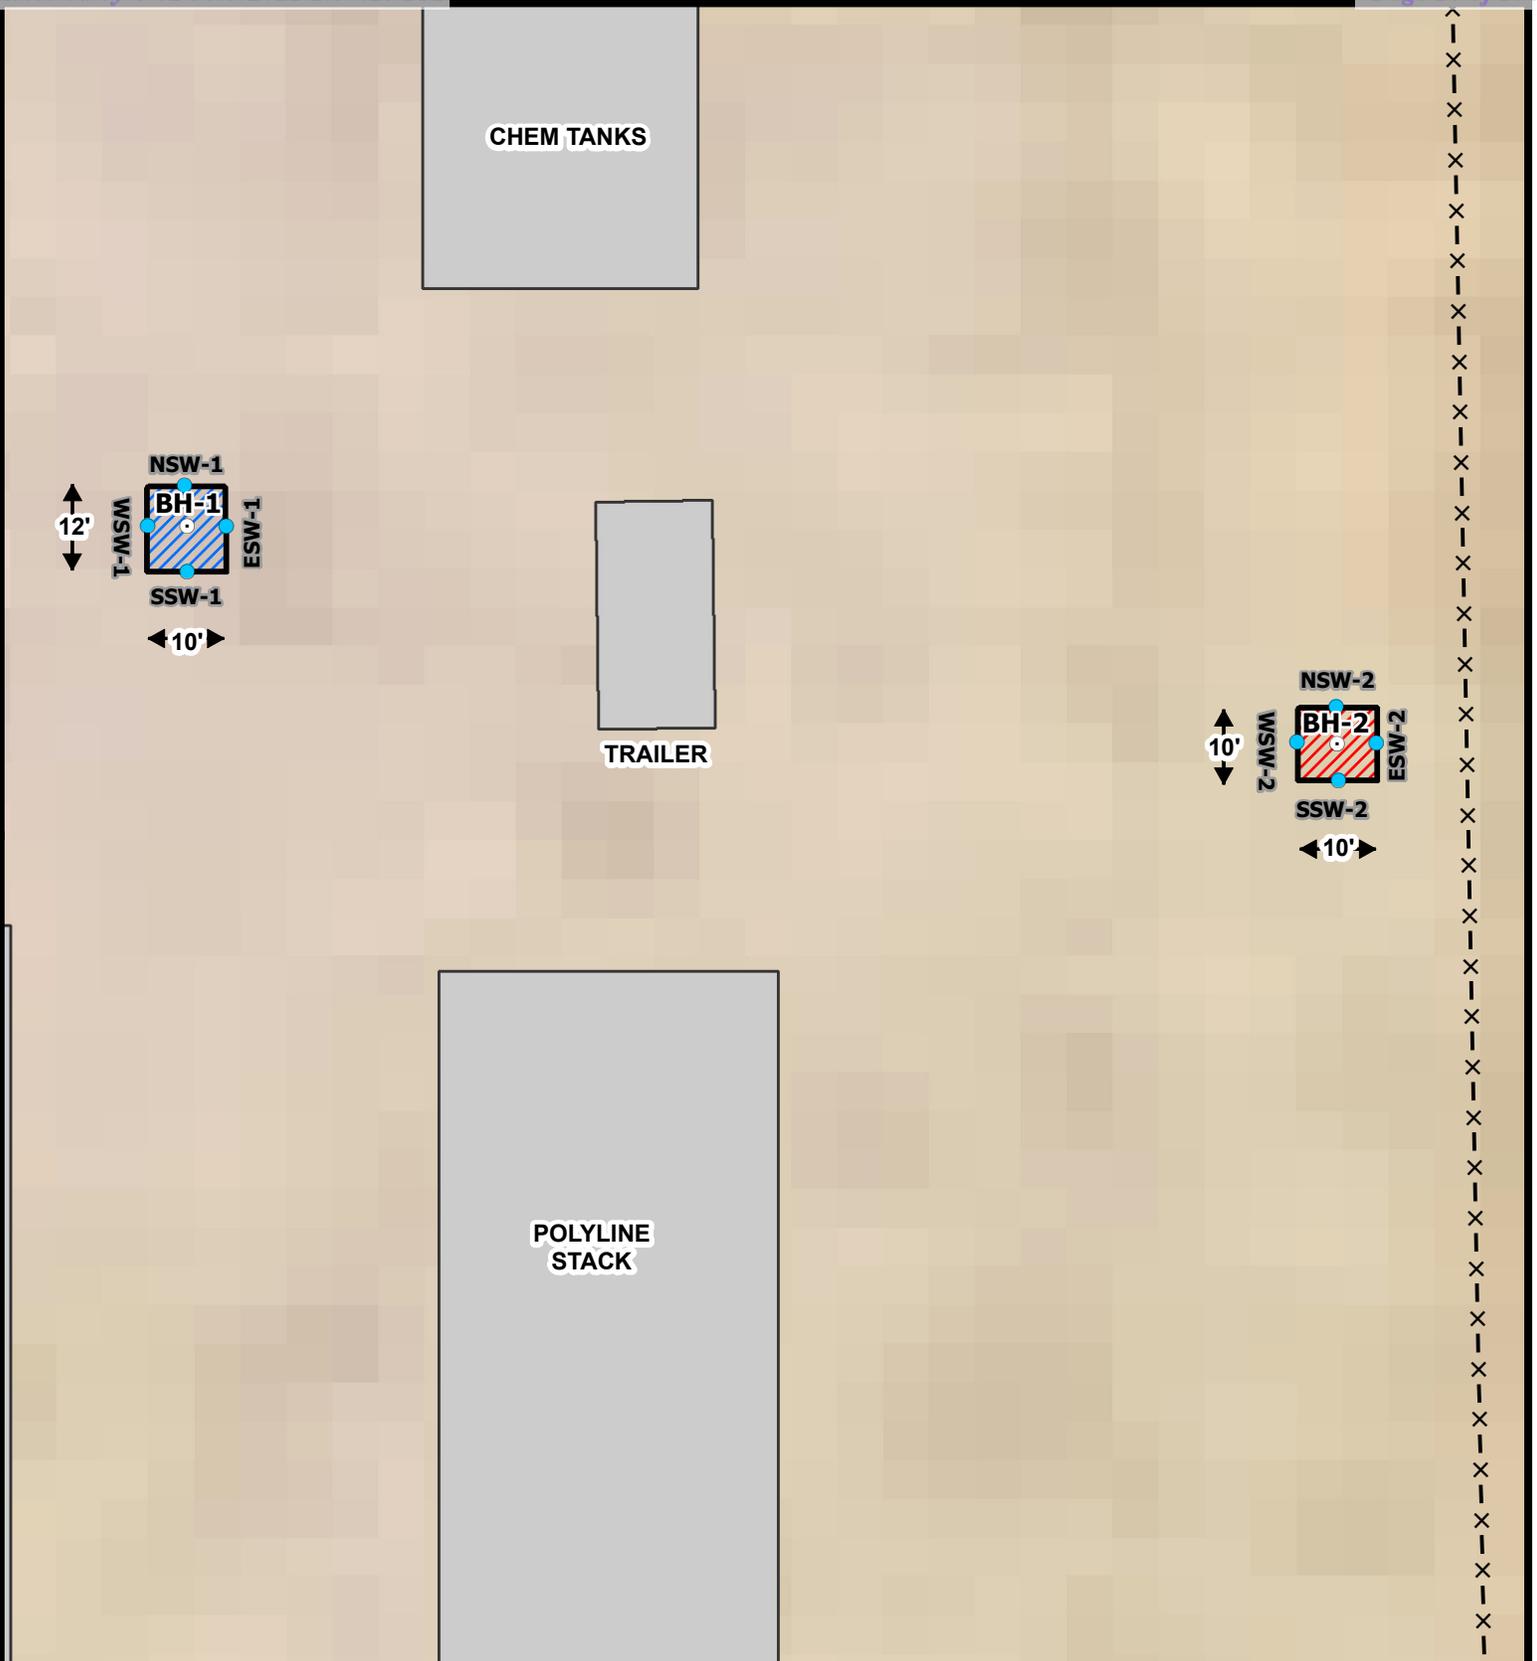
- SIDEWALL SAMPLE LOCATIONS
- BOTTOMHOLE SAMPLE LOCATIONS
- X - X FENCELINE
- 1.0' EXCAVATED DEPTH AREA
- 1.5' EXCAVATED DEPTH AREA
- EQUIPMENT

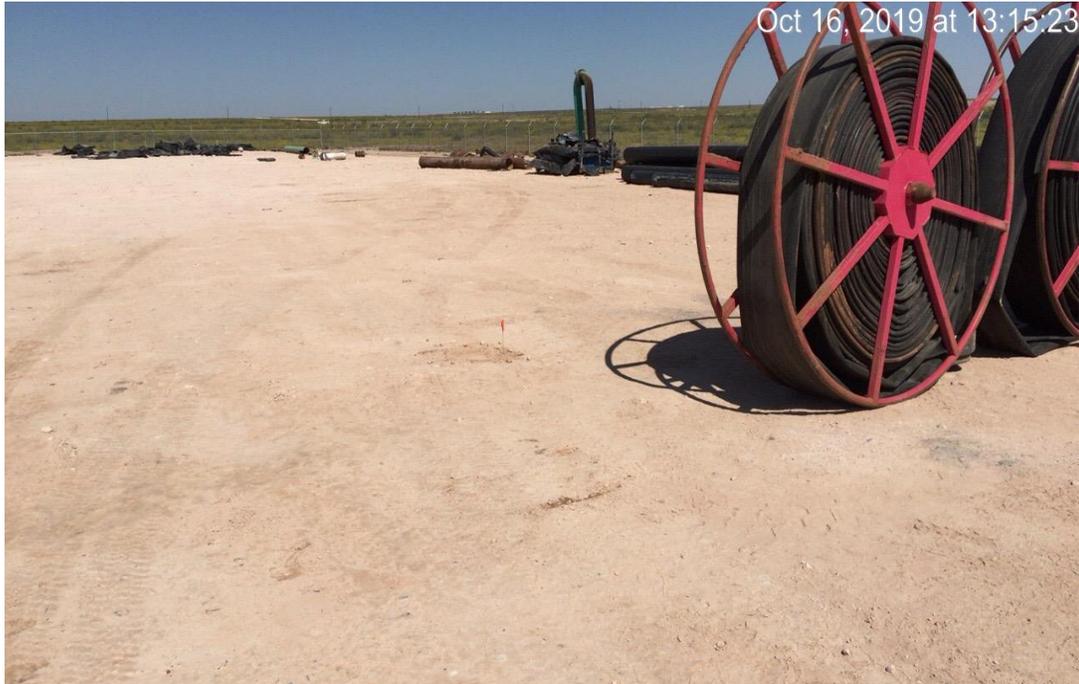
View North, areas of Auger Holes (1-3)

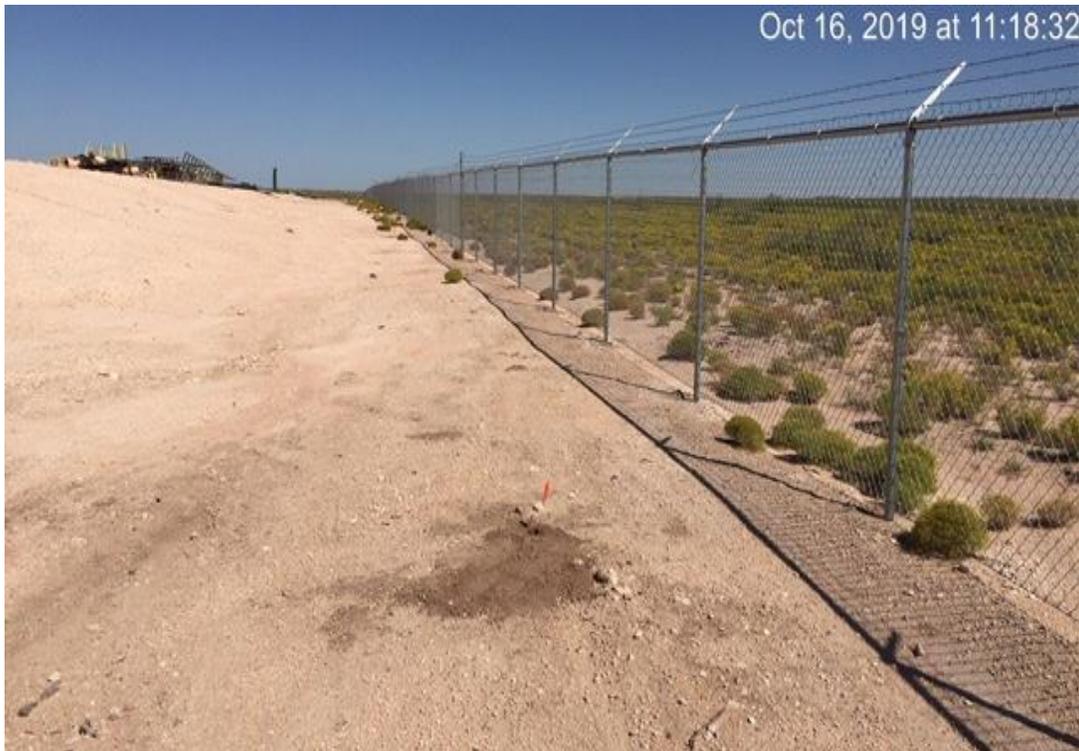
View North, areas of Auger Holes (4-8)

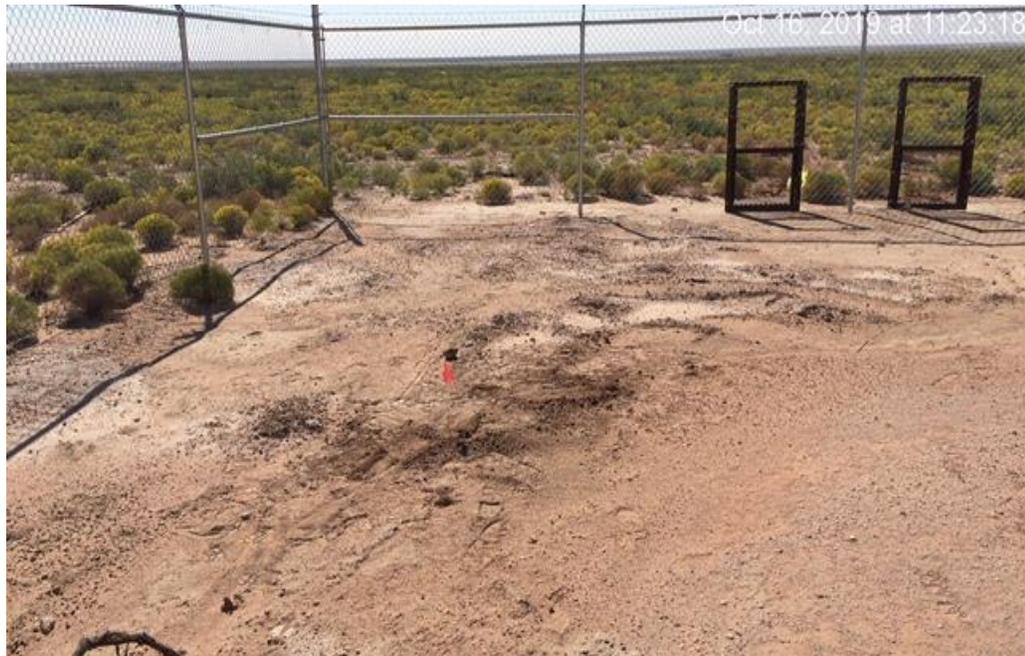
View South, area of Auger Holes (8-9)

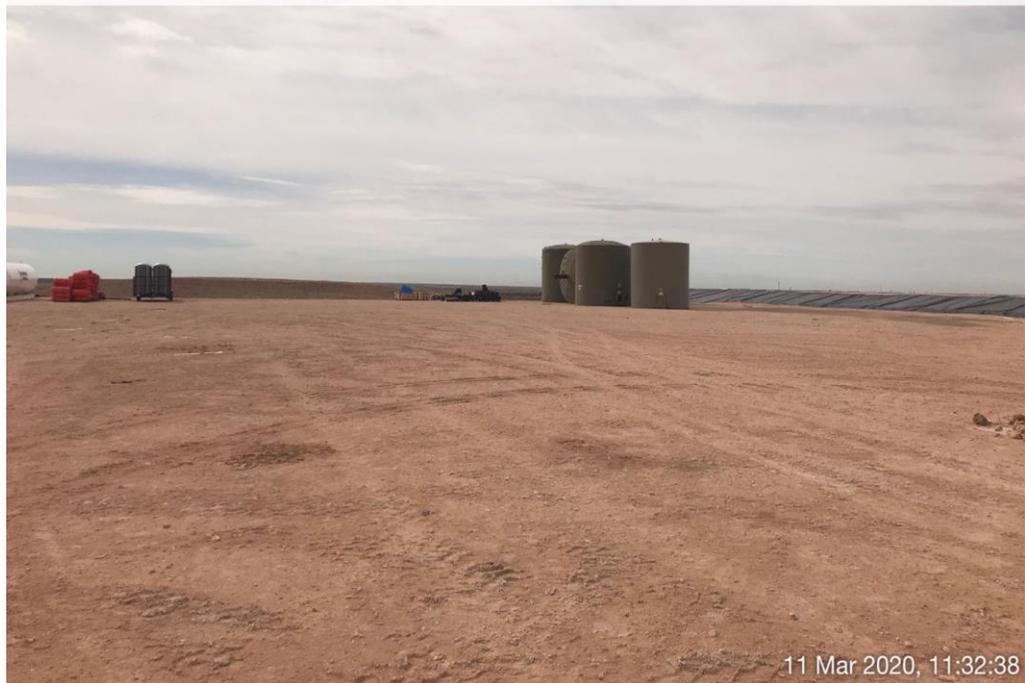
View South, area of Auger Hole (10-11)

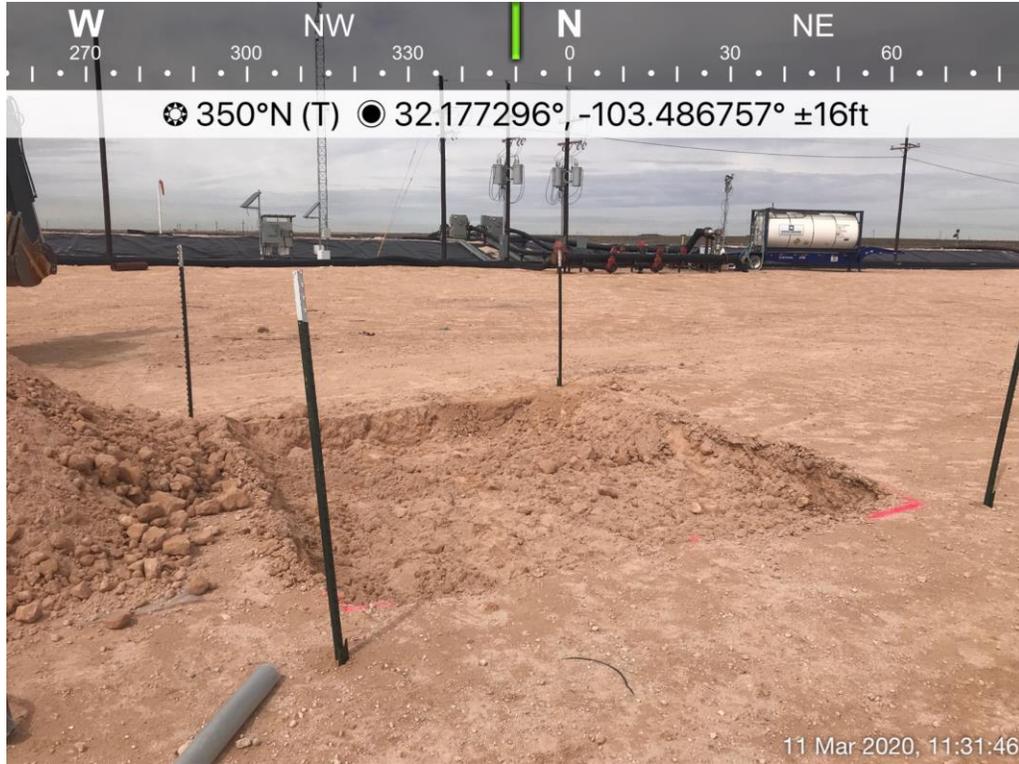
View North, area of Bottom Hole (1)

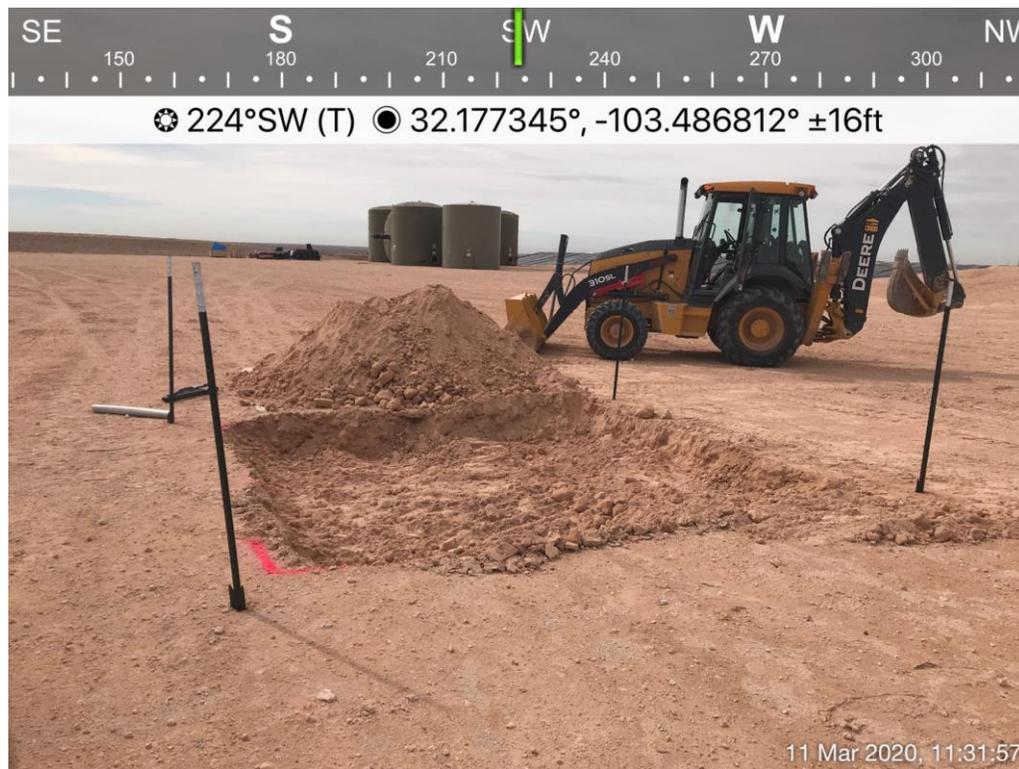
View Southwest, area of Bottom Hole (1)

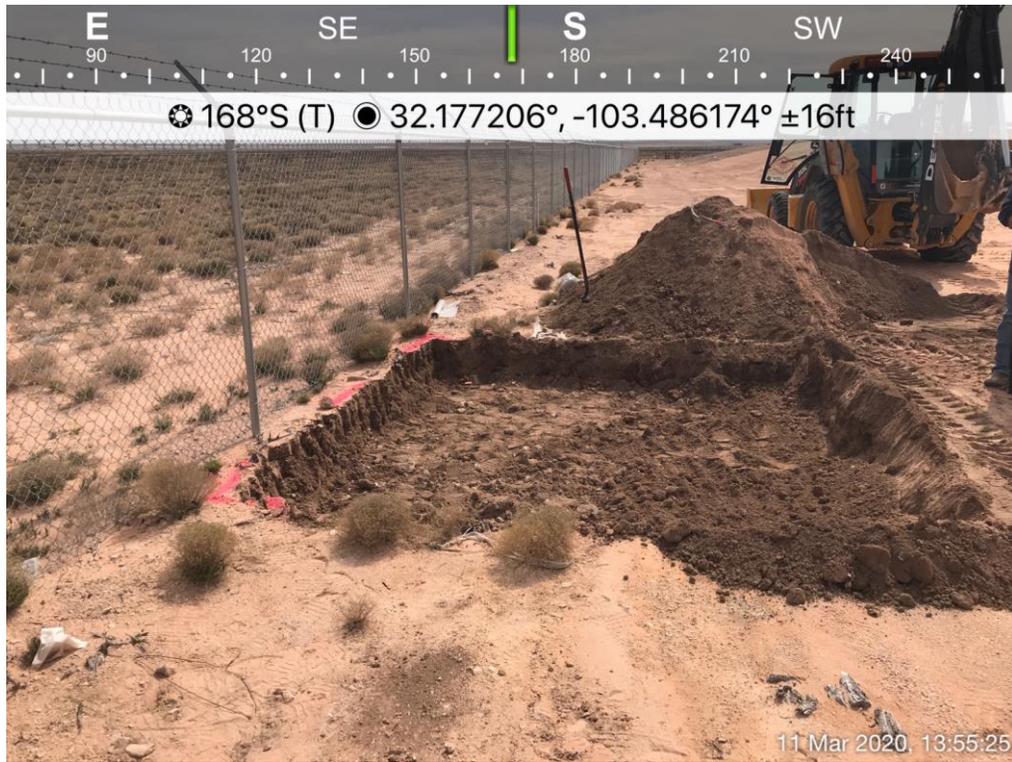
View South, area of Bottom Hole (2)
