**Re: Closure Request Report
Blue Jay Federal 001H (1.8.21)
Tracking # NAPP2102140342
GPS: 32.56643, -103.49549
Unit Letter O Section 30, Township 20 South, Range 35 East
Lea County, New Mexico**

COG Operating, LLC (COG) is pleased to submit the following closure report in response to the fire that occurred at the Blue Jay Federal 001H located in Unit Letter O Section 30, Township 20 South, Range 35 East in Lea County, New Mexico. The spill site coordinates are 32.56643, -103.49549.

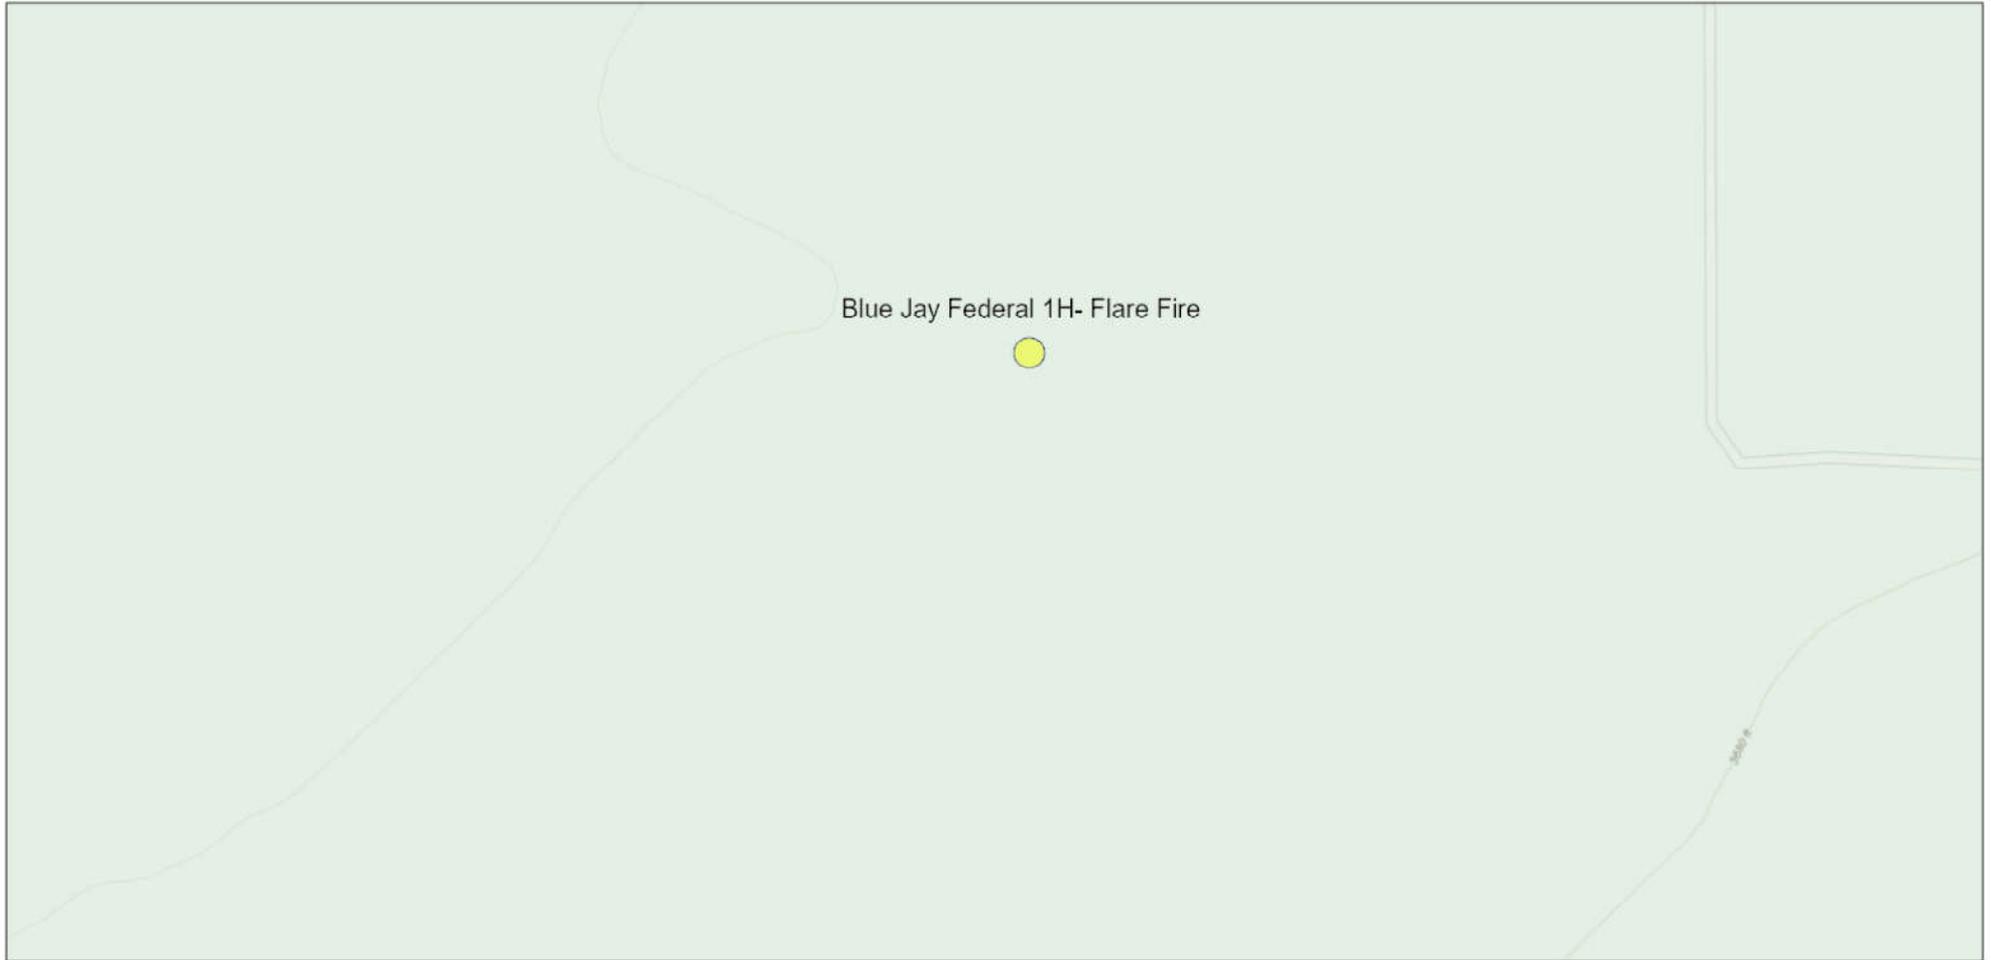
Karst Potential Map

Site Characterization	Average Groundwater Depth (ft.)
Low Karst	> 100 ft
