December 16, 2020

Vertex Project #: 20E-00141-002

Spill Closure Report: Gaucho Unit 6H
Unit P, Section 17, Township 22 South, Range 34 East
County: Lea
API: 30-025-34789
Incident Tracking Number: NAB1914858909

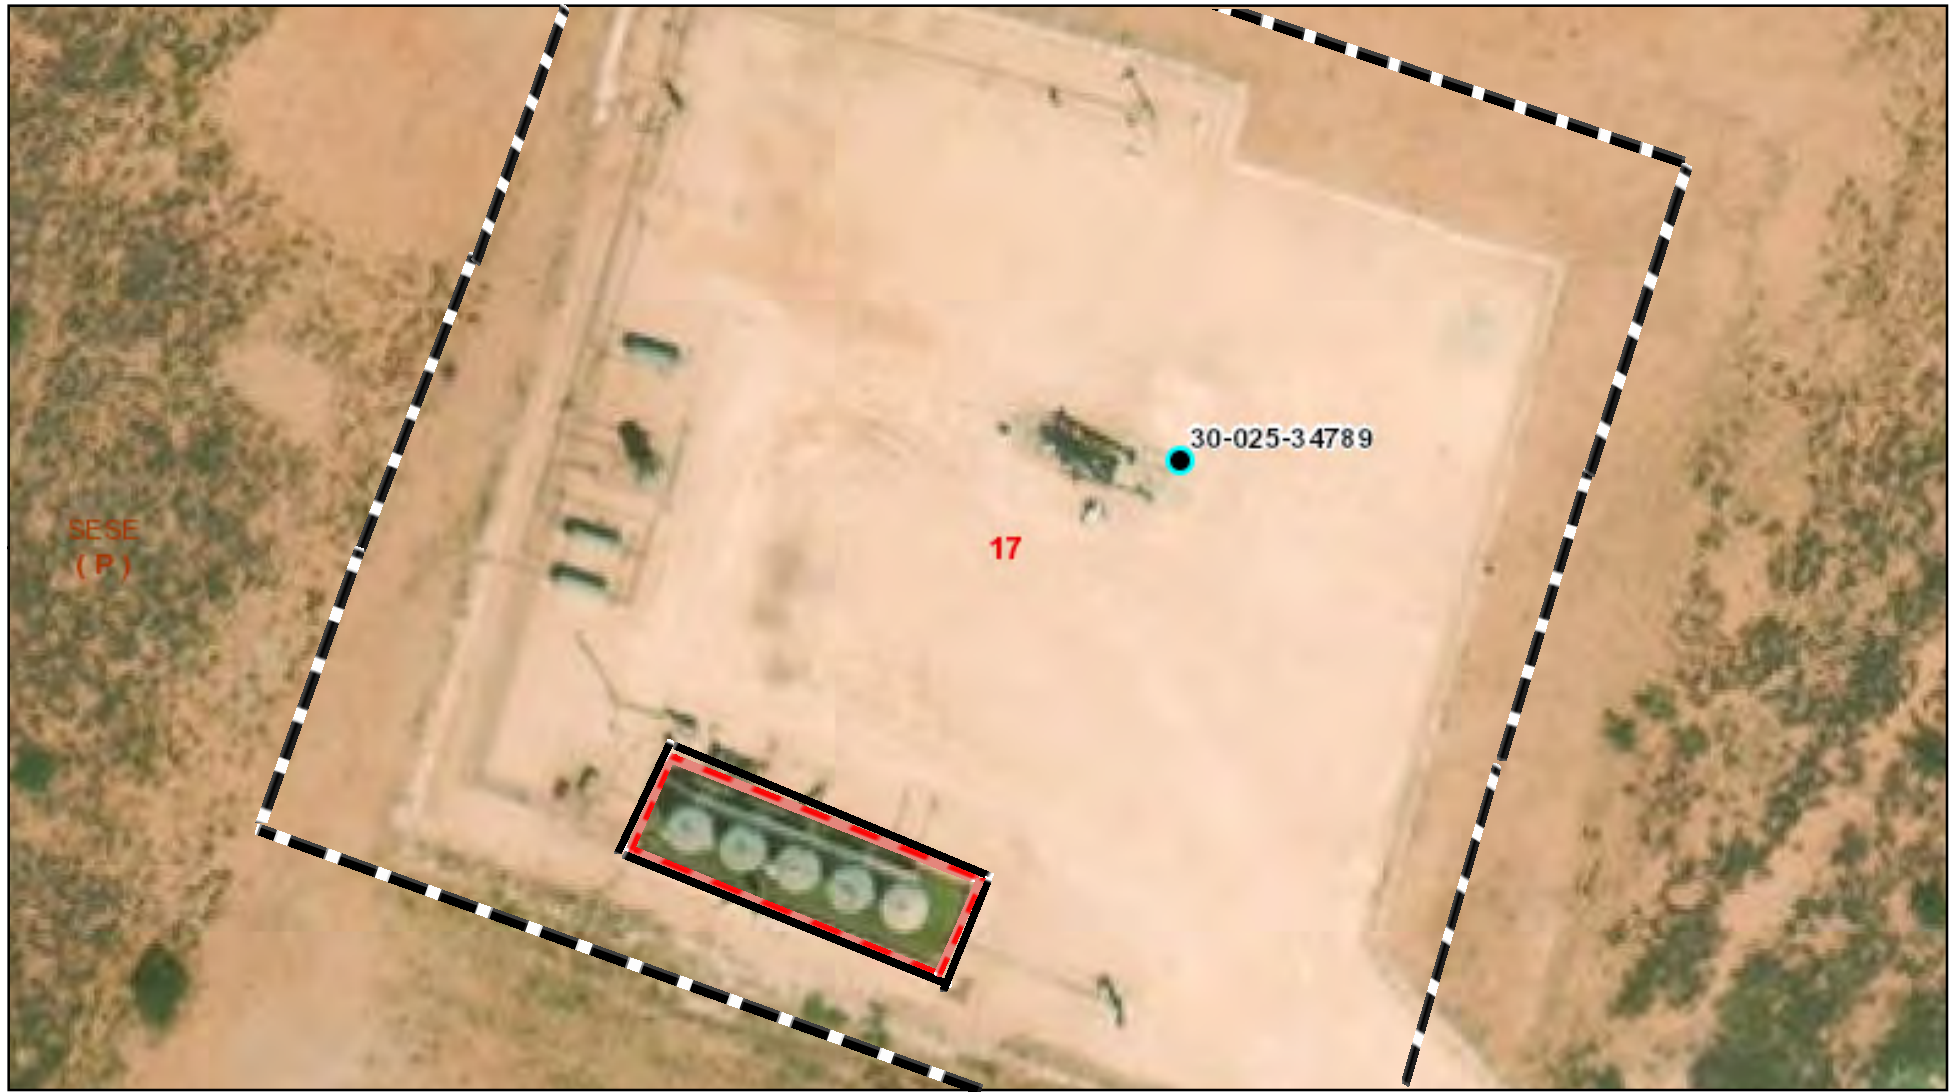
Site Schematic
Gaucho Unit #006

Containment

Approximate Spill Extent (~ 3,280 sq.ft.)
