Site Name Goldenchild	Site Type SWD
Date Release Discovered 12/22/2020	API# (if applicable)

**Re: Closure Request  
Goldenchild SWD  
Incident Number nAPP2100547196  
Eddy County, New Mexico**

**FIGURE 2**  
 DELINEATION SOIL SAMPLE LOCATIONS  
 GOLDENCHILD SWD  
 UNIT P SEC 06 T25S R29E  
 EDDY COUNTY, NEW MEXICO  
 XTO ENERGY, INC.

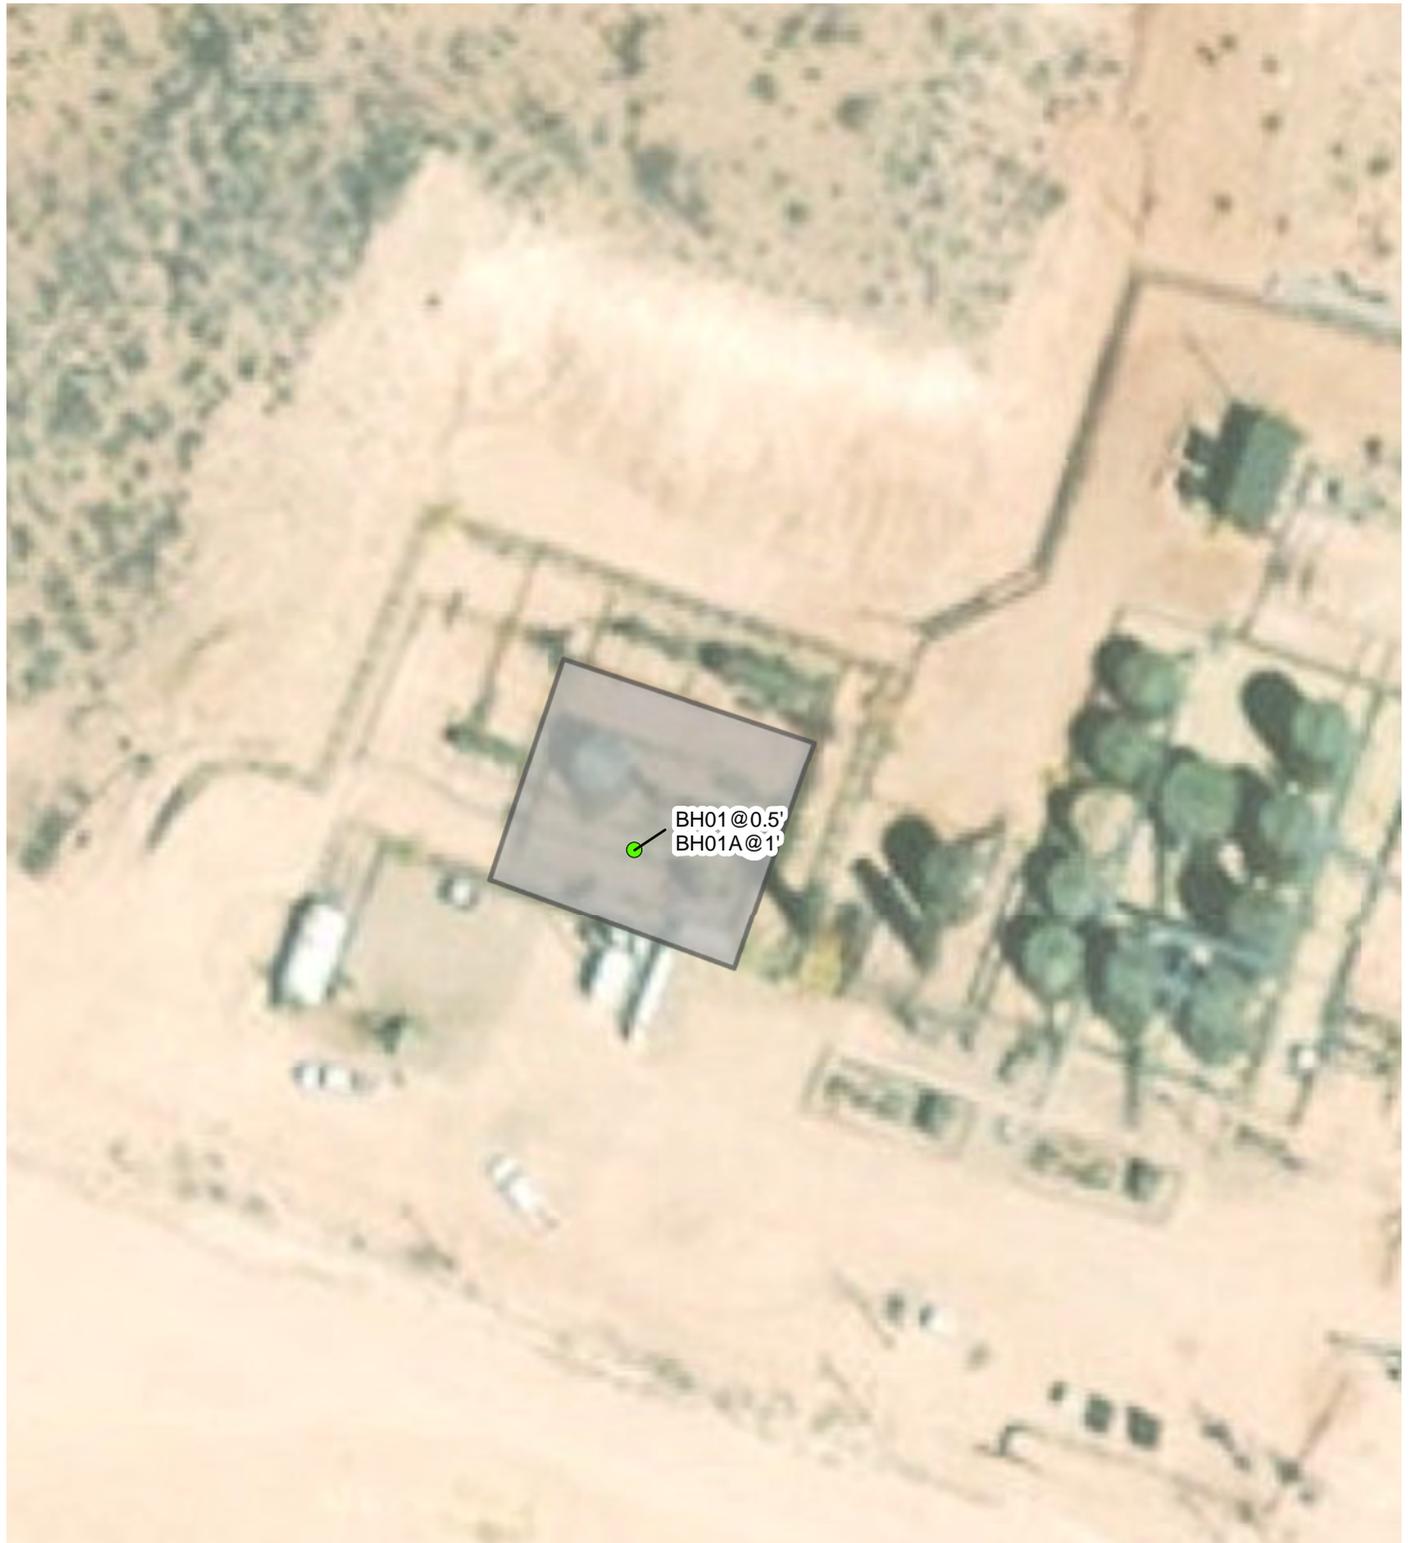
2. The borehole was backfilled with the soil removed and XTO repaired the tear in the liner. The borehole delineation soil sample location is depicted on Figure 2. Photographic documentation was conducted during the Site visit. The photographic log is included in Attachment 3.

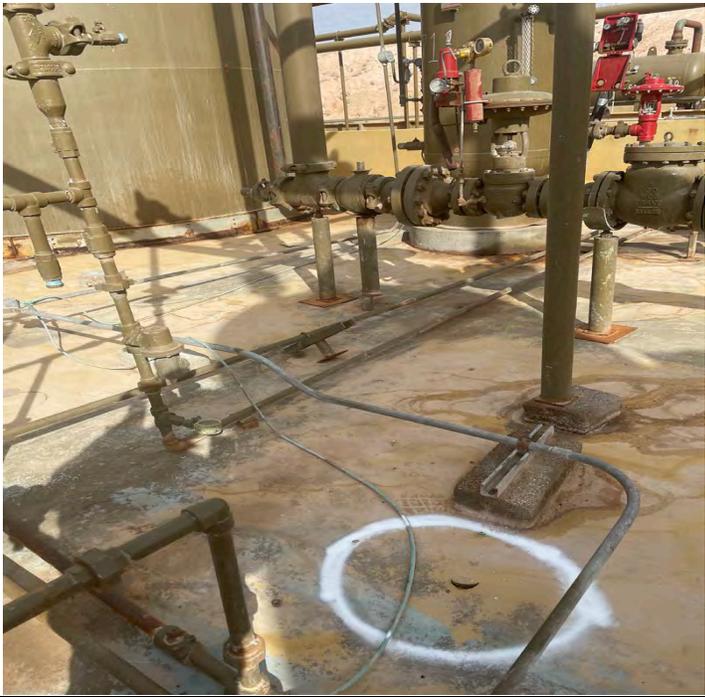
Photo No.	Date	
1	February 8, 2021	
Location of tear in liner and proposed borehole site.

Following the failed liner integrity inspection at the Site, WSP personnel advanced one borehole (BH01) at the location of the tear in the liner to assess for the presence or absence of soil impacts resulting from the December 22, 2020 produced water release within lined containment. Two delineation soil samples were collected from borehole BH01 at depths of approximately 0.5 feet and 1-foot bgs. Laboratory analytical results indicated that benzene, BTEX, TPH, and chloride concentrations were compliant with the Closure Criteria. Additionally, field screening of soil from the borehole indicated no elevated volatile aromatic hydrocarbons or chloride concentrations beneath the tear in the liner. The release was contained laterally by the lined containment and all released fluids were recovered during initial response activities. The tear in the liner was subsequently repaired.

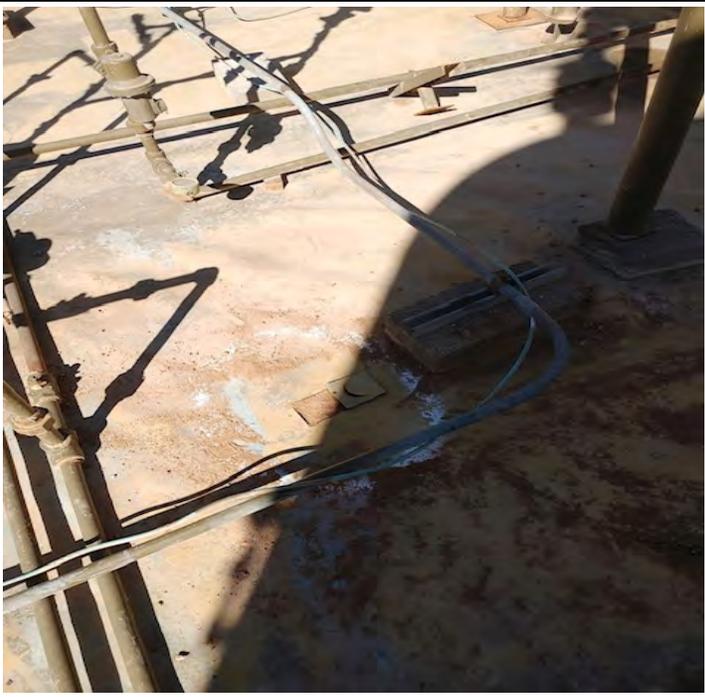
Photo No.	Date	
2	February 8, 2021	
Location of borehole prior to delineation activities.
