Release Notification and Corrective Action

FINAL REPORT SUMMARIZING CLOSURE FOR INCIDENT 2RP-2651-0

AGAVE ENERGY COMPANY
VALVE BOX # 11
SECTION 5, T19S R25E, NM
EDDY COUNTY, NM

Valve Box #11 Closure Report
Agave Energy Company
Sec 5 T19S R25E, Eddy County, New Mexico
December 5, 2014 Revised February 13, 2015

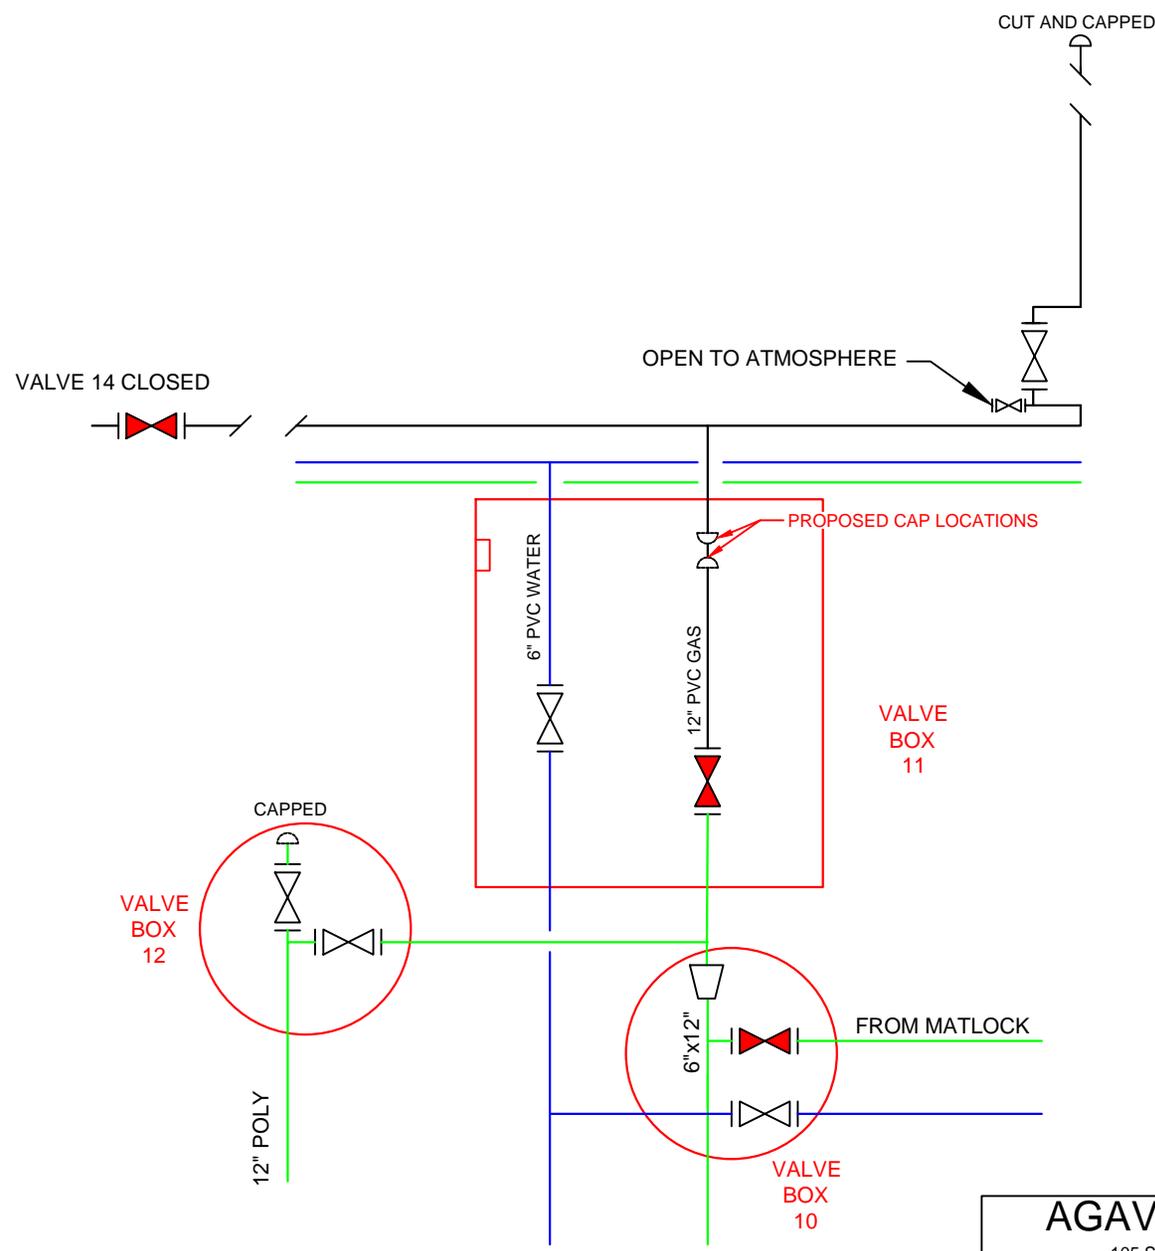
Figure 2

Valve Box #11 Layout 9/18/14

- CAP
- SHUT VALVE
- OPEN VALVE
- REDUCER
- GAS LINE
- ABANDONED GAS LINE
- YATES WATERLINE

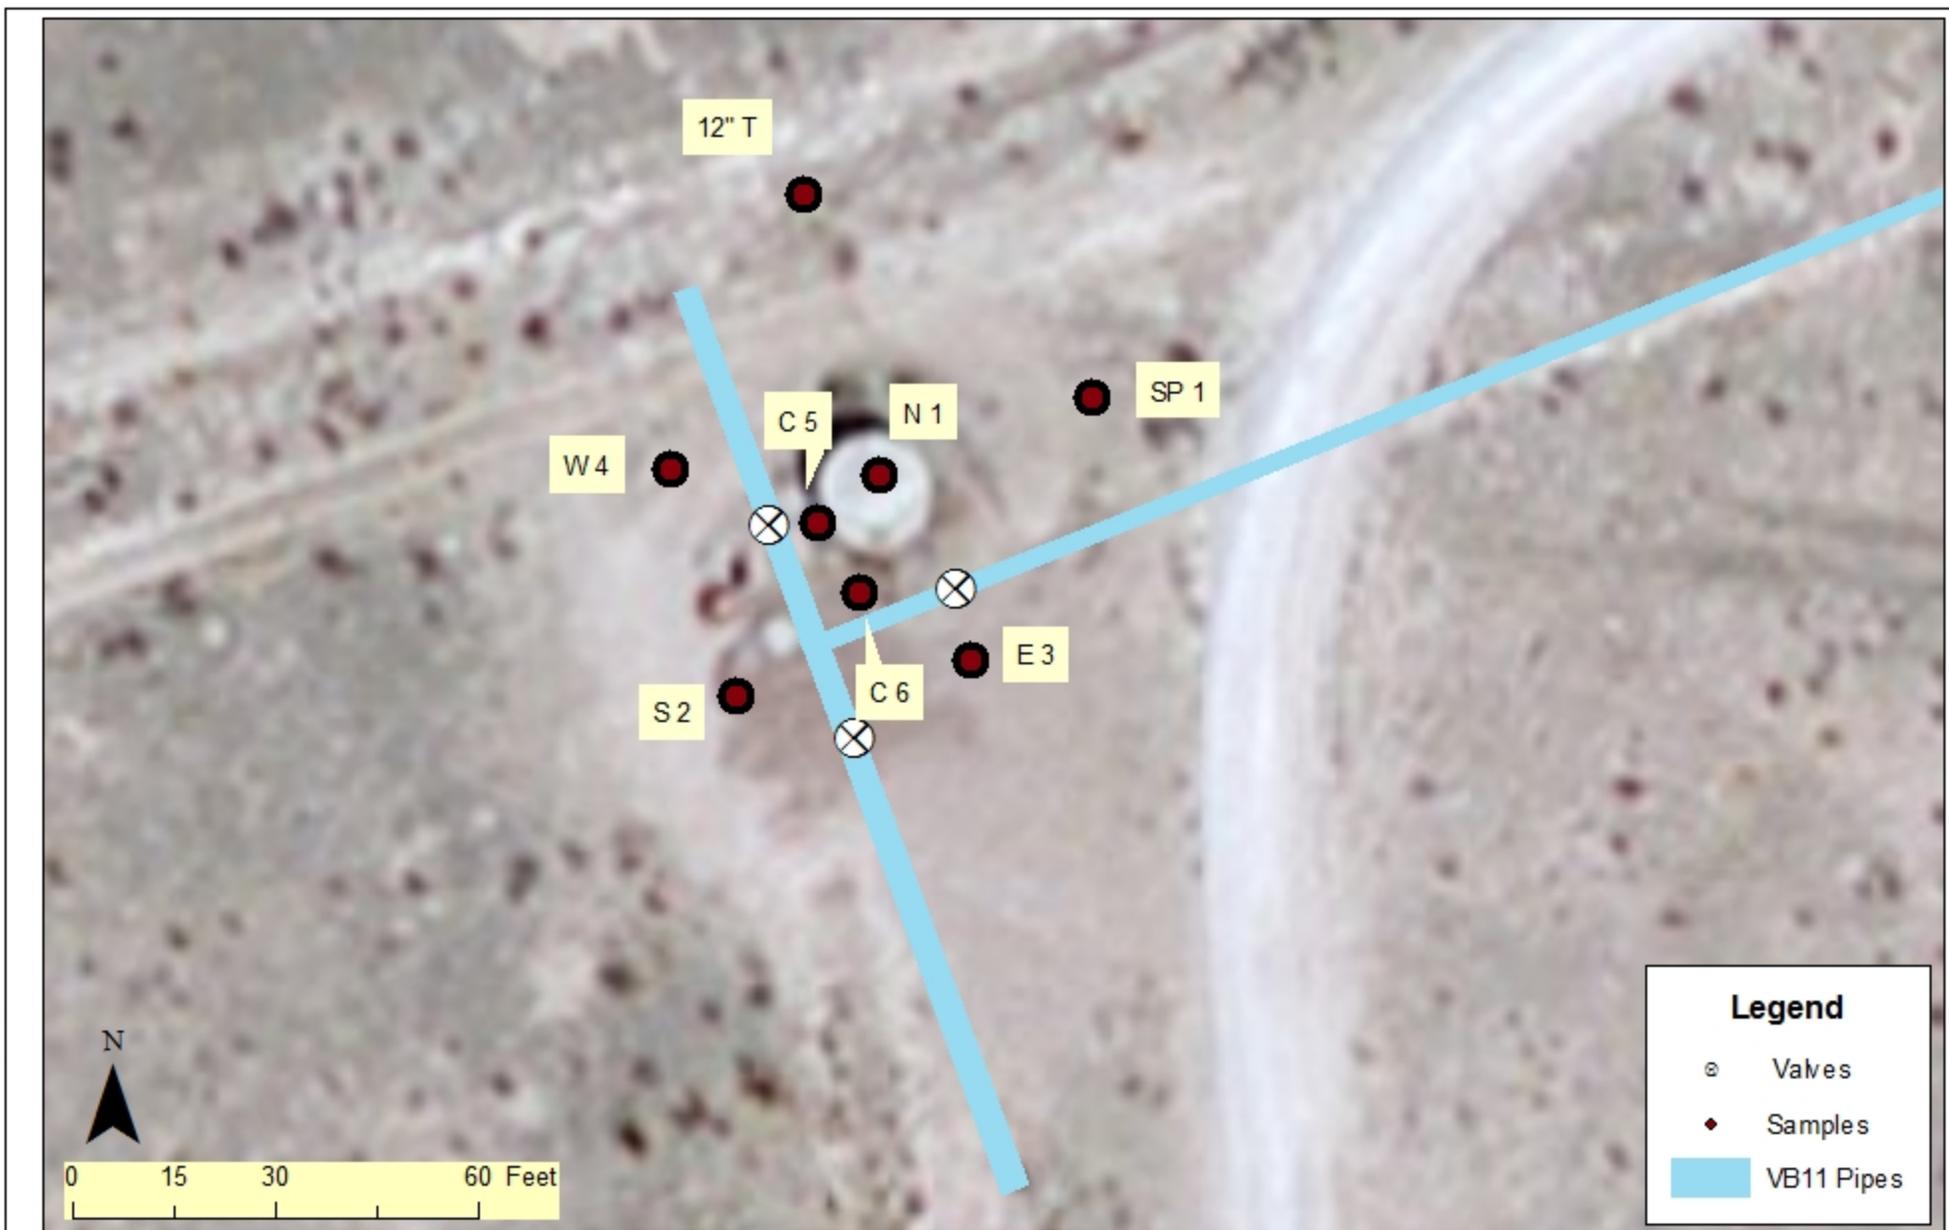
Figure 4

Closure Sampling Map

Vb #11 Sample Map
 Valve Box 11
 Artesia, New Mexico

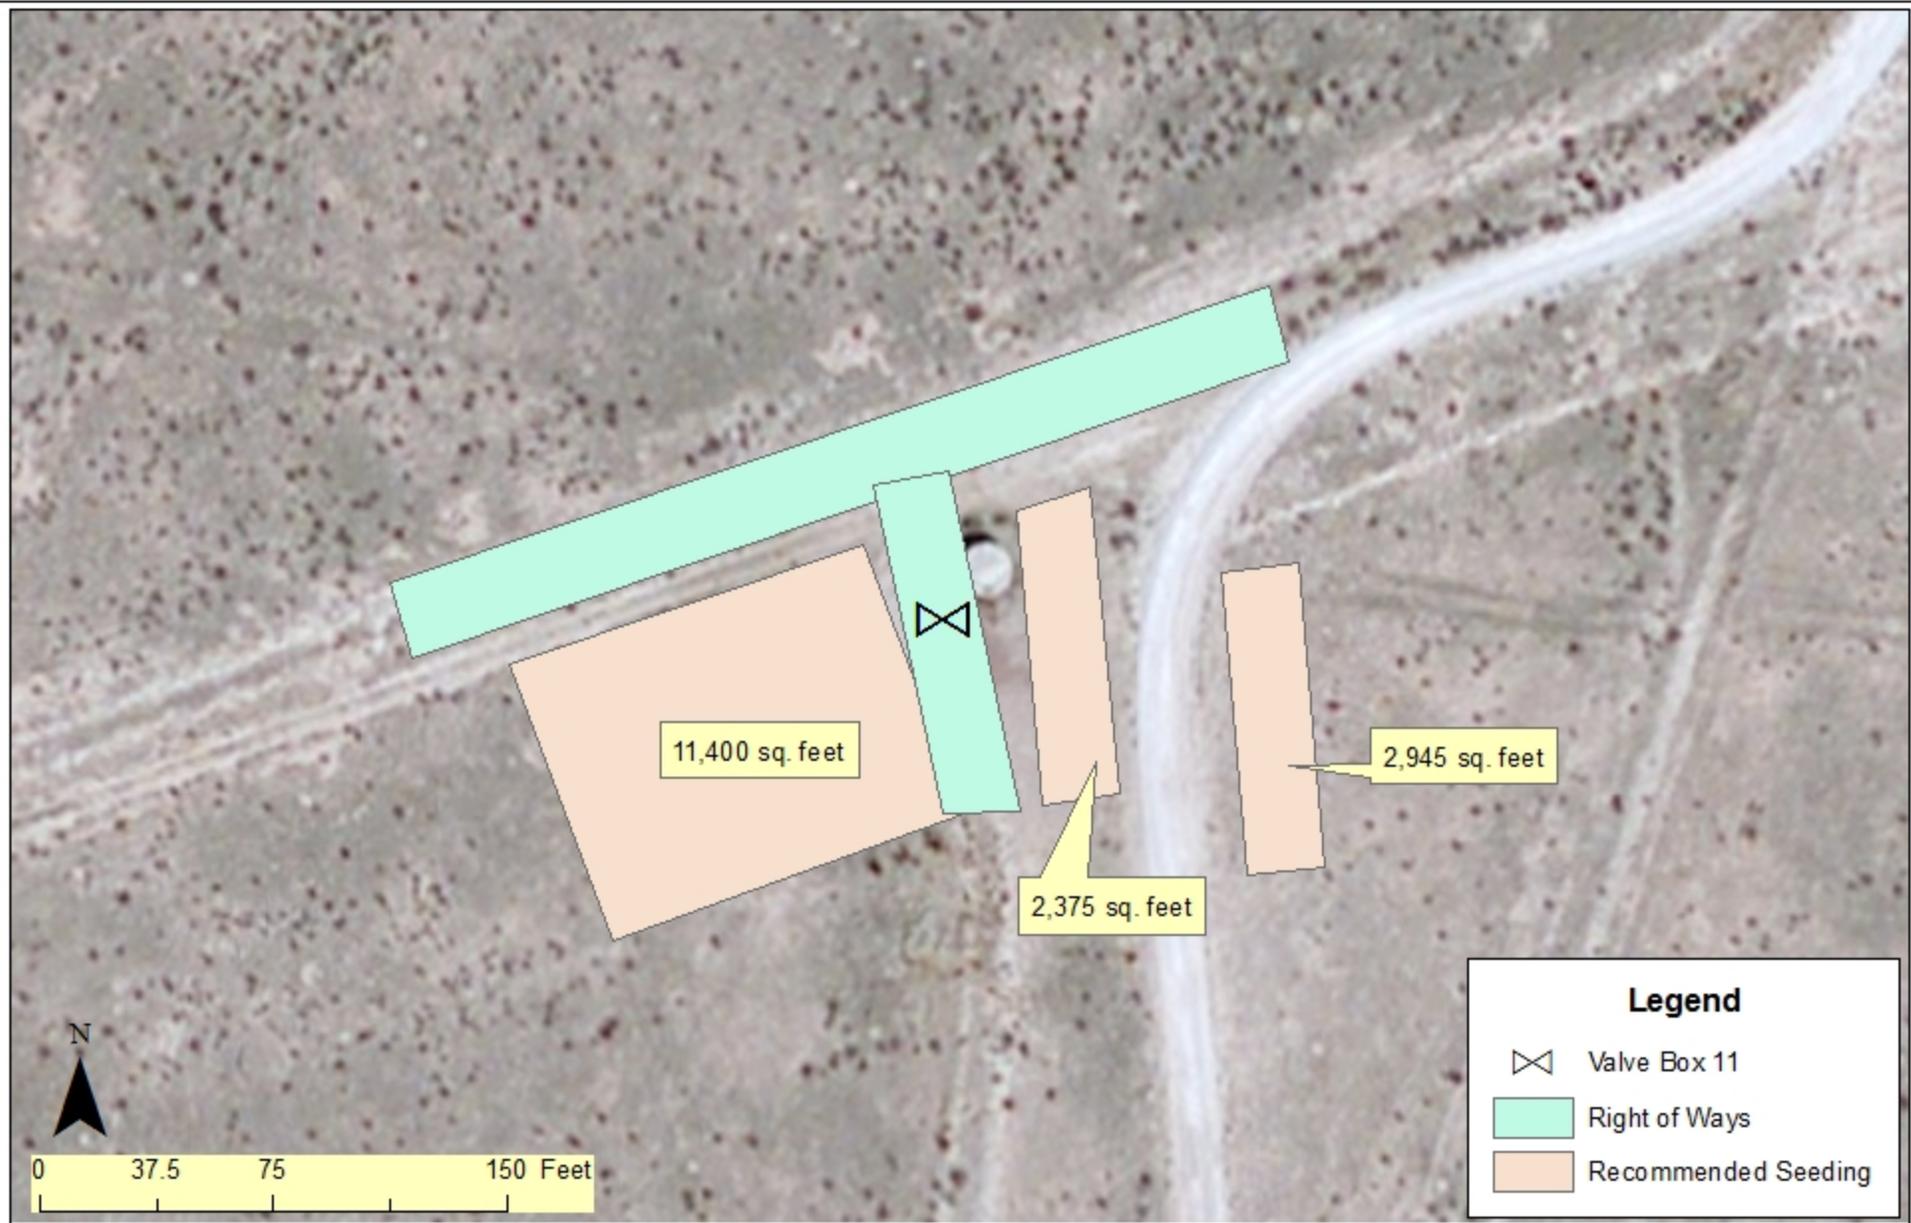
Figure 5

Recommended Revegetation

Recommended Seeding
 Valve Box 11
 Artesia, New Mexico

1. **File for Closure** – This closure report and a signed C-141 Final should be provided to NMOCD for approval.
2. **Revegetation of the location** – To comply NMOCD closure requirements, SMA recommends revegetation of the location by reseeding. Refer to Figure 5.

Livestock in the area may need to be removed or denied access to the area for a short period of time to meet the revegetation objectives. SMA recommends that all reseeding attempts be made during the monsoon season starting in June and ending in August. An estimate of the reseeding cost at the location is presented in Figure 6. Also attached in Appendix F is the BLM recommended seed mix for the area.

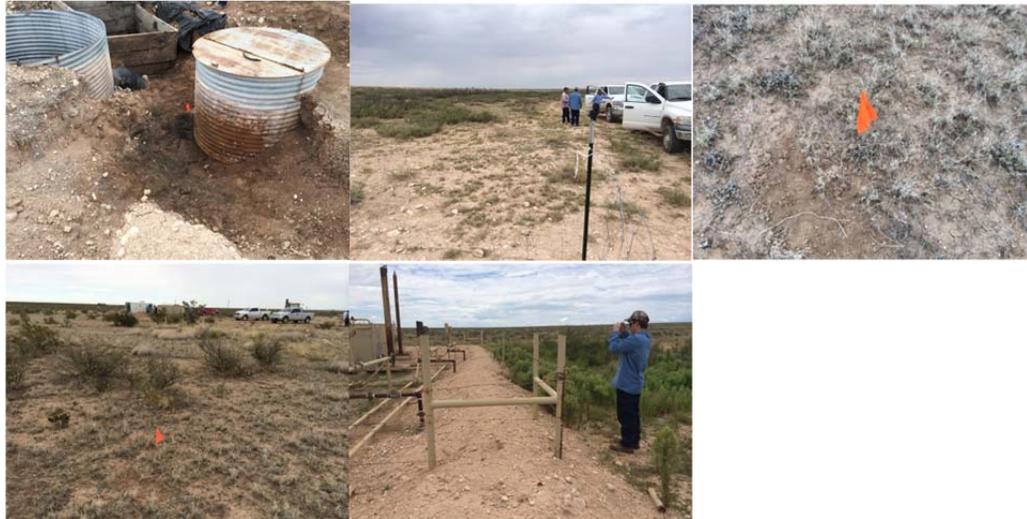
Attached pics left to right: Sample #3 location, JSA on location, Sample #4 location, site from sample 4 location, confirming lock-out Tag-out

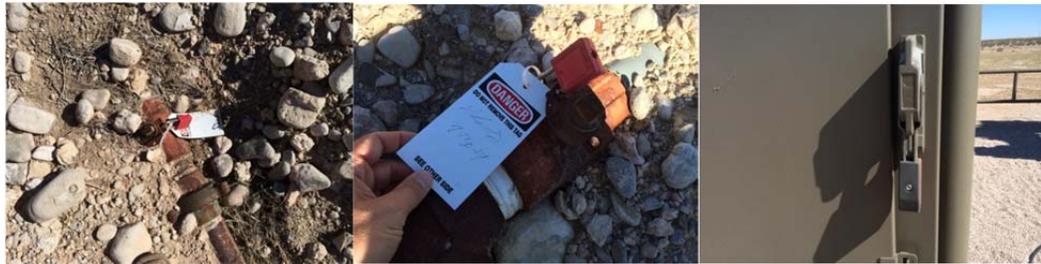
1. September 2
 - a. 7:30-am Arrive at Agave Energy Field Office (CR39) check in. Ready to start work at the Johnson BE Battery to add needed shut-in valves and Isolate six inch PVC south of valve Box 11 to insure safety. Lock-out Tag-out confirmed

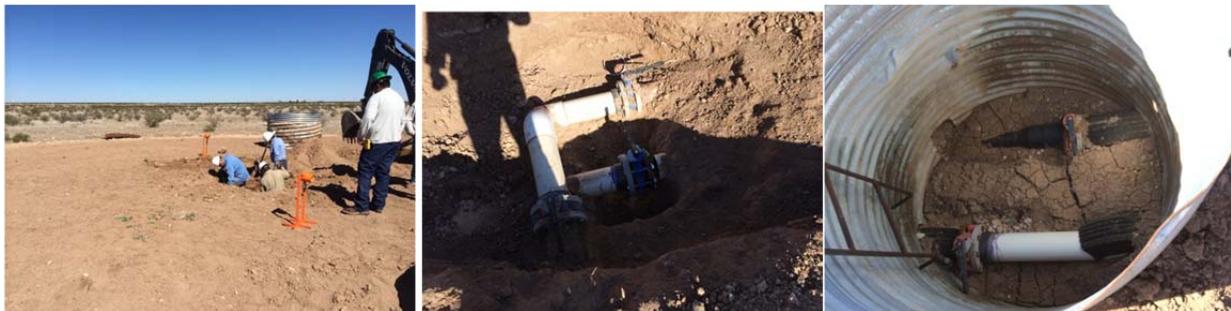
- c. 9:50-am Excavation of the 6" PVC lines north of the Johnson BE battery begins. Excavation Sloped to 30% and sampled for hazardous atmosphere. Cut made and valve installed under air.

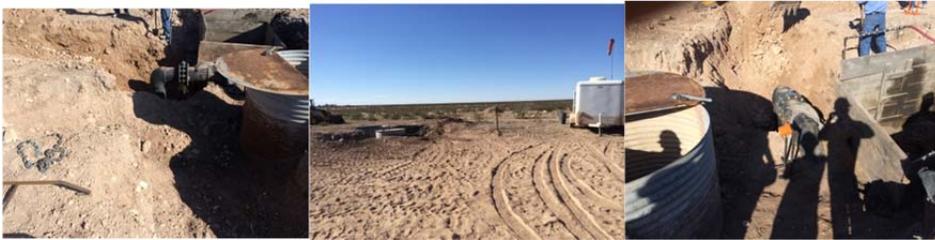
- d. 1:30-pm Met with Agave Pipeline and tested blow-down

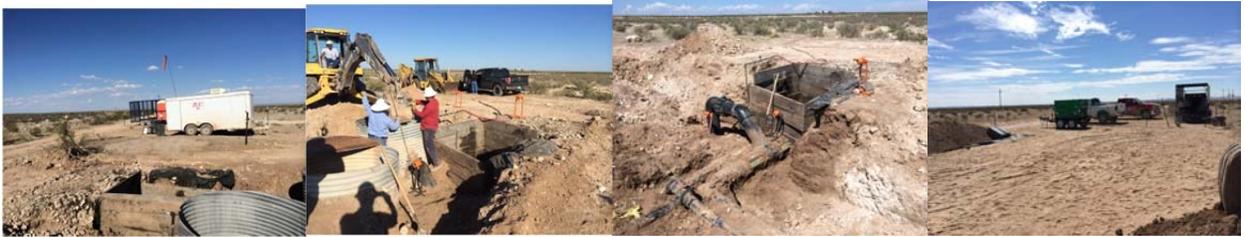
- a. 7:30-am Arrive at Agave Energy Field Office (CR39) check in.
- b. 8:00-am JSA held by ASI. Air trailer and Cool down trailer on site. Crew shaved and ready all H2S cards checked. Site H2S monitors set.
- c. Tin Horns Pulled and area excavated to 30%

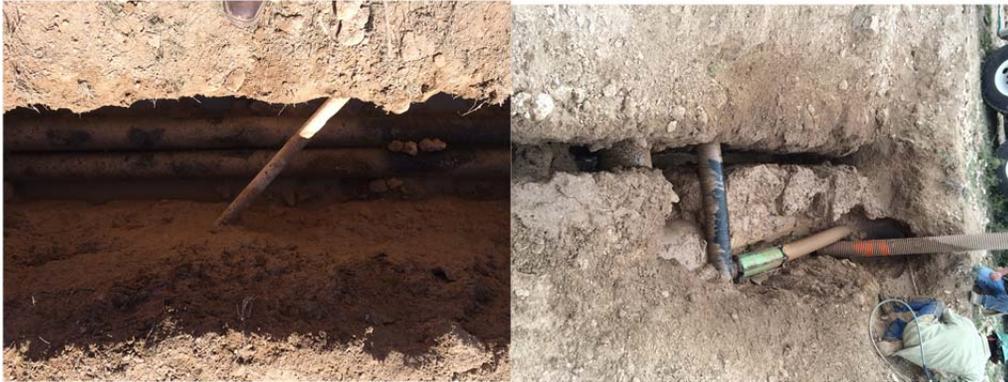
1. September 10
 - a. 7:30am Start Hydro excavation on six inch ROW for YPC water line tie-in and above ground valve setting install. Watson crew is finishing excavation on six inch Matlock line for above ground valve install.

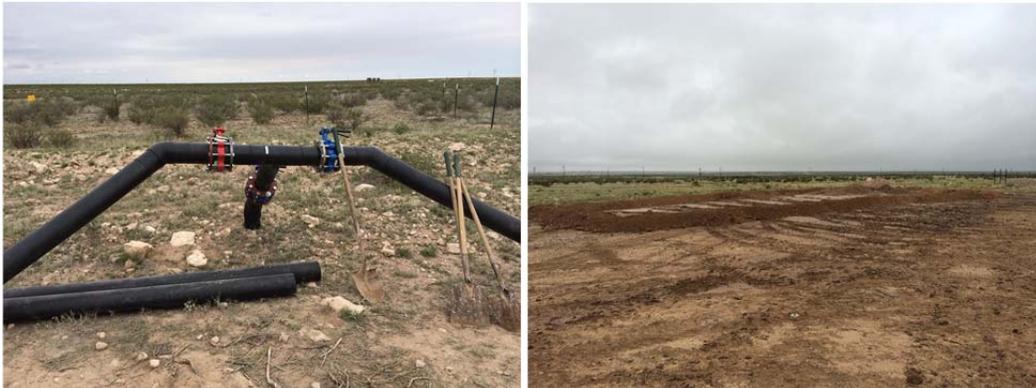
2. September 11
 - a. Build waterline above ground valve station and established vac-truck unloading at Johnson BE

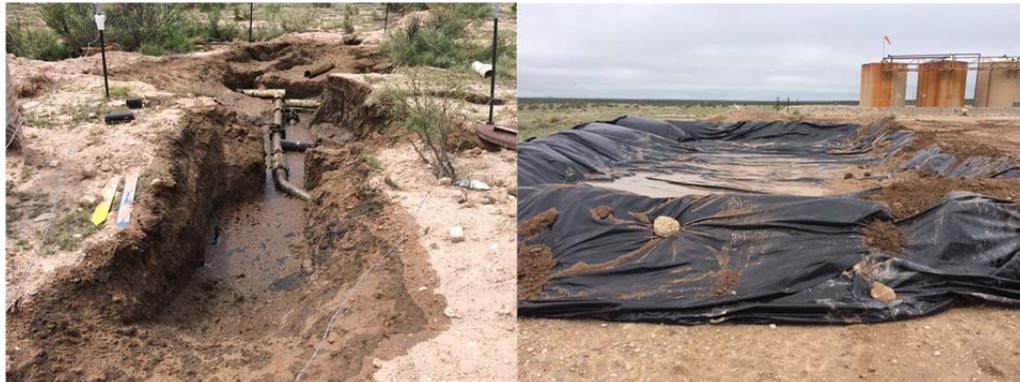
- b. Second vac-truck unloading "lined" for contaminated soils built.

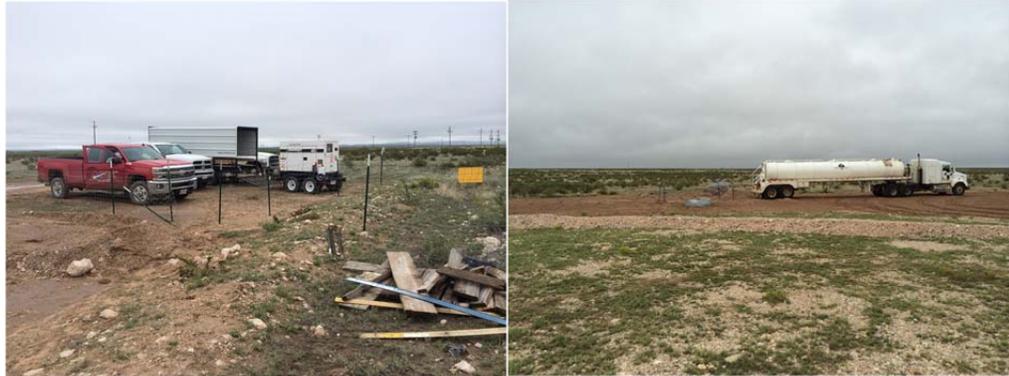
- a. Pinch installed @ Pollo Battery and @ Nicholas. Given permission to cut and remove 12" Poly tie-in and install blind flange. Water system also down ready for valve station install and Valve Box #11 by pass. All cuts made under air and supervision of ASI.

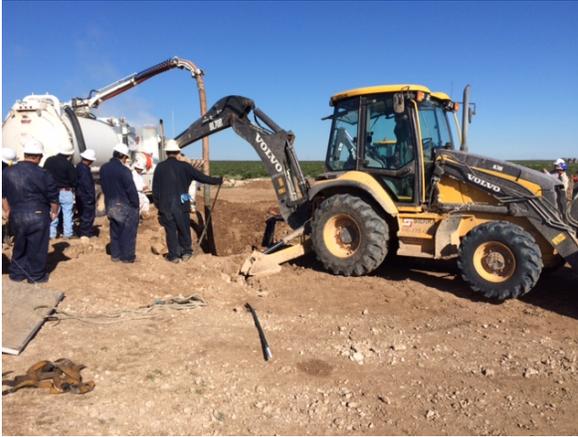
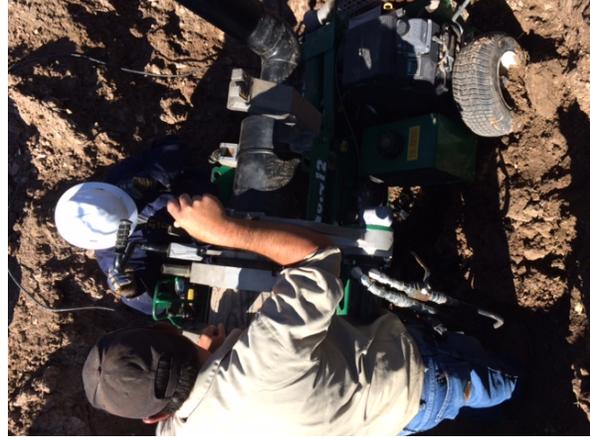
b. Start at 8:30am tie-in of the Nickola's Battery to the above ground valve station at VB#11.

Supervised by Agave Energy Company construction supervisor.

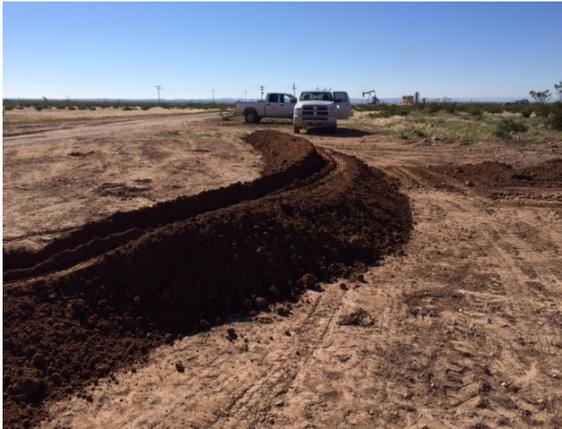
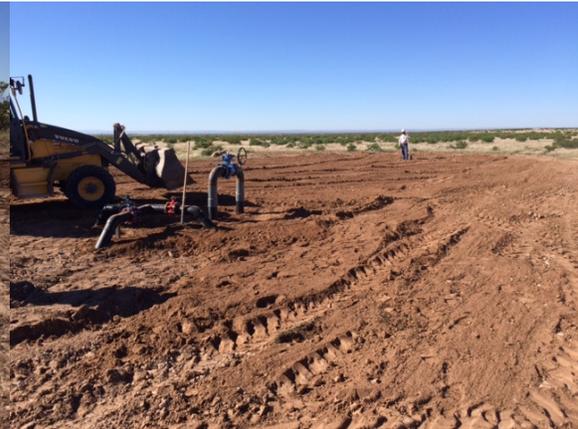
c. Start 8:00am topsoil delivered and back-fill started.
