Release Notification

Site Name Mucho Luck BBW Federal Com #2H	Site Type Battery
Date Release Discovered 02/14/2018	API# 30-015-39348

Re: Mucho Luck BBW Federal Com #2H
30-015-39348
Section 27, T16S-R27E
Eddy County, New Mexico
2RP-4639

V. Liner Integrity

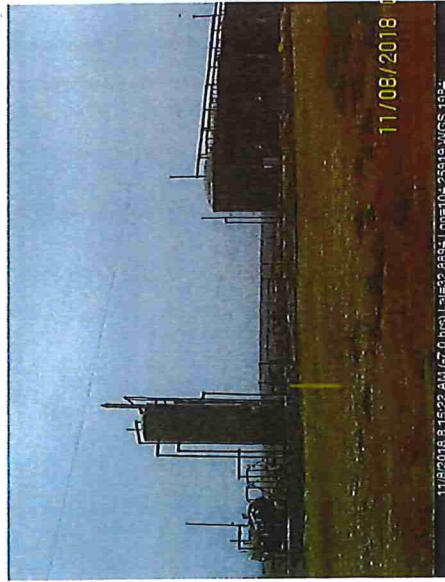
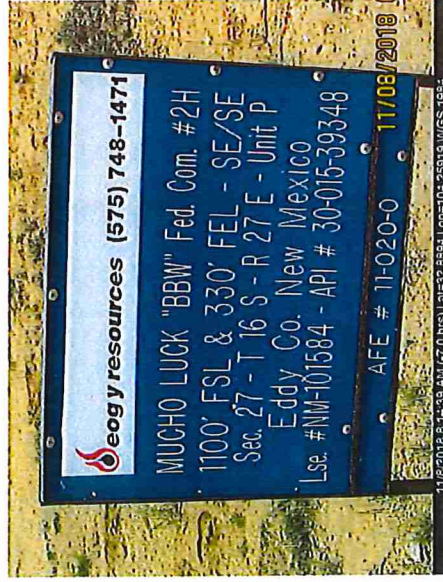
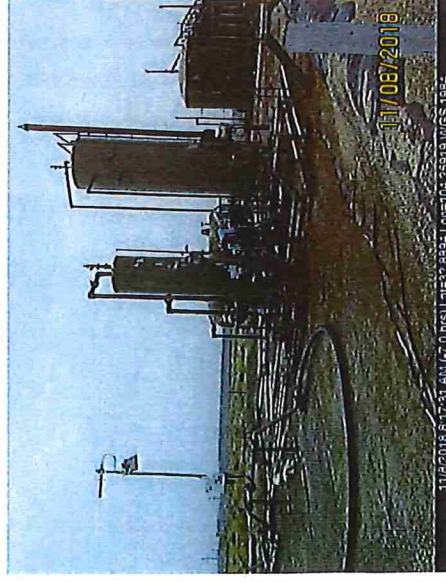
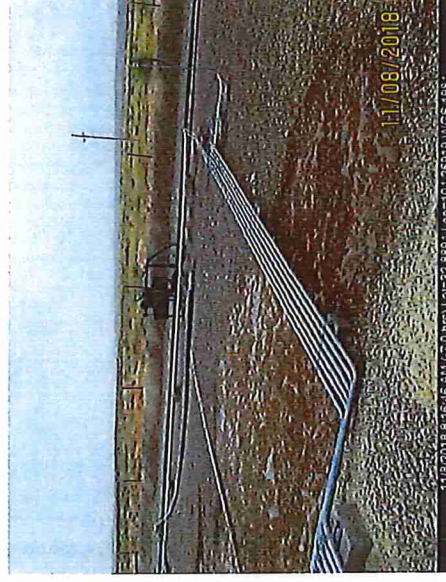
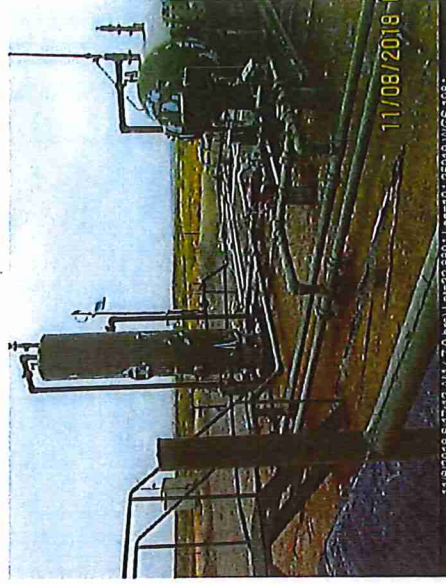
Figure 2

The release occurred within a lined containment area, EOG Y Resources, Inc. demonstrated liner integrity after affected material is removed and the affected area of the liner is exposed and is providing certification on form C-141.

EOG Y Resources, Inc. has visually inspected the liner where the release occurred and the liner remains intact and had the ability to contain the leak in question.
