Release Notification

Site Name Algerita AHR State #1	Site Type Battery
Date Release Discovered 08/12/2009	API# 30-015-26383

Please refer to the attached original C-141 form for 2RP-760 for cause of release and immediate action steps. EOG Resources is submitting for closure via the new form to formally close out this incident. All sampling and correspondence is also attached.

Site and Sample Location Map
 Algerita AHR State #1 - EOG Y
 S 16-T20S-R24E, New Mexico

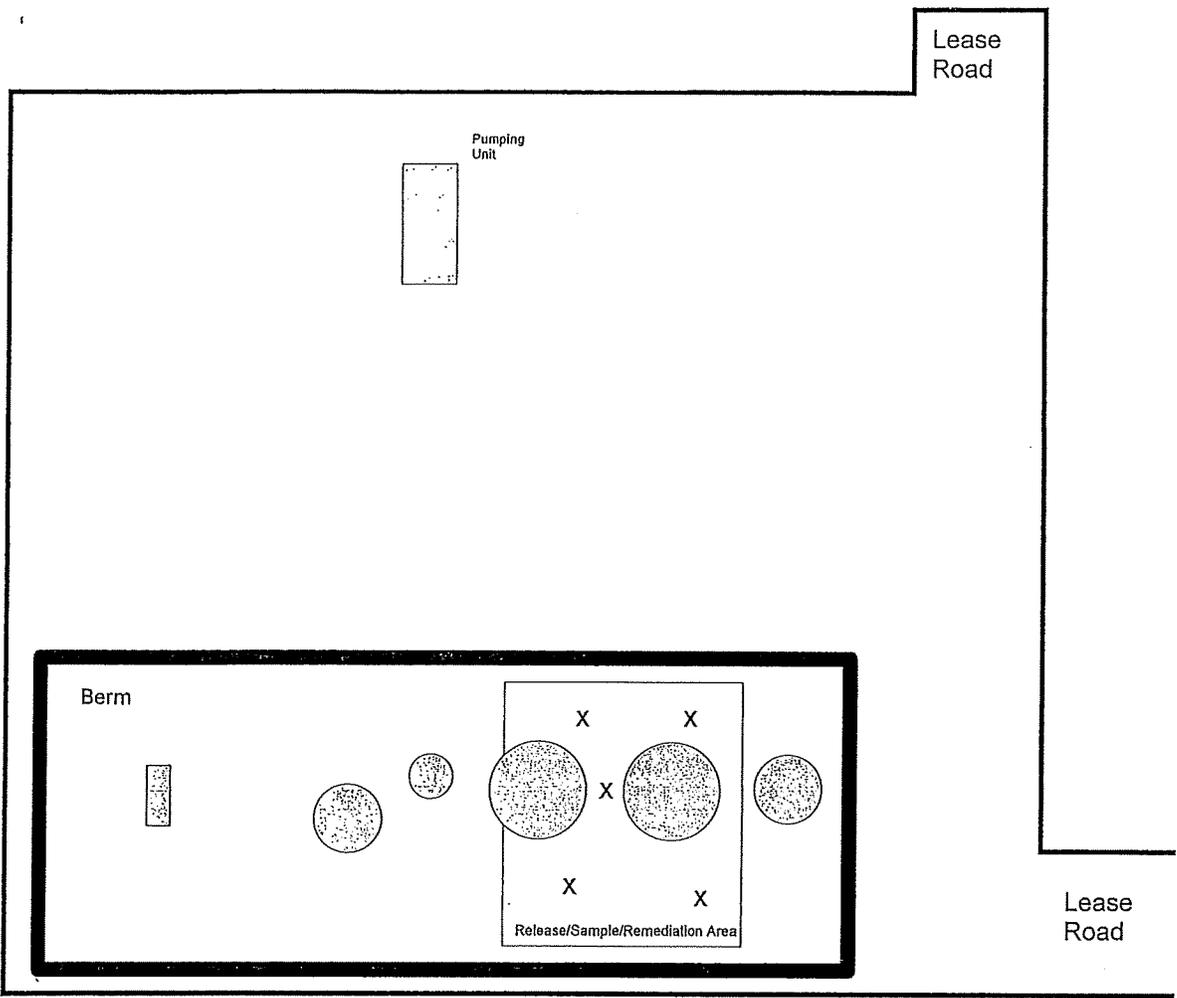
Sample ID	Sample Date	Sample Type	Depth	BTEX	GRO	DRO	TOTAL
GS/Comp-001	9/29/2009	Grab/Auger	4"	2.245	279	1060	1339
GS/Comp-002	9/29/2009	Grab/Auger	1'	101.810	3010	713	3723
GS/Comp-003	9/29/2009	Grab/Auger	2'	94.090	3480	633	4113
Sample ID	Sample Date	Sample Type	Depth	BTEX	GRO	DRO	TOTAL
GS/Comp-001	1/25/2010	Grab/Auger	1'	23.673	245	58.3	303.3
GS/Comp-002	1/25/2010	Grab/Auger	2'	82.900	2960	181	3141
Sample ID	Sample Date	Sample Type	Depth	BTEX	GRO	DRO	TOTAL
GS/Comp-001	5/18/2010	Grab/Auger	1'	1.872	63.4	34.7	98.1
GS/Comp-002	5/18/2010	Grab/Auger	2'	11.310	774	902	1676
GS/Comp-003	5/18/2010	Grab/Auger	3'	16.280	660	43.5	703.5

Site Ranking is Zero (0). Depth to Ground Water >100' (approx.400', per NMOSE).
 All results are ppm.

SAMPLE DIAGRAM (Not to Scale)
 Xenco Report #: 346486
 Report Date: 10/7/20089
 Xenco Report #: 360032
 Report Date: 2/1/2009
 Xenco Report #: 373728
 Report Date: 5/26/2010
 Prepared by Robert Asher
 Environmental Regulatory Agent

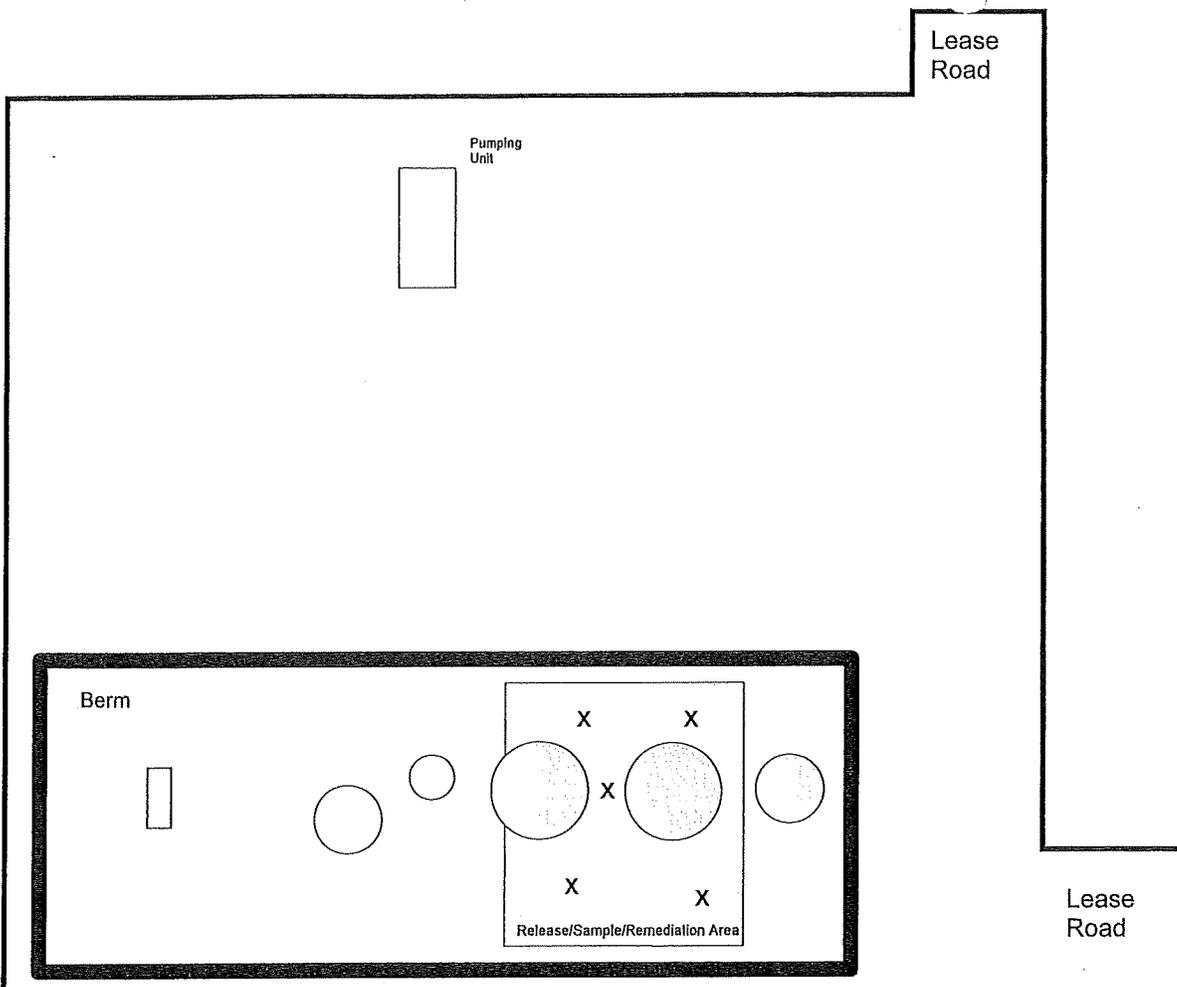
Sample ID	Sample Date	Sample Type	Depth	BTEX	GRO	DRO	TOTAL
GS/Comp-001	9/29/2009	Grab/Auger	4"	2.245	279	1060	1339
GS/Comp-002	9/29/2009	Grab/Auger	1'	101.810	3010	713	3723
GS/Comp-003	9/29/2009	Grab/Auger	2'	94.090	3480	633	4113
Sample ID	Sample Date	Sample Type	Depth	BTEX	GRO	DRO	TOTAL
GS/Comp-001	1/25/2010	Grab/Auger	1'	23.673	245	58.3	303.3
GS/Comp-002	1/25/2010	Grab/Auger	2'	82.900	2960	181	3141
Sample ID	Sample Date	Sample Type	Depth	BTEX	GRO	DRO	TOTAL
GS/Comp-001	5/18/2010	Grab/Auger	1'	1.872	63.4	34.7	98.1
GS/Comp-002	5/18/2010	Grab/Auger	2'	11.310	774	902	1676
GS/Comp-003	5/18/2010	Grab/Auger	3'	16.280	660	43.5	703.5

Site Ranking is Zero (0). Depth to Ground Water >100' (approx.400', per NMOSE).
 All results are ppm.

SAMPLE DIAGRAM (Not to Scale)
 Xenco Report #: 346486
 Report Date: 10/7/20089
 Xenco Report #: 360032
 Report Date: 2/1/2009
 Xenco Report #: 373728
 Report Date: 5/26/2010
 Prepared by Robert Asher
 Environmental Regulatory Agent

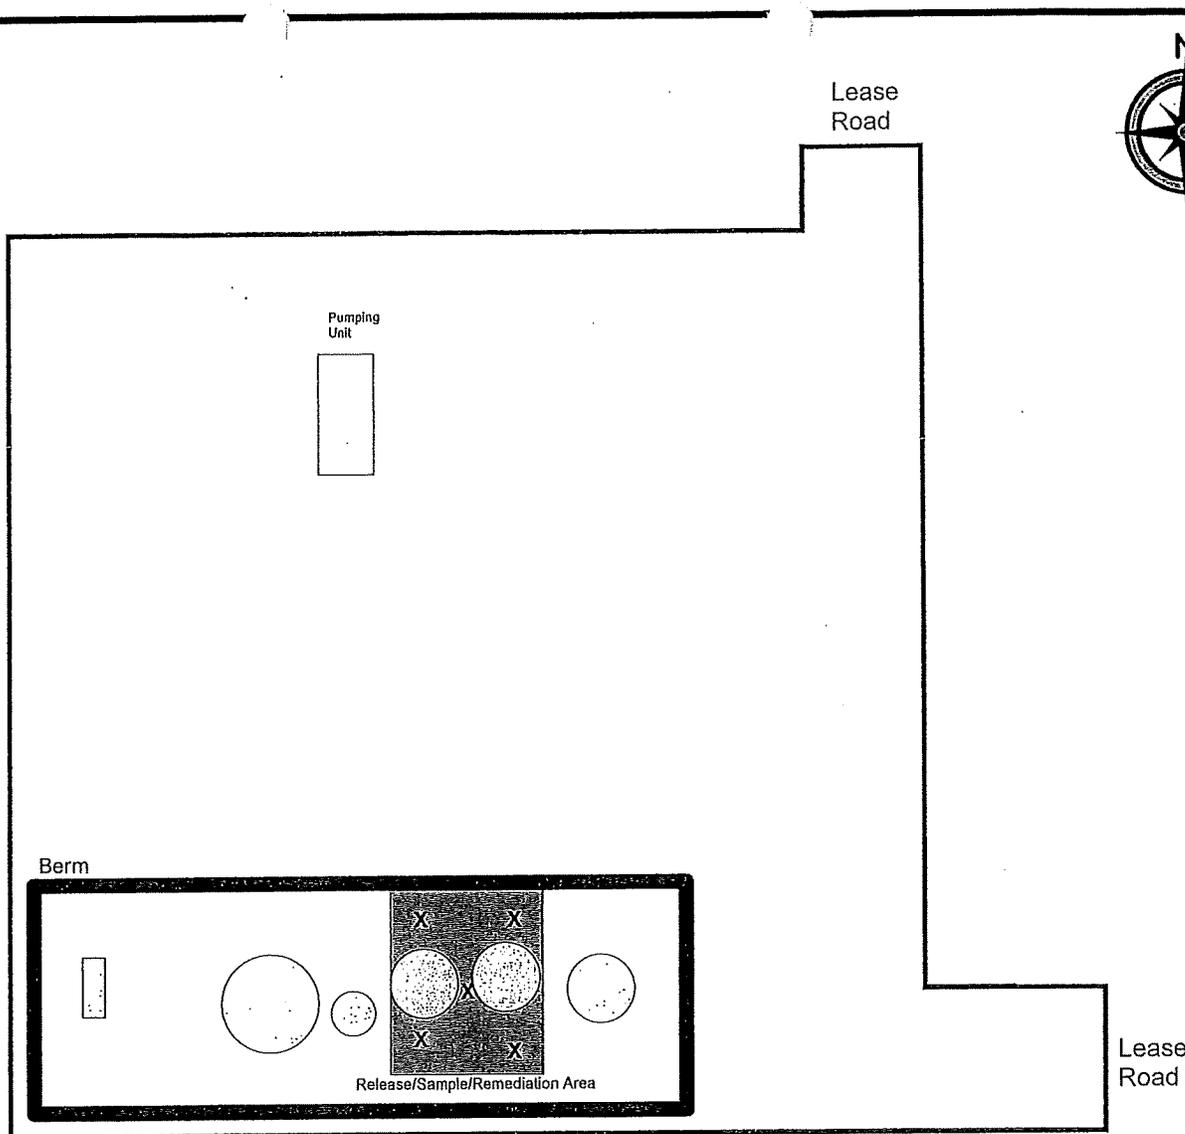
Sample ID	Sample Date	Sample Type	Depth	BTEX	GRO	DRO	TOTAL
GS/Comp-001	10/7/2009	Grab/Auger	4"	2.245	279	1060	1339
GS/Comp-002	10/7/2009	Grab/Auger	1'	101.810	3010	713	3723
GS/Comp-003	10/7/2009	Grab/Auger	2'	94.090	3480	633	4113

Site Ranking is Zero (0).
 Depth to Ground Water >100' (approx. 400', per NM Office of the State Engineer).
 All results are ppm.

SAMPLE DIAGRAM (Not to Scale)
 Xenco Laboratories: #346486
 Report Date: 10/7/2009
 Prepared by Robert Asher
 Environmental Regulatory Agent

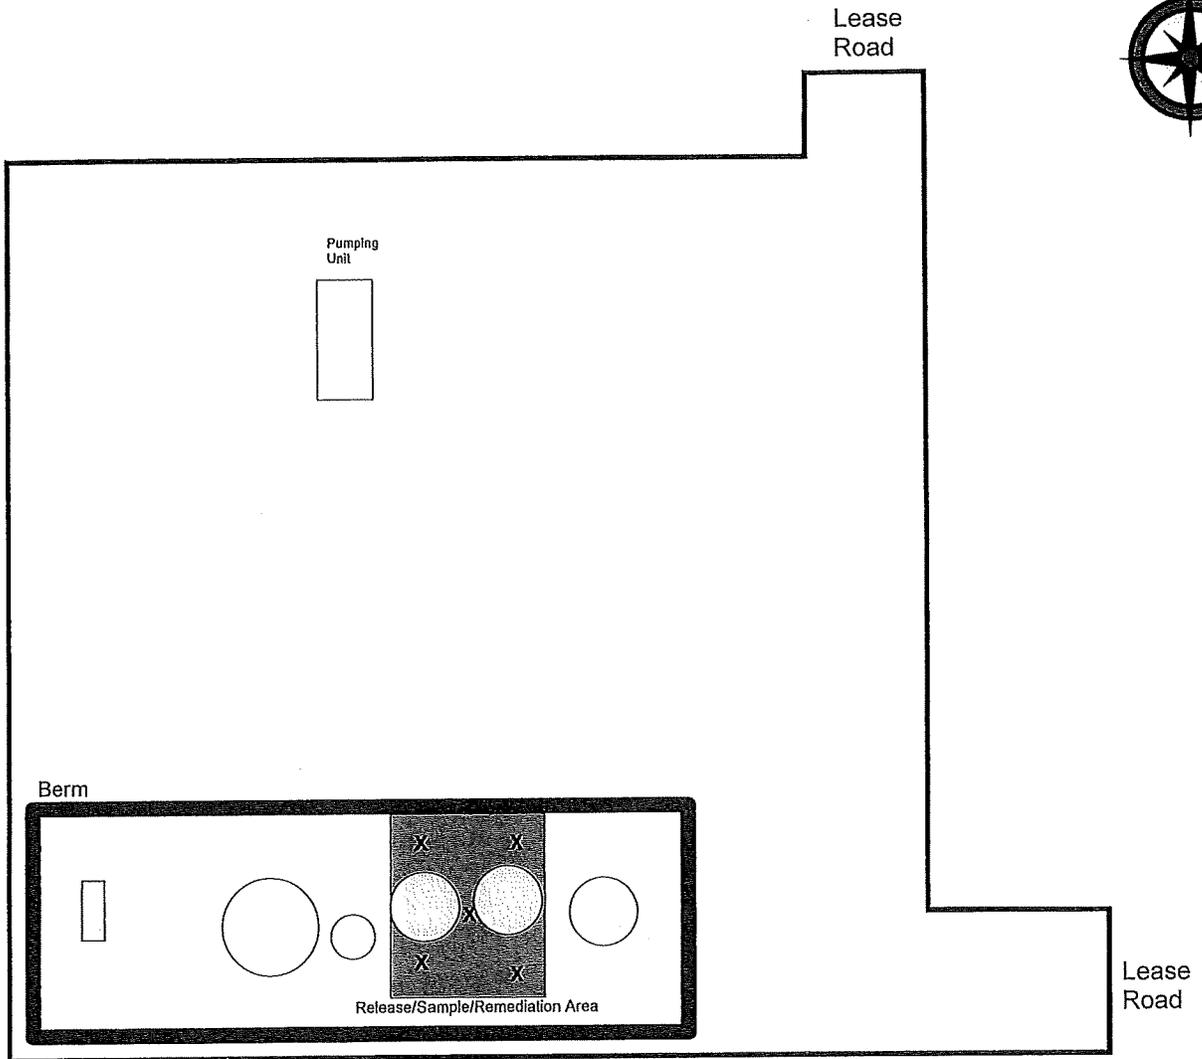
Sample ID	Sample Date	Sample Type	Depth	BTEX	GRO	DRO	TOTAL
GS/Grapp-001	10/7/2009	Grab/Auger	4"	2.245	279	1060	1339
GS/Grapp-002	10/7/2009	Grab/Auger	1'	101.810	3010	713	3723
GS/Grapp-003	10/7/2009	Grab/Auger	2'	94.090	3480	633	4113

Site Ranking is Zero (0).
