## Release Notification

Site Name	Baseball Cap Federal Com 26	Site Type	Tank Battery
Date Release Discovered	8/11/21	API# (if applicable)	30-025-44153

PHOTOGRAPHIC LOG		
<b>ConocoPhillips</b>	<b>Baseball Cap Federal Com 26</b> Incident Number NAPP2122368078	<b>Lea County, New Mexico</b>

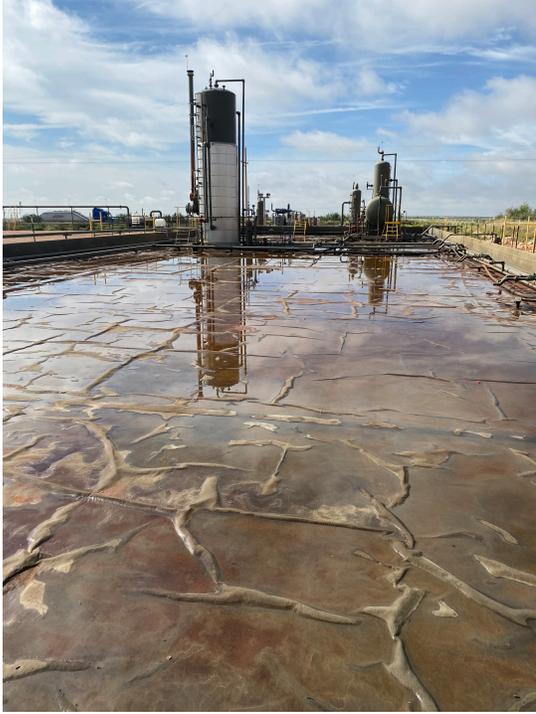
Photo No.	Date	
1	September 2, 2021

<p>The liner was visually inspected and the inspector determined the liner was in good condition.</p> <p>Standing water was precipitation from a rain event.</p>

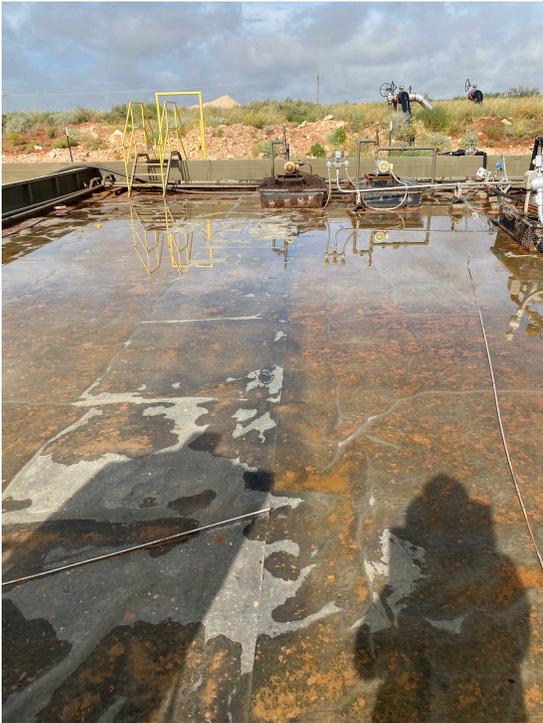
Photo No.	Date	
2	September 2, 2021

<p>The liner was visually inspected and the inspector determined the liner was in good condition.</p> <p>Standing water was precipitation from a rain event.</p>

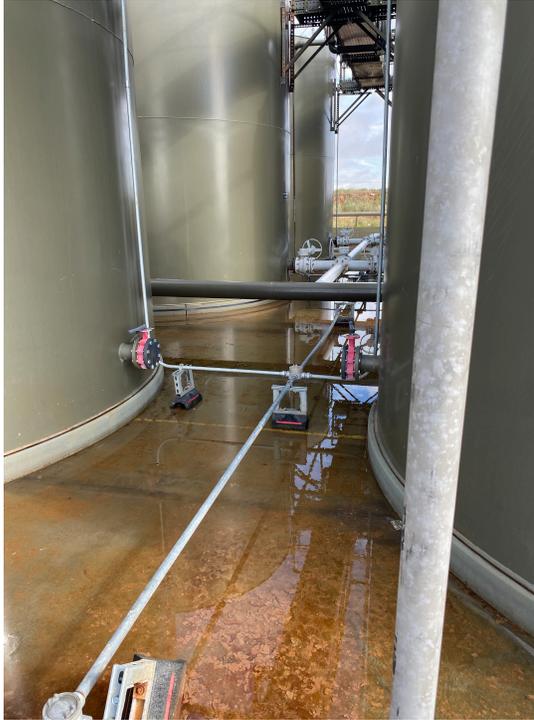
Photo No.	Date	
3	September 2, 2021

<p>The liner was visually inspected and the inspector determined the liner was in good condition.</p> <p>Standing water was precipitation from a rain event.</p>

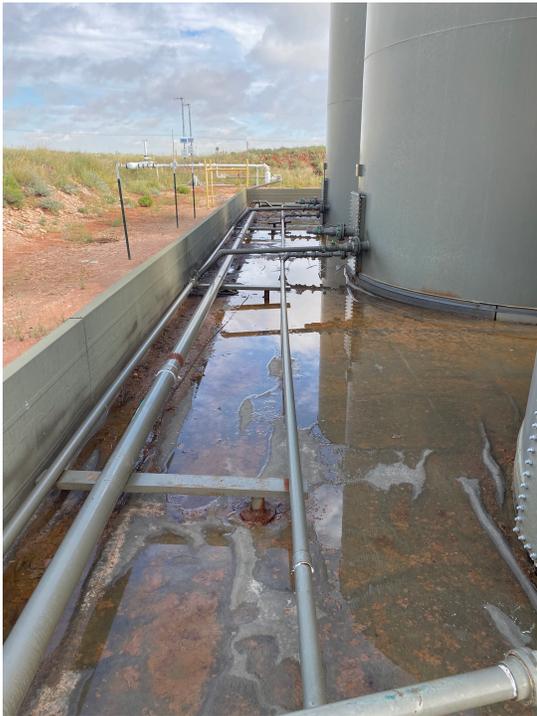
Photo No.	Date	
4	September 2, 2021

<p>The liner was visually inspected and the inspector determined the liner was in good condition.</p> <p>Standing water was precipitation from a rain event.</p>

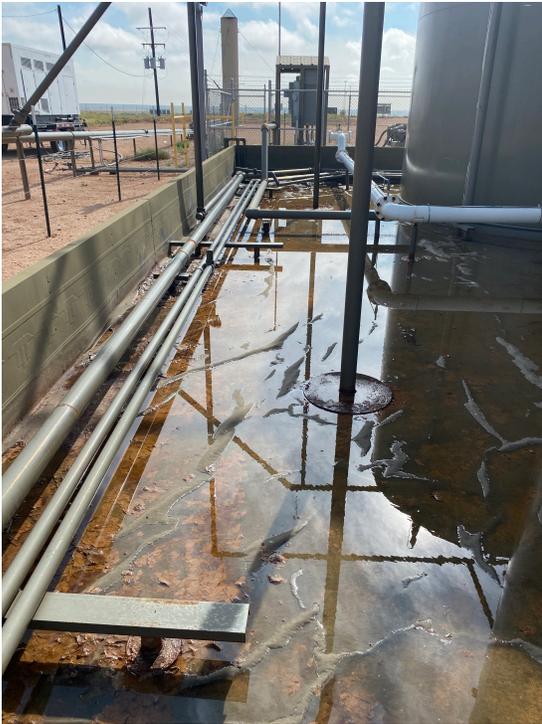
Photo No.	Date	
5	September 2, 2021

<p>The liner was visually inspected and the inspector determined the liner was in good condition.</p> <p>Standing water was precipitation from a rain event.</p>

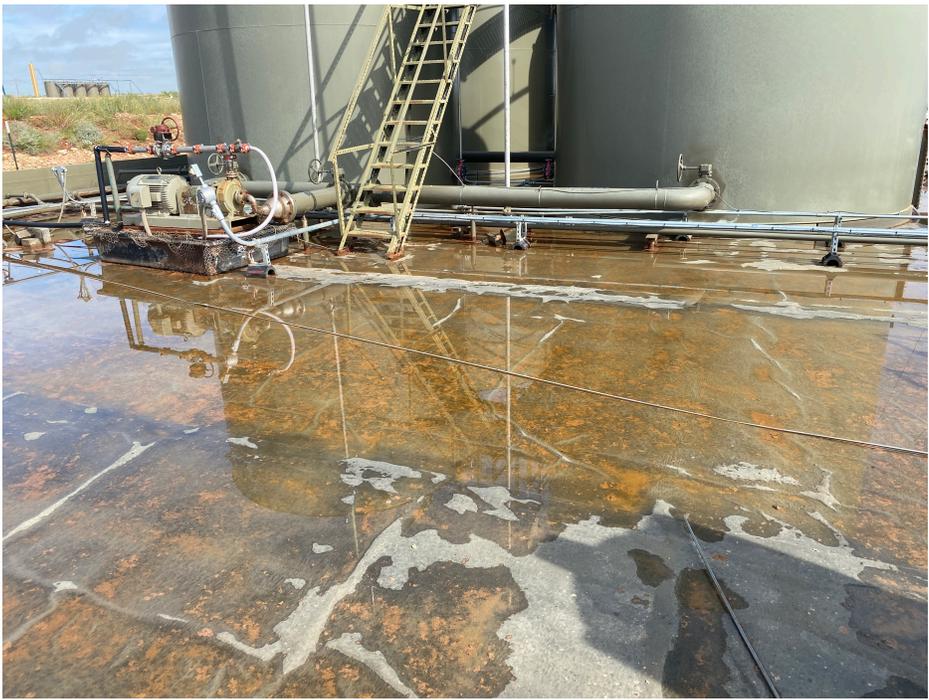
Photo No.	Date	
6	September 2, 2021

<p>The liner was visually inspected and the inspector determined the liner was in good condition.</p> <p>Standing water was precipitation from a rain event.</p>
