## Release Notification

Re: Compromise SWD Closure Report  
30-015-25665  
Section 30, T18S-R27E  
1980' FNL & 880' FEL  
Eddy County, New Mexico  
2RP-4208

**EOG Y Resources, Inc.**  
**Compromise SWD**  
**Closure Report**  
**Section 30, T18S-R27E**  
**Eddy County, New Mexico**  
**May 23, 2018**  
**2RP- 4208**

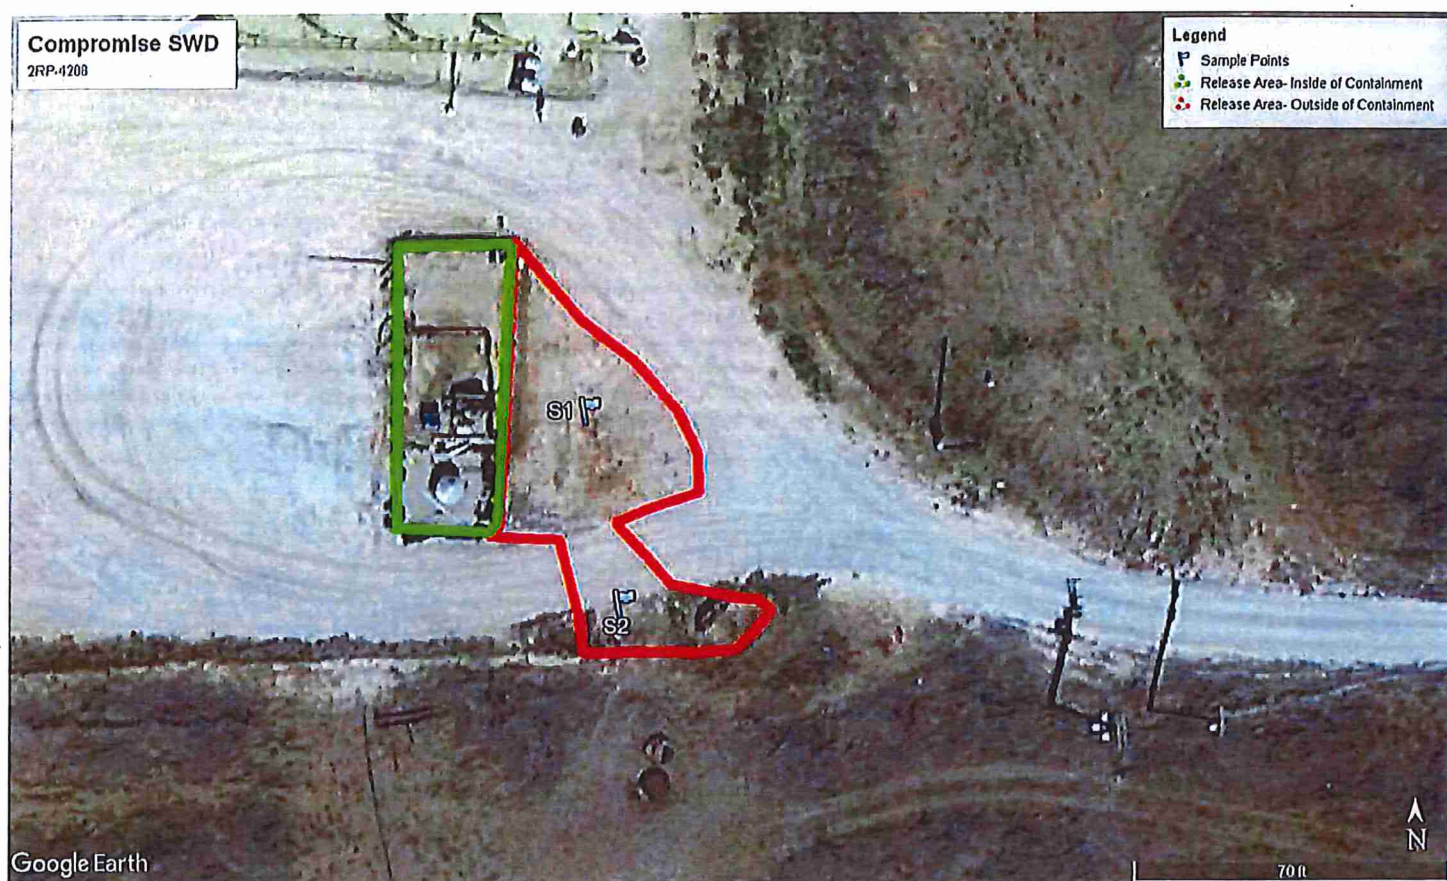
# Figure 2

## Vertical and Horizontal Sample Points

With NMOCD approval of a remediation work plan on November 1, 2017, EOG Y Resources, Inc. excavated four (4) feet of impacted soil from the release area off of the concrete production foundation, hauling all excavated soil to a NMOCD approved facility for disposal. EOG Y Resources, Inc. then took sidewall samples at 1' bgs to confirm that all edges of the release area have been excavated. These results and map of sidewall points were emailed to NMOCD on January 18, 2018, with a request to backfill that was approved by NMOCD on January 23, 2018. EOG Y then installed a 20 ml synthetic liner in the bottom of excavation in all areas except the ONEOK Right Of Way (ROW), as requested by ONEOK and approved by NMOCD on November 30, 2017. The excavation was then backfilled with four (4) feet of caliche, except in the ONEOK ROW where it was their request to have topsoil used for backfill. There will be no re-vegetative measures taken since the release occurred on the production pad of an active salt water disposal facility. The TPH & BTEX for the remaining soil are within the RRAL's for BTEX (50 ppm) and TPH (100 ppm) for the Total Ranking Score of twenty (20), no further analytical testing of TPH and/or BTEX will be conducted. A C-141 Final and request for closure is herein submitted.

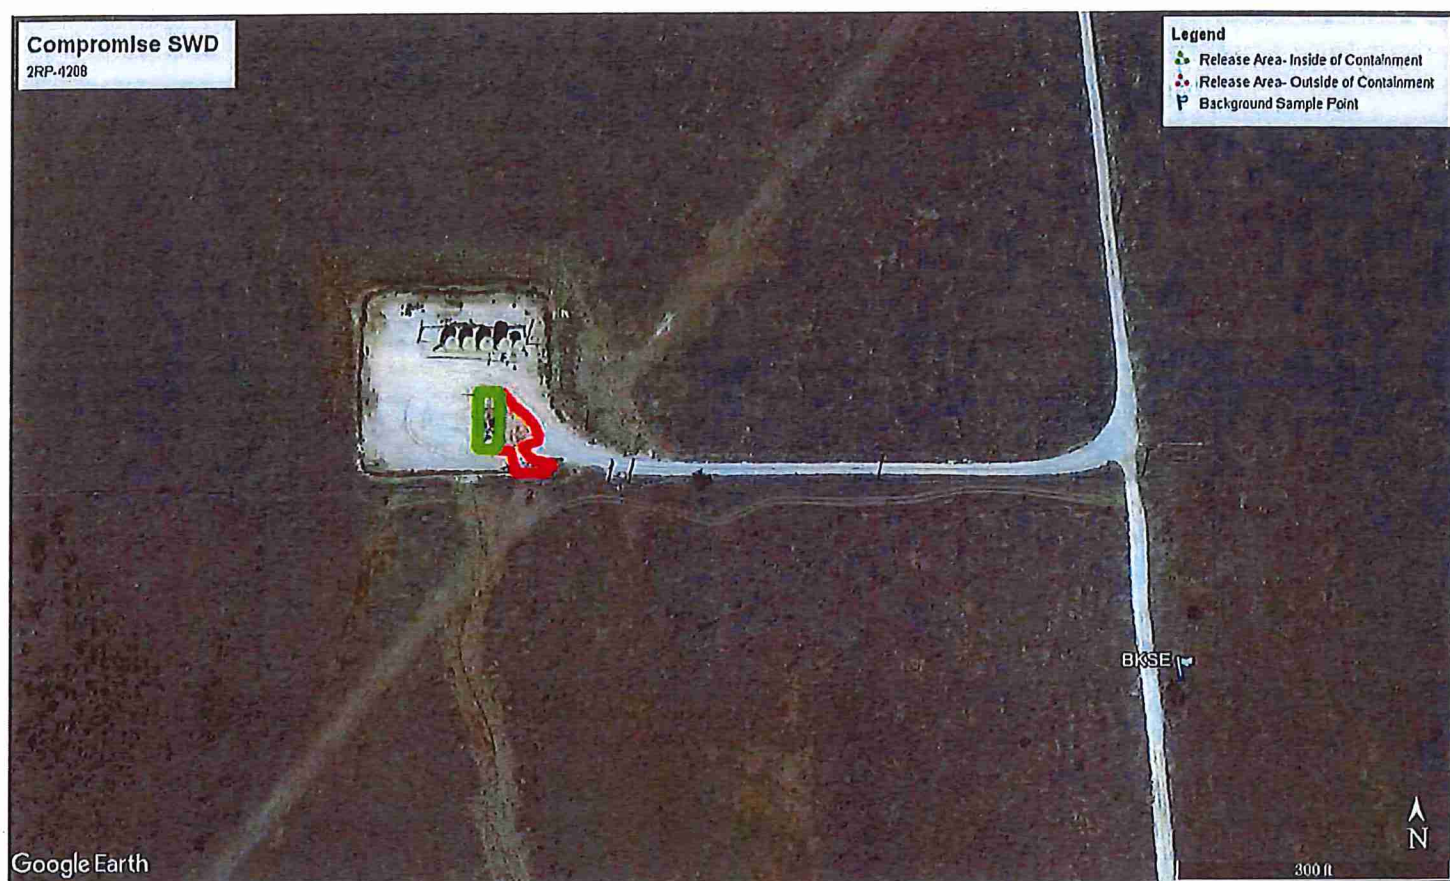
# Figure 3

## Background Sample Point
