| Incident ID | NRM2026238329 |

## Release Notification

| Site Name PLU 28 BS 126H | Site Type Well pad |

**FIGURE 2**  
**PRELIMINARY SOIL SAMPLE LOCATIONS**  
POKER LAKE UNIT 28 BS 126H  
UNIT G SEC 28 T25S R31E  
EDDY COUNTY, NEW MEXICO  
**XTO ENERGY, INC.**

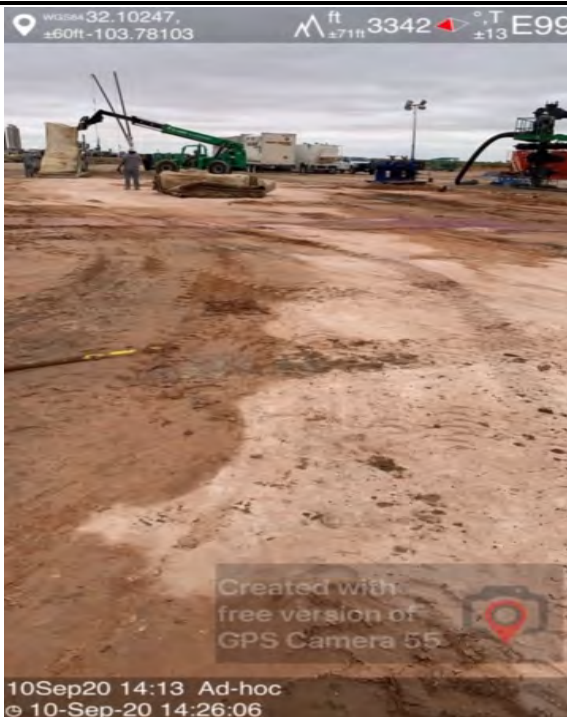
| Photo No. | Date | |
|---|---|---|
| 1 | September 10, 2020 | |

| Photo No. | Date | |
|---|---|---|
| Southeastern view of release extent. | | |

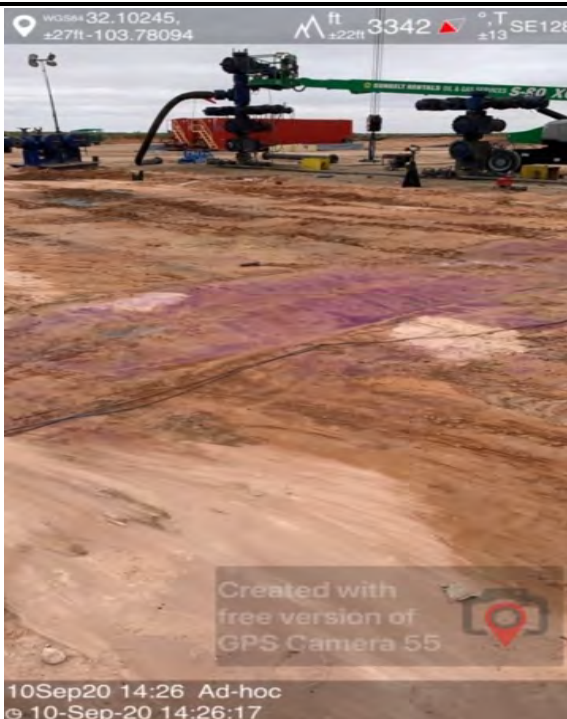
| Photo No. | Date | |
|---|---|---|
| 2 | September 10, 2020 | |

| Photo No. | Date | |
|---|---|---|
| Southeastern view of release extent. | | |

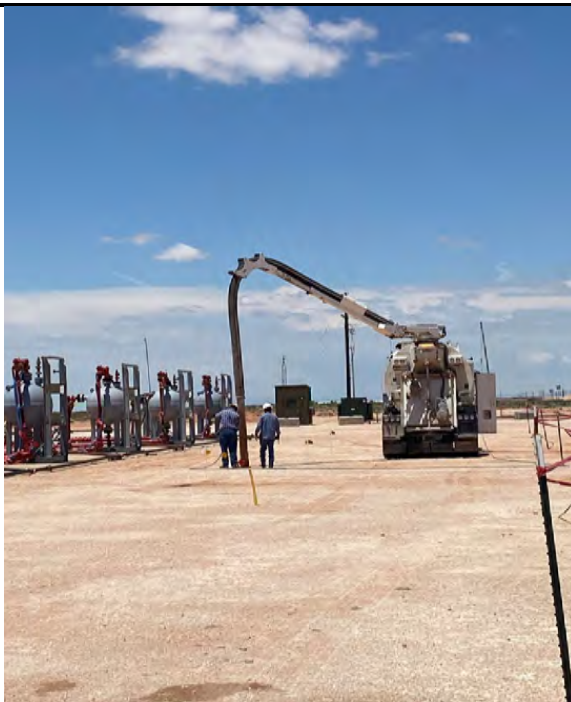
| Photo No. | Date | |
|---|---|---|
| Southwestern view of delineation activities. | | A photograph showing a southwestern view of delineation activities. A large white truck with a long, articulated arm is positioned on a dirt field. Two workers in blue uniforms and hard hats are standing near the truck. In the background, there are several red and white structures, possibly part of a wellhead or pumpjack, and a clear blue sky with some clouds. |

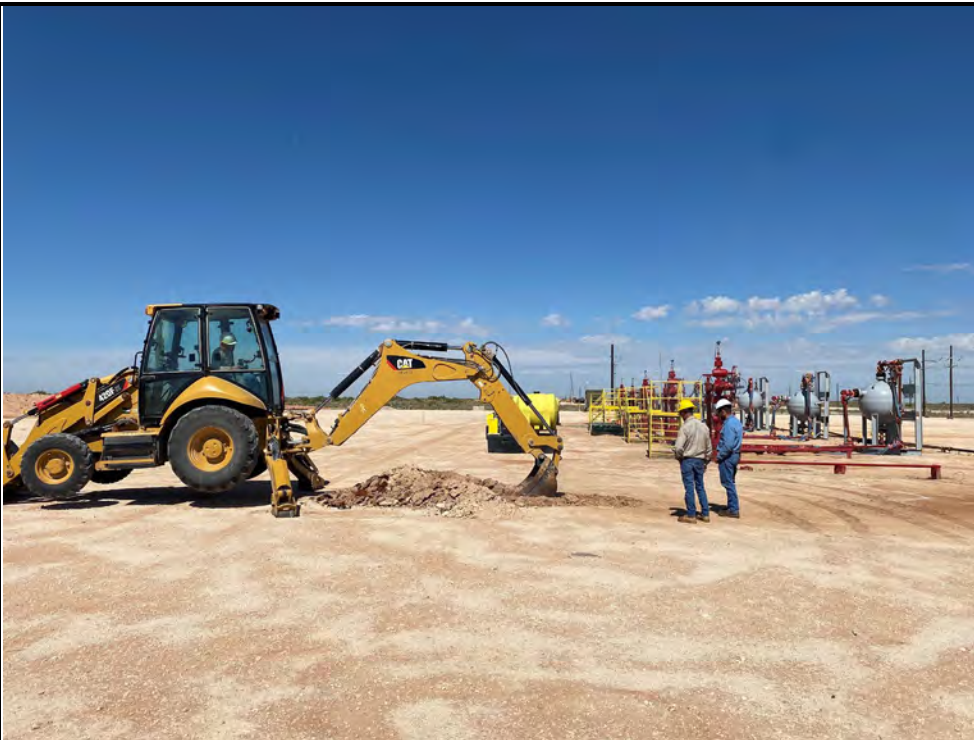
| Photo No. | Date | |
|---|---|---|
| Eastern view of delineation soil sampling activities. | | A photograph showing an eastern view of delineation soil sampling activities. A yellow CAT backhoe loader is digging a hole in the dirt. Two workers in blue uniforms and hard hats are standing nearby. In the background, there are several red and white structures, possibly part of a wellhead or pumpjack, and a clear blue sky with some clouds. |

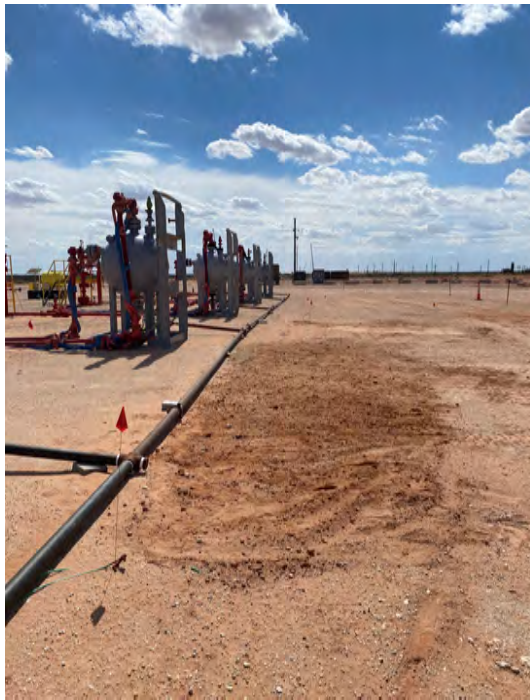
| Photo No. | Date | |
|---|---|---|
| Hand shovel excavation area | | A photograph showing a long, straight line of hand shovel excavation work in a desert environment. The ground is reddish-brown dirt. In the background, there are industrial structures, including a large metal frame and pipes, under a blue sky with scattered white clouds. |

Based on the limited extent of hydrocarbon impacted surface soil identified around preliminary samples SS01 and SS02, excavation and Micro-Blaze® application were warranted. On June 4, 2021, WSP personnel were at the Site to oversee excavation of impacted surface soil as indicated by surficial staining, field screening activities, and laboratory analytical results for preliminary samples SS01 and SS02. The release was located in area with multiple active subsurface lines; therefore, the impacted surface soil was excavated via hand shoveling. The excavations around preliminary samples SS01 and SS02 were completed to a depth of approximately 0.5 feet bgs. Following removal of impacted soil, WSP applied a solution of Micro-Blaze®, a biological amendment promoting microbial degradation, across the excavation areas to further address any residual hydrocarbons.

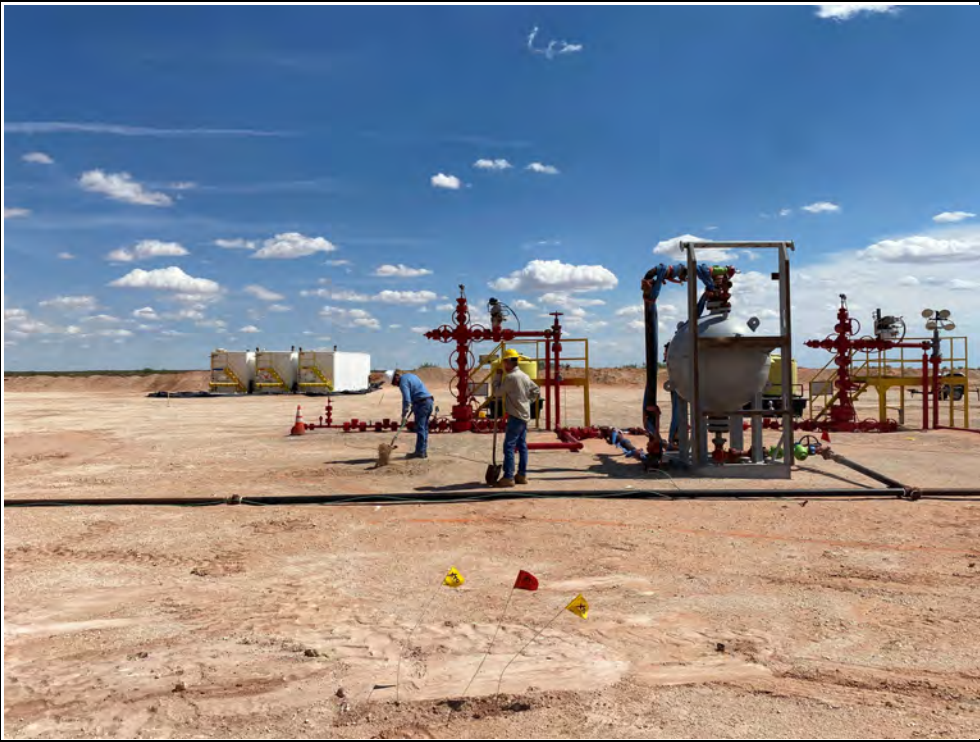
| Photo No. | Date | |
|---|---|---|
| Hand shoveling activities. | | A photograph showing two workers in a desert environment performing hand shoveling activities. The workers are wearing hard hats and safety gear. They are standing near a large industrial structure, possibly a wellhead or pumpjack, which is surrounded by pipes and valves. The ground is reddish-brown dirt. In the background, there are white storage tanks and other industrial equipment under a blue sky with scattered white clouds. |
