Release Notification

Site Name	West Dollarhide Queen Sand Unit Satellite 3	Site Type	Gathering/Header system for injection wells
Date Release Discovered	2/8/2017 10:00am	API# (if applicable)

Release was caused by faulty valve on 4" trunk line. Line was shut in, no further fluid spilled. Line has been repaired. New dikes will be built around all fluid production satellites.

1RP-4599 fOY1704157843 nOY1704158265

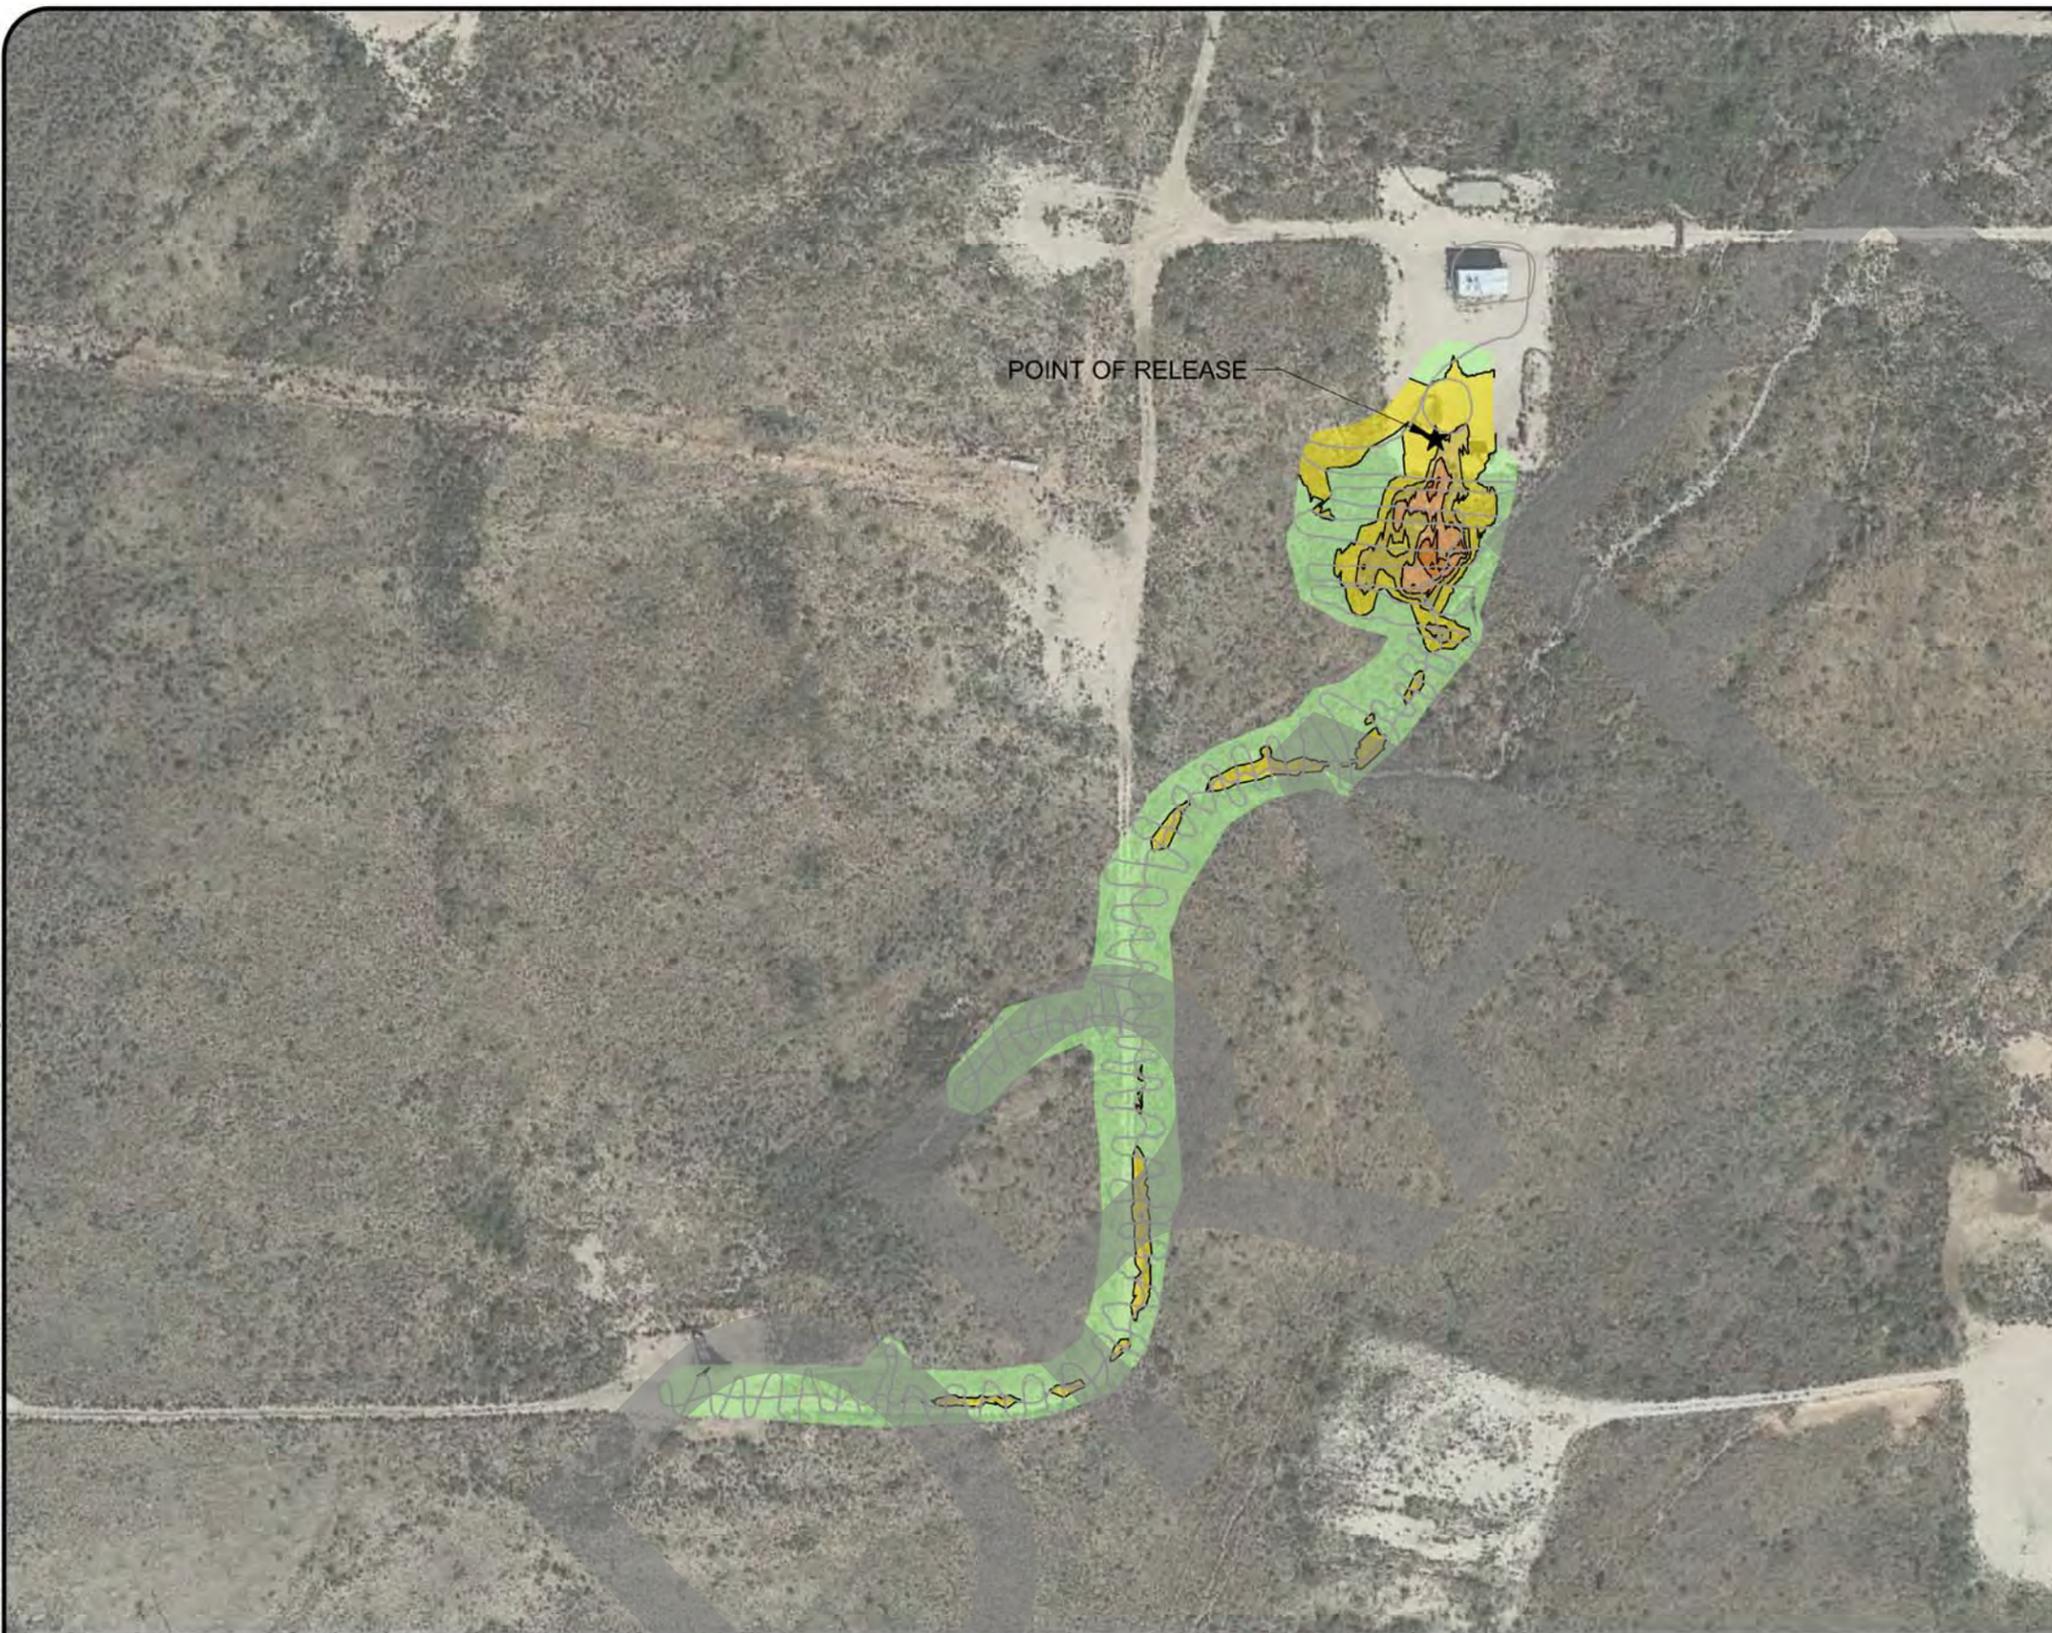
PROJECT NUMBER	FIGURE NUMBER
RAMRNM0001	2

The EM results have been contoured using a 60 mmhos/m interval. Soils having background conductivity levels up to 60 mmhos/m are shown in the light green shading. Based upon ECC's experience with this meter, we expect EM conductivities greater than approximately 60 mmhos/m to exceed the WQCC 250 mg/kg chloride level. Within these light green areas, very little to none of the soils are expected to have been impacted above WQCC levels. Areas shaded in yellow, orange and red are progressively more impacted by brine and will likely require remedial delineation. The following potentially impacted areas have been calculated for both the 0.5-m and 1-m EM responses:

From ECC's review of the conductivity results, it appears that background levels for the WDQSU Sat 3 site range from 3 to 40 mmhos/m. The maximum 0.5-m and 1-m conductivity measurements at the site were 541.95 and 385.70 mmhos/m, respectively.

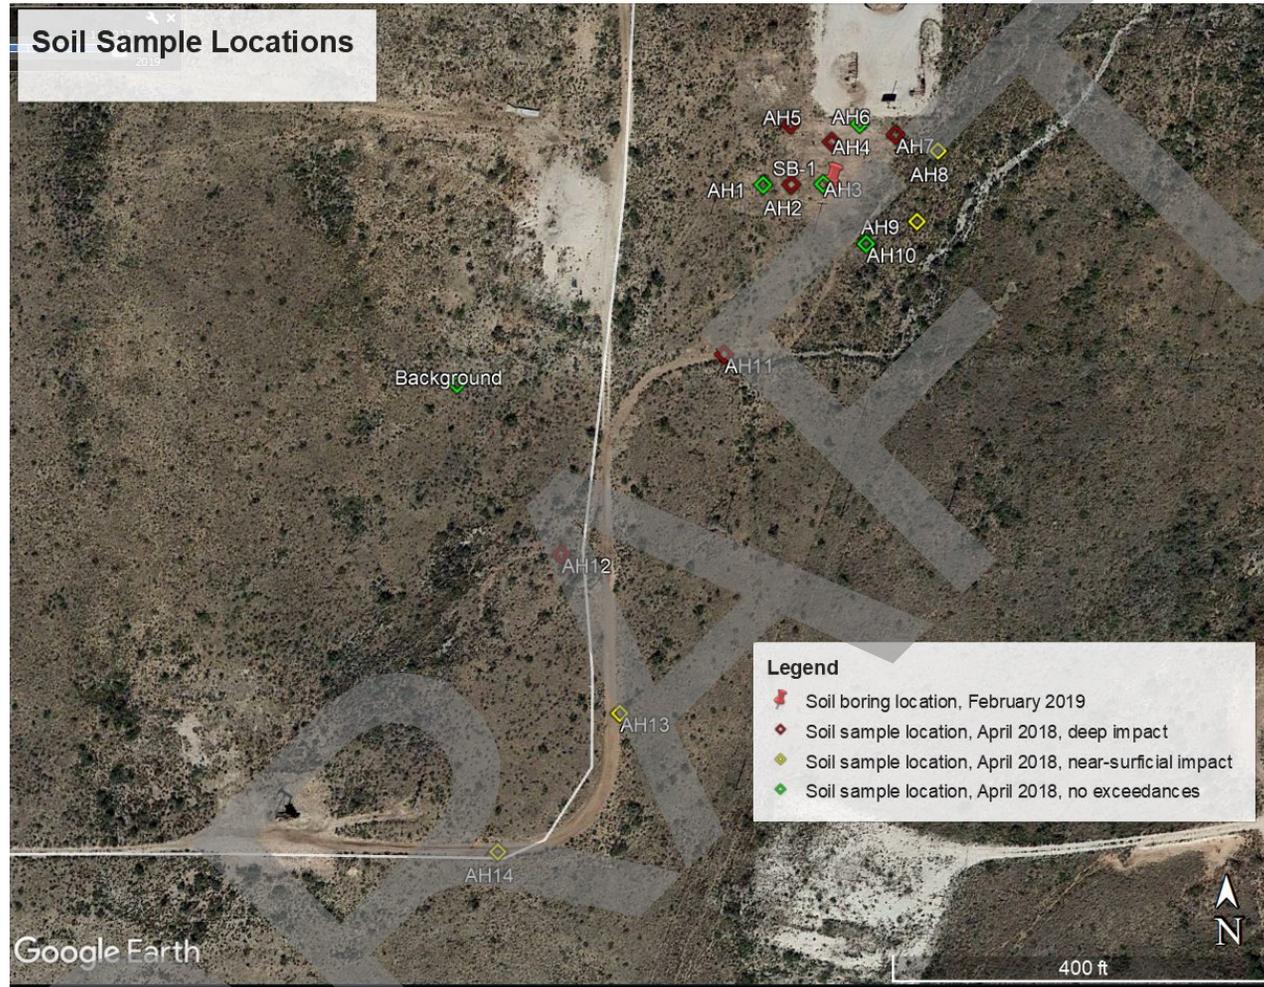
Soil Boring Location Map, RAM Energy, Satellite 3 Release		
Drawn By: DL

Date: 9/3/2018
Project Manager: DL		Figure No.: 3

Through a series of correspondences in 2017 and 2018, NMOCD noted that additional delineation should be completed for the Site, prior to commencing excavation. In March 2018, NMOCD approved a delineation workplan (communicated via e-mail) that included collecting and analyzing samples from 14 hand-augered soil borings and one deeper soil boring within the area that the EM survey and visual observations indicated had been impacted by the release. Samples collected from the borings were to be assessed for Total Petroleum Hydrocarbons (TPH); benzene, toluene, ethylbenzene, and xylenes (BTEX); and chlorides.

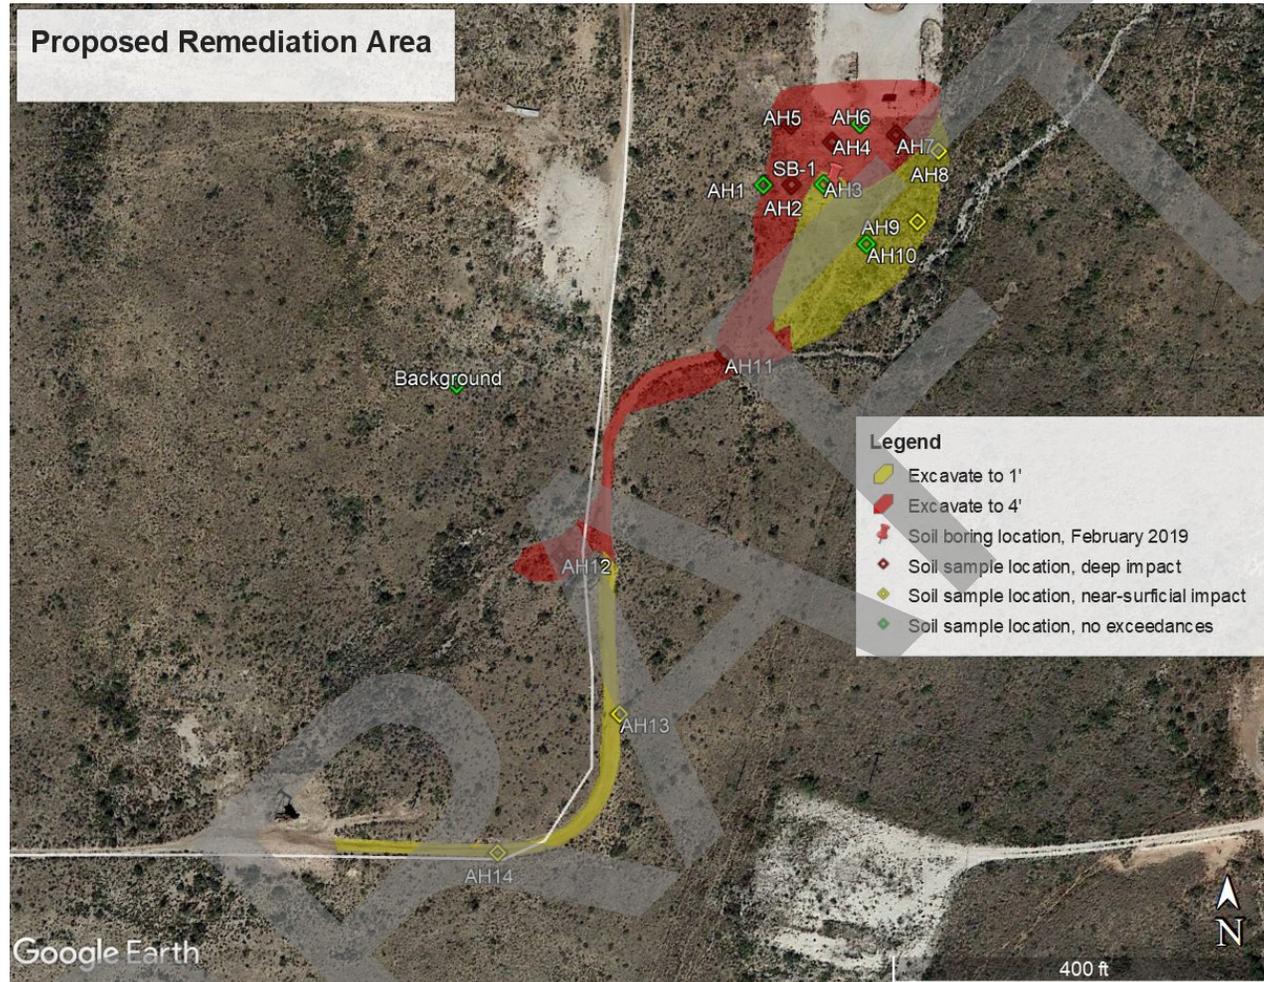
Proposed Remediation Area, RAM Energy, Satellite 3 Release		
Drawn By: DL

The constituent that is the driver for soil remediation is chloride. Since chloride cannot be reduced using degradation processes, the proposed remedial option is the excavation of impacted media coupled with off-site disposal. Altamira recommends the removal and replacement of Site soils that exceed the RRALs and the chloride cleanup level. The proposed remediation areas are shown on *Figure 5*.

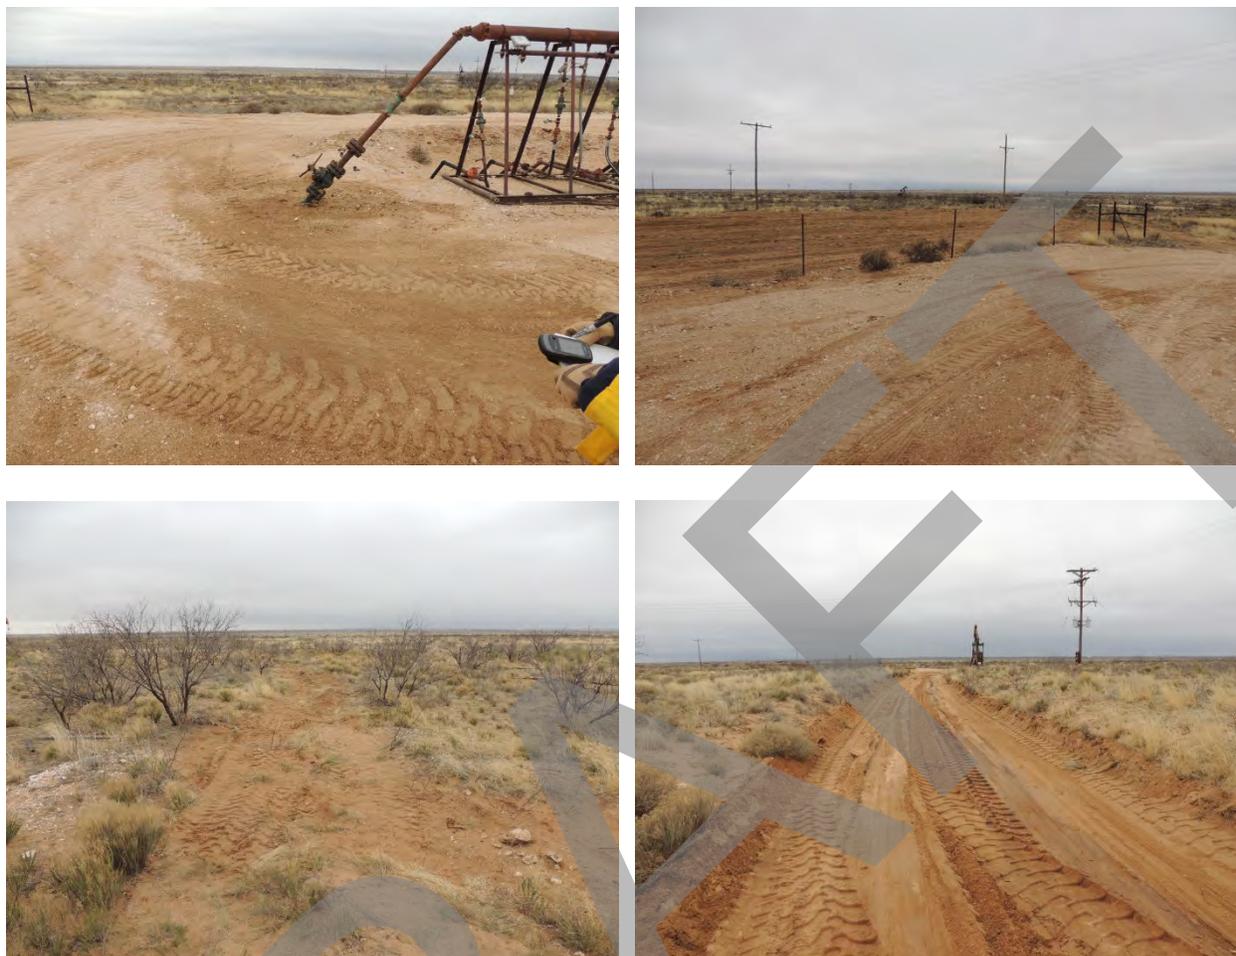
Enviro Clean Cardinal, LLC (ECC) has prepared the following remedial workplan to address the New Mexico Oil Conservation Division (OCD) correspondence concerning the February 8, 2017, release at the RAM Energy Resources (RAM) West Dollarhide Queen Sand Unit Satellite 3 (WDQSU Sat 3), in Lea County, New Mexico. RAM's Form C-141 indicates the release was 10 to 15 barrels (bbls) of produced water which flowed approximately 1,200 feet along a spill path terminating at the West Dollarhide Queen Sand Unit #92 well location. The following photographs represent conditions at the time of release, and current site conditions as observed on February 13th.

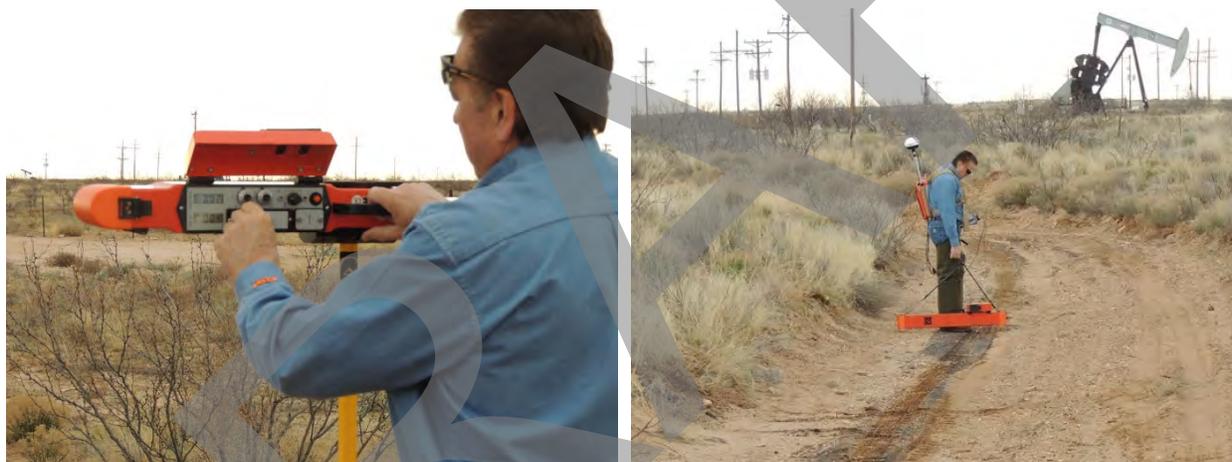
Using walking traverses that were generally perpendicular to the flowpath of the released fluids, ECC collected 6,369 data-point locations across the site. The pathways are shown as light gray lines on the *Survey Results* maps attached to this workplan.

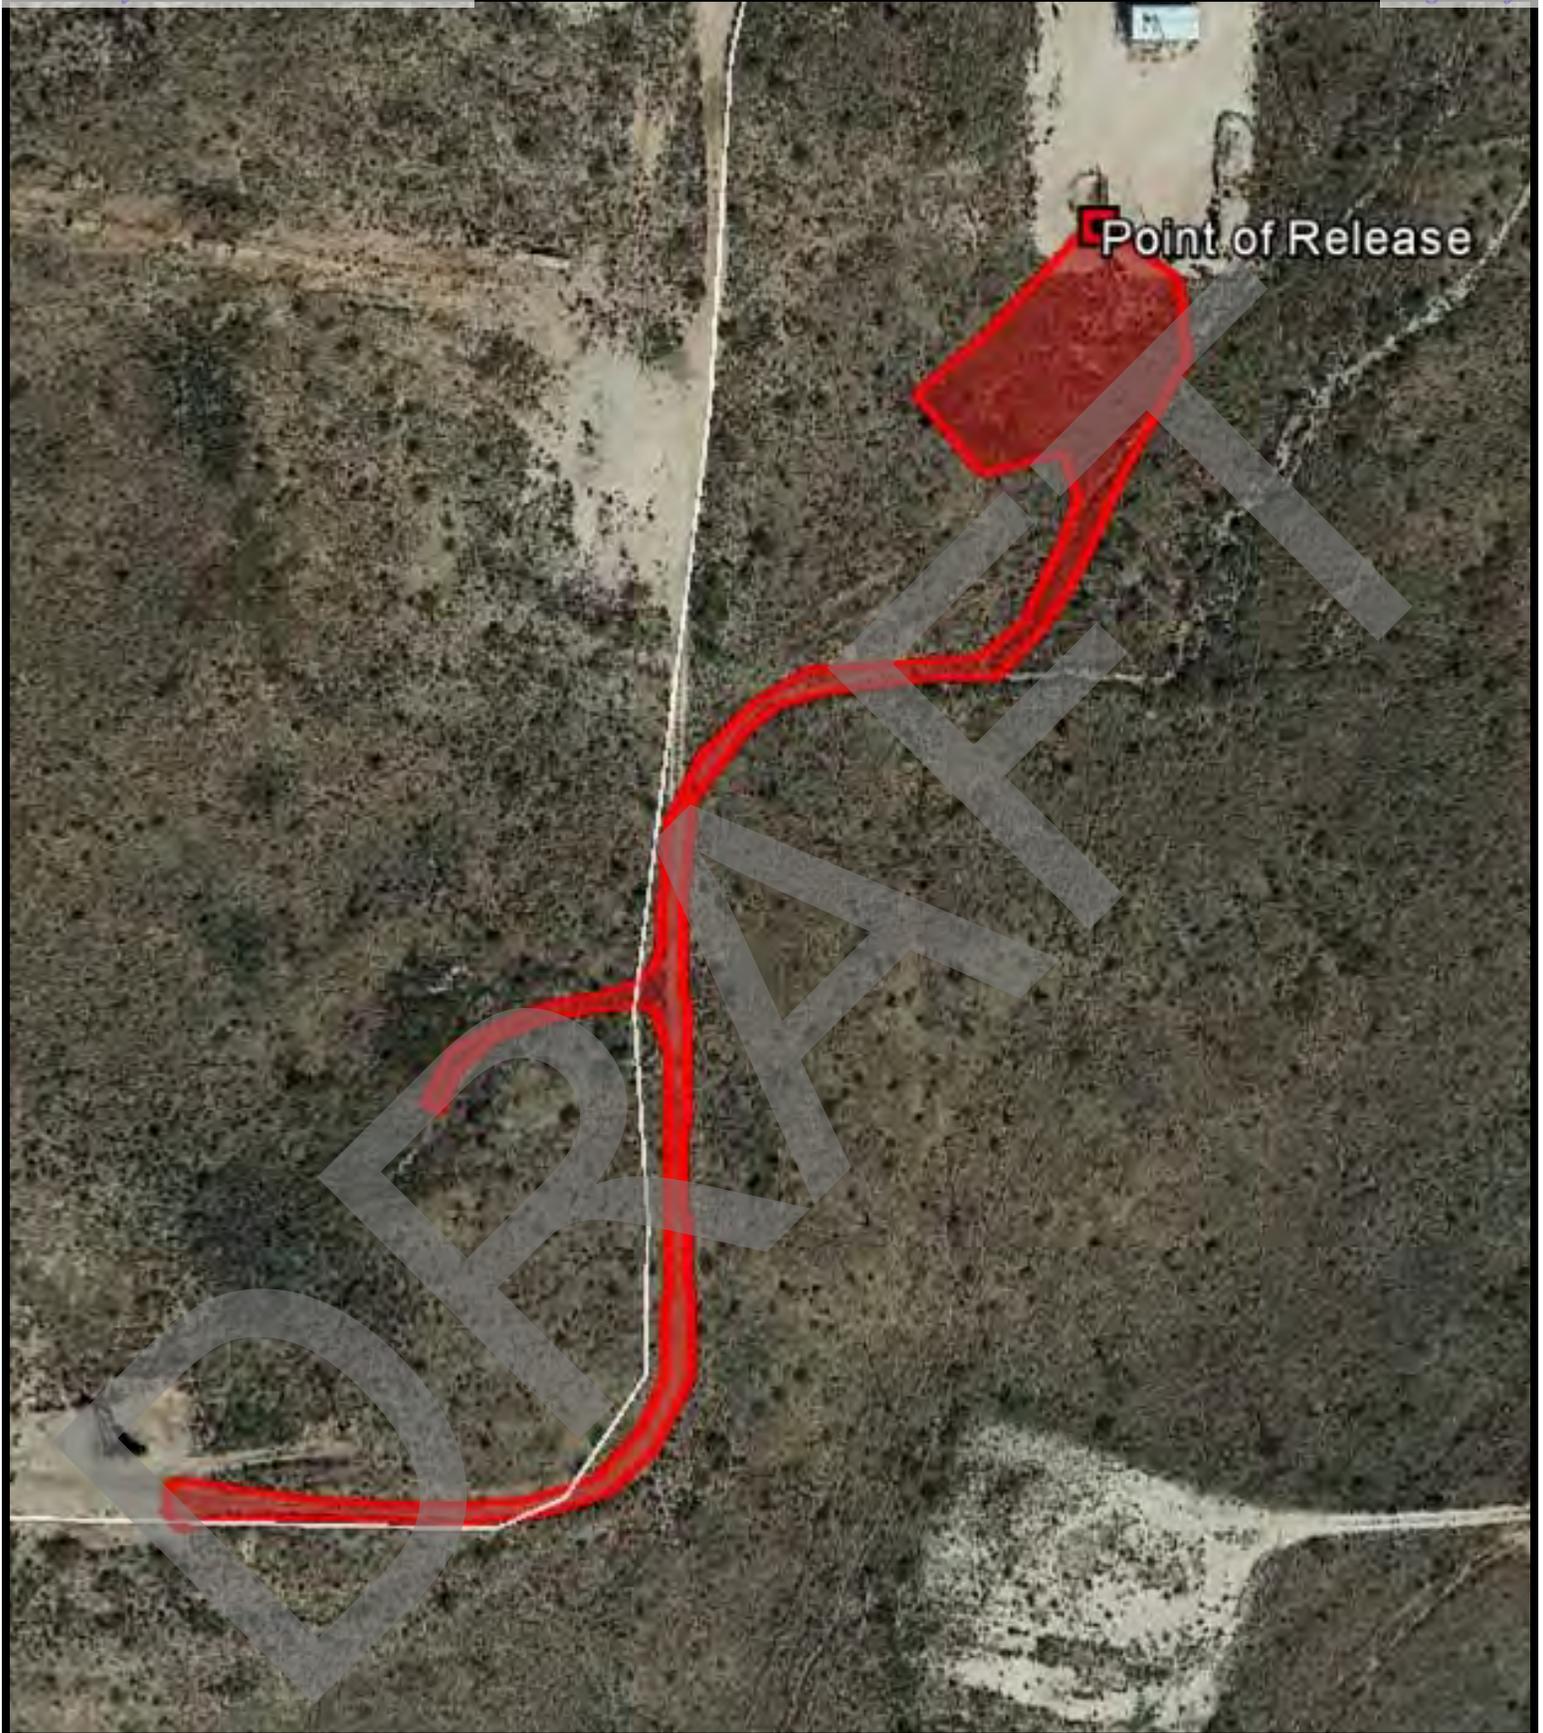
Point of Release

This OCD workplan has been prepared to comply with 19.15.29.11 NMAC as well as the *Guidelines for Remediation of Leaks, Spills and Releases* (August 13, 1993) delineation requirements. The attached *Release Location Map* identifies the visibly impacted media covered by this response workplan.

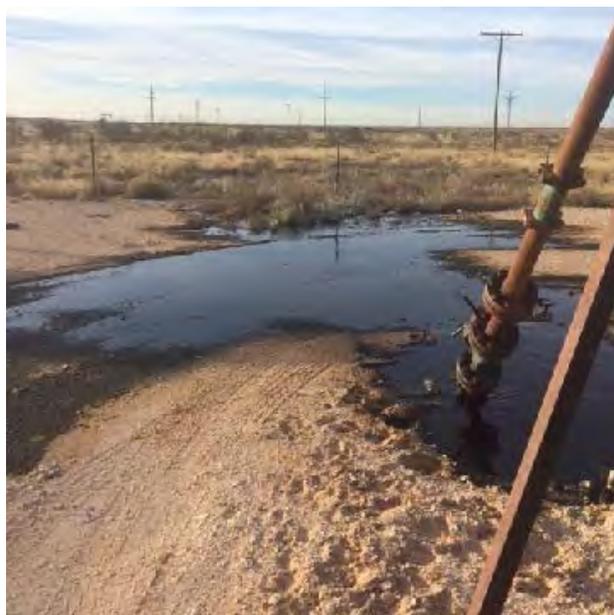
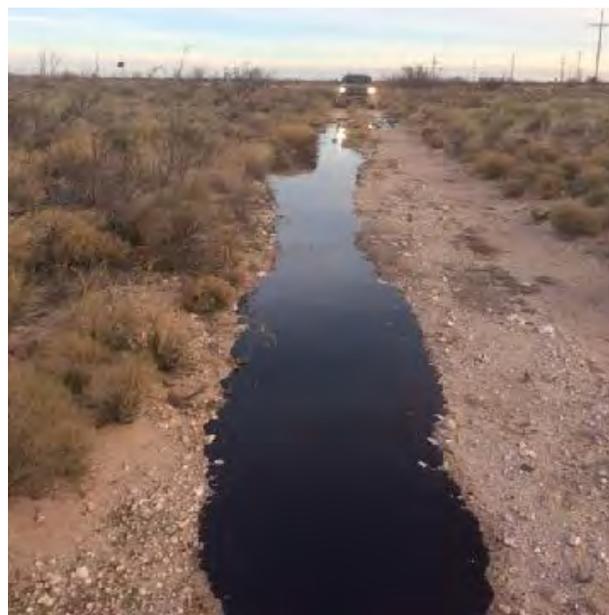
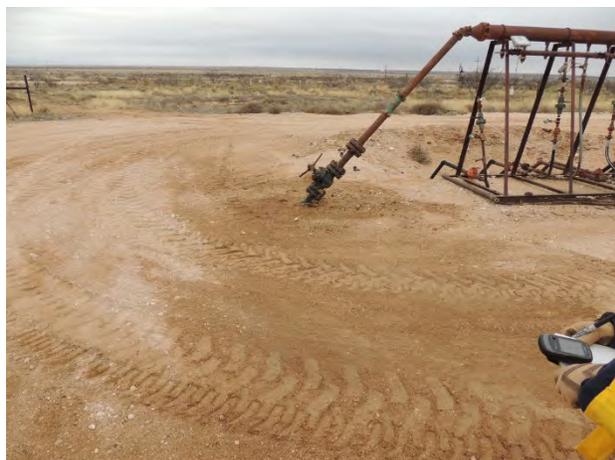
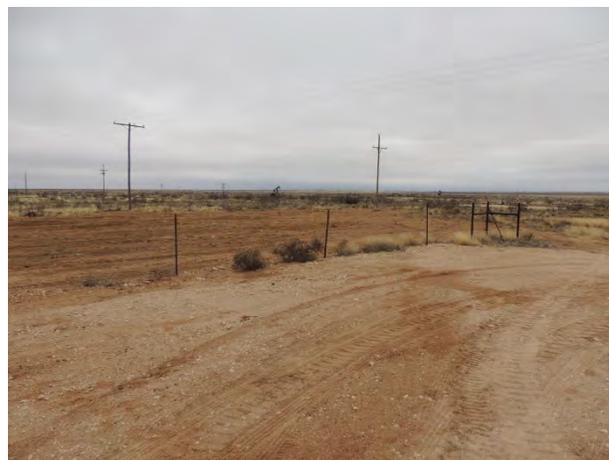
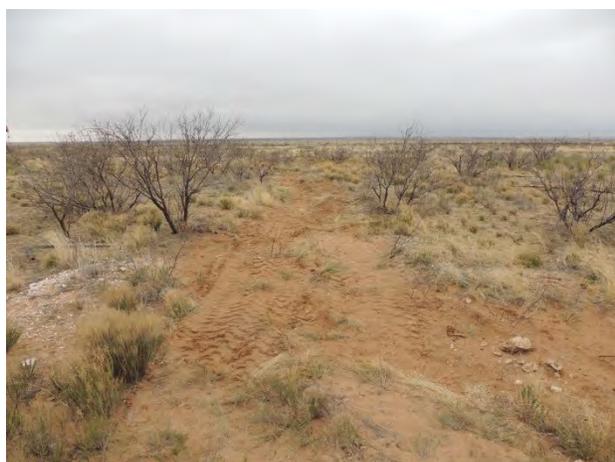
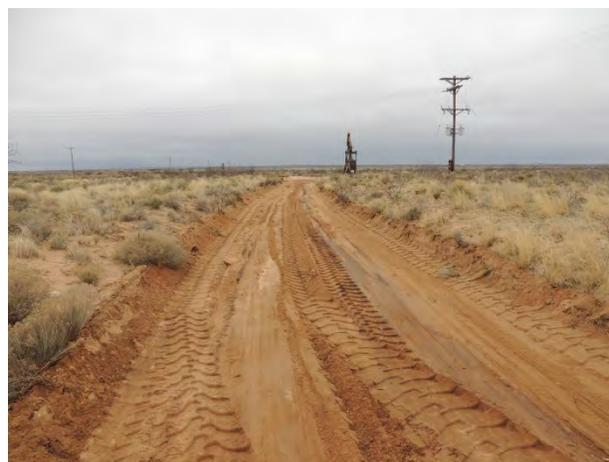
Enviro Clean Cardinal, LLC (ECC) has prepared the following remedial workplan to address the New Mexico Oil Conservation Division (OCD) correspondence concerning the February 8, 2017, release at the RAM Energy Resources (RAM) West Dollarhide Queen Sand Unit Satellite 3 (WDQSU Sat 3), in Lea County, New Mexico. RAM's Form C-141 indicates the release was 10 to 15 barrels (bbls) of produced water which flowed approximately 1,200 feet along a spill path terminating at the West Dollarhide Queen Sand Unit #92 well location. The following photographs represent conditions at the time of release, and current site conditions as observed on February 13th.

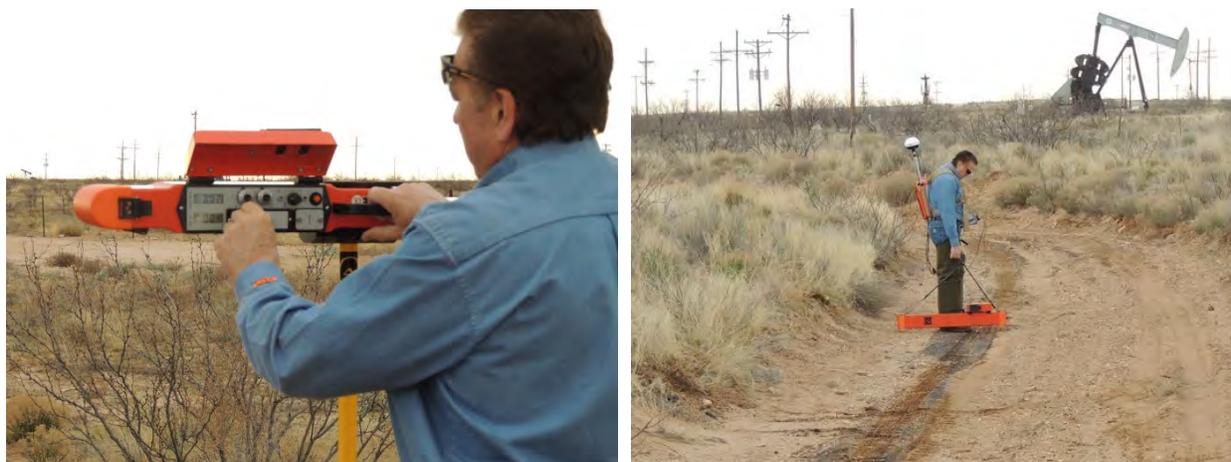
Using walking traverses that were generally perpendicular to the flowpath of the released fluids, ECC collected 6,369 data-point locations across the site. The pathways are shown as light gray lines on the *Survey Results* maps attached to this workplan.

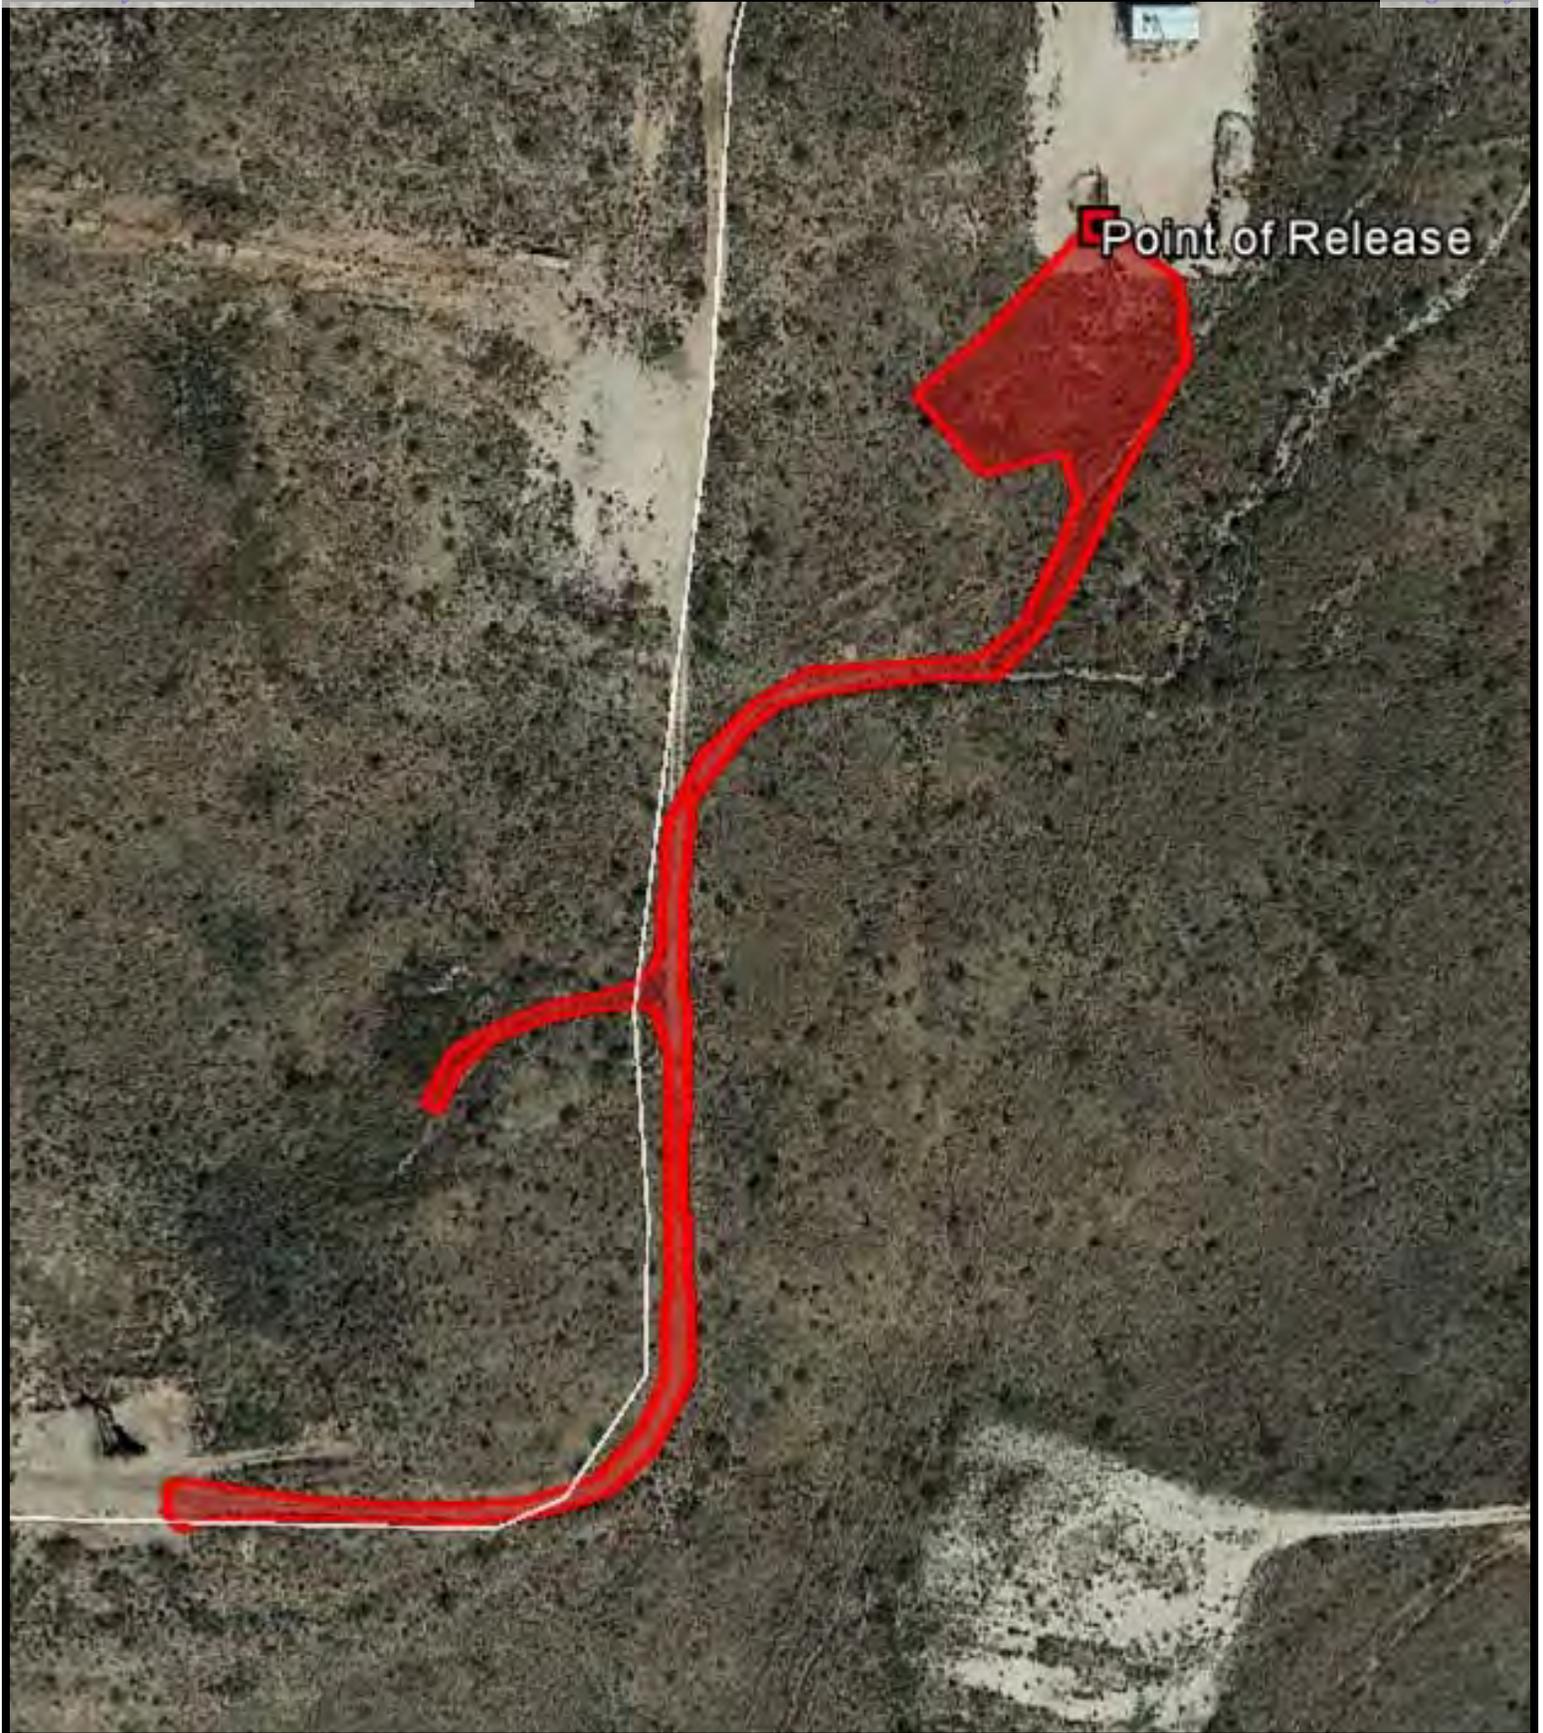
Point of Release

This OCD workplan has been prepared to comply with 19.15.29.11 NMAC as well as the *Guidelines for Remediation of Leaks, Spills and Releases* (August 13, 1993) delineation requirements. The attached *Release Location Map* identifies the visibly impacted media covered by this response workplan.

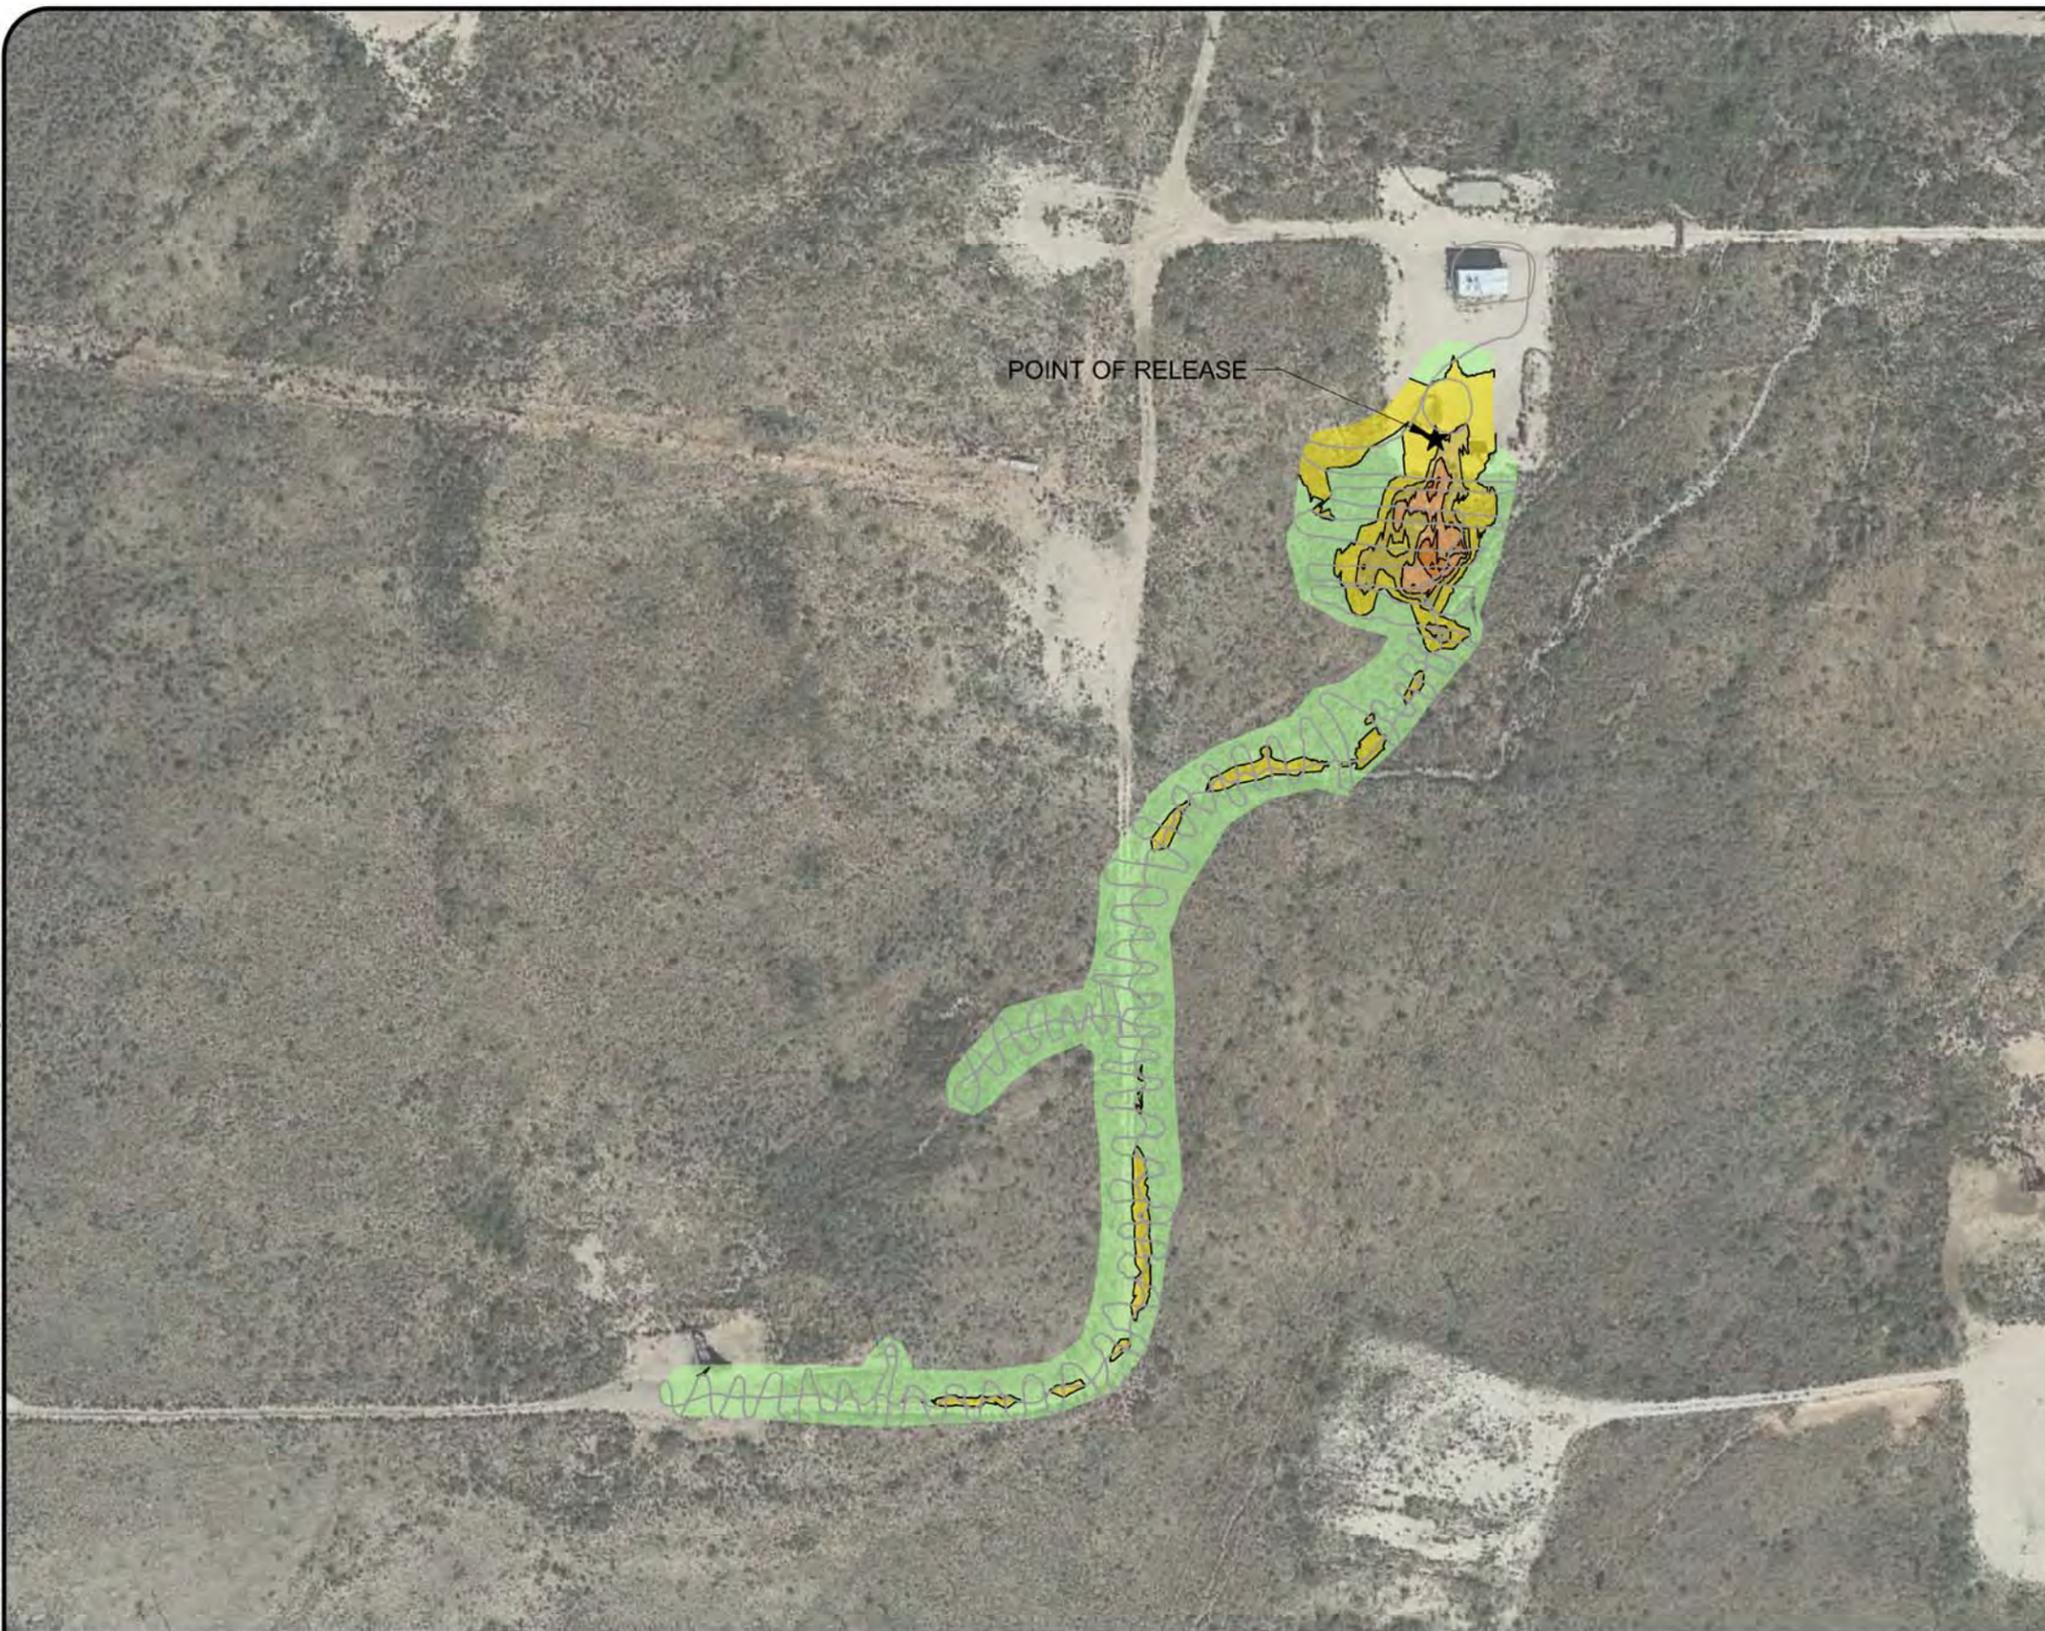
The EM results have been contoured using a 60 mmhos/m interval. Soils having background conductivity levels up to 60 mmhos/m are shown in the light green shading. Based upon ECC's experience with this meter, we expect EM conductivities greater than approximately 60 mmhos/m to exceed the WQCC 250 mg/kg chloride level. Within these light green areas, very little to none of the soils are expected to have been impacted above WQCC levels. Areas shaded in yellow, orange and red are progressively more impacted by brine and will likely require remedial delineation. The following potentially impacted areas have been calculated for both the 0.5-m and 1-m EM responses:

From ECC's review of the conductivity results, it appears that background levels for the WDQSU Sat 3 site range from 3 to 40 mmhos/m. The maximum 0.5-m and 1-m conductivity measurements at the site were 541.95 and 385.70 mmhos/m, respectively.
