Release Notification

Site Name	West Dollarhide Queen Sand Unit Satellite 3	Site Type	Gathering/Header system for injection wells
Date Release Discovered	2/8/2017 10:00am	API# (if applicable)

Release was caused by faulty valve on 4" trunk line. Line was shut in, no further fluid spilled. Line has been repaired. New dikes will be built around all fluid production satellites.

1RP-4599 fOY1704157843 nOY1704158265

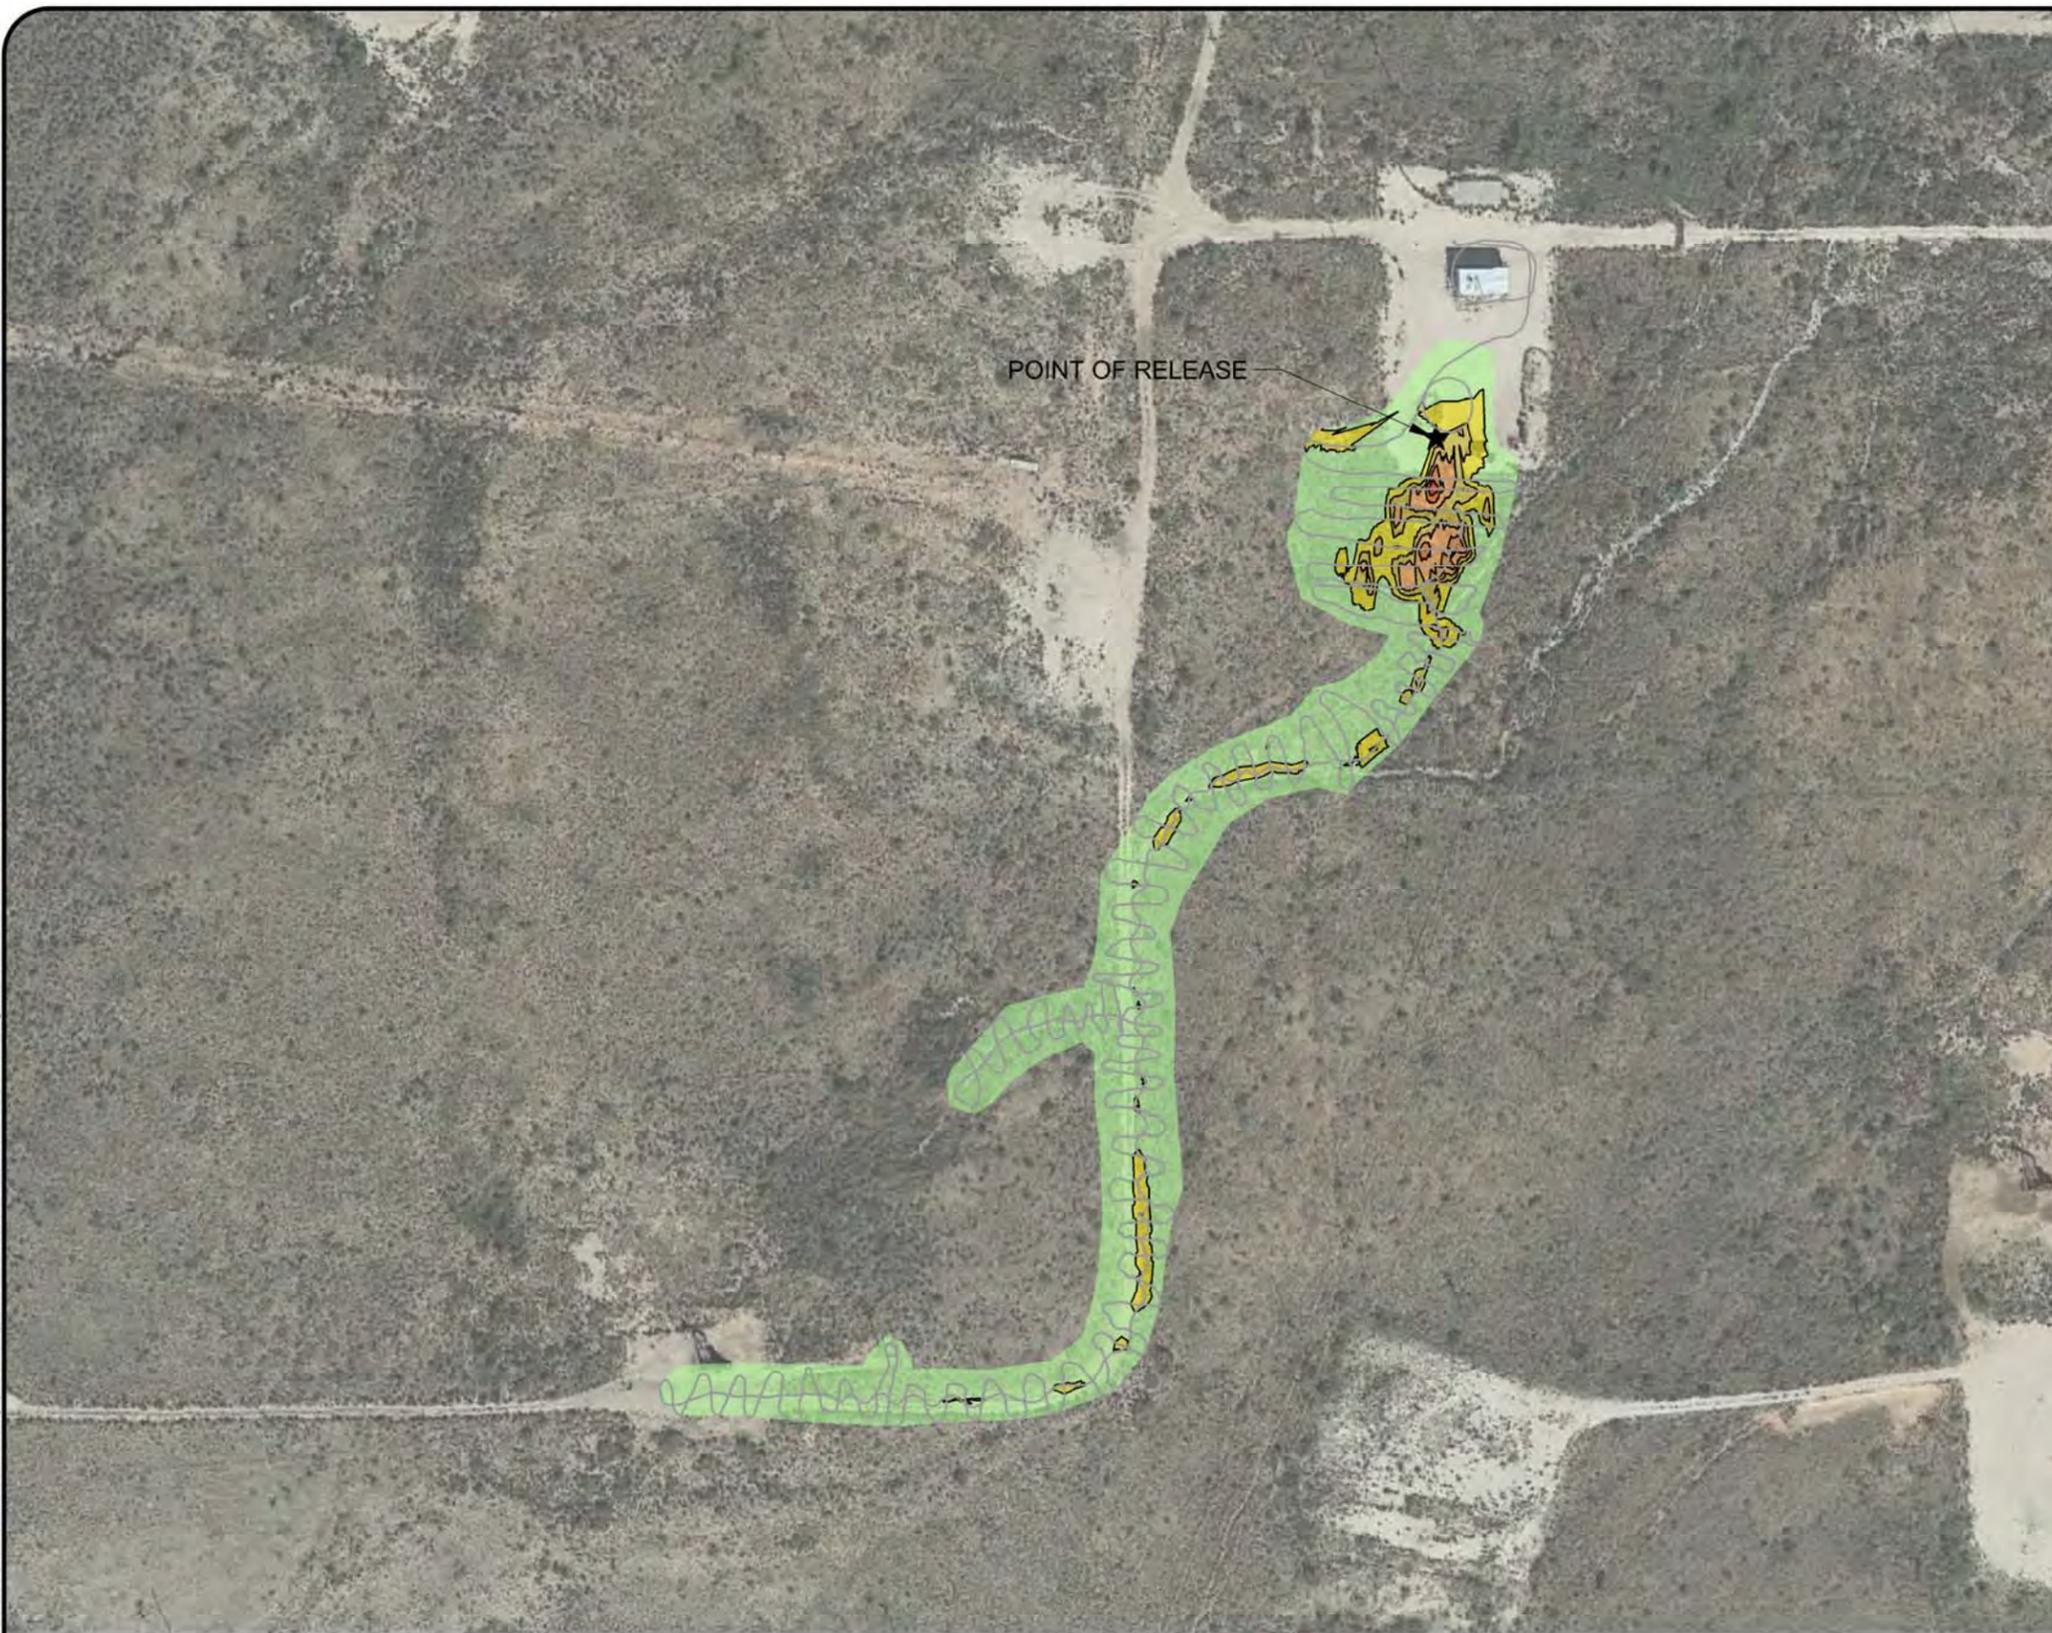
The EM results have been contoured using a 60 mmhos/m interval. Soils having background conductivity levels up to 60 mmhos/m are shown in the light green shading. Based upon ECC's experience with this meter, we expect EM conductivities greater than approximately 60 mmhos/m to exceed the WQCC 250 mg/kg chloride level. Within these light green areas, very little to none of the soils are expected to have been impacted above WQCC levels. Areas shaded in yellow, orange and red are progressively more impacted by brine and will likely require remedial delineation. The following potentially impacted areas have been calculated for both the 0.5-m and 1-m EM responses:

From ECC's review of the conductivity results, it appears that background levels for the WDQSU Sat 3 site range from 3 to 40 mmhos/m. The maximum 0.5-m and 1-m conductivity measurements at the site were 541.95 and 385.70 mmhos/m, respectively.
