Re: Site Assessment, Remediation, and Closure Report
Beech Federal #2 Battery
API No. N/A
GPS: Latitude 32.8023071 Longitude -104.2290268
UL "J", Sec. 25, T17S, R27E
Eddy County, NM
NMOCD Ref. No. NAPP2119560689

Pima Environmental Services, LLC. (Pima) has been contracted by Spur Energy Partners, LLC. (Spur) to perform a spill assessment and submit this closure report for a produced water release that occurred at the Beech Federal #2 Battery (Beech). The initial C-141 was submitted on July 19th, 2021 (Appendix C). This incident was assigned Incident ID NAPP2119560689 by the New Mexico Oil Conservation Division (NMOCD)

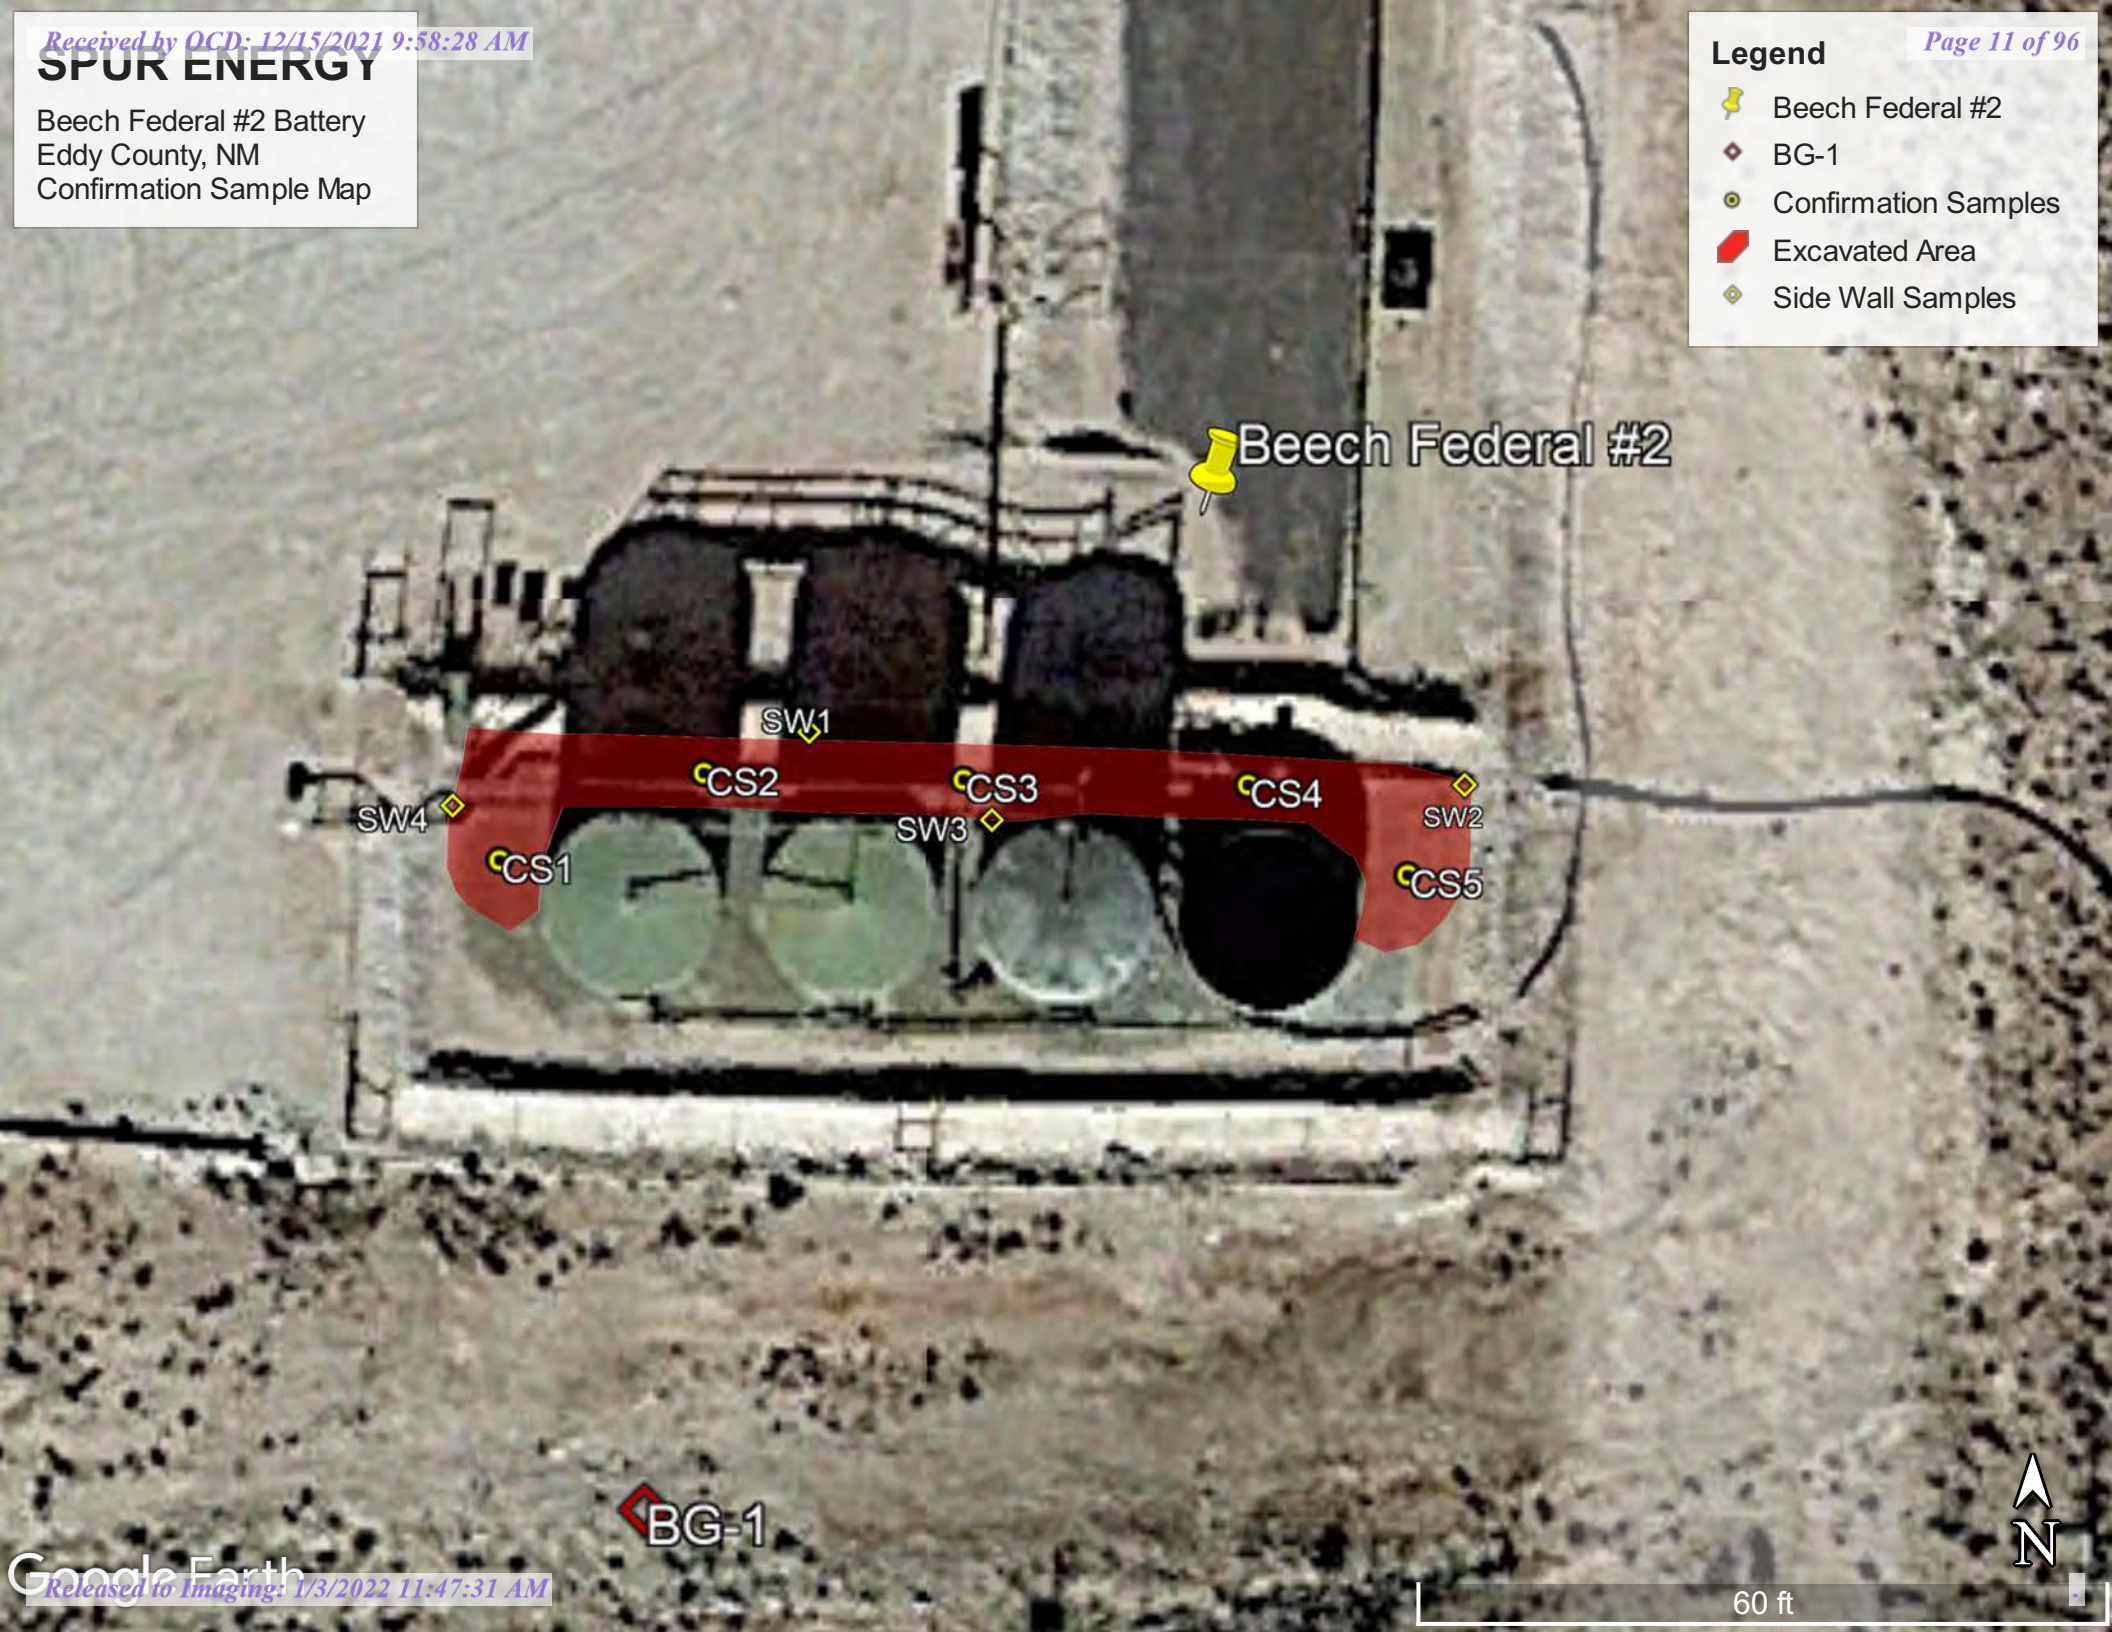
Beech Federal #2 Battery
Eddy County, NM
Confirmation Sample Map

Based on the sample results, the bottom and sidewalls were below NMOCD Closure Criteria 19.15.29 NMAC. The contaminated material was transported to Lea Land, an NMOCD approved disposal site. The excavation was then backfilled with clean like material, machine compacted and contoured to match the surrounding terrain. See Appendix D for Photographic Documentation. A Confirmation Sample Map can be found in Figure 5.

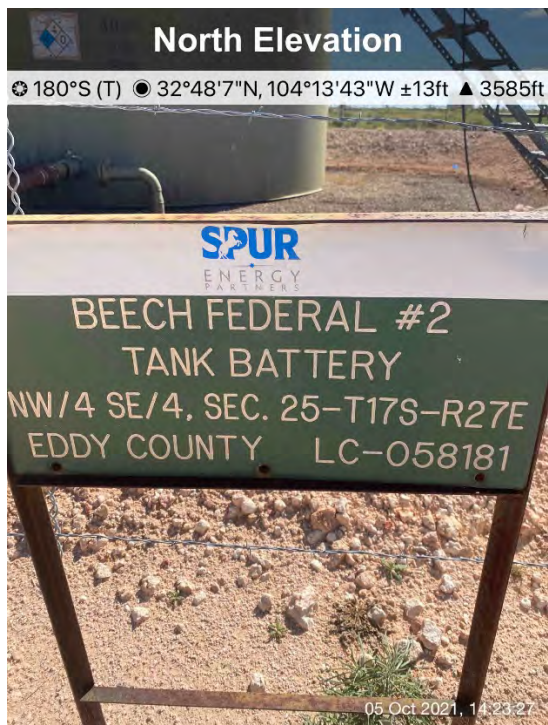
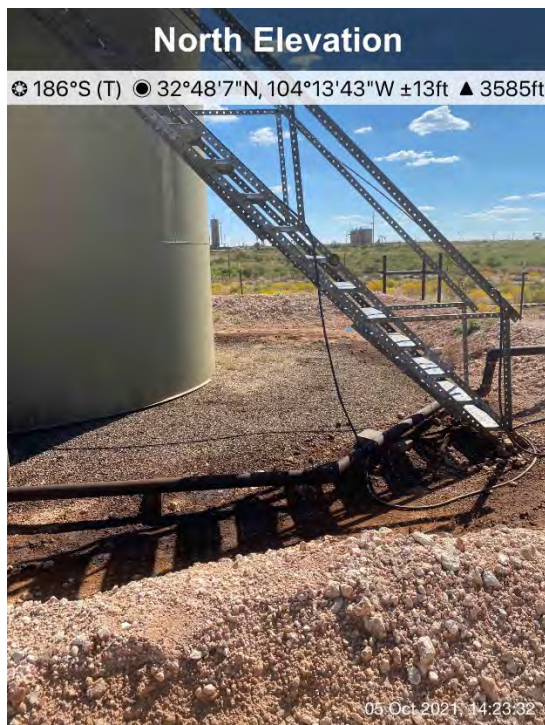
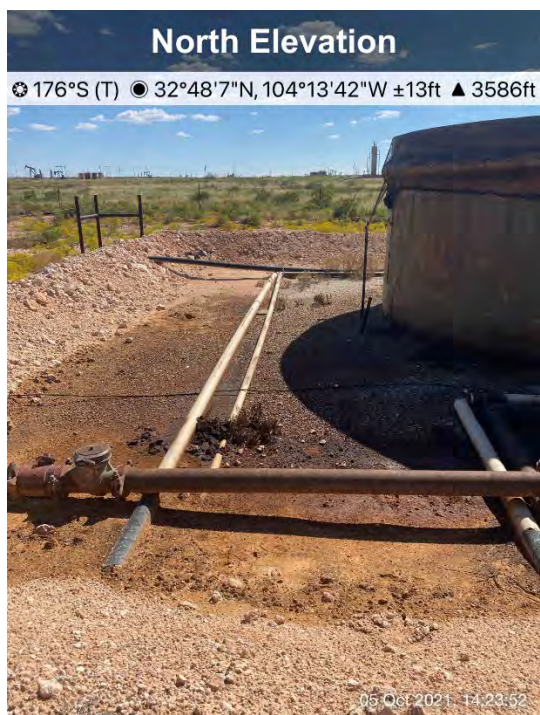
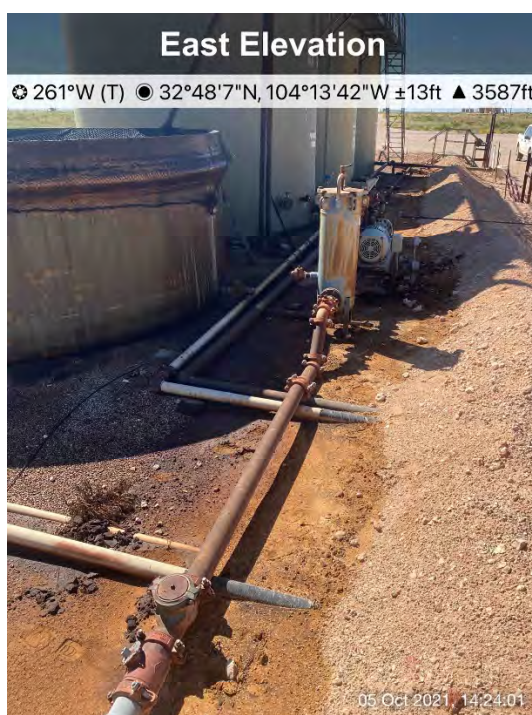
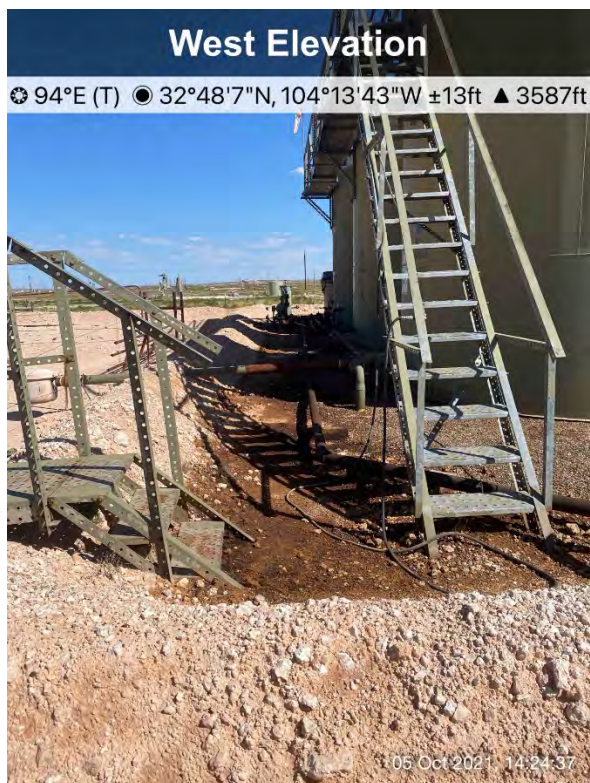
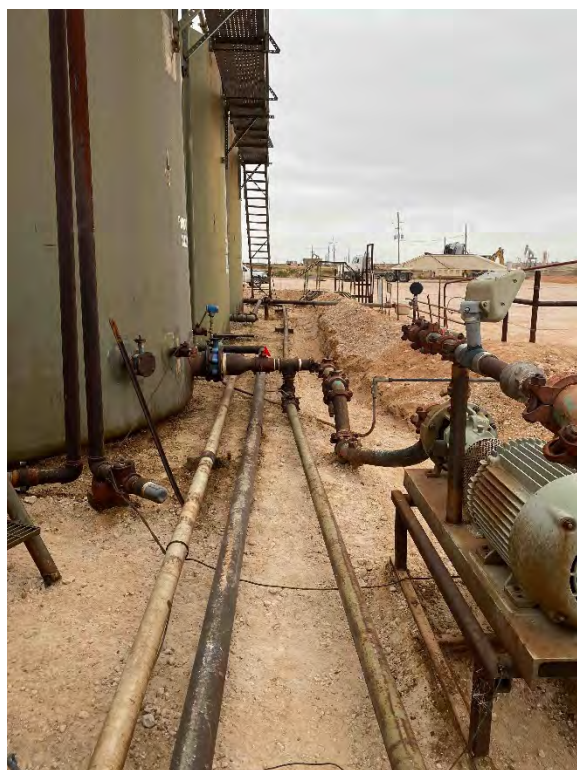
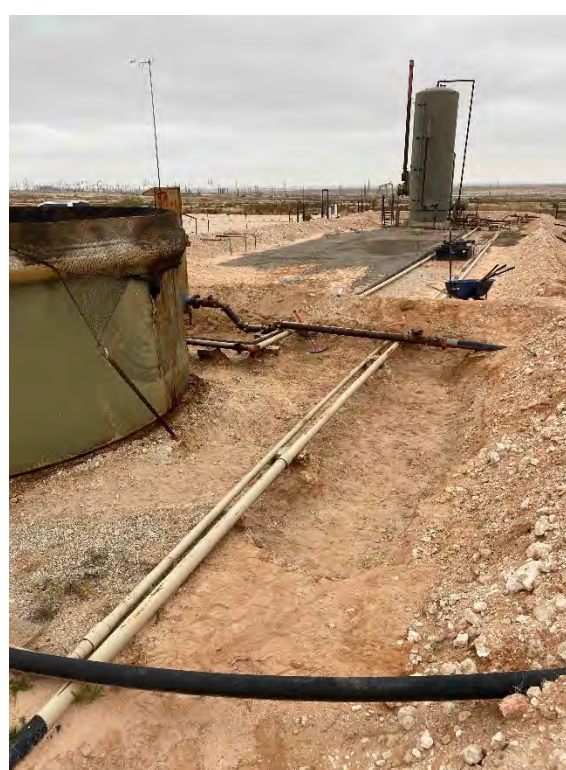
Pre-Treatment

NAPP2119560689: On July 6th, 2021, a water transfer pump went down on an overload trip, causing the tank to overfill. The released fluids were calculated to be approximately 22 barrels (bbls) of produced water. A vacuum truck was able to recover approximately 20 bbls of fluid.

On October 28th, 2021, Pima mobilized personnel and equipment to conduct remedial activities. In the areas of S-1 thru S-3 we excavated to the depth of 2-foot BGS. Bottom and sidewall composite samples were obtained to ensure that the horizontal extents of the contamination had been removed.
