**RE: Closure Request  
Tin Foil Federal Com 23N CTB  
Incident Number NAPP2128040988  
Lea County, New Mexico**

WSP USA Inc. (WSP) on behalf of COG Operating, LLC (COG), presents the following Closure Request detailing site assessment and soil sampling activities at the Tin Foil Federal Com 23N CTB (Site) in Unit N, Section 23, Township 25 South, Range 35 East, in Lea County, New Mexico (Figure 1). The purpose of the site assessment and soil sampling activities was to assess for the presence or absence of impacts to soil following a release of crude oil within lined containment at the Site. Based on field observations, field screening activities, and soil sample laboratory analytical results, COG is submitting this Closure Request and requesting no further action (NFA) for Incident Number NAPP2128040988.

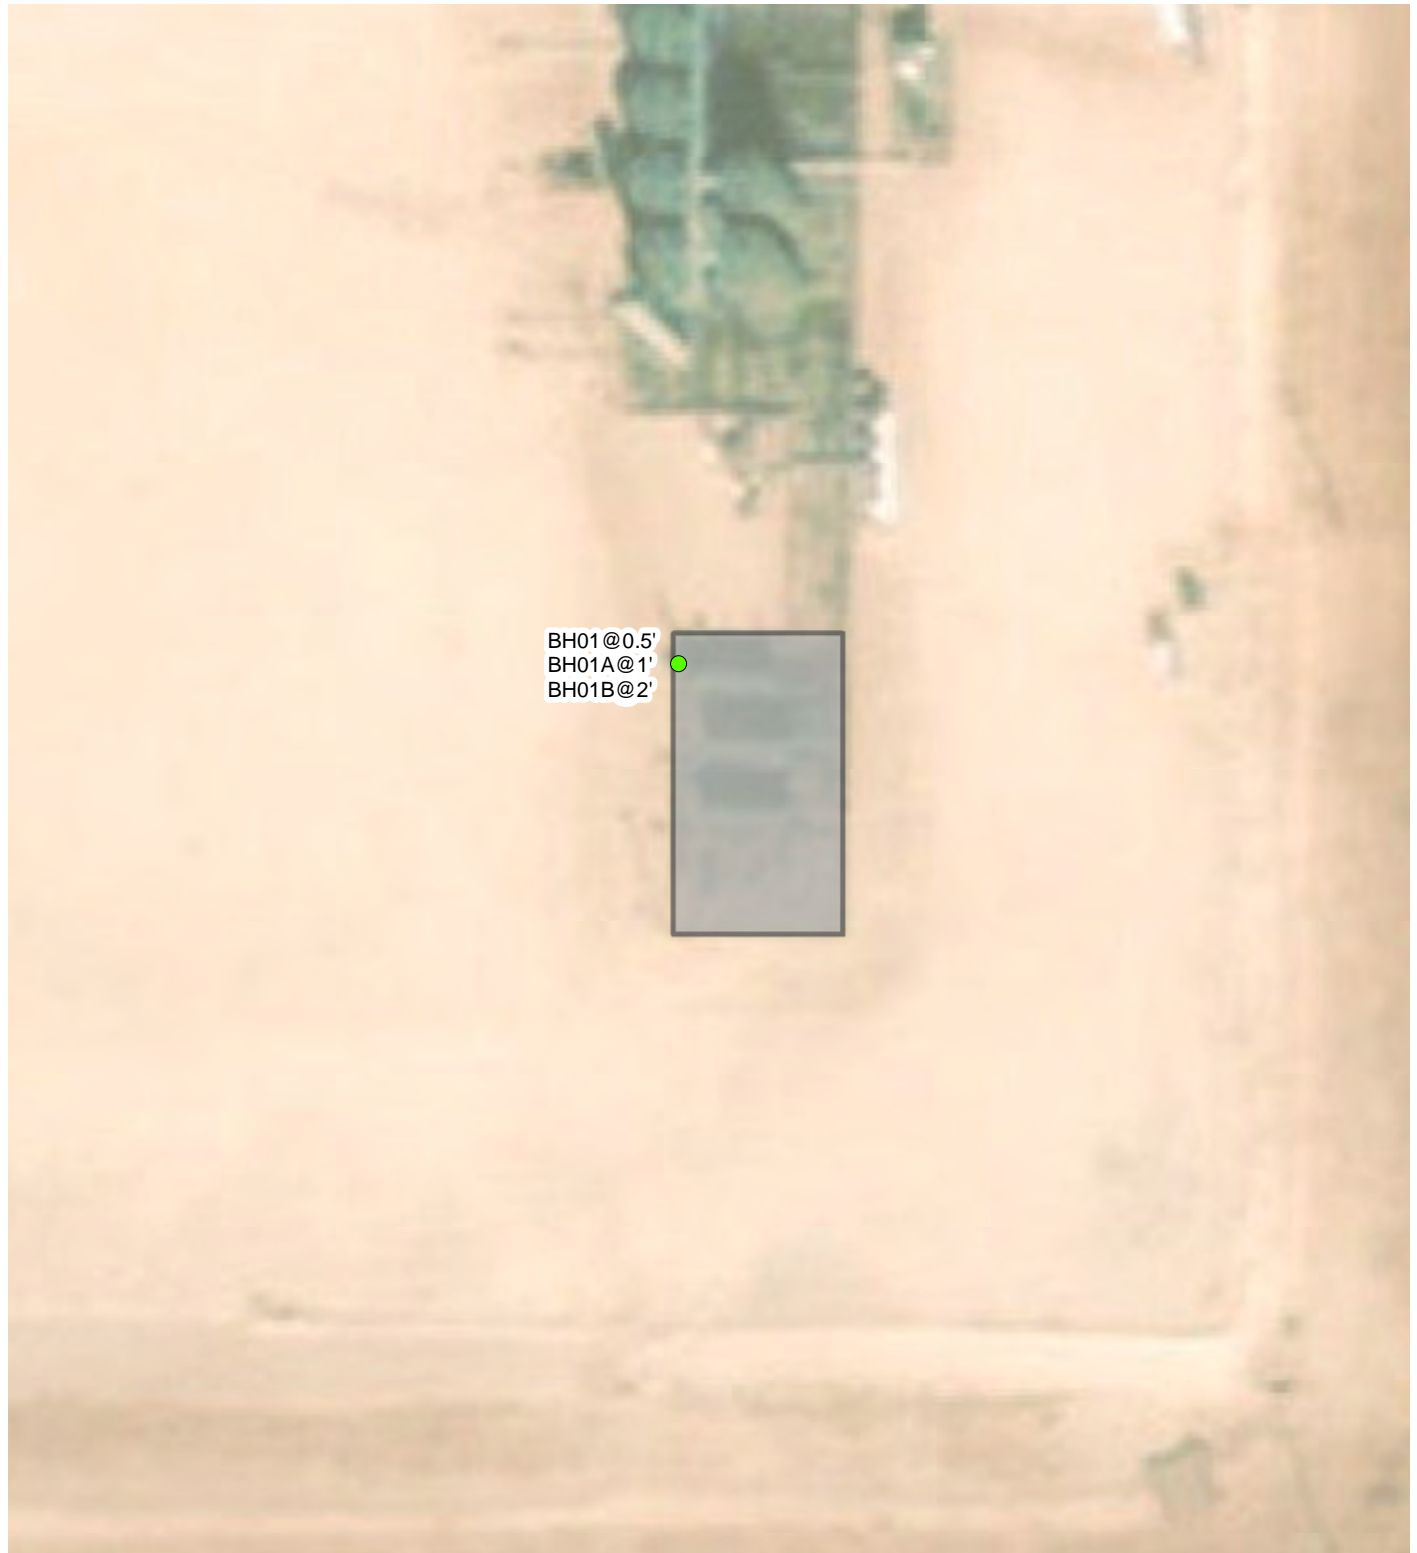
**FIGURE 2**  
**DELINEATION SOIL SAMPLE LOCATIONS**  
**TIN FOIL FEDERAL COM 23N CTB**  
**UNIT N SEC 23 T25S R35E**  
**LEA COUNTY, NEW MEXICO**  
**COG OPERATING, LLC**

sampling log, which is included as Attachment 2. The borehole was backfilled with the soil removed and a COG contractor repaired the tear in the liner. The borehole location is depicted on Figure 2. Photographic documentation was conducted during the Site visit. A photographic log is included in Attachment 3.

Laboratory analytical results for delineation soil samples BH01, BH01A, and BH01B indicated that benzene, BTEX, TPH-DRO/TPH-GRO, TPH, and chloride concentrations were compliant with the Site Closure Criteria. In addition, delineation soil samples BH01A and BH01B collected at 1 foot and 2 feet bgs were compliant with the most stringent Table 1 Closure Criteria. Laboratory analytical results are summarized in Table 1 and the complete laboratory analytical report is included as Attachment 4.

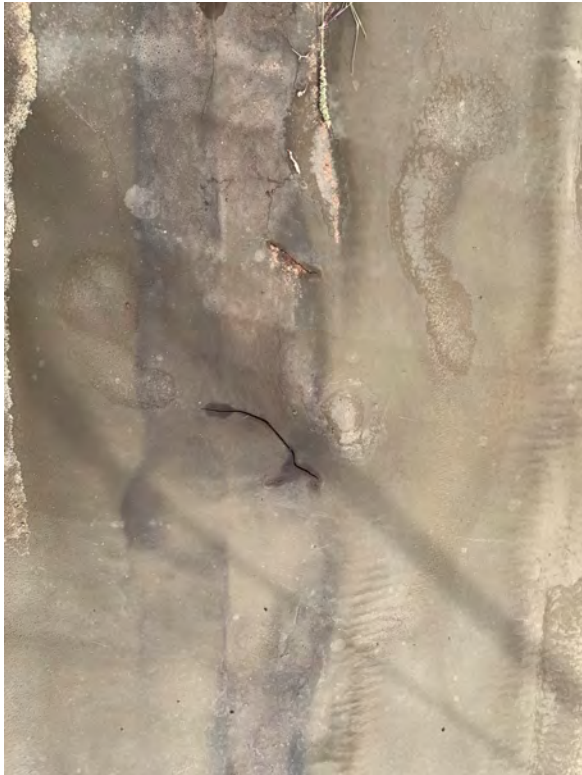
Photo No.	Date	
1	October 18, 2021	
View of hole found in the compromised liner.

A close-up photograph showing a dark, irregular hole in a light-colored, textured liner. The hole is surrounded by some debris and a small amount of water.

Following the failed liner integrity inspection at the Site, WSP personnel advanced one borehole, (BH01), within the lined containment to assess for the presence or absence of soil impacts resulting from the June 9, 2021 crude oil release within lined containment. Three delineation soil samples were collected from borehole BH01, at depths of approximately 0.5 feet, 1 foot, and 2 feet bgs. Laboratory analytical results for the delineation soil samples indicated that benzene, BTEX, TPH-DRO/TPH-GRO, TPH and chloride concentrations were compliant with the Site Closure Criteria. In addition, delineation soil samples BH01A and BH01B collected at 1 foot and 2 feet bgs were compliant with the most stringent Table 1 Closure Criteria. The release was contained laterally by the lined containment and all released fluids were recovered during initial response activities. The tear in the liner was subsequently repaired.

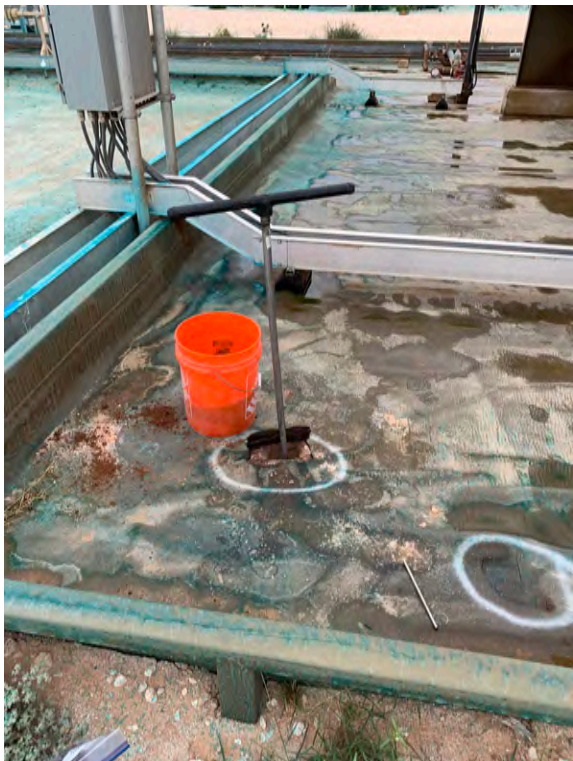
<b>Photo No.</b>	<b>Date</b>	
4	November 3, 2021	
View of borehole during delineation activities.

A photograph showing a view of a borehole during delineation activities. The borehole is located on a concrete surface. A red bucket is visible on the left. A metal rod with a circular attachment is positioned over the borehole. The background shows a construction site with various equipment and materials.
