Closure Report

Foster FF #2 Battery

2RP-2284

nHMP1412239433

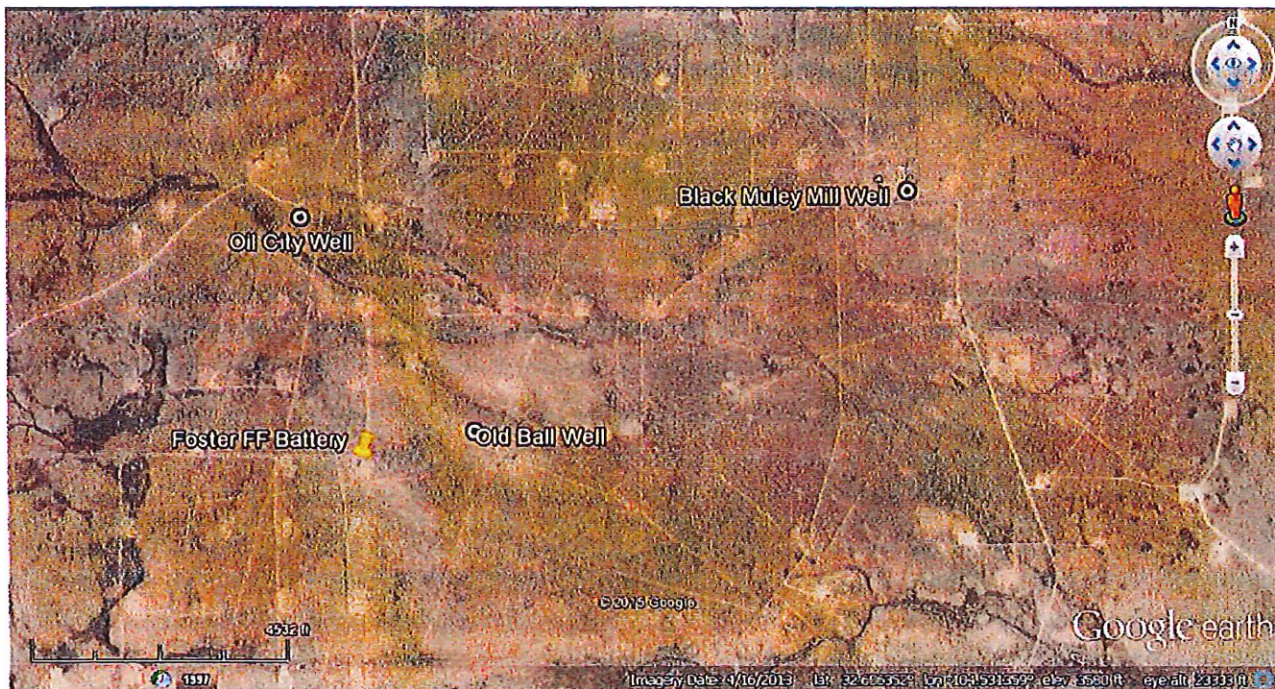
Water Well Locations, Vicinity of Foster FF Battery, Eddy County, New Mexico

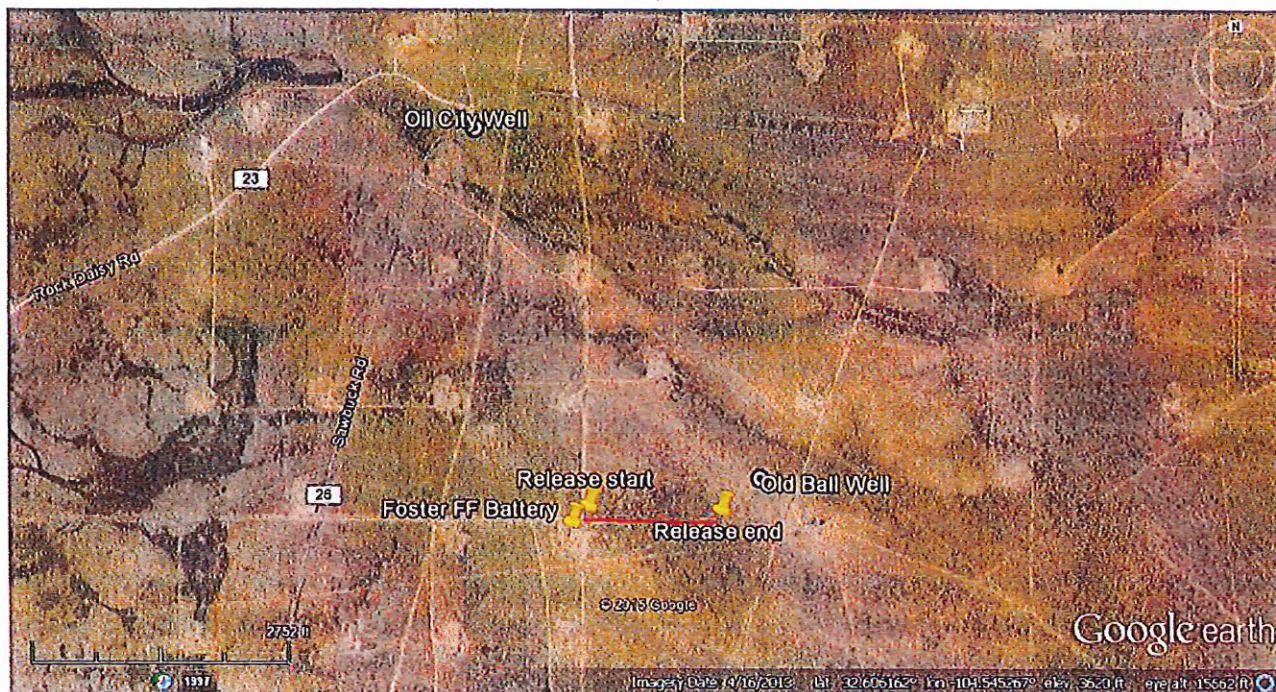
Water Wells in Proximity to Foster FF Battery Release Location

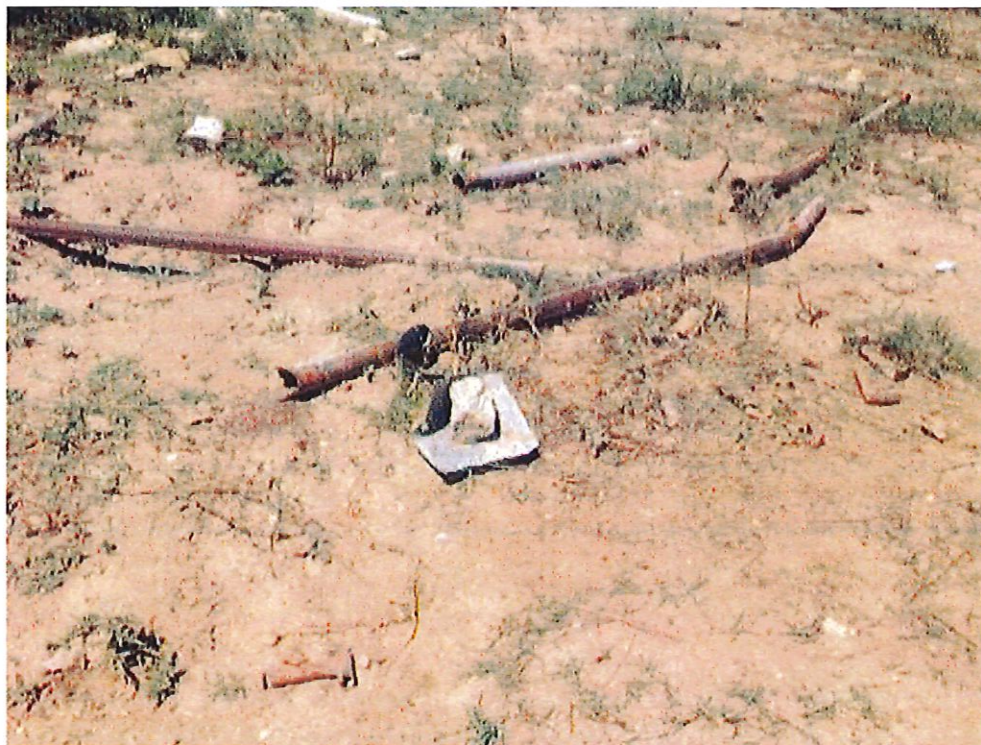
Well location under sheet metal piece

I met Mr. Robert Asher of Yates and we arrived at the location of the Oil City well about 11:00 a.m. State Engineer information had the depth of the well at 300 feet but no other information was available from their online data base. Upon arrival we noted the well casing was at ground level with a rock over a piece of sheet metal. There was no protection from runoff in the event of a heavy rainfall. We inserted a water level probe and found water at 54.61 feet below ground surface. We measured the depth of the well and found it plugged at 56.2 feet. The bottom was relatively solid and no mud was observed on the probe. The 1.6 feet of water in the well is most certainly surface drainage from recent very heavy rainfall in the area.

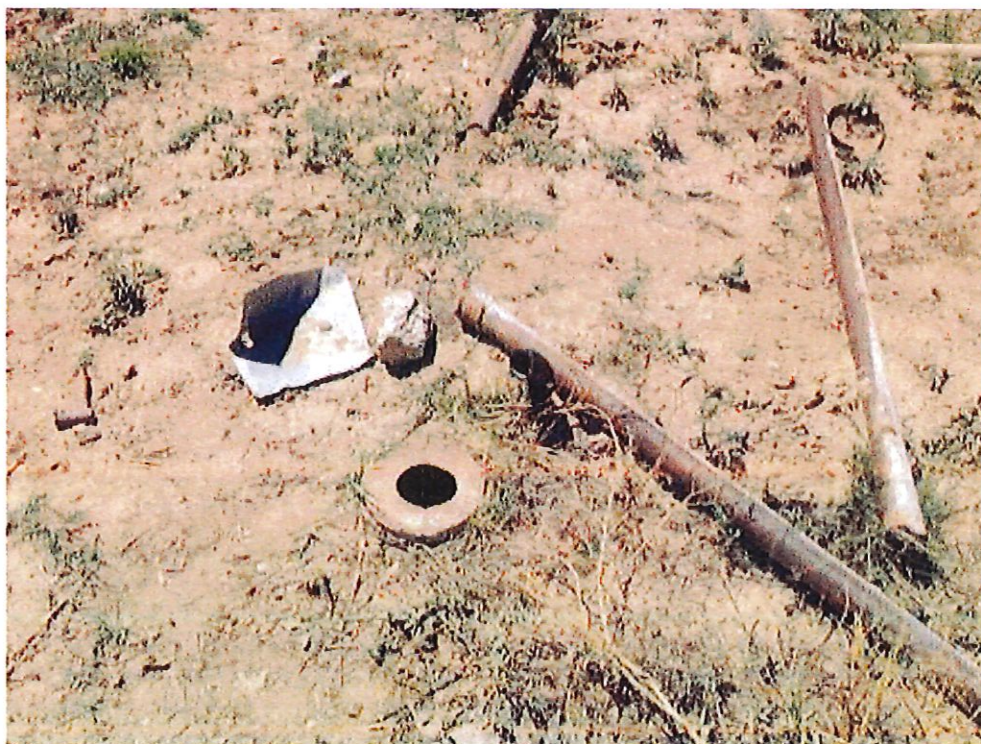
Top of open well at ground surface

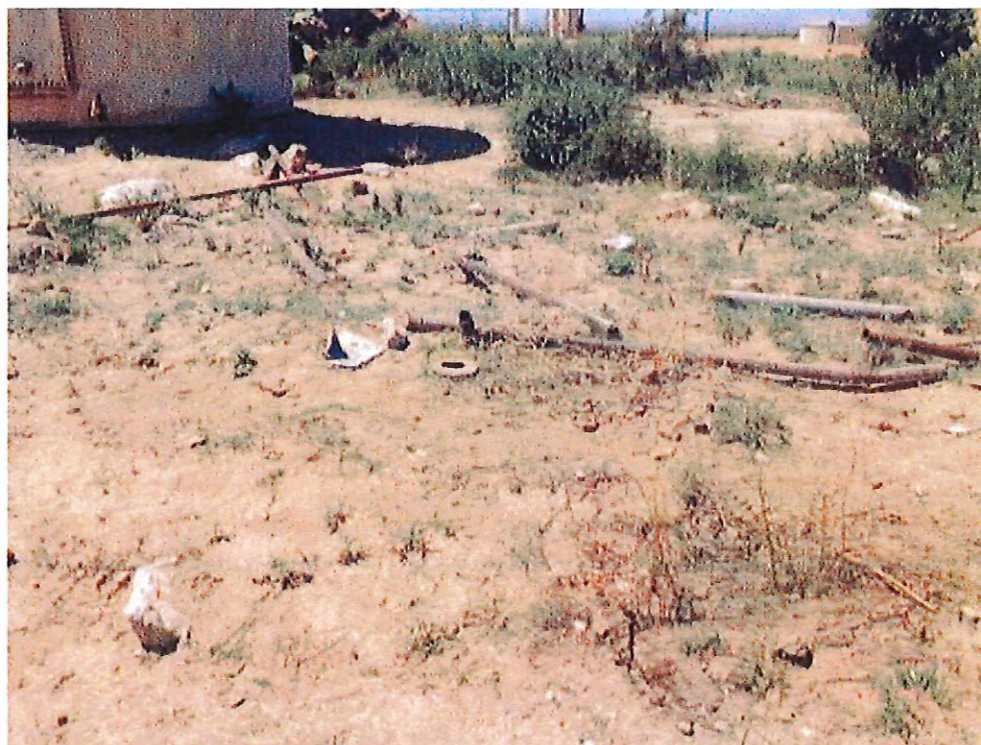
Open well. Water tank in left background receives water from another source
