**SITE CHARACTERIZATION AND PROPOSED REMEDIATION  
PLAN**

**AMOLE AMM STATE #2  
UNIT K, SECTION 16, TOWNSHIP 19S, RANGE 25E  
EDDY COUNTY, NEW MEXICO  
32.658273, -104.491577  
RANGER REFERENCE NO. 5375**

**OCTOBER 28, 2021**

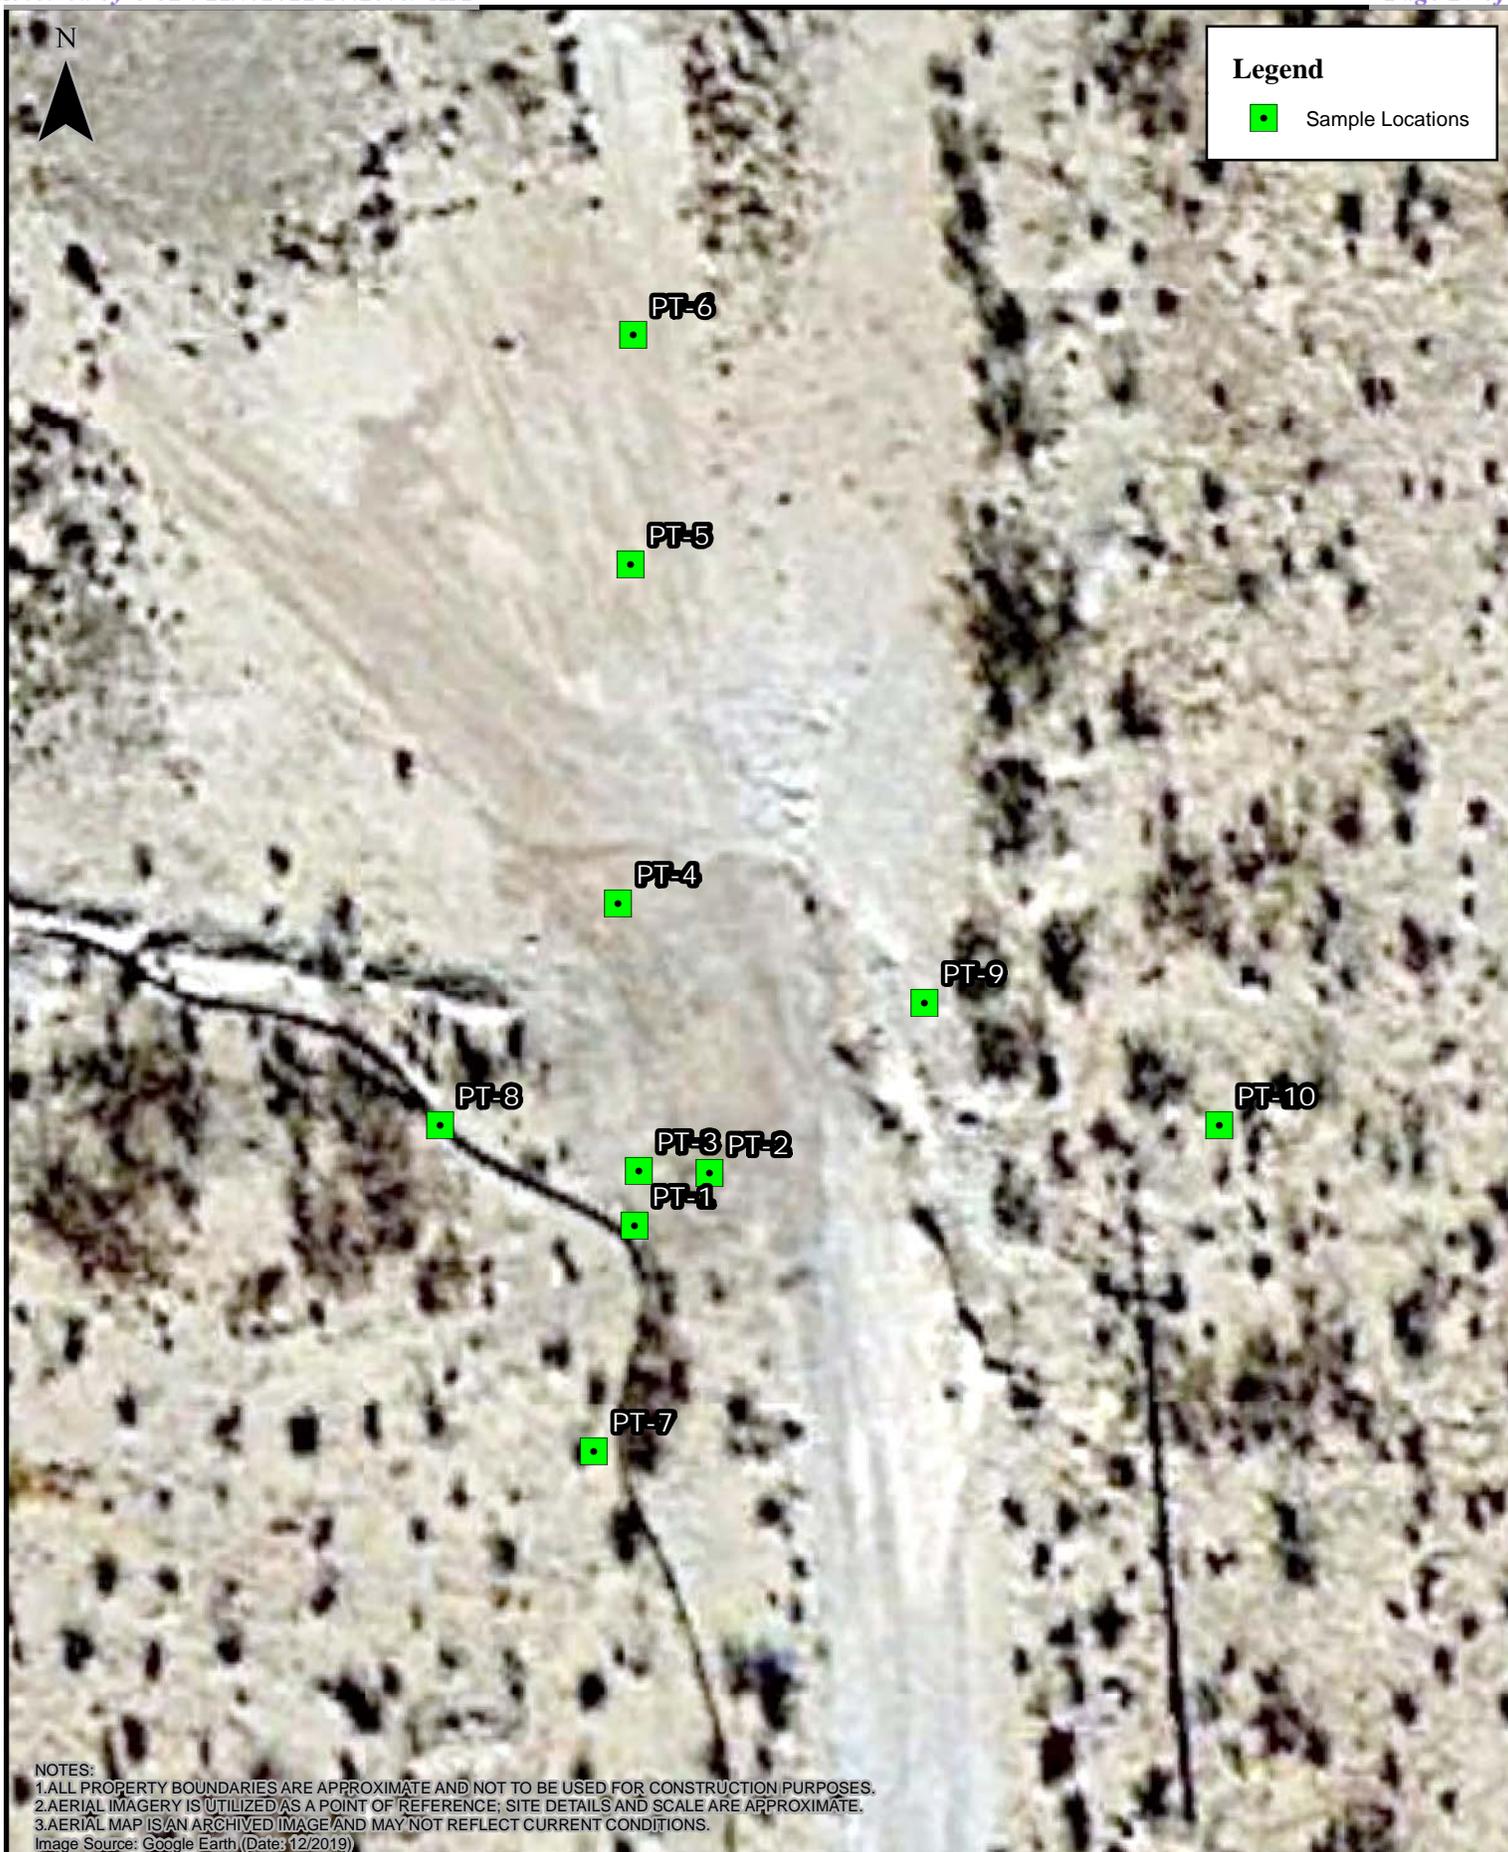
**Assessment Sample Location Map**  
 Amole AMM State #2  
 EOG Resources, Inc.

On August 12, 2021, Ranger personnel and representatives for EOG mobilized to the Site to conduct assessment activities. To assess the soil impacts, a total of ten sampling locations were selected (PT-1 through PT-10). Ranger initially attempted to install test hole excavations at the PT-1 and PT-2 locations since this was the “potential reportable release” GPS location reported by the Howell Ranch. The test holes at these locations, however, were unable to be installed due to the presence of underground utilities (a water line and gas line). No similar issues were encountered at the remainder of the sampling locations and, as such, test holes were advanced at assessment locations PT-3 through PT-10.

The surface soil at the PT-2 location was noted to be discolored, but there were no elevated OVM readings at this location. No discolored soils or elevated OVM readings were encountered at any of the other assessment locations. Elevated field chloride titration results were documented in the surface soil at the PT-2 location. With regard to the test hole locations, elevated field chloride titration results were documented at the PT-3, PT-4, PT-5, and PT-9 locations.

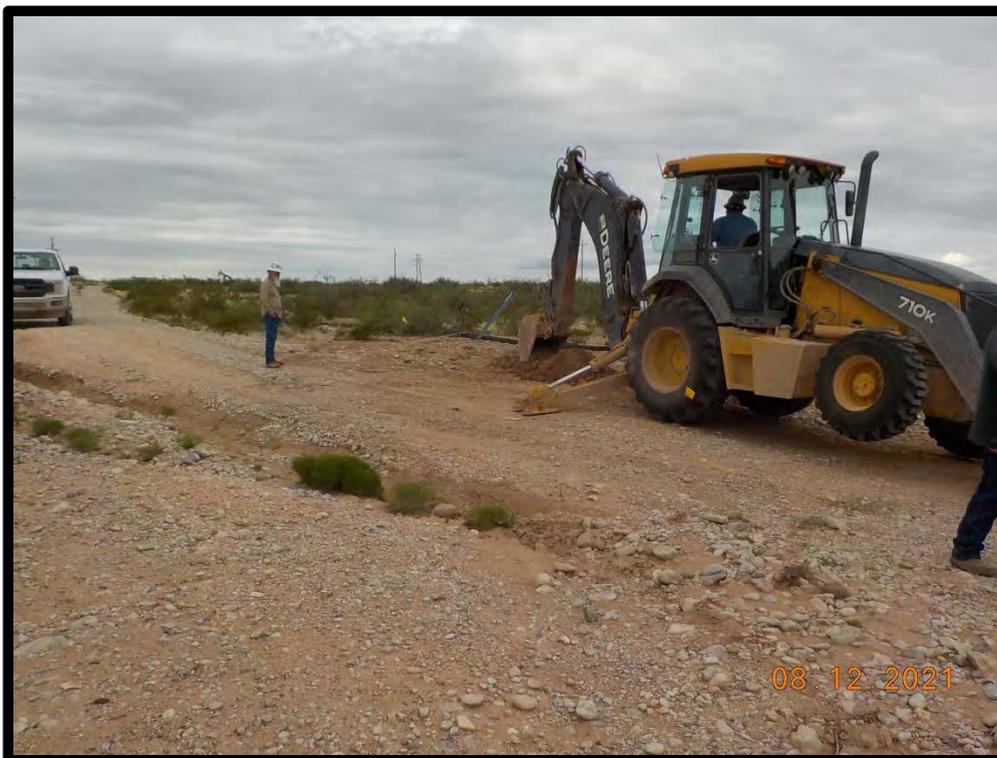
**PHOTOGRAPH NO. 1 – A general view of the Site assessment activities at the PT-3 location. The view is towards the southeast.**
