December 13, 2021

SUBJECT: Revised Remediation Closure Report for the Line B-6 350 Release (NAPP2117237696), Eddy County, New Mexico

Vacinity and Well Head Protection Map
 Line B-6 350 Pipeline - Enterprise Field Services LLC
 32.519990, -104.323661, Eddy County, New Mexico

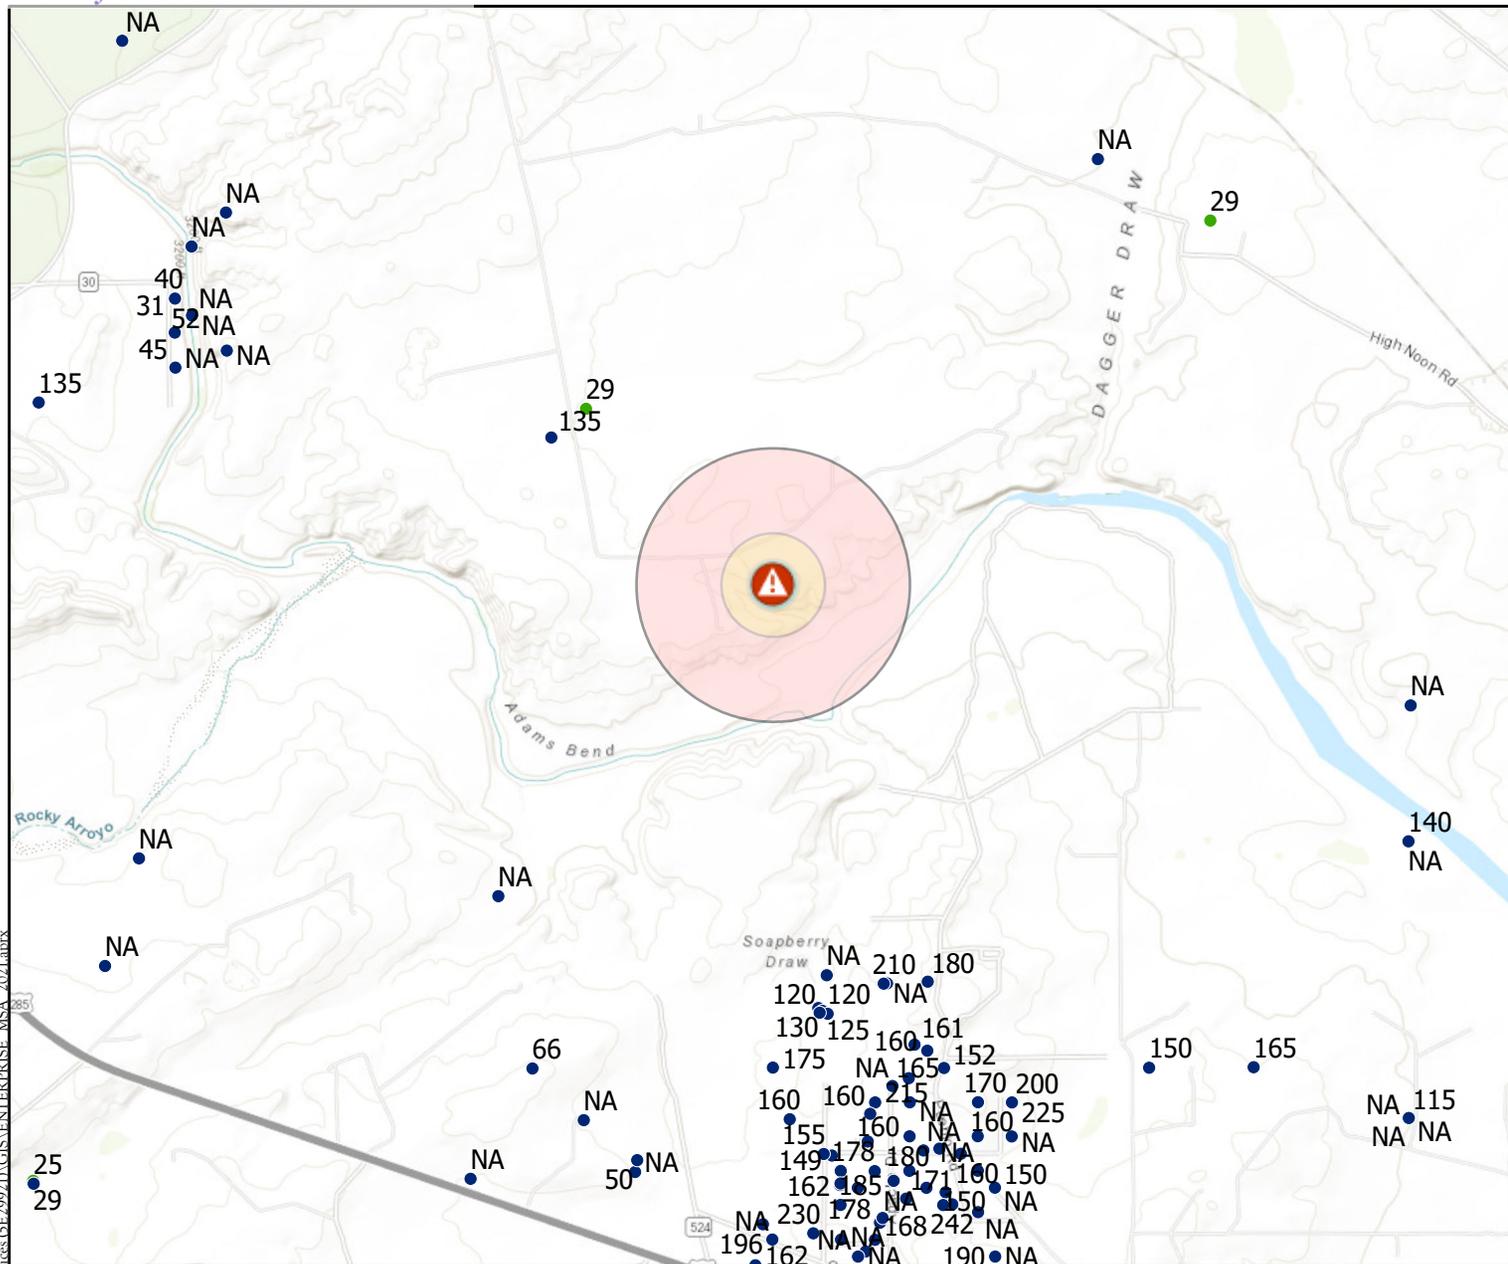
Figure 1

There are no known water sources within ½-mile of the location, according to the Office of the State Engineer (OSE) New Mexico Water Rights Reporting System (NMWRRS). Registered wells in the vicinity are shown on Figure 1.

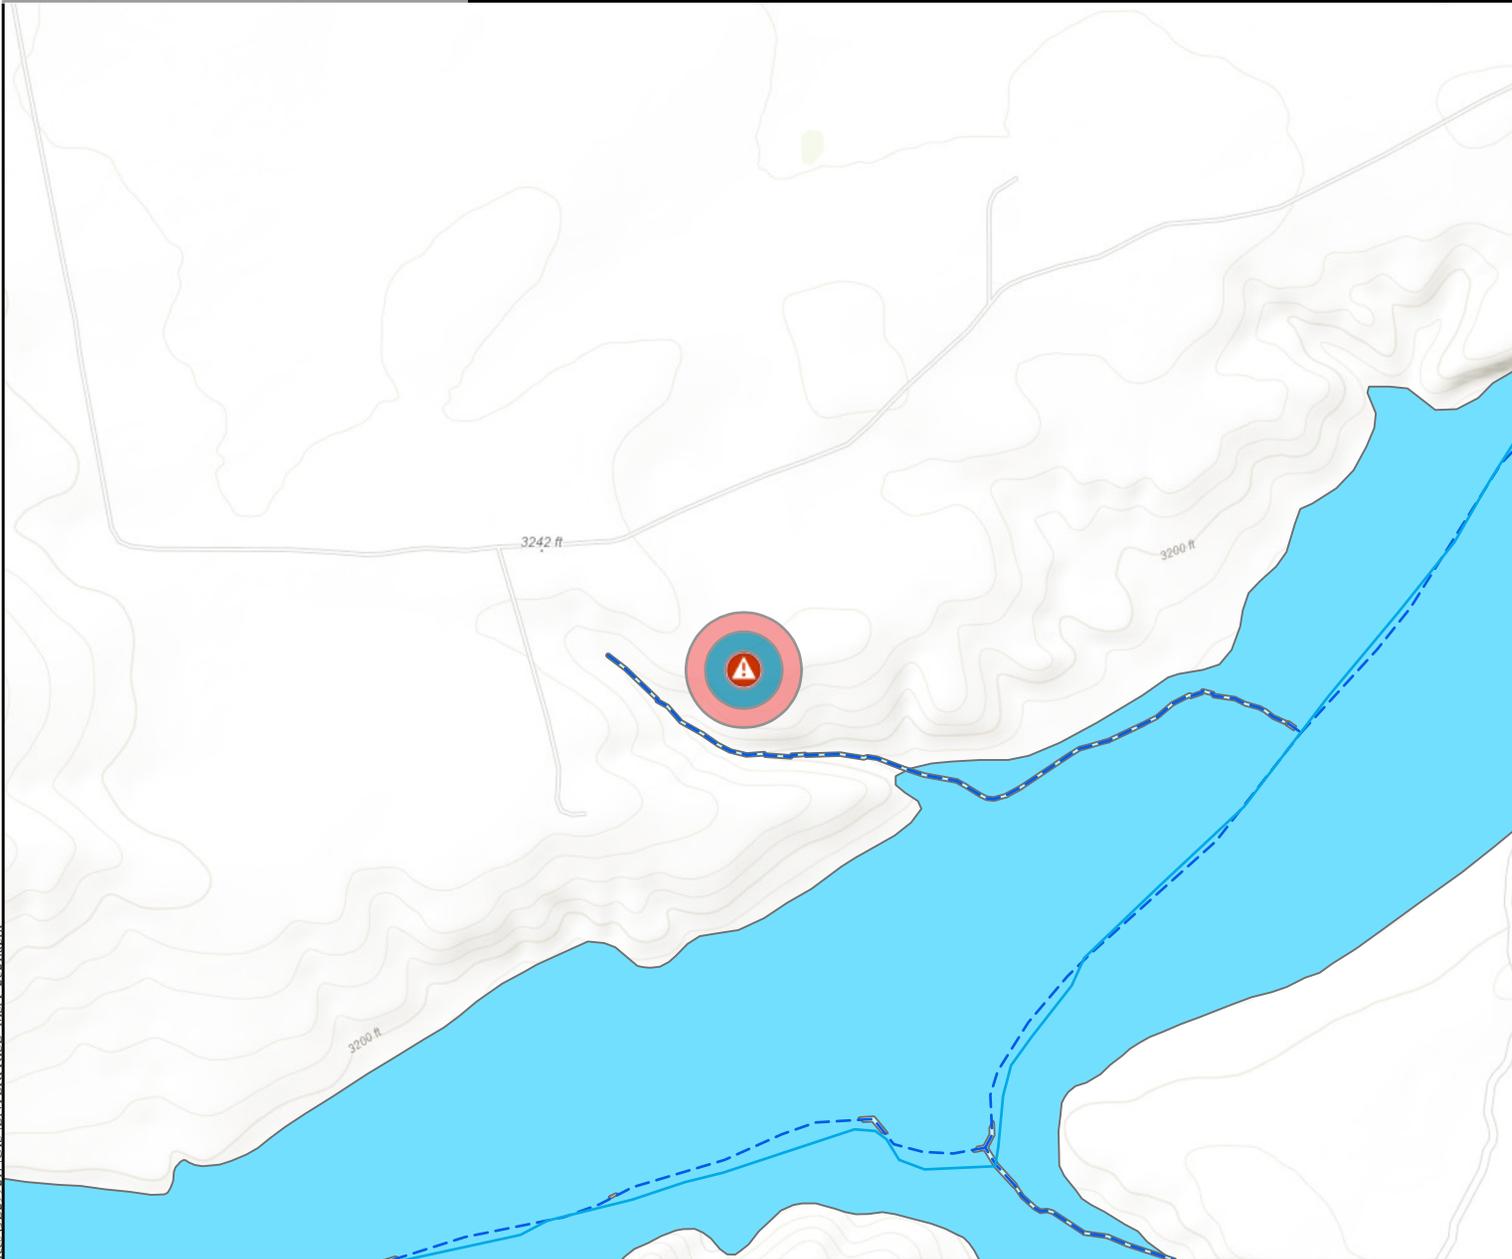
Figure 2

The nearest significant watercourse is a tributary of the Pecos River, located approximately 80 feet to the south.

Table 2 demonstrates the Closure Criteria applicable to this location. Figures 1 and 2 illustrate the 200 and 300-foot radii which indicate that the site does lie within a sensitive area as described in Paragraph (4) of Subsection (C) 19.15.29.12 NMAC.

Surface Water Protection Map
 Line B-6 350 Pipeline - Enterprise Field Services LLC
 32.519990, -104.323661, Eddy County, New Mexico

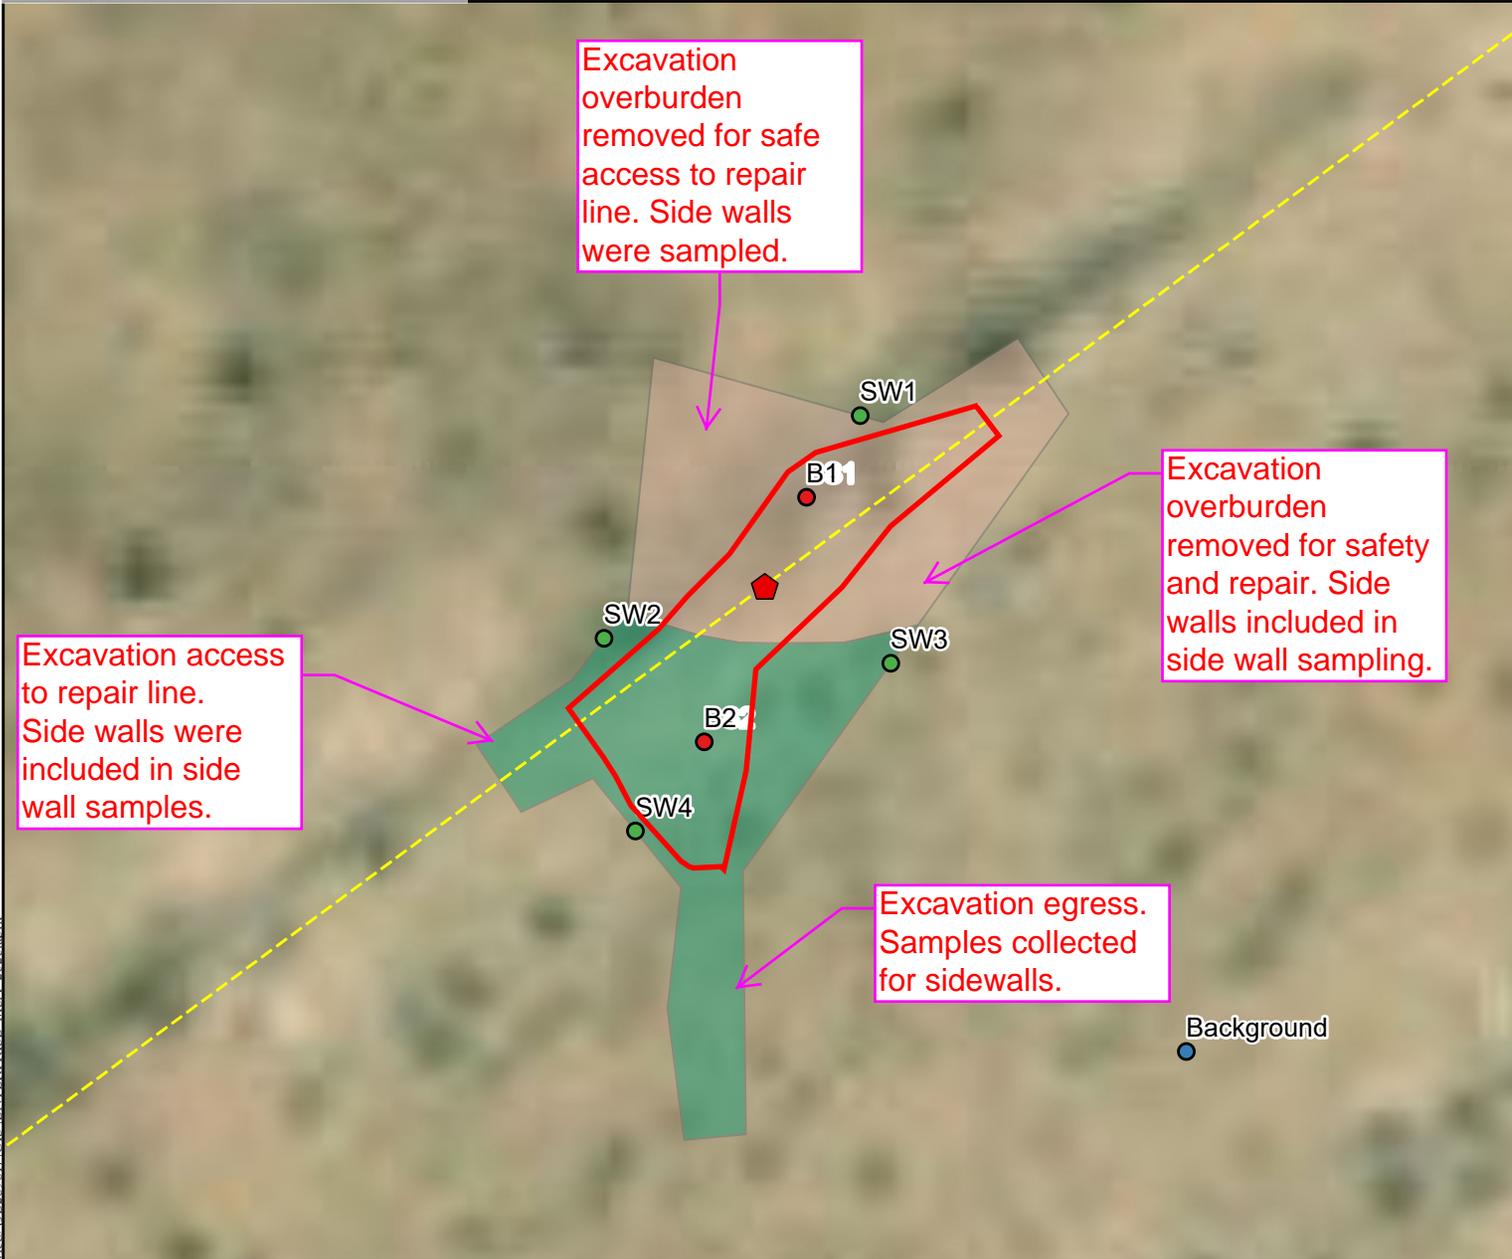
Figure 3

Excavation extents and closure confirmation sample locations are depicted in Figure 3. A photo log is included in Appendix D. Confirmation laboratory results are summarized in Table 3. Laboratory reports are included in Appendix E.

Site and Sample Location Map
 Line B-6 350 Pipeline - Enterprise Field Services LLC
 32.519990, -104.323661, Eddy County, New Mexico

At the request of Mike Bratcher, NMOCD District 2 Supervisor, amended Figures 3 and 3A are included in the revised report detailing compliance with the 200 ft² sampling requirement.

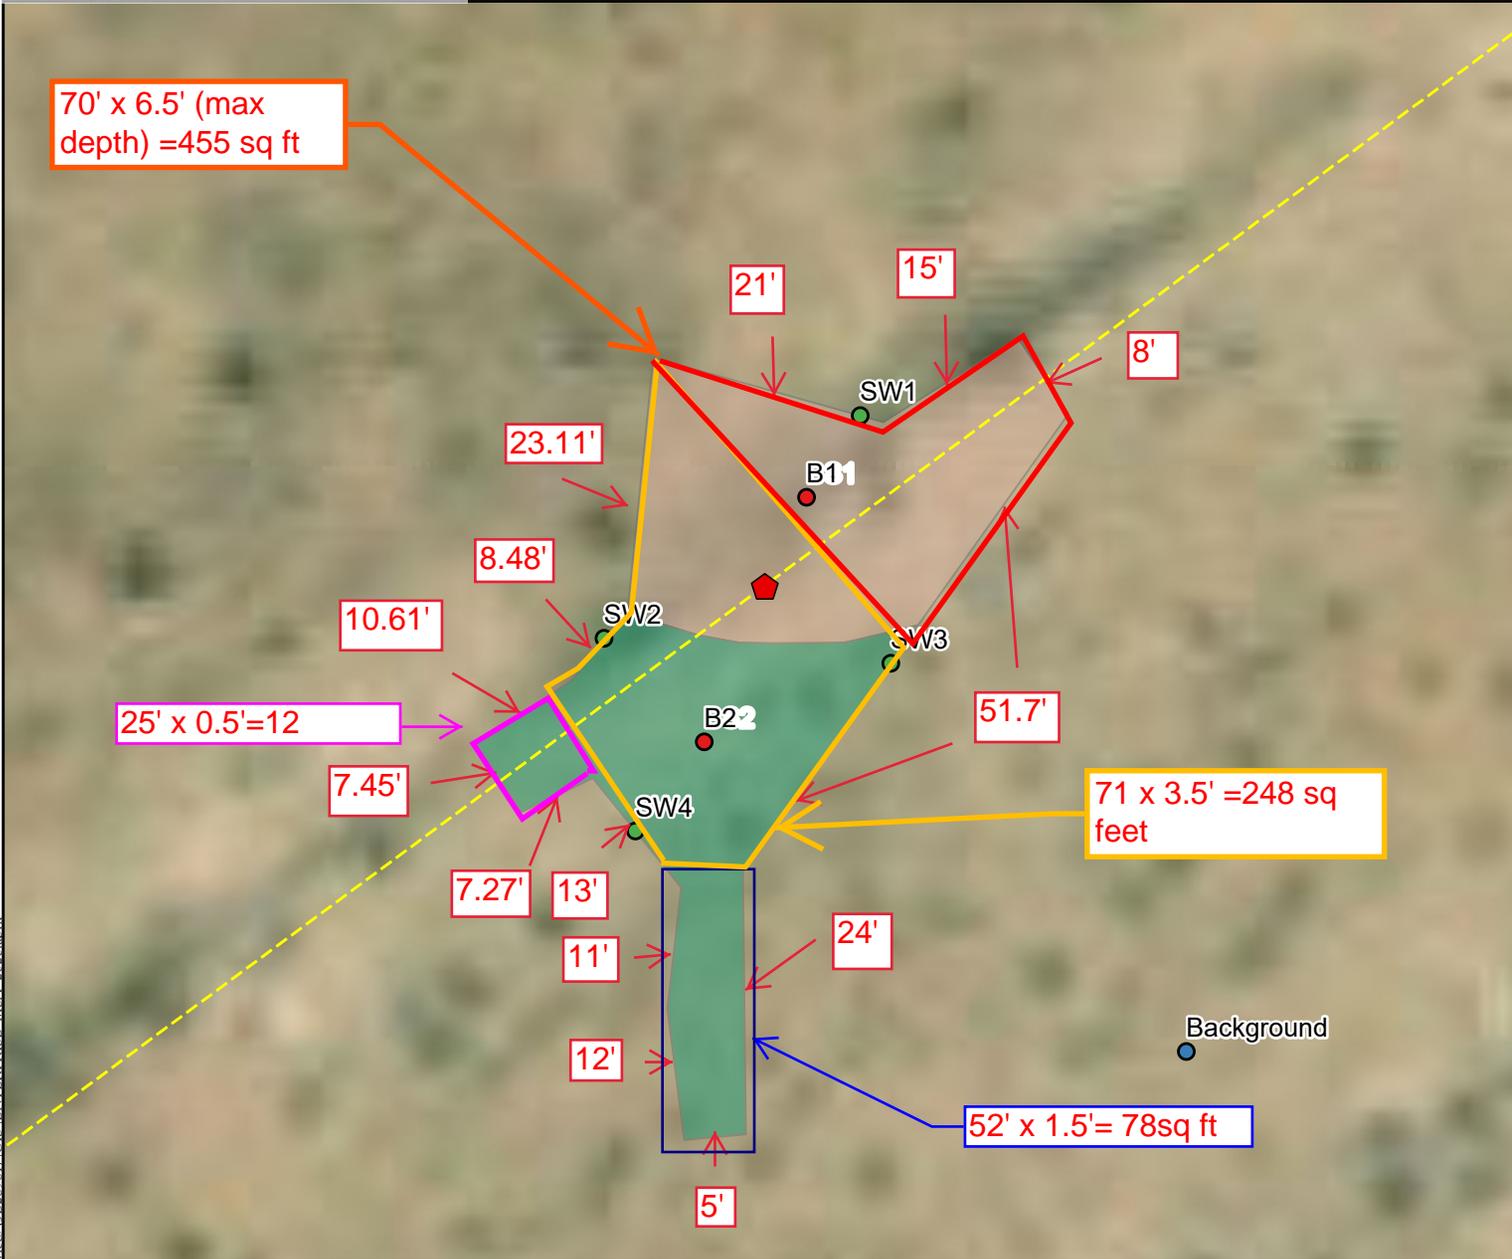
Figure 3A

SIDEWALL
 $455 + 248 + 78 + 12 = 793$ sq feet of sidewall
 $793 / 200 = 3.9$ samples when calculated at max depth.
 Excavation depths ranged from 0.5 to 6.5 feet.

Site and Sample Location Map
 Line B-6 350 Pipeline - Enterprise Field Services LLC
 32.519990, -104.323661, Eddy County, New Mexico

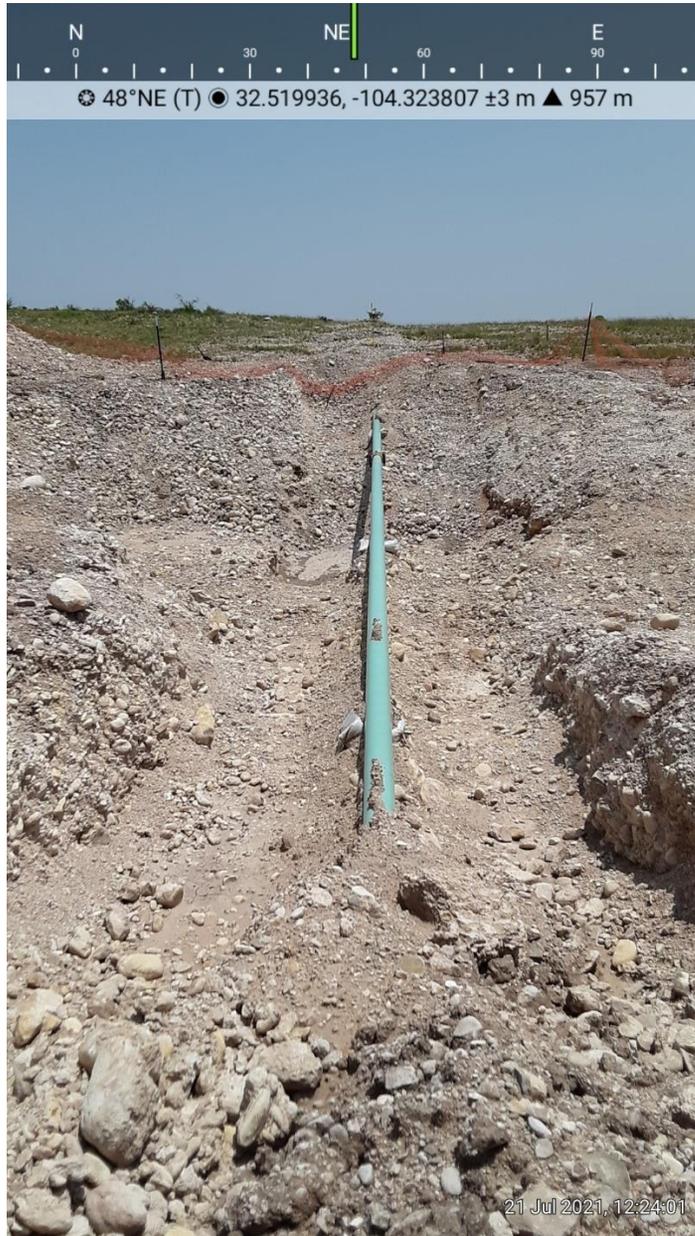
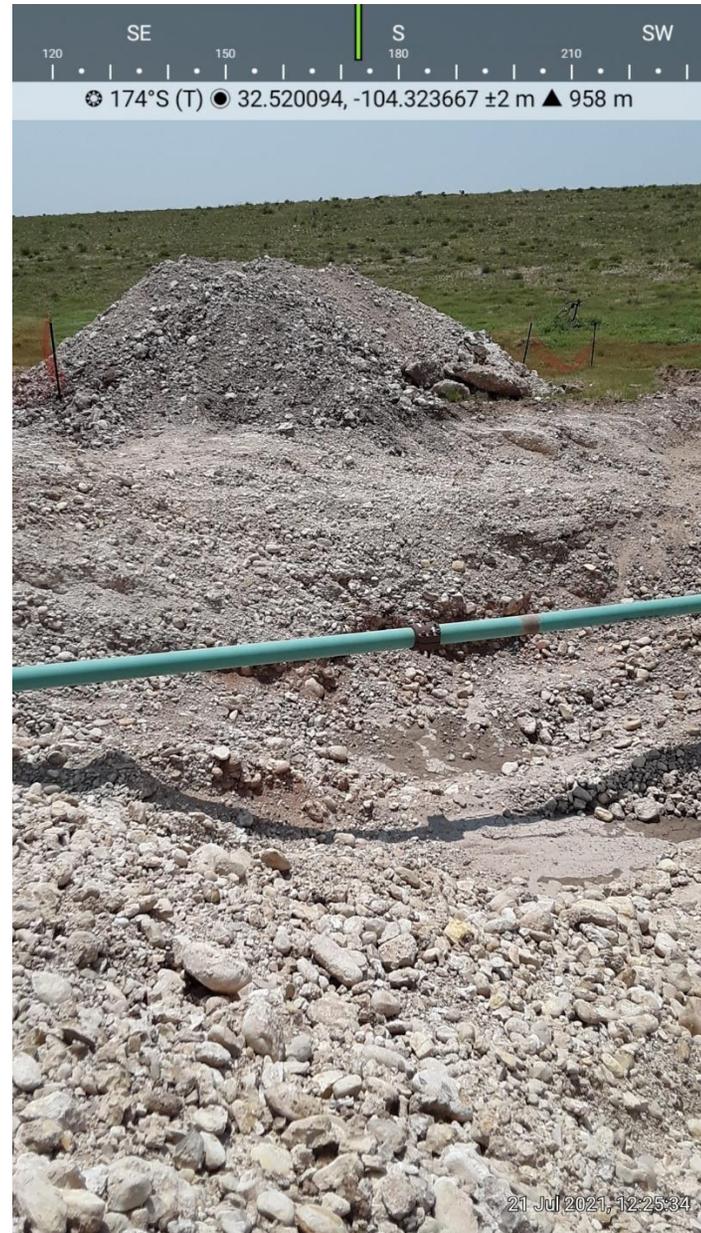
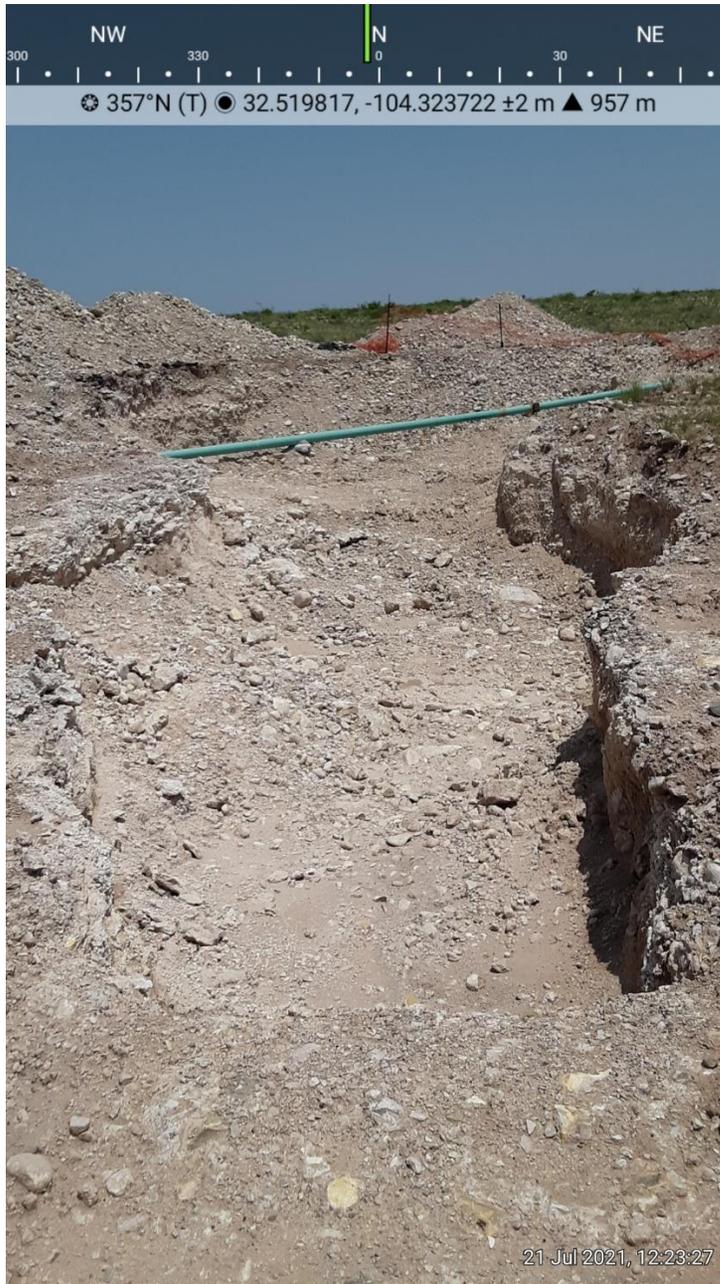
APPENDIX D
FIELD NOTES
&
PHOTO LOG
