Release Notification

RE: CLOSURE REPORT
Galt J2 Pipeline Release
NMOCD Incident No. nAPP2105656531
NW¼ NW¼, Section 6, T27N, R10W
San Juan County, New Mexico

Galt J2 Pipeline Excavation Clearance Report

Galt J2
NMOCD Incident No. nAPP2105656531
Pipeline Release Excavation Clearance

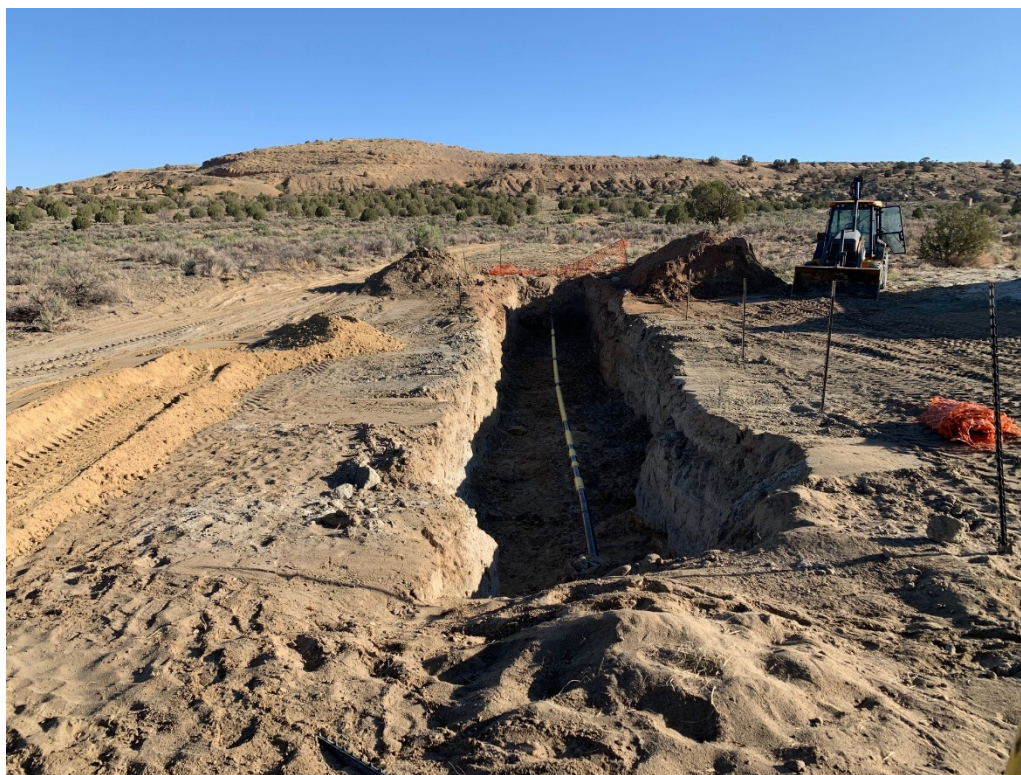
Photo 1: Excavated pipeline, view is to the north, May 17, 2021.

On February 25, 2021, a hole resulting from internal corrosion was discovered in the pipeline. The site was excavated, and the pipe was replaced. The initial release was of approximately three Mcf of natural gas. Due to the proximity to a watercourse, the release was classified as “major”.

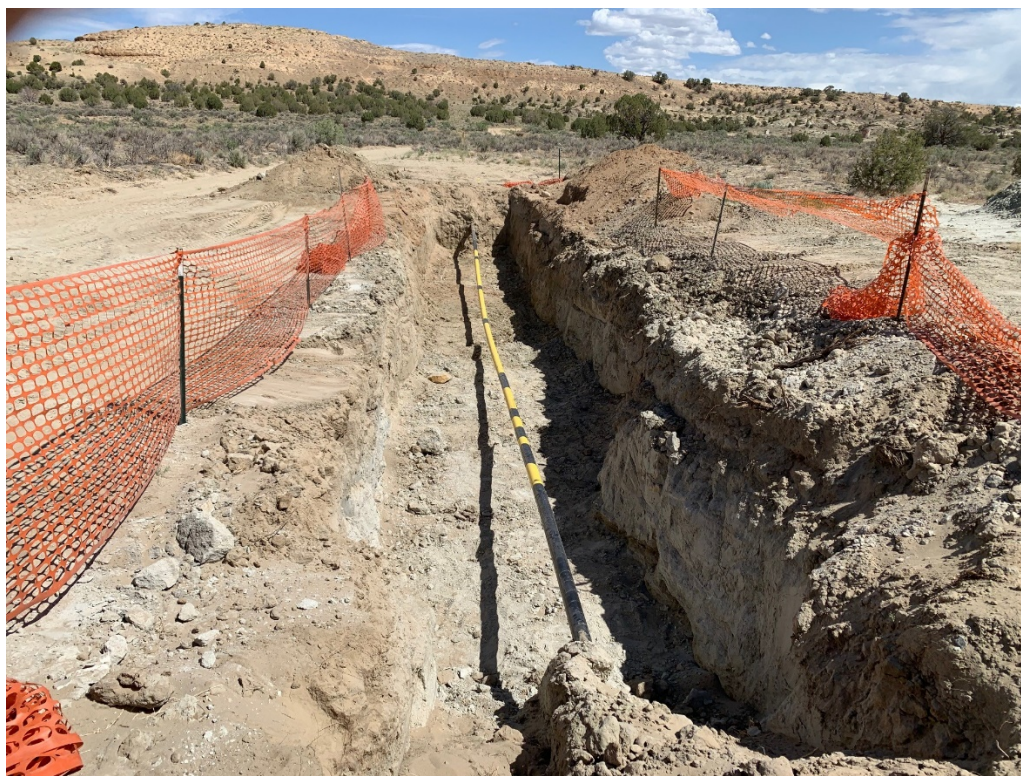
Photo 2: Final excavation extents, May 17, 2021.

Harvest on May 17, 2021, after additional soils were removed from the excavation base. Harvest collected six 5-point composite samples including four from the side walls and two from the base. The final excavation measured approximately 11 ft by 64 ft by 6 to 8 ft deep and included 40 cubic yards of overburden and contaminated soil.

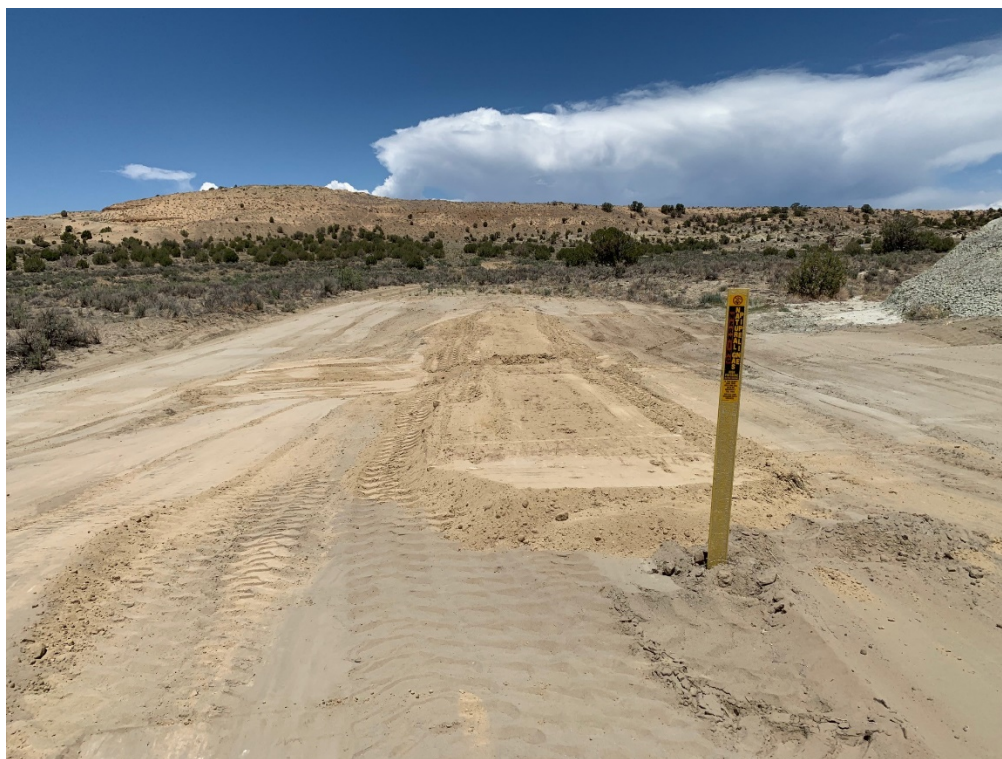
Photo 3: Backfilled excavation, May 20, 2021.

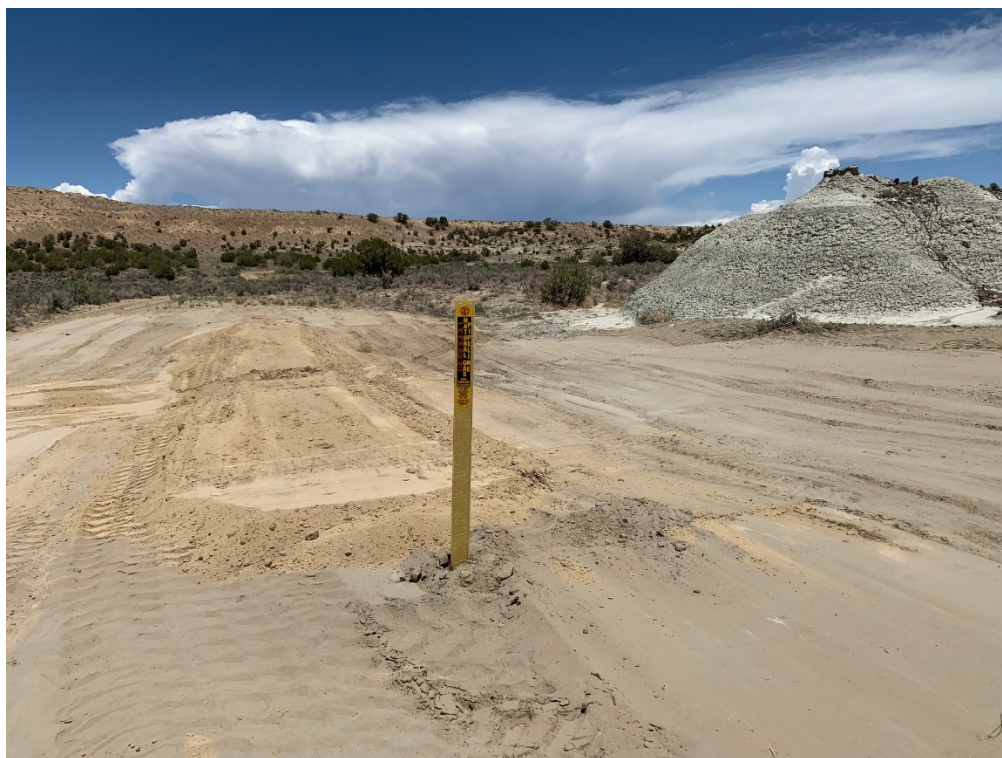
Photo 4: Backfilled excavation, May 20, 2021.
