## DELINEATION/REMEDIATION WORKPLAN

### OXY – CEDAR CANYON 16 ST0011H (Leak Date: 11/2/21)

#### Incident Reference #: NAPP2132239558

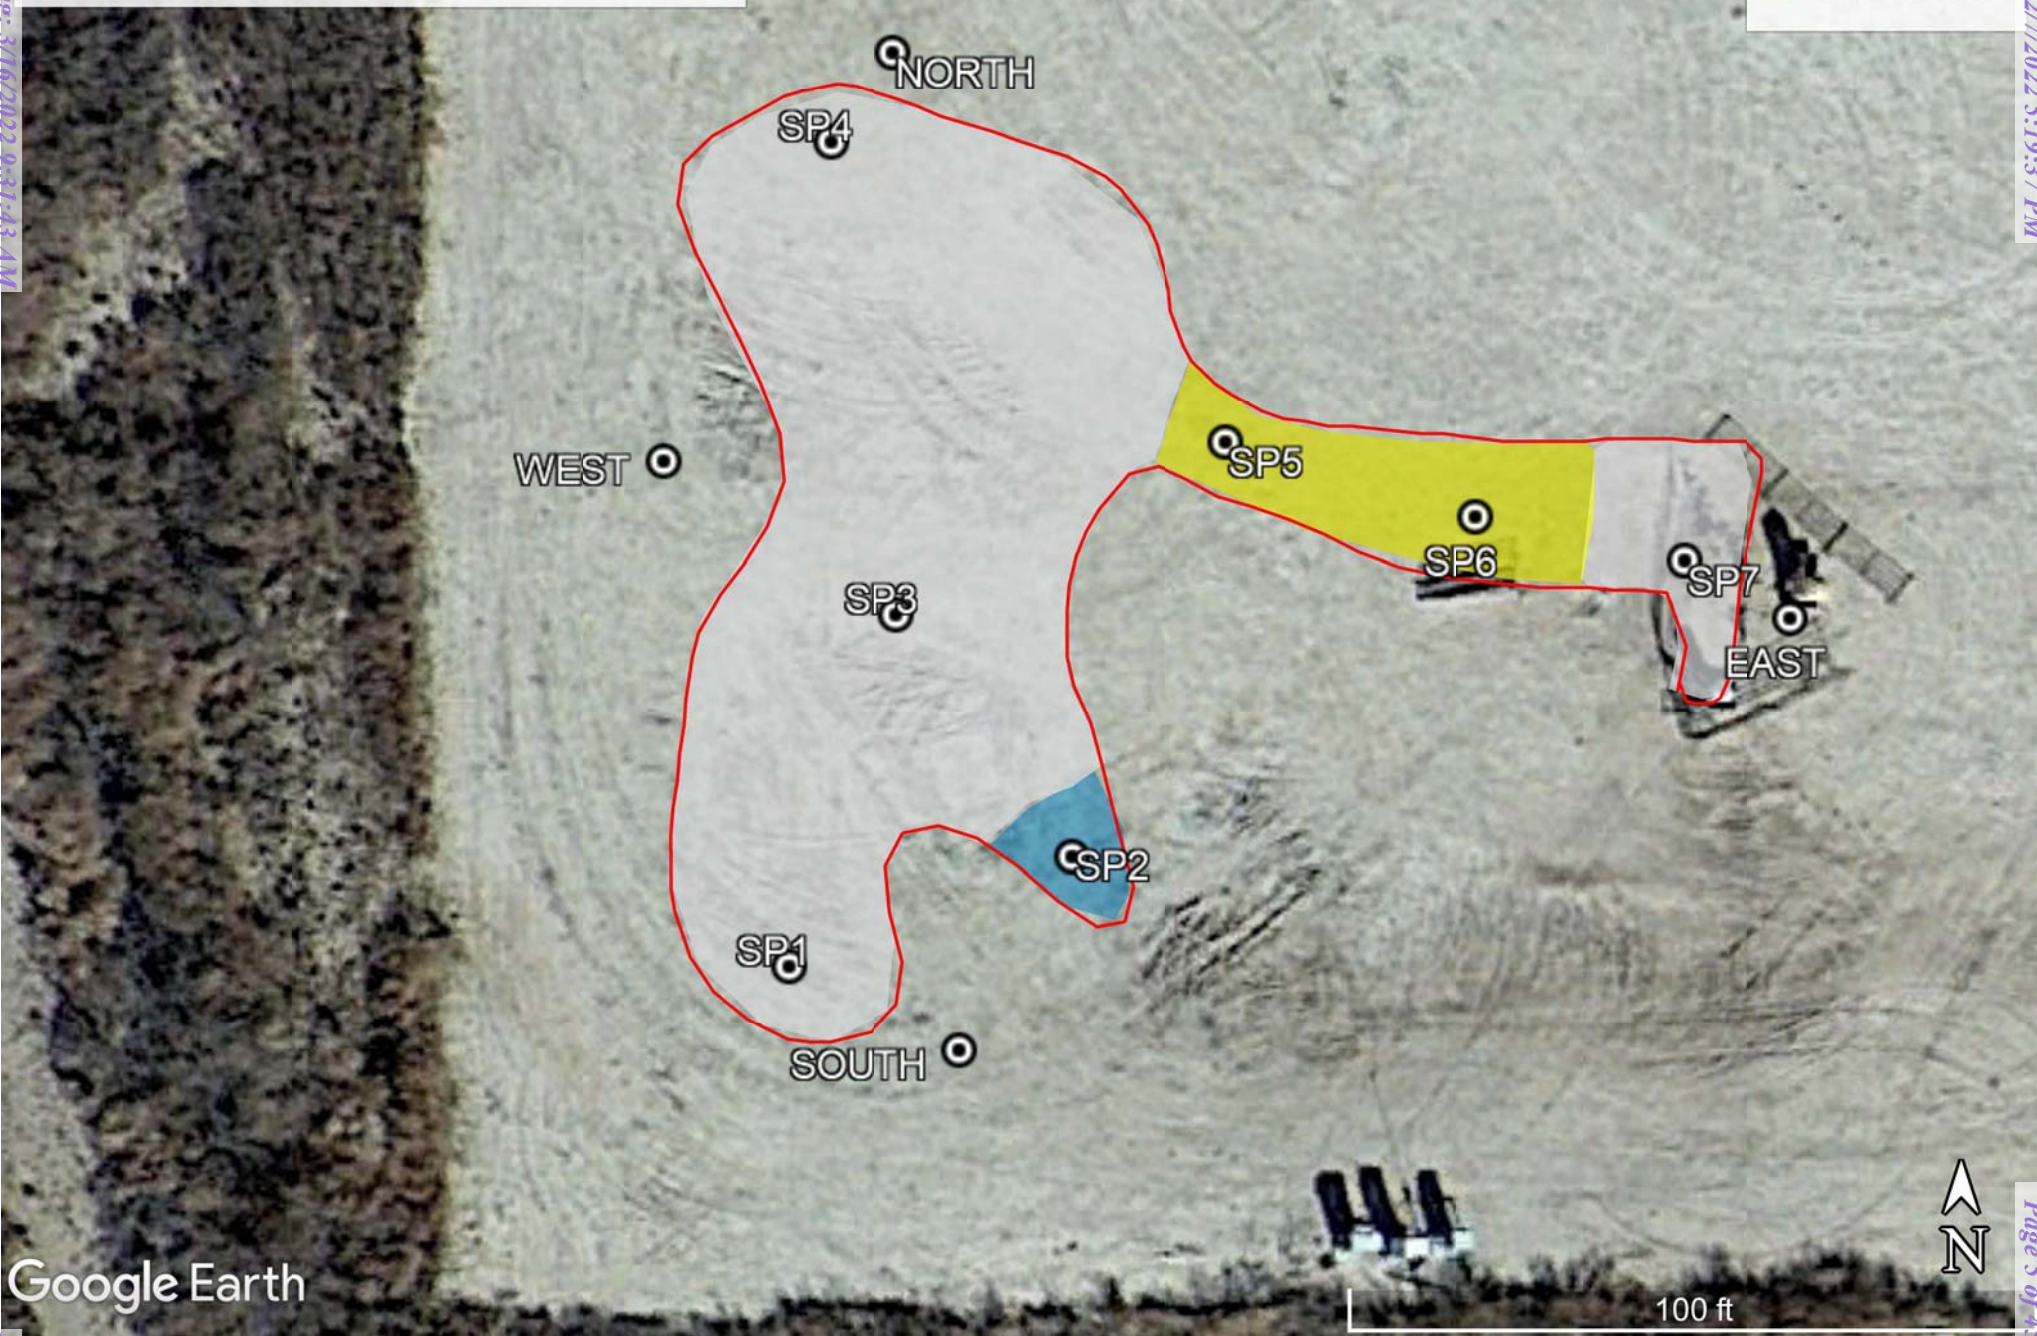
CEDAR CANYON 16 ST 0011H

***The leak area near SP1, SP3, SP4, and SP7 (WHITE shade on diagram) will be excavated to a depth of 2 feet. The leak area near SP2 (BLUE shade on diagram) will be excavated to a depth of 3 feet. The leak area near SP5 and SP6 (YELLOW shade on diagram) will be excavated to a depth of 1 foot.***

2FT DEPTH

3FT DEPTH

***OXY will excavate the spill area as depicted on the following site diagram.***

***OXY will collect sidewall and bottom confirmation samples every 200 square feet. The estimated amount of soil to be excavated is 607 cubic yards. The remediation will be completed within 90 days of approval.***
