Release Notification

Site Name: Burroughs #011	Site Type Gas
Date Release Discovered: 12/30/2021	API# (if applicable) 30-045-26619

Morningstar Operating submitted the initial C-141 to the NMOCD and was given incident number **NaPP2136454686**. All surface fluids were removed. No evidence of any residual soil was noted after clean- up efforts were conducted. The release from the Cathodic determined no hydrocarbon constitutions were evident.

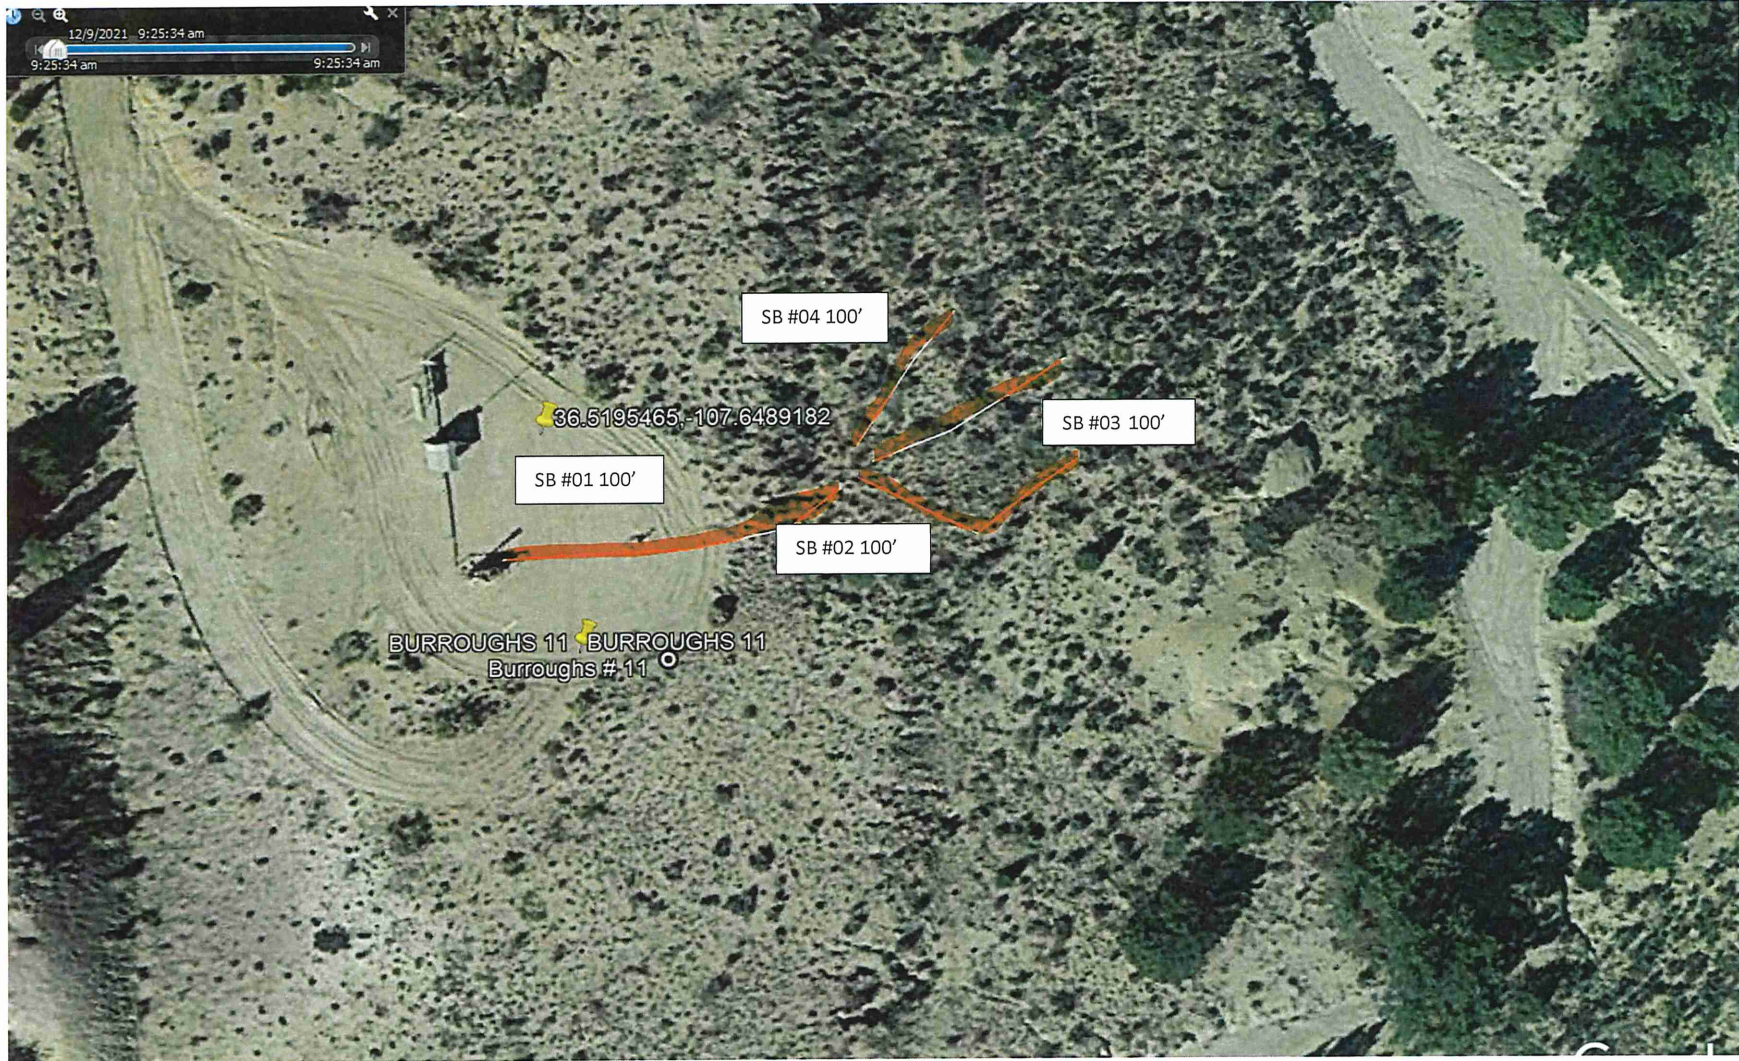
Sampling Map

Sampling was conducted on January 21, 2022, the NMOCD nor the State Land Office were present for sampling. (5) 5 composite samples were collected along the release paths as demonstrated in the attached photos at 1 foot below grade surface. Sample path was each 100' x2' in length. Photos will demonstrate that no staining was observed. All analytical results came below regulatory standards
